## KAZ: CAREC Corridors 1 and 6 Connector Road (Aktobe–Makat) Reconstruction Project

# Semi-Annual Environmental Monitoring Report

Project No.: 3416-KAZ  
Reporting Period: July-December 2019

## **REPUBLIC OF KAZAKHSTAN: CAREC CORRIDORS 1 AND 6 CONNECTOR “AKTOBE-MAKAT” ROAD RECONSTRUCTION PROJECT (SECTION KM160-330)**

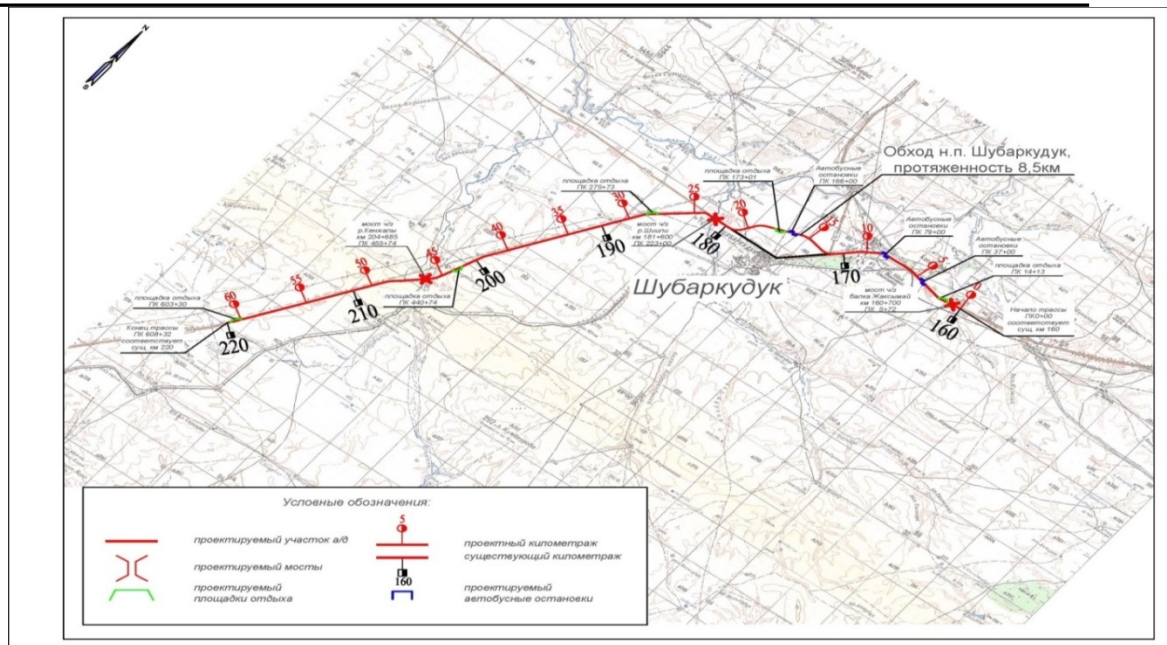
10. Lot 1: Km160 - km220 (Shubarkuduk - Karaulykeldy villages): This section includes reconstruction of the road from category III to category II with a total length of 60, 833 km and construction of one bypass. A detour of Shubarkuduk (km 172+600 to km 181+100) will take place along the new route. Figure 2 below shows the layout of Lot 1.

Figure 2. Lot 1 section scheme

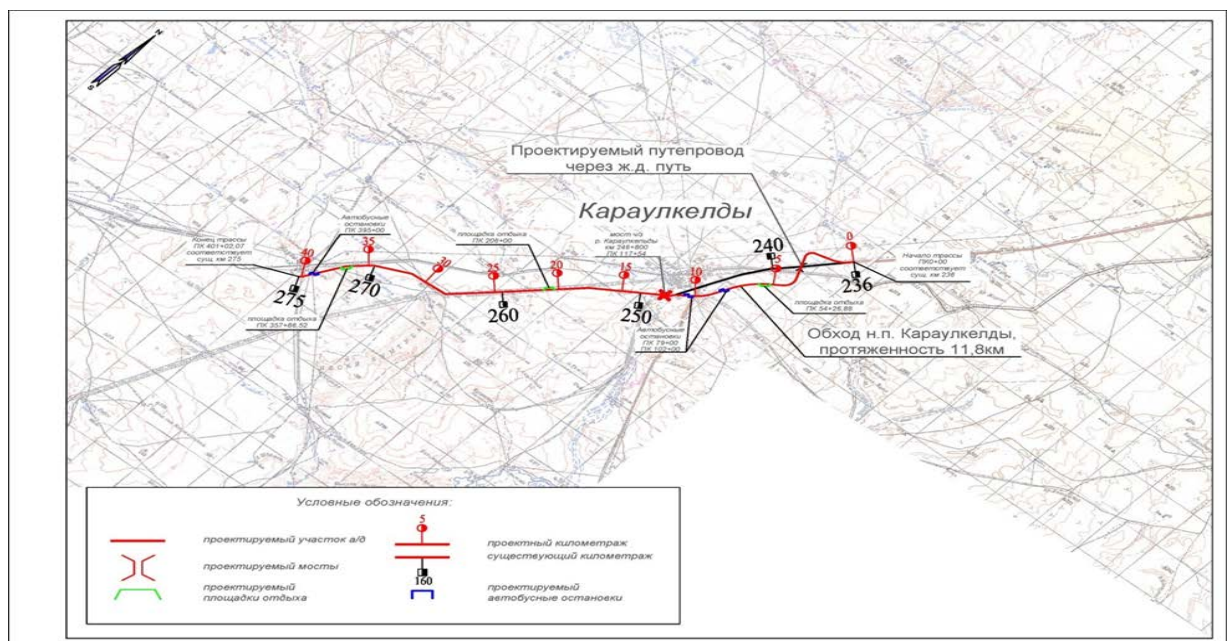
11. Lot 2: km 236 - km 275 (Karaulykeldy village): This section includes reconstruction of road from category III to category II with a total length of 39 km and construction of one bypass. The bypass of Karaulykeldy (km 236 to km 247) (11.8 km) will pass along a new road. Other parts of this section, the direction of traffic flow coincide with existing pavement with partial slopes from the embankment in straight and curve area. In this section, the project envisages construction of 1 bridge and 1 overpass. The following Figure 3 shows the scheme of the lot 2.

Figure 3. Lot 2 section scheme.

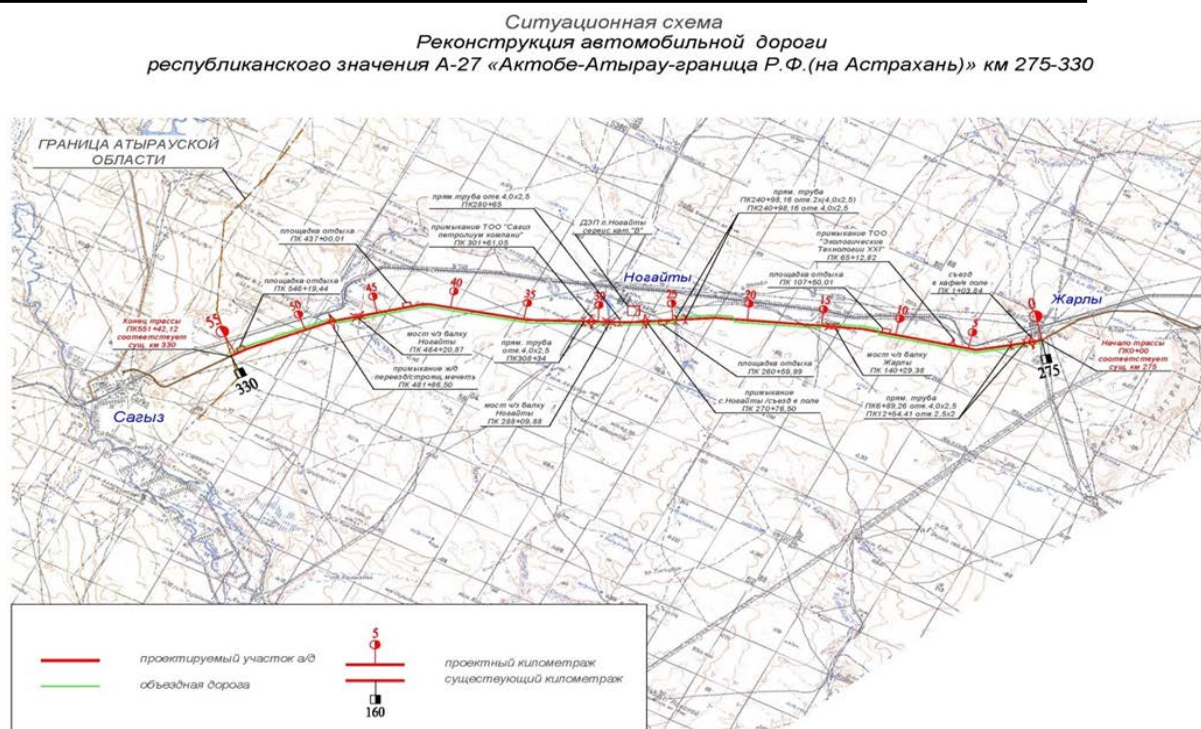
12. Lot 3: km 275 - km 330 (Zharly v.—Nogaity v.): This section includes reconstruction of road from category III to category II with a total length of 55 km. Other parts of this section, the direction of traffic flow coincide with existing pavement with partial slopes from the embankment in straight and curve area. Figure 4 below shows Lot 3 section scheme.

Figure 4. Lot 3 section scheme.

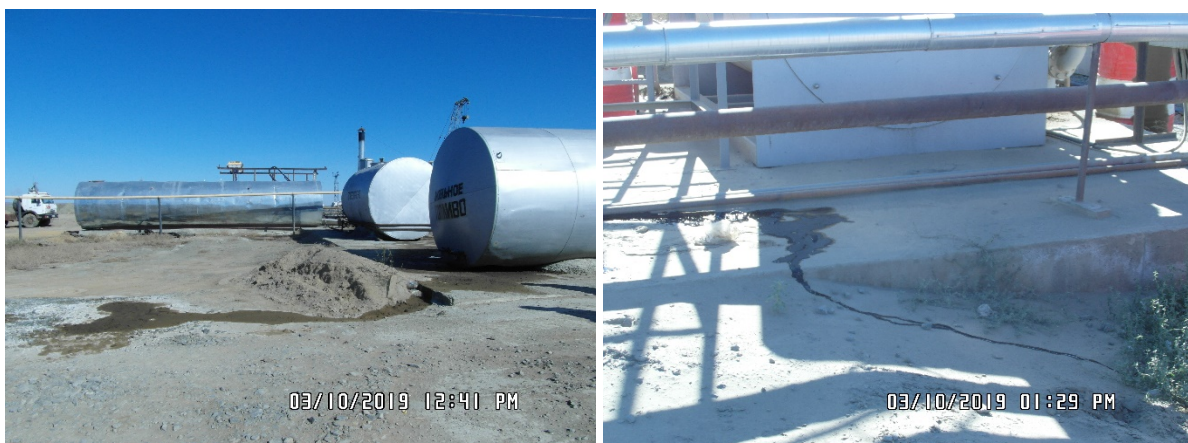
- Local fuel and lubricant spills at the Zhaksymay production base in the area of the mechanical repair shop and at the fuel and lubricant storage site

Figure 6. Fuel and oil spills to the concrete foundation at the Zhaksymay PB, October 2019

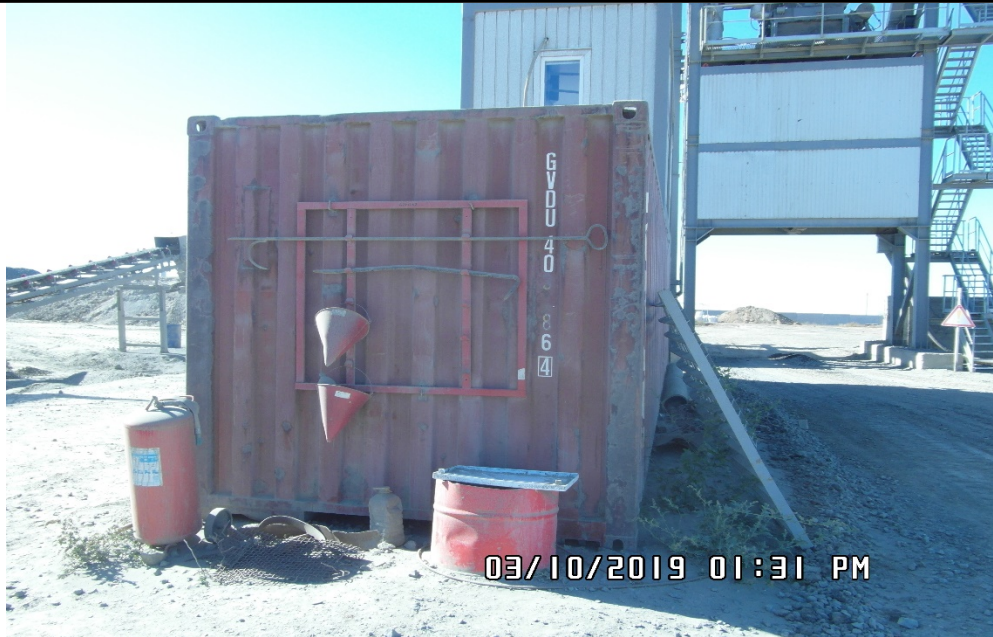
- Failure to equip fire shields with resources to eliminate emergency fuel and oil spills

Figure 7. Unequipped fire shield at the asphalt plant, October 2019

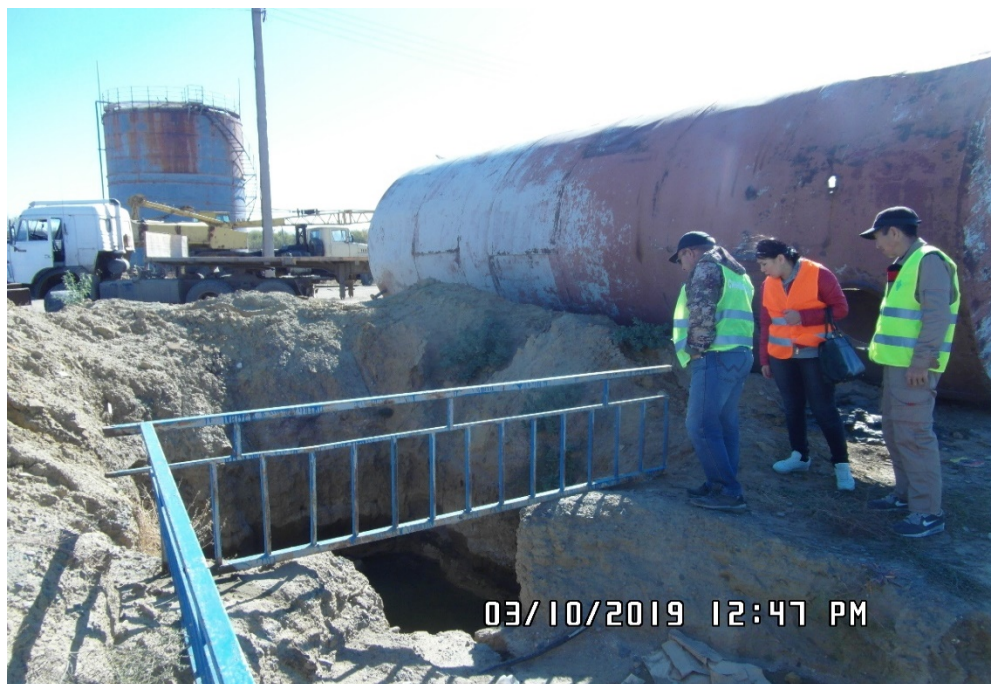
- There is a spontaneous disposal of production waste on the territory of asphalt plant

Figure 8. Unorganized spontaneous disposal of liquid industrial waste in "Zhaksymay" PB, October 2019

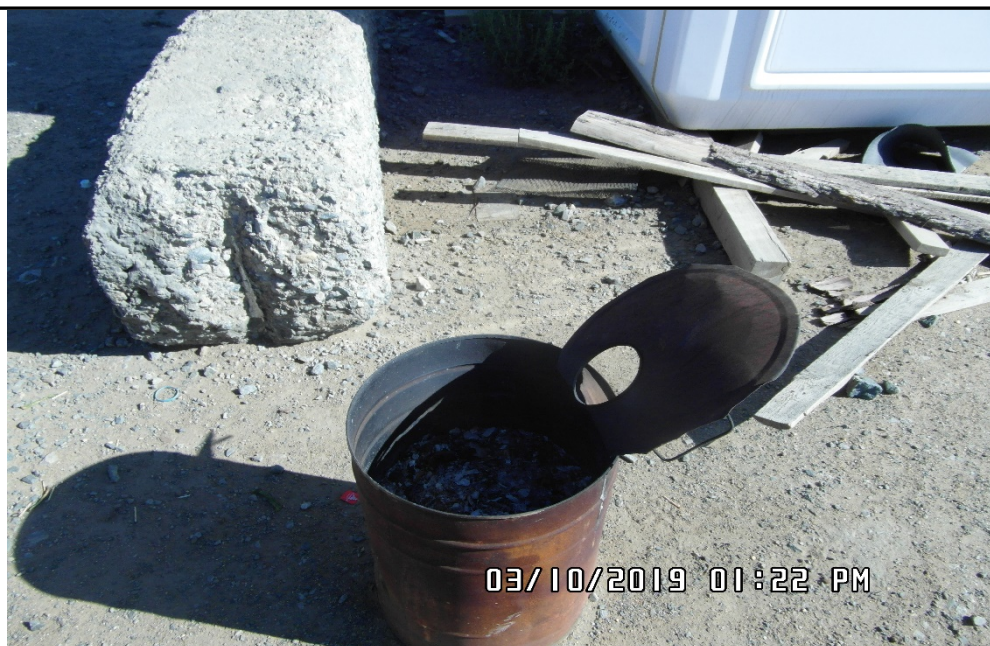
- There is no control over the segregation of waste and solid waste at the site of the Contractor's laboratory; residues of waste incineration are observed.

Figure 9. Violation of the requirements of the EC RK on the prohibition of burning solid waste, October 2019

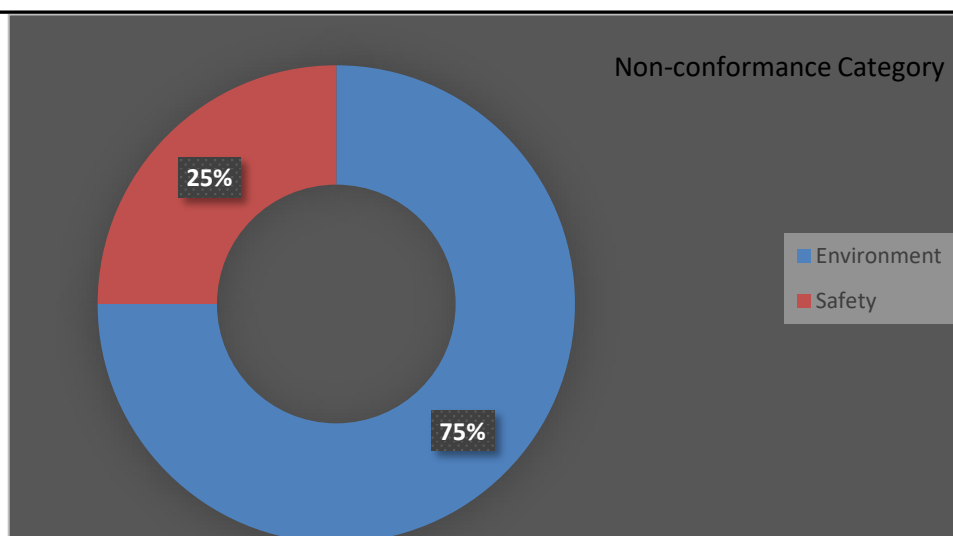
Figure.10 Non-conformance category diagram

54. The diagram in Fig. 6 shows the categorization of non-conformities for the reporting period. Compared to the previous period (first half of 2019), when environmental protection accounted 62%, 75% of the total number of identified non-conformities were recorded in the reporting period. Security in the previous period accounted 15%, in the reporting period - 25%. Positive dynamics in social impact and health safety is noted. If in the previous period accounted 15% and 8% respectively, then in the reporting period for these two categories there were no non-conformities. This positive dynamics by categories of social impact and health safety is the result of active monitoring and evaluation of the sites by the Engineer and the Contractor's responsible specialists. Similar work should be strengthened by environmental specialists at the sites.

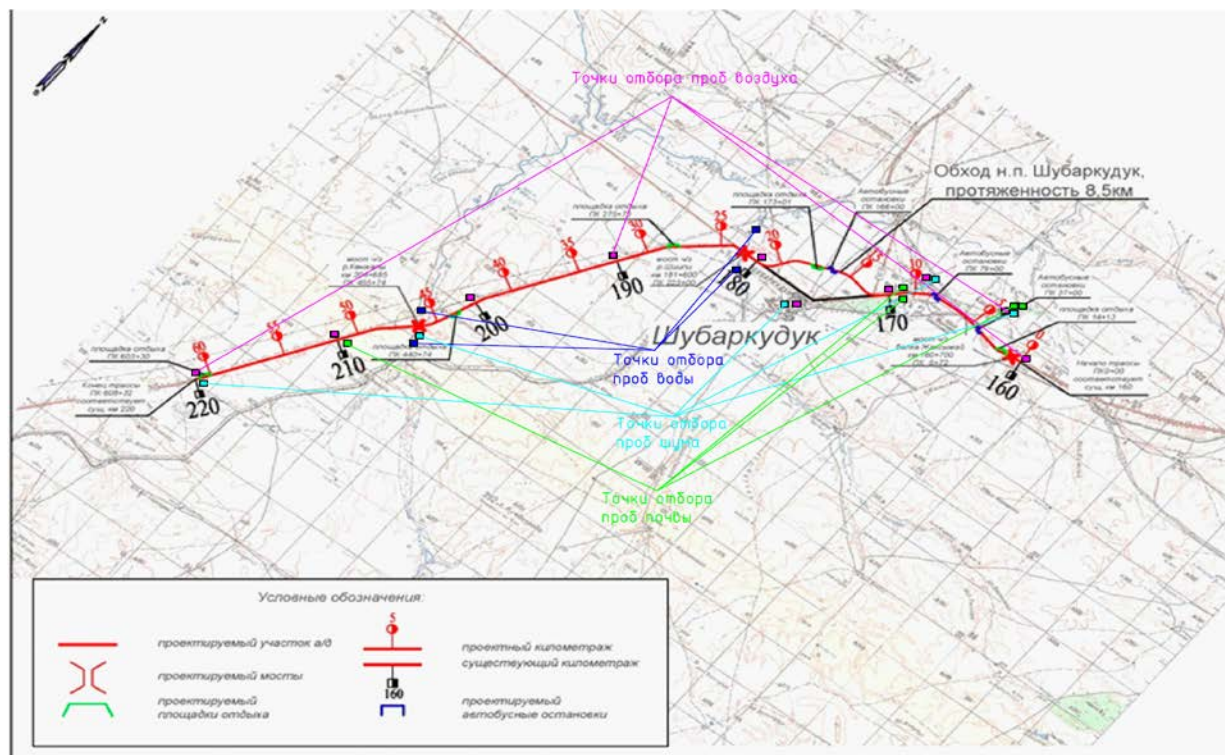
64. On lot 1, measurements of vibration and noise level, soil sampling was carried out in accordance with the approved scheme of sampling points. Figure 11 below shows a diagram with sampling points and measurements of vibration and noise levels.

Figure 11: Situation diagram with water sampling points (dark blue), noise and vibration measurements (light blue), air (pink) and soil sampling (green) on Lot 1

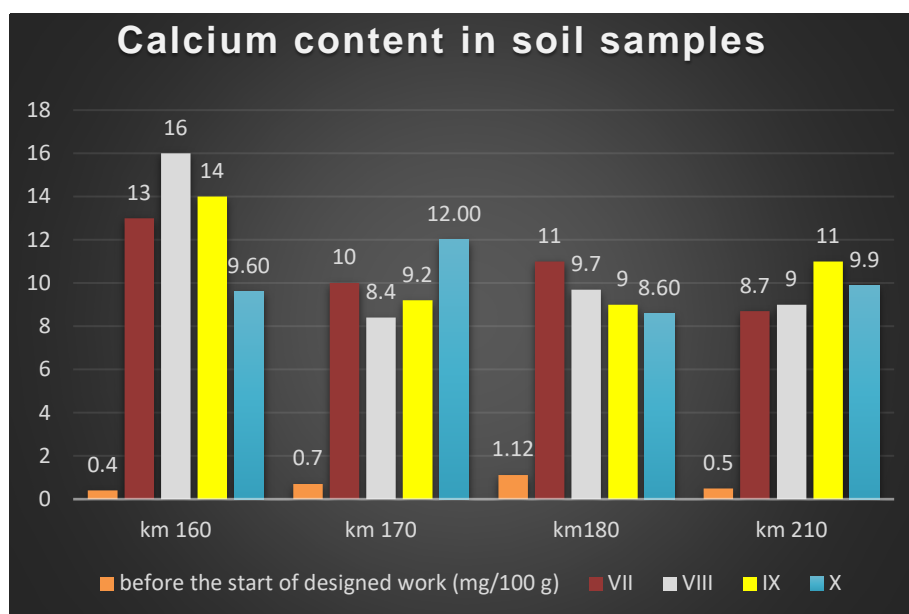
Figure 12. Dynamics of changes of calcium content in soil samples - Lot 1 road section

74. During the primary measurement at Km 160, a calcium value of 0.4 mg / 100 g was recorded. But in July this indicator was already 13.0 mg/100 g, in August - 16.0 mg/100 g, in September - 14.0 mg/100 g and in October - 9.6 mg/100 g. On Km 170 earlier was recorded 0.7 mg/100 g, in July this indicator was already 10.0 mg/100 g, in August - 8.4 mg/100 g, in September - 9.2 mg/100 g and in October - 12.0 mg/100 g. At Km 180, the primary indicator for calcium was 1.12 mg/100 g, in July this indicator decreased to 1.0 mg/100 g, in August it rose to 9.7 mg/100 g, in September - 9.0 mg/100 g and in October 8.6 mg/100 g. Such a change in calcium is due to the calcium content in the materials used for the embankment construction on the sites. The increase in calcium content does not have a serious impact on the person and on the area where construction works are being carried out. The negative impact is possible on the cultivated plants, but there are no growing crops in these areas.

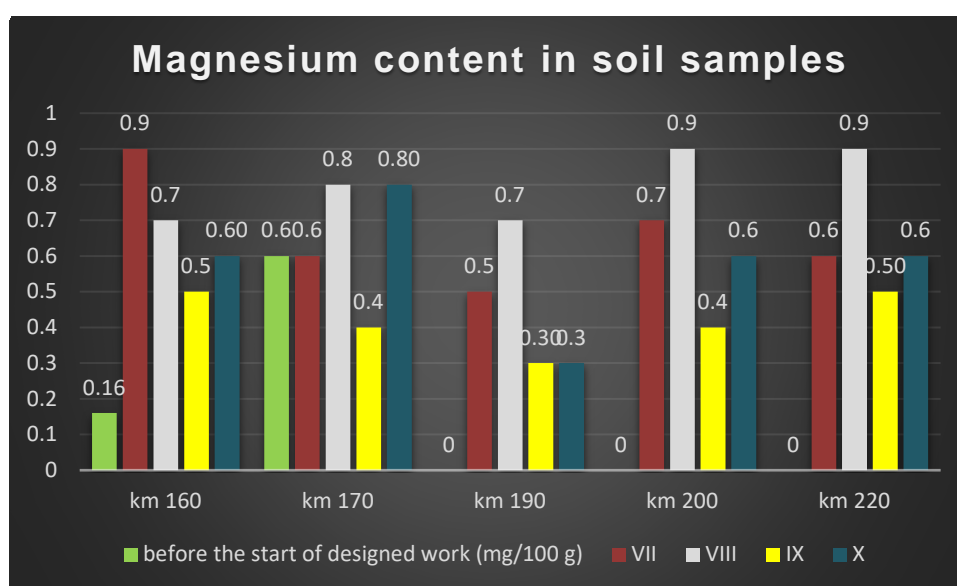
**Figure 13. Dynamics of changes in the magnesium content in soil samples Lot 1.**

76. On Km 160, at the initial measurement before start of the project, measurements of magnesium content showed 0.16 mg/100 g, and in July magnesium content 0.9 mg/100 g was recorded in this area, then there is a decrease in August and September to 0.7 and 0.5, respectively, and in October a slight increase to 0.6 mg/100 g. On Km 170 there is an increase in August and October to 0.8 mg/100 g. On Km 190, magnesium content increased in August to 0.7 mg/100 g. On Km 200 and Km 220 was an increase in magnesium content in August and October to 0.9 mg/100 g and 0.6 mg/100 g, respectively. Such changes in magnesium content as well as in calcium are due to content of these substances in materials used for construction of the embankment at construction sites. Increase in magnesium does not have a serious impact on humans and terrain where construction works are carried out. Negative impact is possible on cultivated plants, but there are no growing crops in these areas.

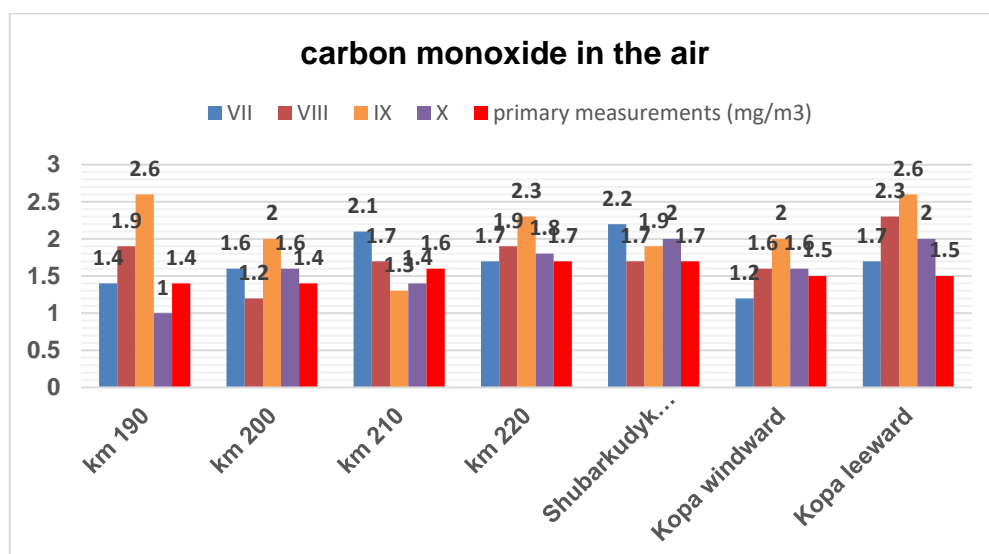
85. Measurements at Km 190, Km 200, Km 210, Km 220, at Shubarkudyk and Kopa villages indicate a slight excess of the values for carbon monoxide primary measurements made before start of construction work in 2018, but do not exceed the MPC of 5 mg/m<sup>3</sup>. The following figure 14 shows the excesses in the indicated sections.

Figure 14. Dynamics of changes in the content of carbon monoxide in the air on Lot 1 site.

86. The relief of the road, the mode of movement of construction equipment and the actual technical condition of the equipment have a significant impact on carbon monoxide emissions. Considering the fact that during acceleration and braking airborne monoxide content increases by almost 8 times in the exhaust gases, and construction work in the areas mainly work in this mode, it is understandable that excess of carbon monoxide in the areas with intensive work was carried out during this period.

87. Analysis of the data shows that due to heavy traffic of construction equipment and vehicles, maximum concentrations of carbon monoxide were recorded in July and September. In these months there were adverse weather conditions for the dispersion of carbon monoxide concentrations.

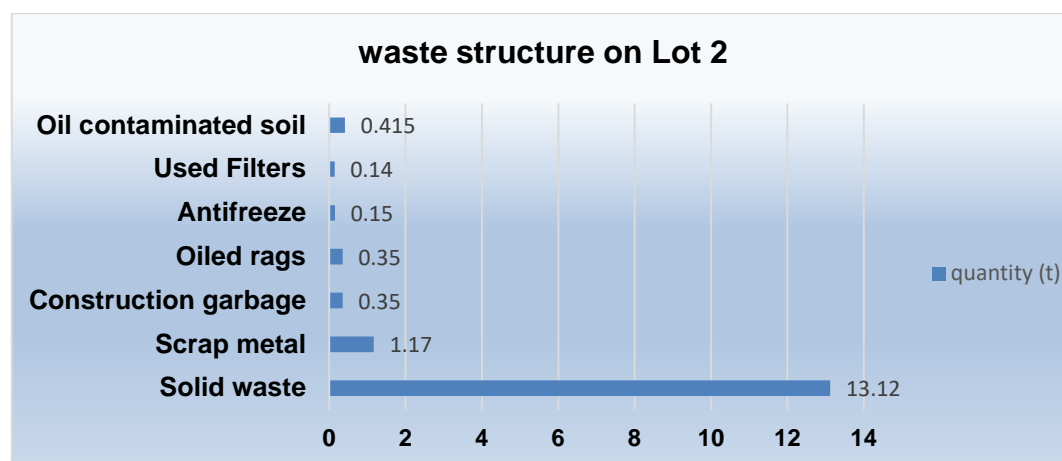
121. Composition of the total waste generation in Lot 1 is only solid waste. No other data was provided by the contractor. Lot 2 shows composition of the waste reflected below in Fig. 15. Lot 3 data are not reflected in the reports of the contractor.

Figure 14. Composition of waste in second half of the year on Lot 2

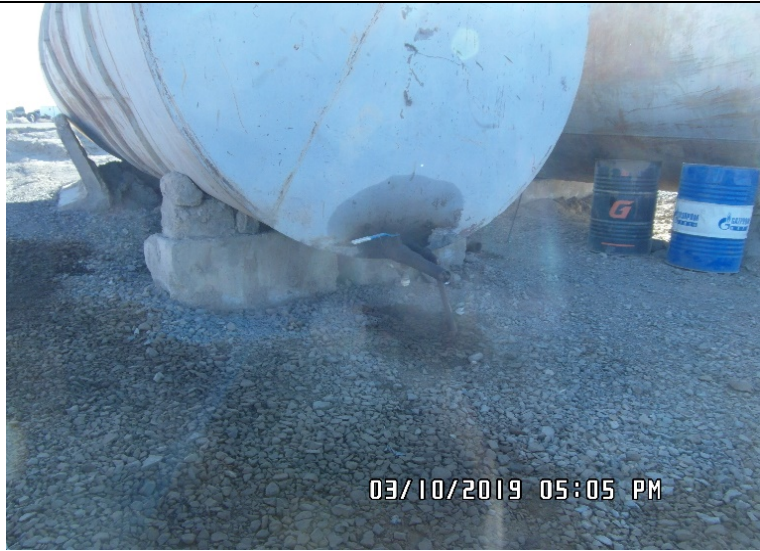
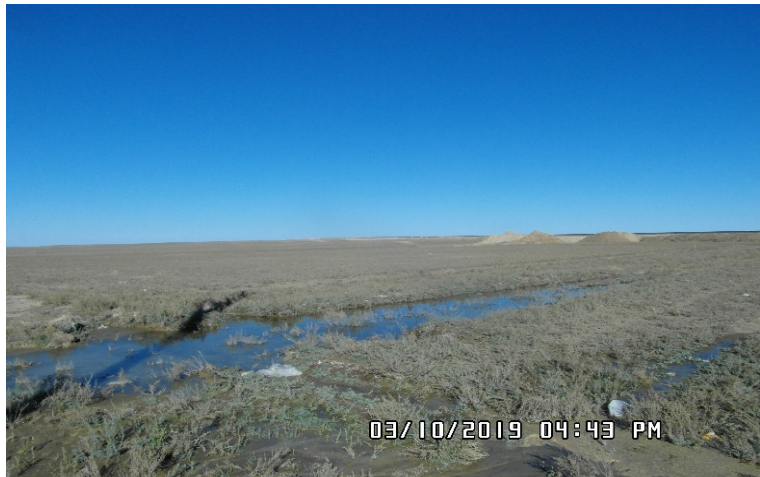
<p>Irrational use of water resources: a hose in the well which has constant discharge of water outside the base camp</p>	<p>Install valves at the well to prevent water spills or provide measures for use of water for dust suppression or other needs.</p>	<p>Major</p>	<p>07.10.2019</p>	<p>high</p>

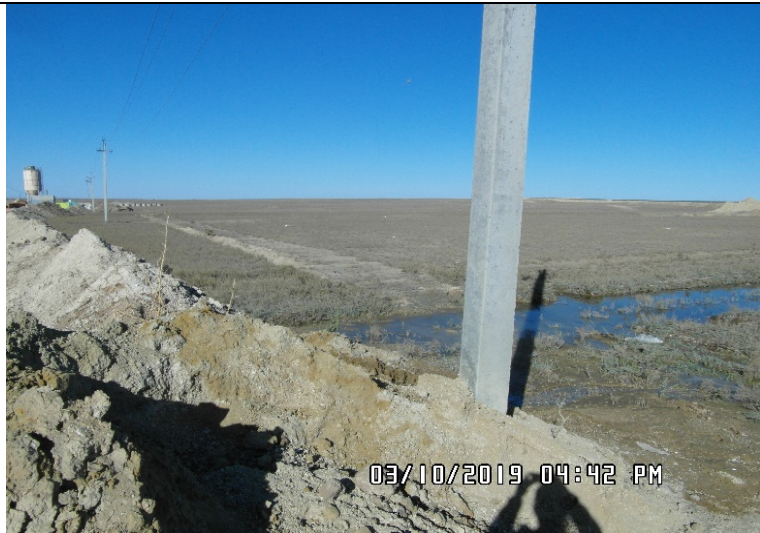
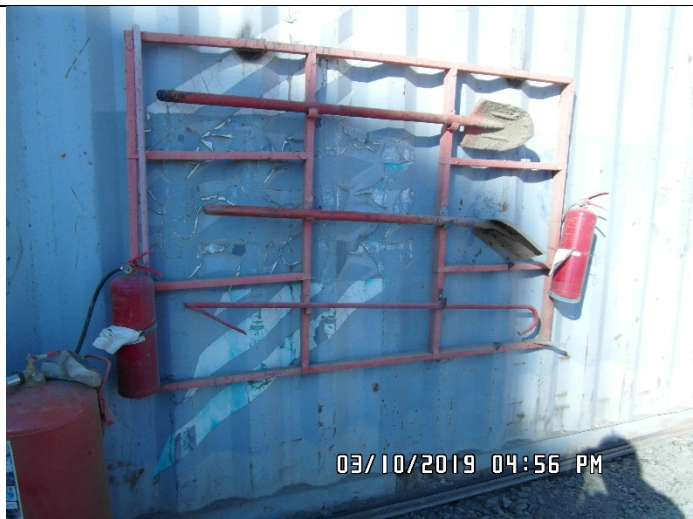
Fire fighting means are not observed at local gas station	<p>Check completeness and expiration dates of fire extinguishing equipment on the territory of the production base</p> <p>Brief with local gas station operator</p> <p>Conduct trainings for emergency cases at the production base and local gas station</p>	Major	07.10.2019	high
