Environmental Monitoring Report

KAZ: CAREC Corridors 1 and 6 Connector Road (Aktobe–Makat) Reconstruction Project

Reporting Period: January-June 2020

REPUBLIC OF KAZAKHSTAN: CAREC CORRIDORS 1 AND 6 CONNECTOR “AKTOBE-MAKAT” ROAD RECONSTRUCTION PROJECT (SECTION KM160-330)

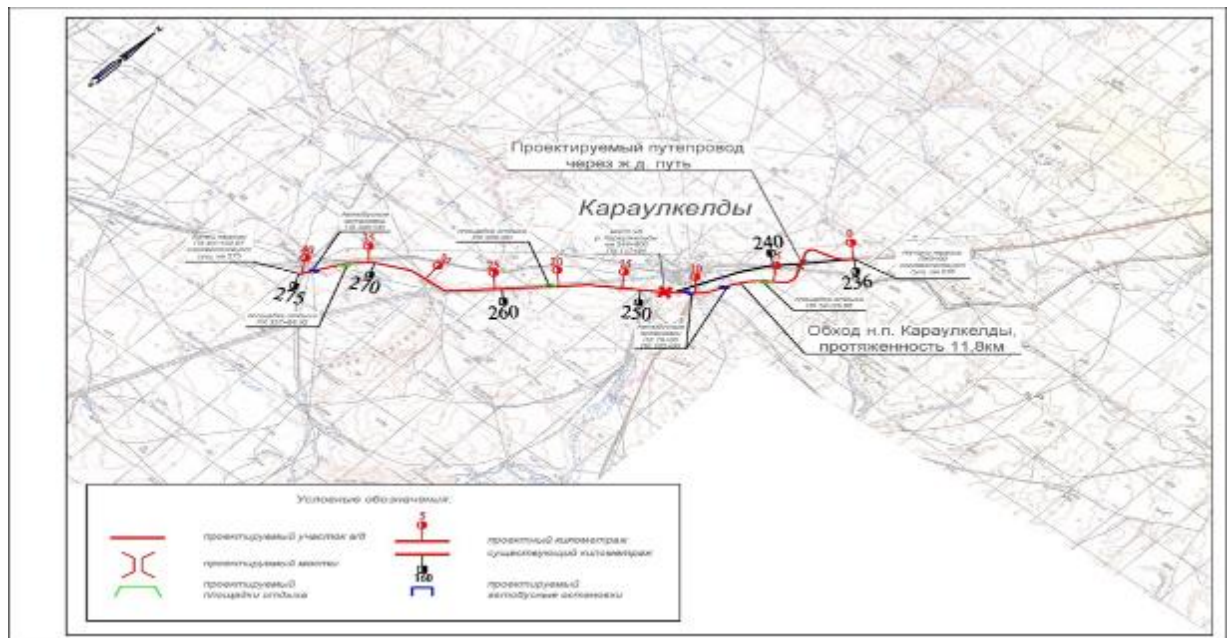
11. Lot 2: km 236 - km 275 (Karaulykeldy village): This section includes reconstruction of road from category III to category II with a total length of 39 km and construction of one bypass. The bypass of Karaulykeldi (km 236 to km 247) (11.8 km) will pass along a new road. Other parts of this section, the direction of traffic flow coincide with existing pavement with partial slopes from the embankment in straight and curve area. In this section, the project envisages construction of 1 bridge and 1 overpass. The following Figureure 3 shows the scheme of the lot 2.

Figure 3. Lot 2 section scheme.

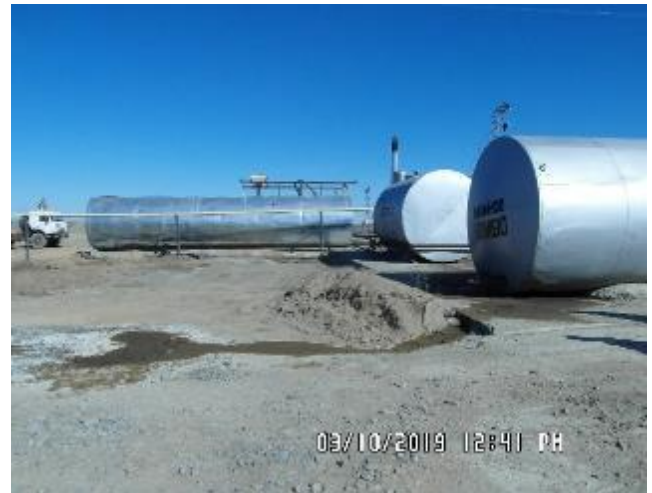
Audit on 03.10.2019

Figure 8. Fuel and oil spills to the concrete foundation at the Zhaksymay PB, October 2019 and March 2020

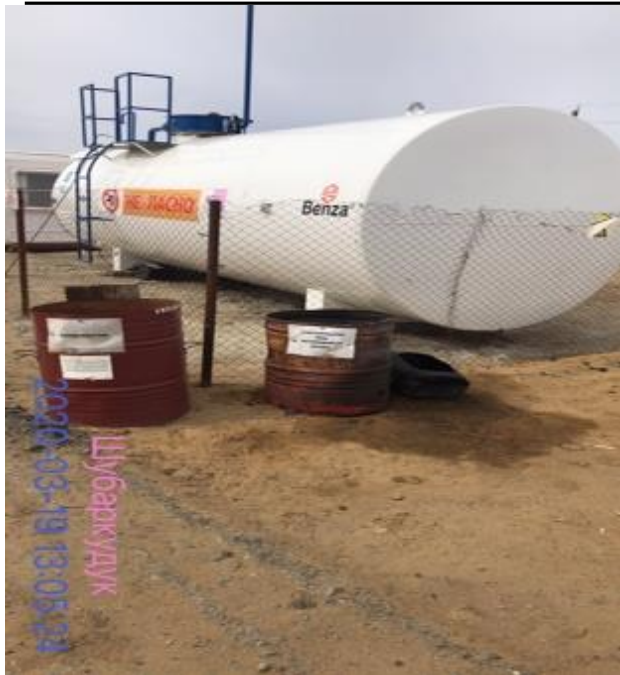
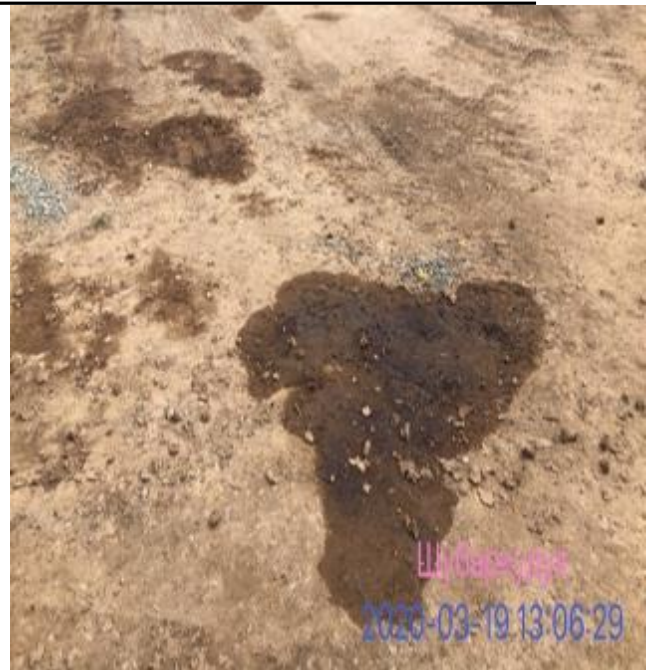
- Local fuel and lubricant spills at the Zhaksymay production base in the area of the mechanical repair shop and at the fuel and lubricant storage site

Audit on 19.03.20

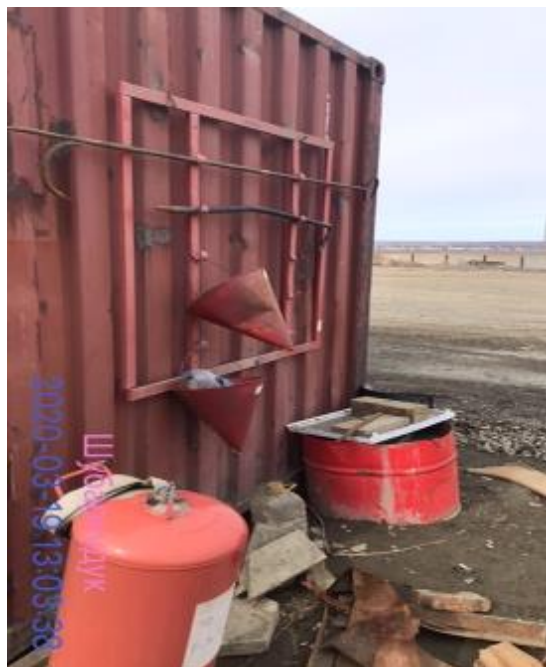
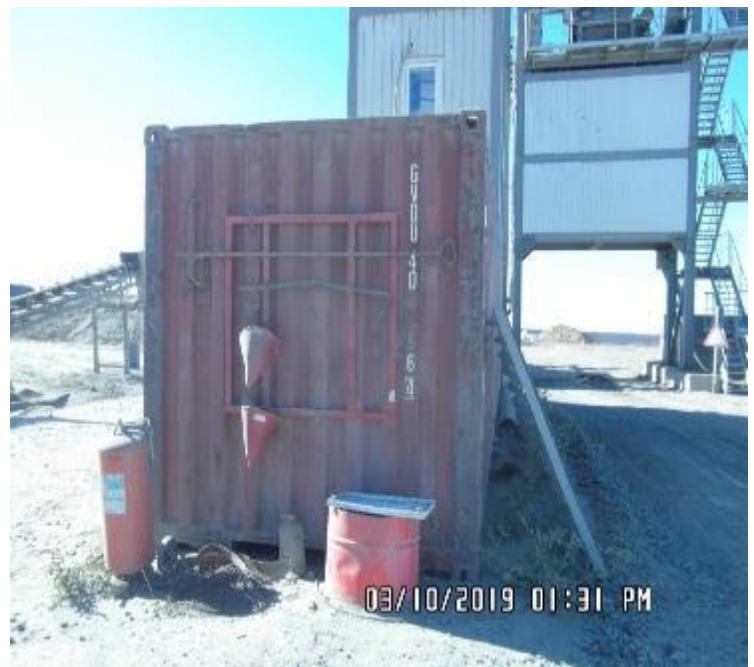
Figure 9. Fire shield at the asphalt plant of Lot 1 Zhaksymay PB, comparison of the situation between the audits

- Failure to equip fire shields with resources to eliminate emergency fuel and oil spills

Audit on 19.03.2020

Audit on 03.10.2019

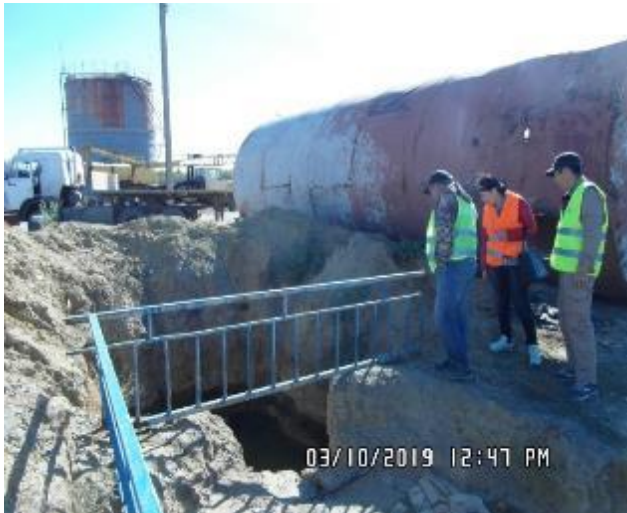
Figure 10. Production base "Zhaksymay", Lot 1 comparison of situations between audits

- There is a spontaneous disposal of production waste on the territory of asphalt plant

Audit on 03.10.2019, unorganized runoff of liquid waste.

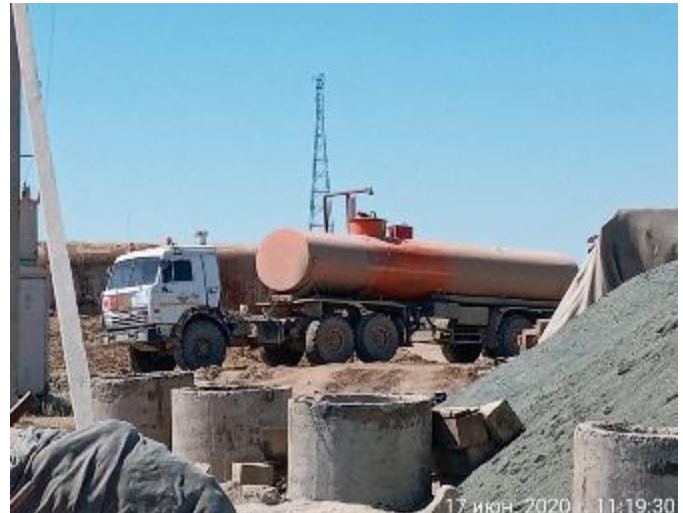
Audit on 17.06.2020, reinforced concrete rings for arranging a septic tank for collecting liquid waste

115. In the previous period, the recorded non-conformity in organization of a place for collecting liquid waste produced by the plant for reuse for the purpose of dust suppression was brought into proper condition during the reporting period. Reinforced concrete rings were installed to collect liquid industrial waste and prevent groundwater pollution. This type of waste is used in dust suppression

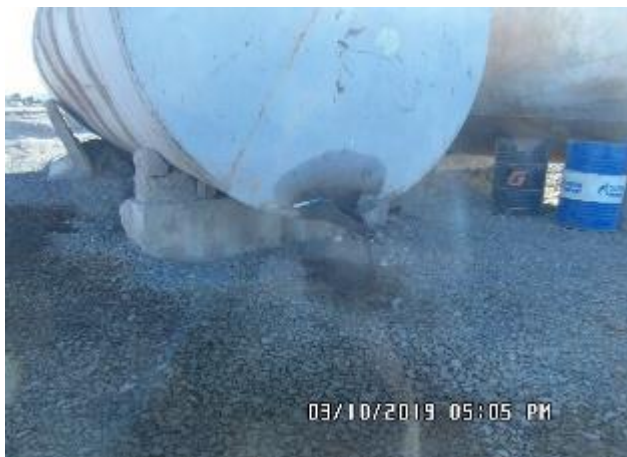
Figure: 11. Comparison of the fuel storage site between audits

Spills at the storage site for fuels and lubricants, Production base of Karaulkeldy settlement, Audit in October 2019

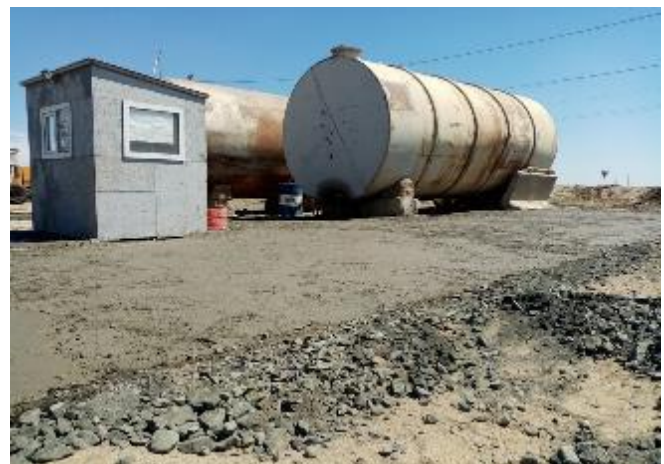
Concreting of the site under the storage tank for fuels and lubricants, Production base in Karaulkeldy village, Audit in May 2020.

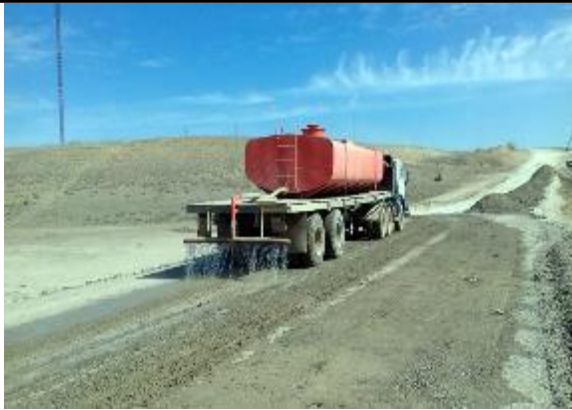
Fig. 14. Dust suppression on Lot 2, 18 June 2020
