Environmental Monitoring Report

Project Number: 51132-002
Semestral Report (July to December 2021)
May 2022

Georgia: Sustainable Water Supply and Sanitation Sector Development Program

Prepared by the United Water Supply Company of Georgia for the Government of Georgia and the Asian Development Bank.

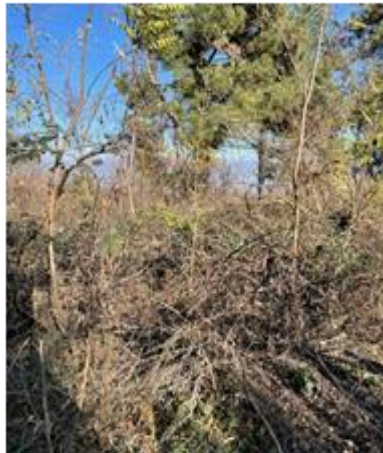
Date of Visit	Name of Company & Name of Contract	Auditors Name	Purpose of audit	Summary of any Significant Findings	Implemented Actions	Implementation Status
Continuously during reporting period (July-December 2021)	China Geo-Engineering Corporation Telavi Water Supply Sub-project, TEL-01	Environmental Specialist of Supervision Company Temelsu International Mrs. Ketevan Chubabria	Compliance with Environmental safeguard requirements	Environmental issues on construction sites	Prepare Quarterly and Semiannual Environmental Monitoring Reports and send to UWSCG; Issue Non-compliance Notices	Completed in December 2021
22 November 2021		Environmental Specialist of SC Mrs. Ketevan Chubabria	Regular monitoring of sites	<p>During the site visit, the construction activities were suspended due to the COVID situation, and the Contractor did not present at sites. No activities were observed at construction sites.</p> <p>Photo 1</p>

No actions were implemented	No actions were required

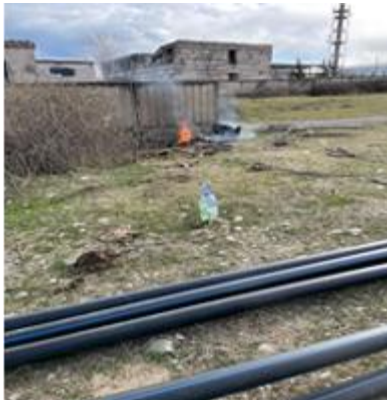
22 December 2021		Environmental Specialist of SC Mrs. Ketevan Chubabria	Regular monitoring of sites	<p>As the Camp site has already been organized, it's the time to arrange hazardous waste materials and waste storage area, the area shall be organized in accordance with local legislation and ADB Initial Environmental Examination.</p> <p>There is no environmental personal on board.</p> <p>Waste collection points shall also be identified, and sufficient number and quality bins shall be labeled and placed.</p> <p>The Contractor shall elaborate the Company's waste management plan that need to be submitted to the Ministry of Environment Protection and Agriculture for approval.</p> <p>Contractor shall have a layout of the project</p>	<p>Verbal instruction was given to contractor to immediately improve the situation and stop unsafe activity.</p> <p>Environmental Training was conducted on site to raise awareness of the workers.</p> <p>Non-compliance Notice was prepared and sent to the Contractor (please see Annex B)</p>	The additional training session is planned to be organized in February 2022, the agenda, signed list of participants and relevant photos will be presented in the next SAEMR, July-December 2022.

Date of Visit	Name of Company & Name of Contract	Auditors Name	Purpose of audit	Summary of any Significant Findings	Implemented Actions	Implementation Status
				<p>area which will indicate location of temporary storage area of topsoil, workshops, hazardous materials waste storage area, etc.</p> <p>The site reinstatement and Re-cultivation plan shall be elaborated.</p> <p>All personal shall undergo environmental management training before commencement of construction activities and the training matrix and log shall be maintained</p> <p>The weather was windy and cold, and the workers built a fire to keep warm, which created a risk of fire spreading due to the wind and dry bushes next to the fire.</p> <p>Photo 3</p>

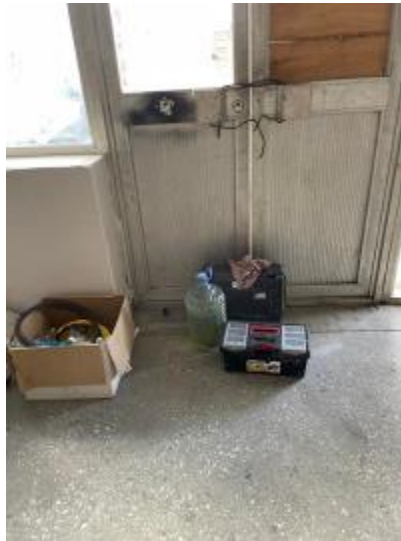
Date of Visit	Name of Company & Name of Contract	Auditors Name	Purpose of audit	Summary of any Significant Findings	Implemented Actions	Implementation Status
				<p>As the Camp site has already been organized, it's the time to arrange hazardous waste materials and waste storage area, the area shall be organized in accordance with local legislation and ADB Initial Environmental Examination.</p> <p>Photo 4</p>

Ongoing as the deadline still open

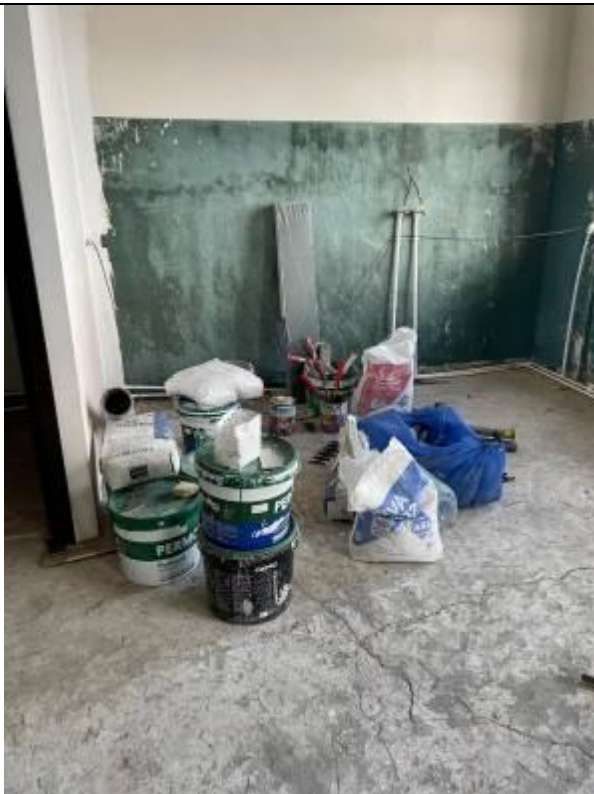
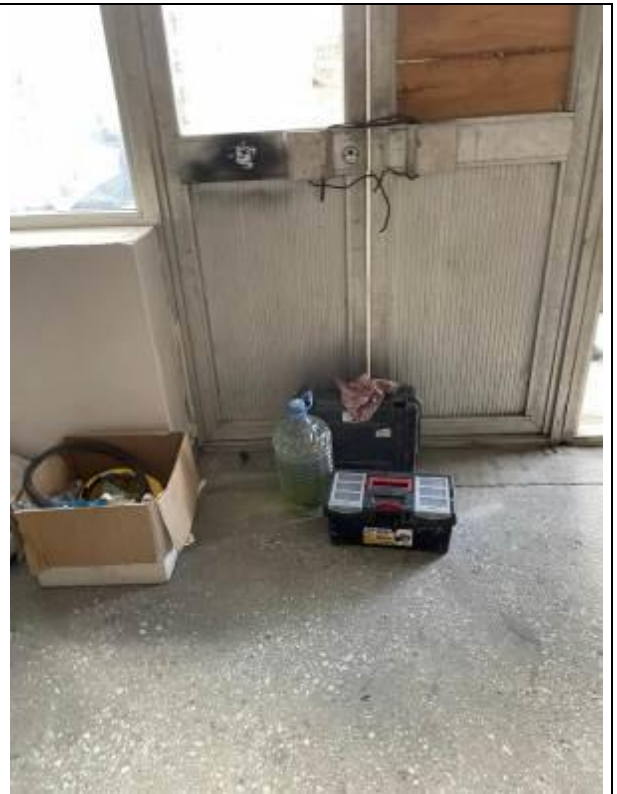
During the site visit we inspected the Camp site of the contractor. The area seems to be abandoned factory or technical yard, which is leased by Contractor for the Camp. No arrangement has been organized; only two-three rooms are renovated for offices. There is no material storage area, all type of materials is placed together in unorganized way; no hazardous materials and waste storage areas are arranged, there is no construction machinery parking area. Etc.

Photo 1 and 2: The way how the materials are stored at Camp site, this is a main entrance of the building

- As the Camp site has already been organized, it's the time to arrange hazardous waste materials and waste storage area, the area shall be organized in accordance with local legislation and ADB Initial Environmental Examination.

- Contractor shall have a layout of the project area which will indicate location of temporary storage area of topsoil, workshops, hazardous materials waste storage area, etc.

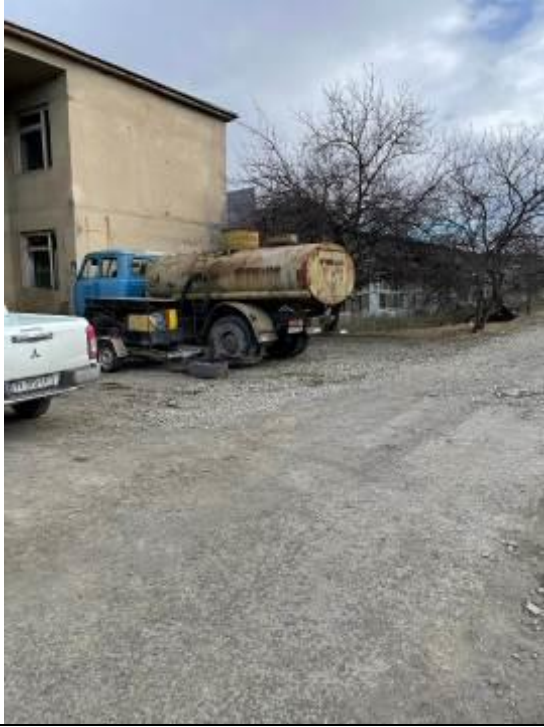
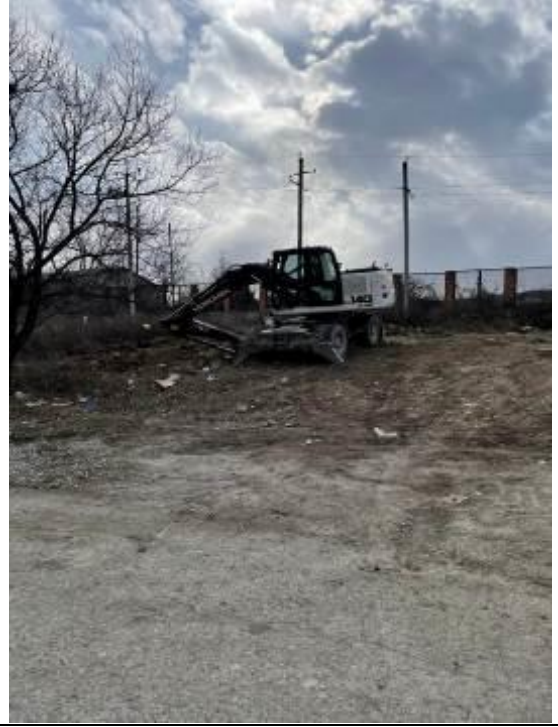
During the site visit it was observed that progress of the Contractor is too low. Only two teams worked on excavation works. One of the teams worked next to the Camp Site. We observed violation of environmental and Health and safety rules at active sites. The weather was windy and cold, and the workers built a fire to keep warm, which created a risk of fire spreading due to the wind and dry bushes next to the fire. Worker were not equipped with Personal Protective Equipment that would protect them from cold weather and wind. Besides, diesel in plastic bottle was placed next to the bonfire. Diesel is flammable substances and classified as hazardous materials, Contractor shall organize storage of hazardous materials and waste at specially arranged hazardous material and waste storage area. No refueling is allowed at the construction site.

Photos 3 and 4: Illustration of spontaneous parking of construction machinery

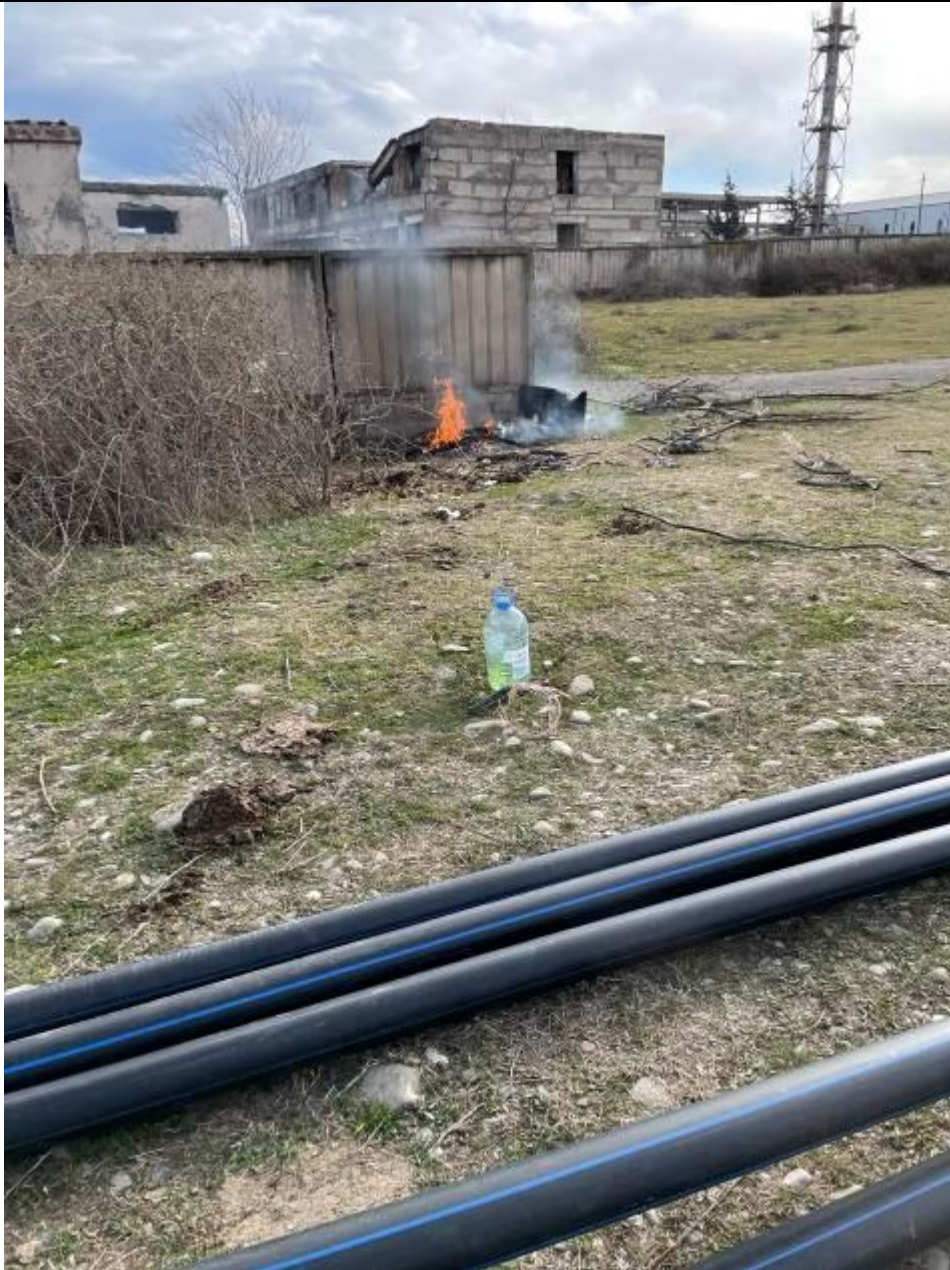
Photo 5: Fire lit for warming next to the dry bushes and diesel containing bottle
