Semi-annual Environmental Monitoring Report

Emergency Assistance Project

ADB Project 52174-001 | Grant 0582-BAN | TA 9546 BAN

Third Semi-Annual Environmental Monitoring Report

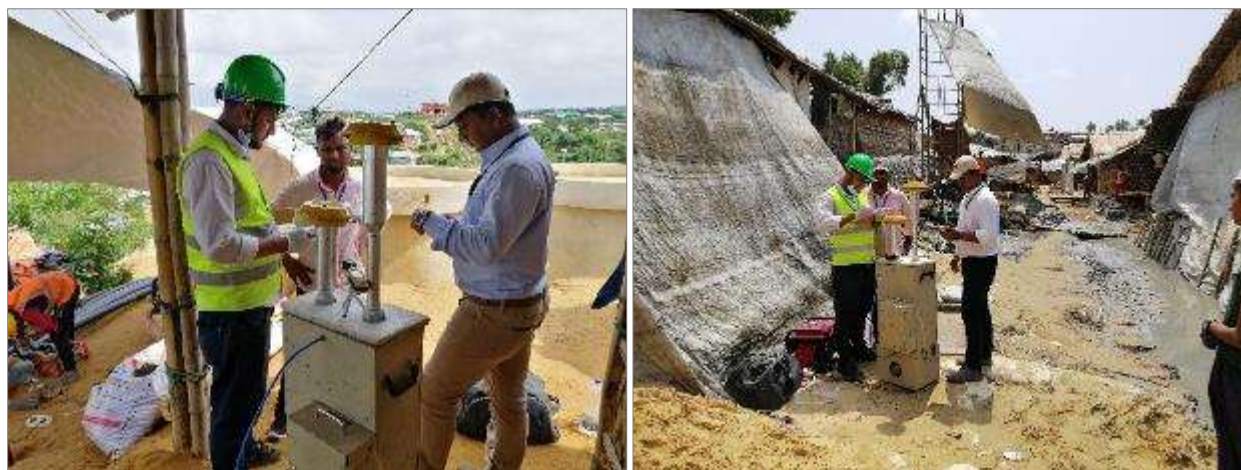
Figure 6 Air quality monitoring in DPHE/W2 site

86 Ambient air quality data at the project site measured to verify the current quality of air. The aim was to collect the existing air quality data and to compare the data with the air quality data during future project activities to check if there is any high air pollution level due to the construction activities and to design adequate mitigation measures, as applicable. Dispersal of pollutants depends upon factors like prevailing wind direction and other weather conditions, atmospheric stability, height of the source. The air quality testing was performed at the project area from 02 October 2019 to 03 October 2019 (**Figure 6**). Filter and each chemical were measured before testing. Electro-Chemical Sensor device were calibrated before testing some other parameters. Results of the air quality monitored at the project location have been showed in **Table 14**. The details of this result are shown in Appendix III of this report.

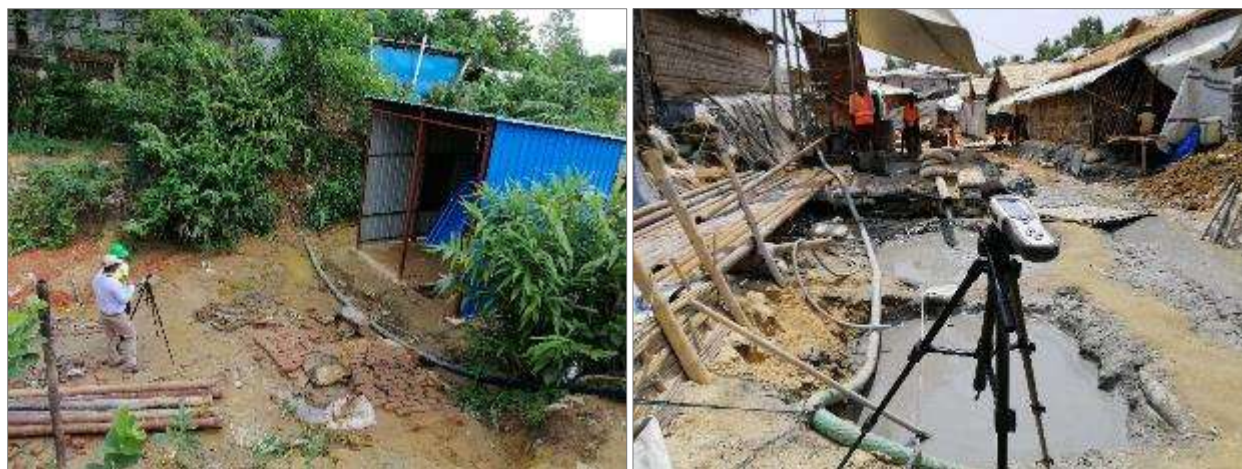
Figure 7 Noise level monitoring in DPHE/W2 site

92 Noise level data were collected from 05 project locations during day time from 02 to 3 October 2019 (**Figure 7**) for 2 hours. Noise level measurement device was calibrated before noise level measurement. Result of the noise level monitored along with details of the sampling locations have been showed in **Table 15**. The details result is given in Appendix III of this report.

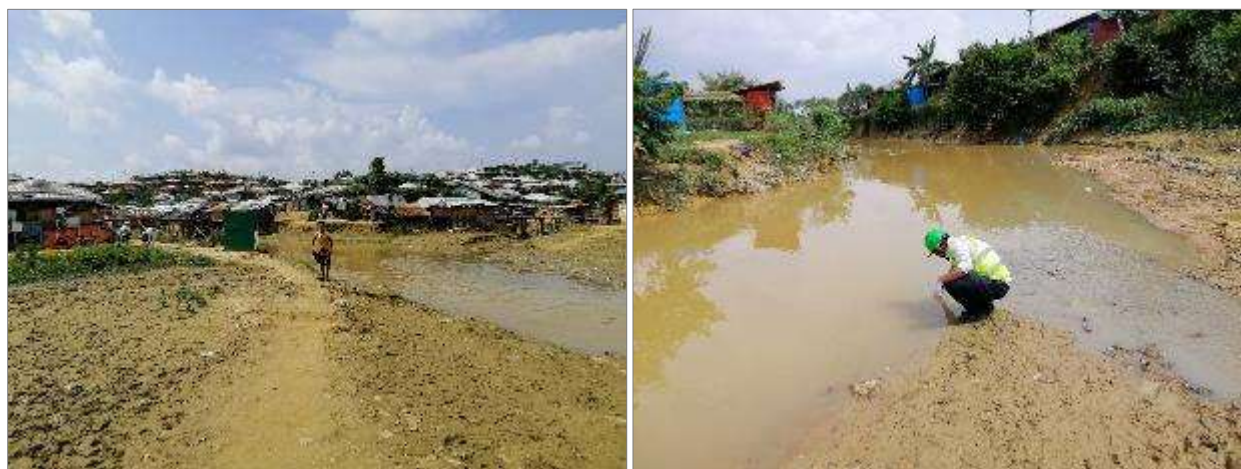
Figure 8 Surface water sampling and onsite testing in DPHE/W2 site

94 The surface water sample was collected on 3 October 2019 from a large canal flows through camp 8W (**Figure 8**). EZDO-8200 Multi-meter was used the conduct the on-site test of pH and EC for surface water. The collected samples have been sent to Department of Public Health Engineering (DPHE) for other remaining parameters. Before collecting water sample, sample bottle was washed with distilled water. Results of the surface water quality at the project location have been showed in **Table 16**. The Laboratory test result is given in Appendix III of this report.

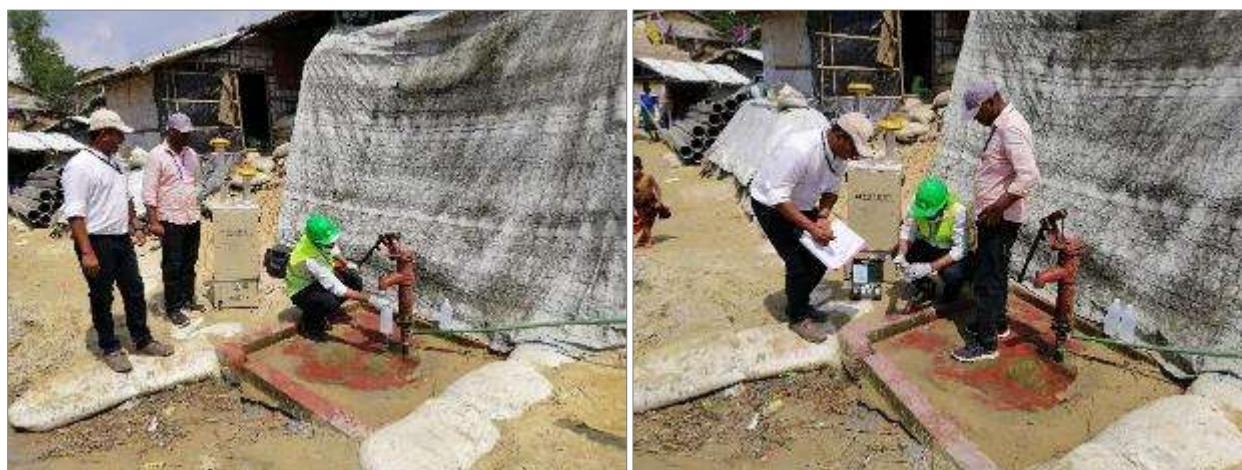
Figure 9 Groundwater sampling and onsite testing in DPHE/W2 site

104 Groundwater sample is collected from shallow tube well in Water Distribution Zone: 8W.8, Camp: 8W (**Figure 9**). The depth of the tube well is around 100ft. It is used for drinking and bathing purposes. EZDO-8200 Multi-meter was used to conduct the on-site test of pH, EC and TDS for groundwater. The groundwater sample was collected on 3 October 2019. The bottle was washed by distilled water before using for water sample collection. Results of the groundwater quality at the project location have been showed in **Table 17**. The Laboratory test result is given in Appendix III of this report.

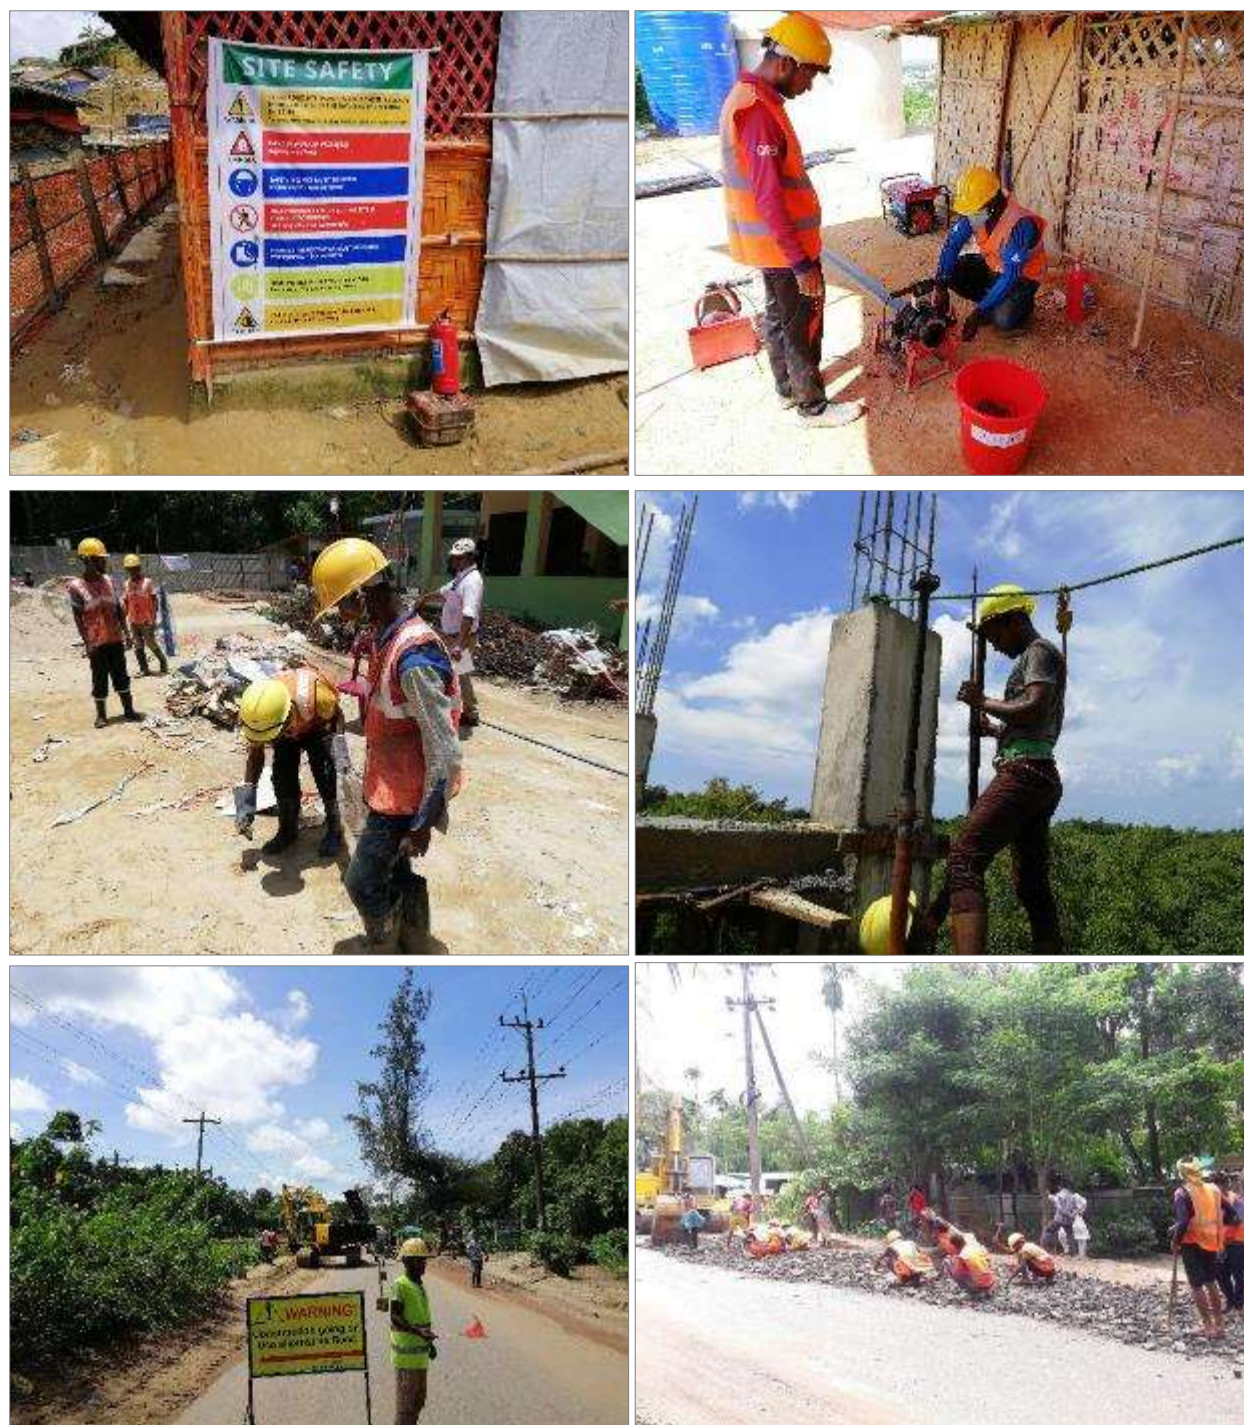
Figure 11 Safeguards status at various sites. Most of them found as partially to fully satisfactory

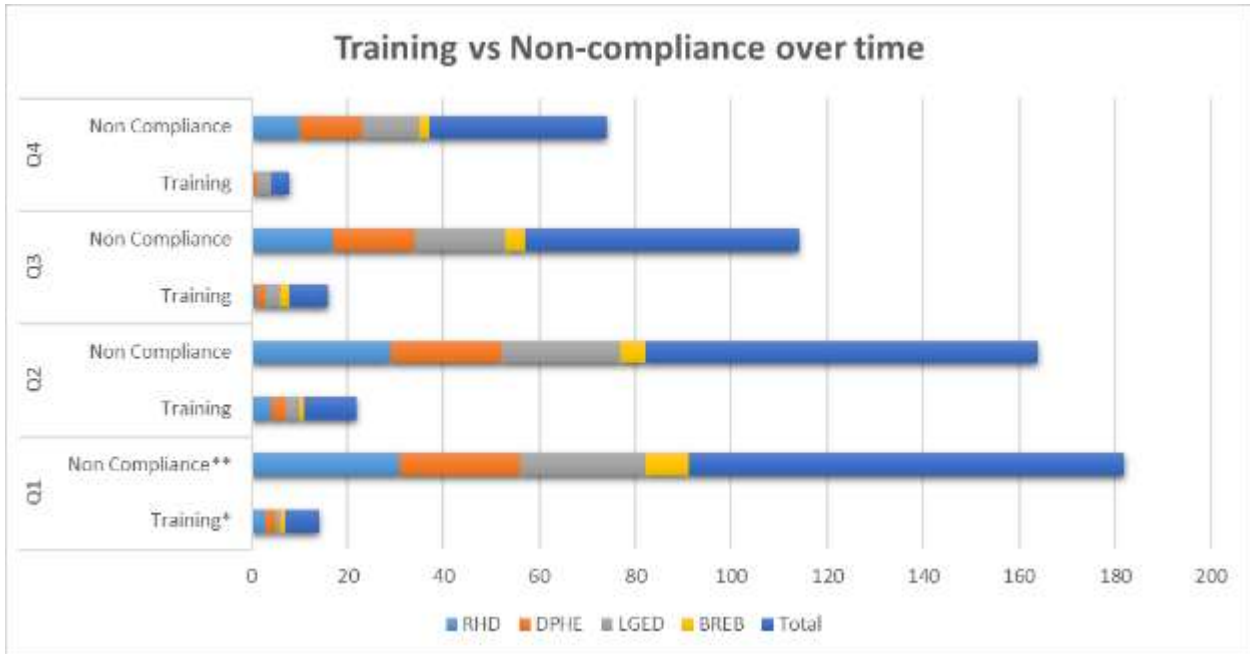
120 **Trend in performance:** A time trend analysis for EMP non-compliance has been studied against hands-on training provided to the workers for the time period of year 2019. It has been found that the non-compliance is increasing over time with a steady input of hands-on training for workers. **Figure 13** and **Figure 14** explains the situation in detail. Given the comparative study, it can be concluded that steady and continuous training can improve the H&S situation at site and may produce better EMP compliance.

Figure 13 Training vs EMP non-compliance over time (information of year 2019) **indicate information up to November 2019

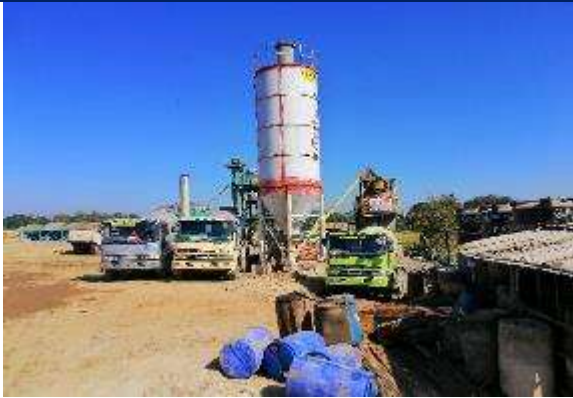
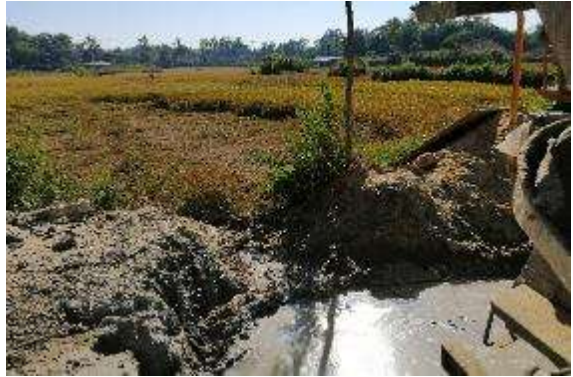
Issues	Observation	Corrective Action	Deadline	Responsibility	Photograph
Management of Concrete batching plant	Concrete batching plant is operated in the camp located along the agricultural land is a potential source of waste water with high pH and turbidity level which is discharged directly to the adjacent paddy land.	Contractor must undertake the following measures: <ul style="list-style-type: none"> • No waste water to be drained to the paddy. • All runoff and wastewater is to be collected and contained onsite in a sufficiently large recycle tank/sedimentation pit. • Working and washout areas to be bunded to contain runoff. • Wastewater to be reused as part of the dust suppression system at earliest possible opportunity to restore storage capacity. • Reducing the volume of wash-up water used can reduce the buildup of waste water. 	1 st week of December 2019	Contractor and CSC

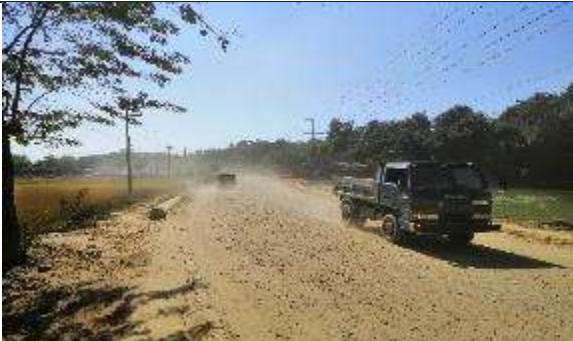
Dust pollution	Dust pollution is being occurred severely due to irregular dust suppression measure.	Contractor should spray water at least 4 times a day to reduce the dust level and also truck drivers should instruct to cover the top with a tarpaulin after loading the truck with soil at the source.	1 st week of December 2019	Contractor

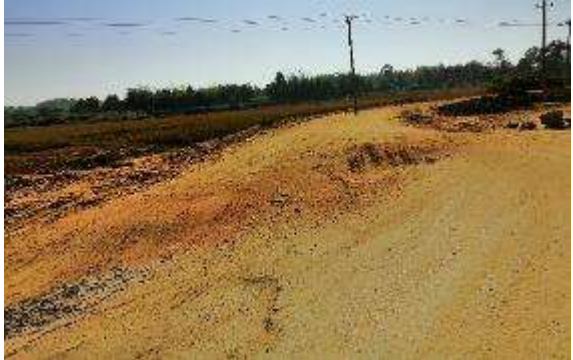
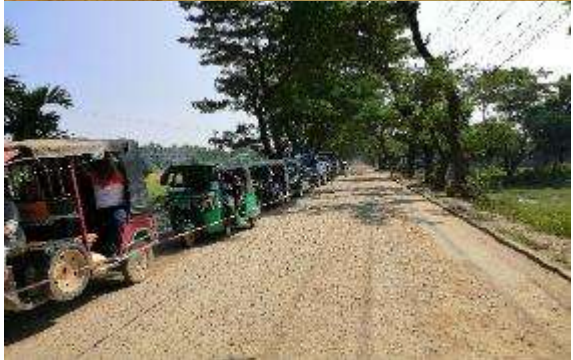
Issues	Observation	Corrective Action	Deadline	Responsibility	Photograph
Road Safety and traffic management	<ul style="list-style-type: none"> None of the road diversion section is equipped with warning signs and any safety barriers. No signal man is found on the busy road section as a result, long tailback is being observed frequently. 	<ul style="list-style-type: none"> Road safety measures should be installed at the road diversion section. Signal man with proper safety gears should be placed at the diversion section to control the traffic. 	1 st week of December 2019	Contractor

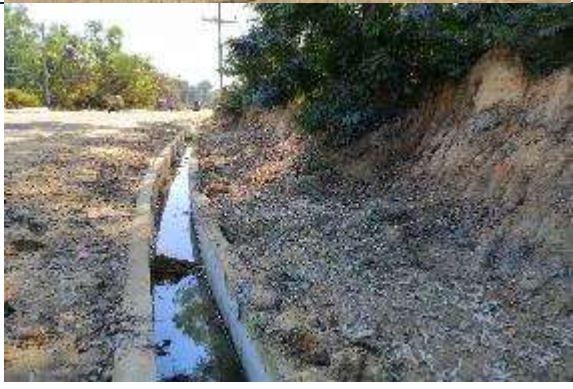
Drainage congestion	U drain constructed by the contractor was filled by eroded earth materials which created drainage congestion in the drain.	Contractor should clean the drains periodically.	1 st week of December 2019	Contractor

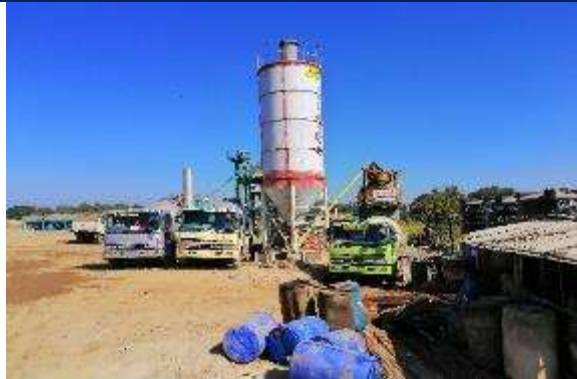
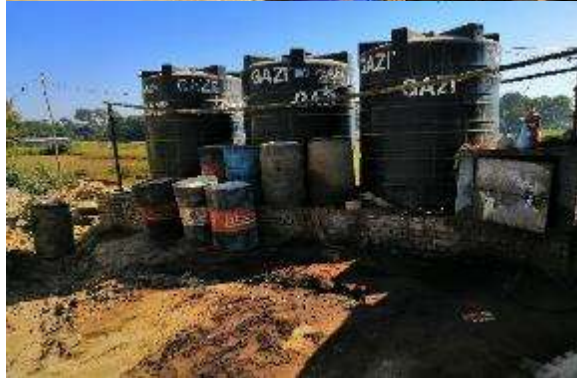
Issues	Observation	Corrective Action	Deadline	Responsibility	Photograph
Control of Petroleum Products	<ul style="list-style-type: none"> Petroleum products are stored in scattered way at different locations where no absorbent kit is kept. Storage of petroleum products are located adjacent to the batching plant where large amount of waste water generated and mixed with spillage and discharged to the paddy land which contaminate soil as well as water. The fuel storage is not confined and mixing trucks are frequently moved along the fuel drums, therefore, accident may occur at any time. No safety signage is placed at the storage area. 	<ul style="list-style-type: none"> All petroleum products shall be stored in a designated storage location where any spillage can be safely maintained without contamination of the surrounding area. Storage of petroleum products shall not be permitted in the vicinity of streams, rivers or other bodies of water. Storage should be confined and established away from haulage. Safety signs must be installed at the storage site. 	1 st week of December 2019	Contractor

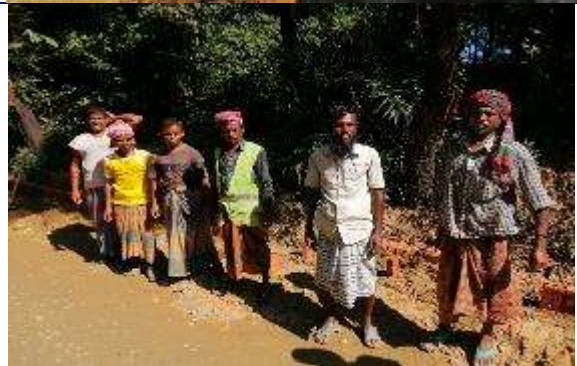
Worker Health and Safety	<ul style="list-style-type: none"> Labors were observed to work without proper PPEs at the site. Child labors are appointed and engaged in hazardous activity without PPEs. No health and safety checklist is followed at work site. No first aid box was found in the construction site. 	<ul style="list-style-type: none"> Proper PPEs need to be supplied to workers and enforced them to use at site. Contractor should comply with requirements of Government of Bangladesh Labour Law of 2006 (amended in 2013). Provide first aid facilities that are readily accessible by workers. 	1 st week of December 2019	Contractor

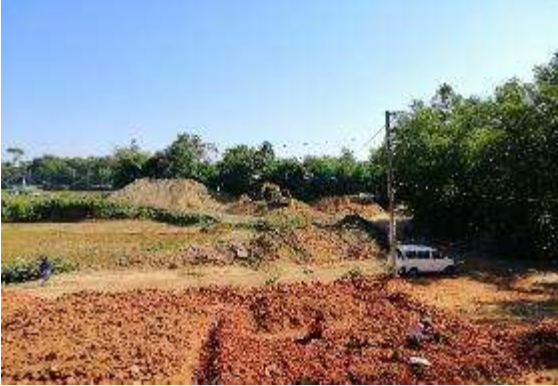
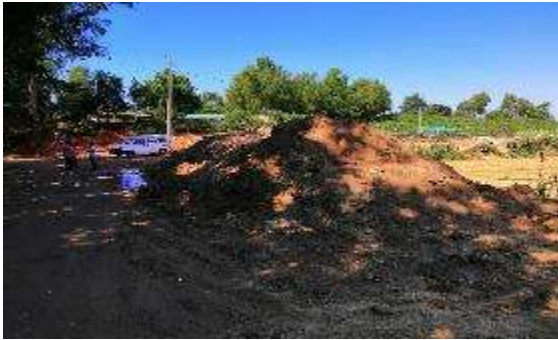
Construction camp	<ul style="list-style-type: none"> Construction camp is not managed satisfactorily where no boundary fence with security is observed. No safety signs are placed at the camp site. Emergency procedure is not followed in the camp. No waste management is observed in the camp. Construction wastes were dumped openly along the access road to the camp which may create diffuse pollution and contaminate the agricultural land adjacent to the camp. No housekeeping was observed there. Moreover, wastes are burnt in the camp. Toilets for the labors are built without proper doors and septic tank is opened which emitted odor in the surrounding. No drainage network has been developed yet inside 	<ul style="list-style-type: none"> Site safety signage must be placed at designated locations in the camp. Contractor should install garbage bins and construct a concrete waste disposal site which have the concrete floor and wall and covered by shed to avoid air pollution, soil and ground water pollution. Emergency contact information should be displaced at the camp site. Sanitation facility should be improved. Noisy operation should not be conducted at night and operation sites with high noise level must be confined by noise barrier. 	1 st week of December 2019	Contractor

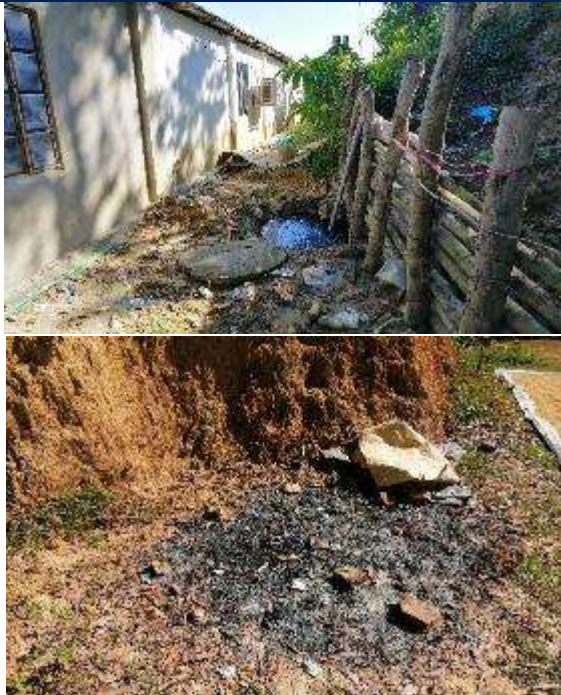
Issues	Observation	Corrective Action	Deadline	Responsibility	Photograph
	<p>the camp where waste water management is not observed at all.</p> <ul style="list-style-type: none"> At camp area, construction activity is proceeded at night with high level of noise along the residential area.

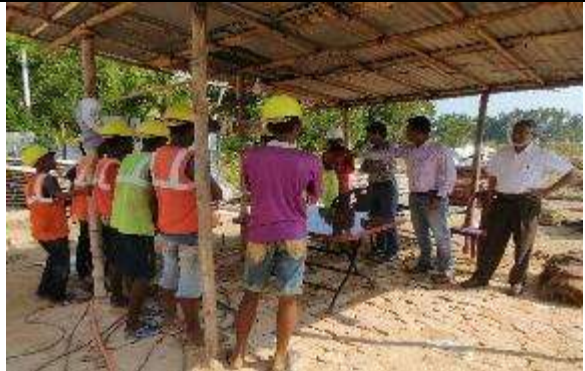
Issues	Observation	Corrective Action	Deadline	Responsibility	Photograph
Onsite Training on EHS	Two onsite training on EHS were conducted at Paglirbil GPS on 18 November 2019 where 12 workers were participated respectively. ADB Environmental Specialist has given a brief lecture to the participants majorly focused on: job hazard analysis, occupational health and safety including PPEs, safety signage, housekeeping, waste management, management of hazardous materials, emergency procedures, accident report and also trained them how to administer first aid. Moreover, explained about the importance of regular tool box meeting at the site. However, all the participants hold a very positive attitude towards the training program.

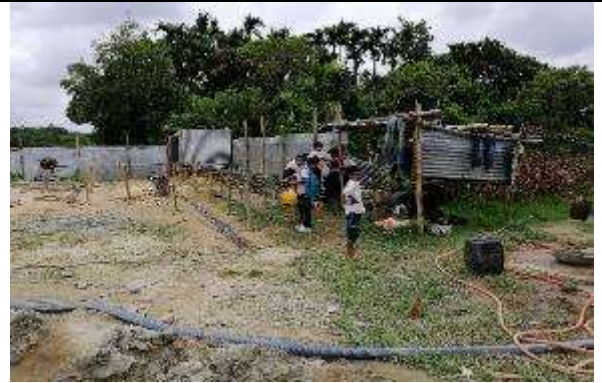
Issues	Observation	Corrective Action	Deadline	Responsibility	Photograph
Water supply to the school	Water supply system to the school building has been disrupted for 5 months due to construction work. As a result, sanitation facility is also being affected in the school.	Contractor should repair the water supply system immediately.	December 2019	Contractor

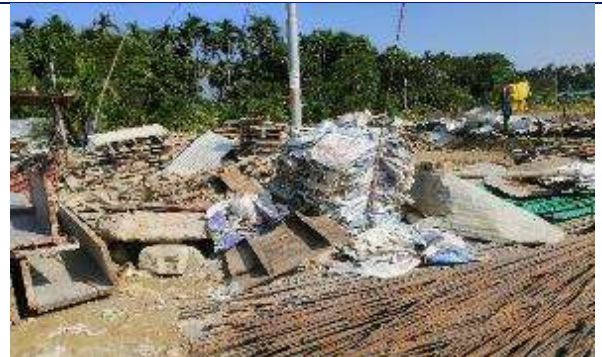
Waste management	No waste management in the site for both construction and domestic wastes are found during monitoring.	Separate garbage bins should be supplied for organic and inorganic wastes at the site and finally disposed at the designated location in the camp.	December 2019	Contractor

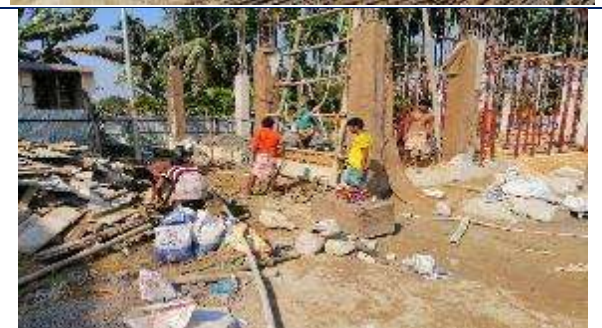
Worker health and safety	<ul style="list-style-type: none"> • Labors were observed to work without proper safety gears. • Without fall protection and standard ladder, they are working at height which might cause fatal accident at any time. • Child labors are found in the site. • No electric safety was ensured in the site where electric wire was found in water which might cause accident. 	<ul style="list-style-type: none"> • Proper PPEs needs to be implemented at site by force. • Contractor should comply with requirements of Government of Bangladesh Labour Law of 2006 (amended in 2013). • Contractor should conduct tool box talk regularly at each site. • Fire protection measures such as fire extinguisher 	December 2019	Contractor

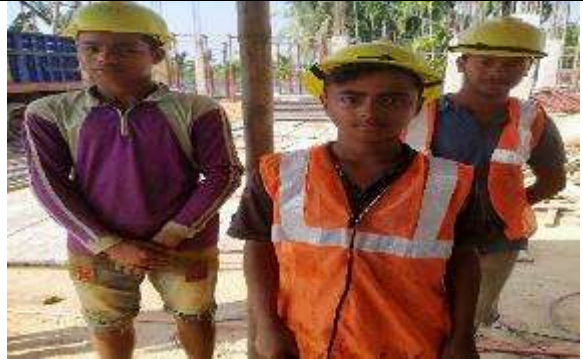
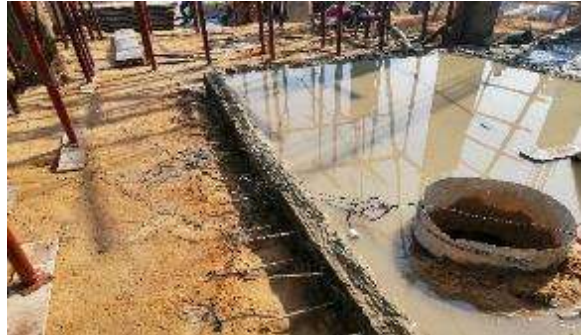
Issues	Observation	Corrective Action	Deadline	Responsibility	Photograph
	<ul style="list-style-type: none"> No health and safety checklist is followed at work site. Emergency procedure for accident, fire incident is not maintained at the site. Site safety signboards are placed at the site. First aid box is available at the site. 	should be available at the site.

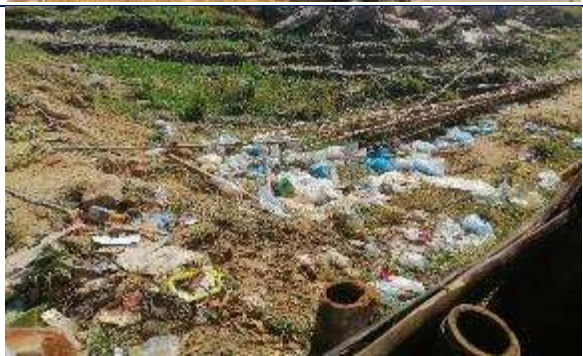
Labor camp	<ul style="list-style-type: none"> Hazardous materials including fuel drums are stored in the labor shed where no fire extinguisher is kept to put out the fire. Kitchen wastes are dumped openly which causes soil as well as groundwater pollution. 	<ul style="list-style-type: none"> All petroleum products shall be stored in a designated storage location where any spillage can be safely maintained without contamination of the surrounding area. Fire extinguisher should be available in the camp. Contractor should construct a concrete waste disposal site which have the concrete floor and wall and covered by shed to avoid air pollution, 	December 2019	Contractor

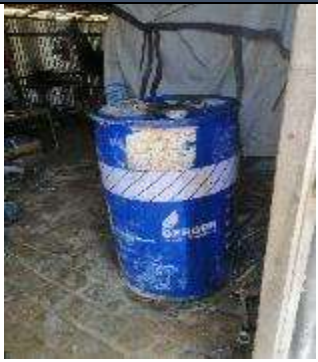
Issues	Observation	Corrective Action	Deadline	Responsibility	Photograph
		soil and groundwater pollution.

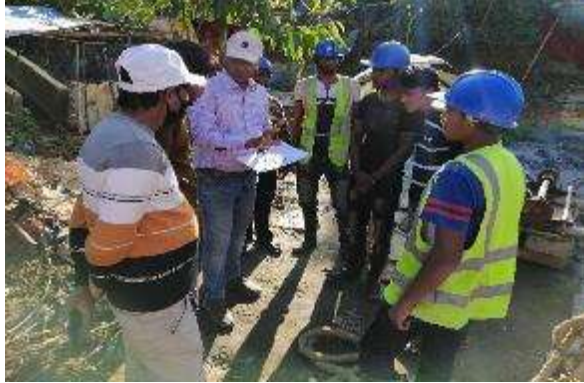
Issues	Observation	Corrective Action	Deadline	Responsibility	Photographs
Onsite Training on EHS	Onsite training on EHS was conducted on 4 December 2019 where 8 workers were participated. ADB Environmental Specialist has given a brief lecture to the participants majorly focused on: job hazard analysis, occupational health and safety including PPEs, safety signage, housekeeping, waste management, management of hazardous materials, emergency procedures, accident report and also trained them how to administer first aid. Moreover, explained about the importance of regular tool box meeting at the site. However, all the participants hold a very positive attitude towards the training program.

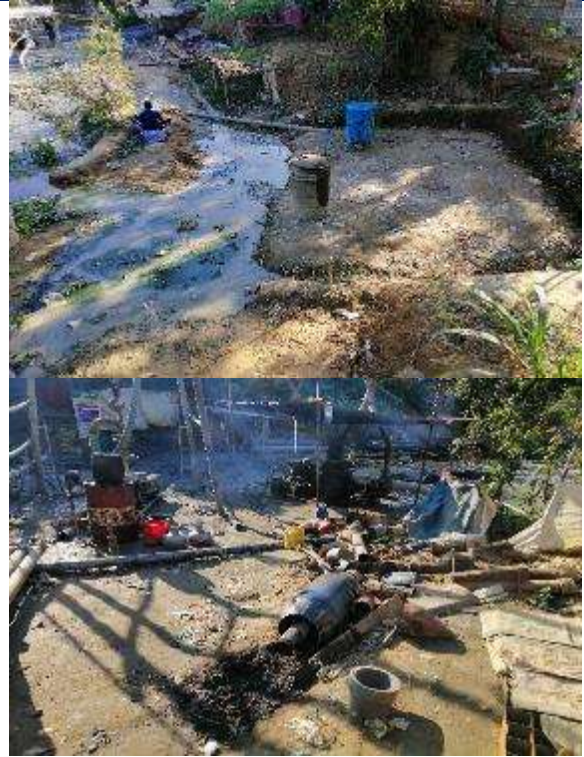
Issues	Observation	Corrective Action	Deadline	Responsibility	Photographs
	contractor has not received the plan yet.				
Control of Petroleum Products	<ul style="list-style-type: none"> Petroleum products are stored in scattered way at different locations where no absorbent kit is kept. Fuel drums were stored in the vicinity of drainage channel which may pollute the surface water. The fuel storage is not confined and open burning was found along the fuel drums where accident may occur at any time. No safety signage is placed at the storage area. No fire protection is found in the site. 	<ul style="list-style-type: none"> All petroleum products shall be stored in a designated storage location where any spillage can be safely maintained without contamination of the surrounding area. Storage should be confined and established far from the water body. Fire extinguisher must be kept at storage site Safety signs must be installed at the storage site. 	December 2019	Contractor

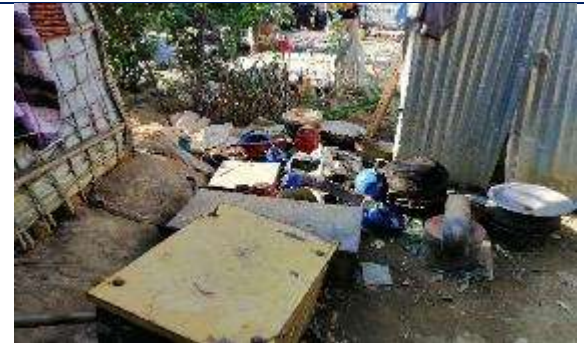
Waste management	No waste management in the site for both construction and domestic wastes are found during monitoring.	Separate garbage bins should be supplied for organic and inorganic wastes at the site and finally disposed at the designated location in the camp.	December 2019	Contractor

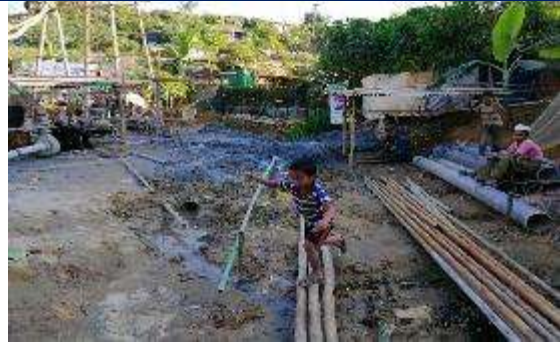
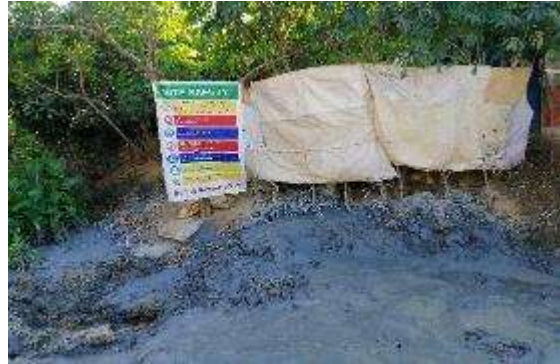
Issues	Observation	Corrective Action	Deadline	Responsibility	Photographs
Site Office	<ul style="list-style-type: none"> The construction site was not confined, thus unauthorized access including children were observed in the site. Site safety signboards are placed in the site. 	The work site should be confined using safety tape/fence and install a signage so that unauthorized movement can be restricted around the work site.	December 2019	Contractor

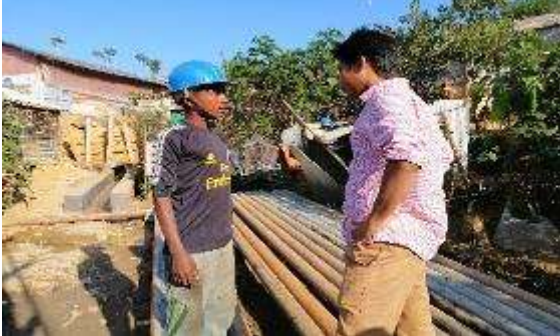
Worker Health and Safety	<ul style="list-style-type: none"> HSP is not followed at the site. PPEs were not implemented at the site. Child labor is appointed and engaged in hazardous activity without proper PPEs. No safety measure was taken to work at height. No first aid box not supplied at the site. Emergency procedure was not followed at site. 	<ul style="list-style-type: none"> Proper PPEs should be provided at site. Provide first aid facilities that are readily accessible by workers. Fire protection measures such as fire extinguisher should be available at the site. Contractor should conduct tool box meeting regularly at each site. 	December 2019	Contractor

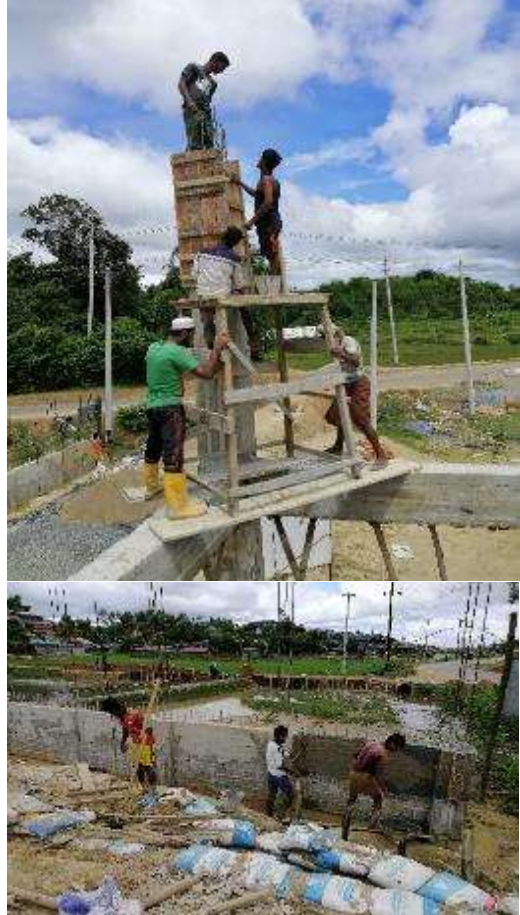
Issues	Observation	Corrective Action	Deadline	Responsibility	Photographs
Worker health and safety	<ul style="list-style-type: none"> The labors were working at height without any fall protection where fatal accident might be occurred at any moment. Most of labors were observed to work without proper safety gears. No site safety signboards were placed. Emergency procedure is not maintained at the site. No fire protection was found in the site. Rohingya labors were identified, currently about 60% labors were hired from the nearby camps. 	<ul style="list-style-type: none"> Proper staging/platform, barriers as well as safety harness must be supplied to the labors who worked at height and need to be implemented at site by force. Site safety signboards should be placed in the construction site. Fire protection measures such as fire extinguisher should be available at the site. Contractor should conduct tool box talk regularly. Rohingya labor should not be appointed. 	10 September 2019	Contractor
