Semi-annual Environmental Monitoring Report

Emergency Assistance Project

ADB Project 52174-001 | Grant 0582-BAN | TA 9546 BAN

Fourth Semi-Annual Environmental Monitoring Report

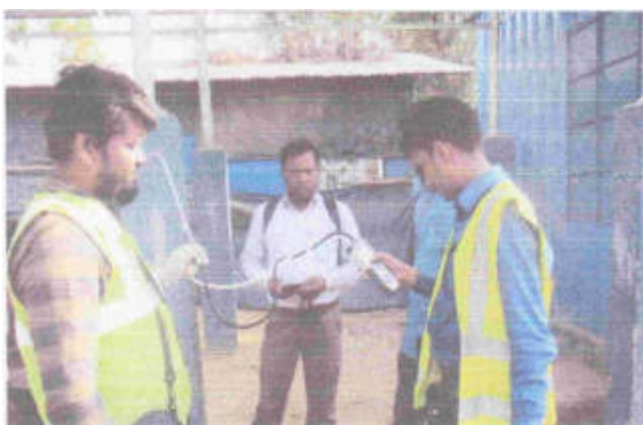
DPHE/W1/AAQ-1 in KRC

93 Ambient air quality data at the project site measured to verify the current quality of air. The aim was to collect the existing air quality data and to compare the data with the air quality during project implementation phase to check if there is any high air pollution level due to the construction activities and to design adequate mitigation measures, as applicable. Dispersal of pollutants depends upon factors like prevailing wind direction and other weather conditions, atmospheric stability, height of the source. Ambient air quality testing was performed at DPHE/W1, DPHE/W2, DPHE/W3, DPHE/W5 and DPHE/W10 area in 1st quarter (January-March) of 2020 (**Figure 7**). Filter and each chemical were measured before testing. Electro-Chemical Sensor device were calibrated before testing some other parameters. Results of the air quality monitored at the project location have been showed in **Table 16**. The details of this result are shown in Appendix III of this report.

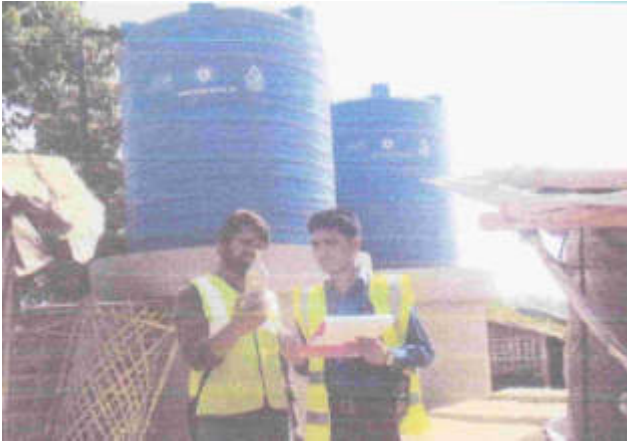
DPHE/W1/NM-01 in KRC

100 A-weighted sound pressure level was measured at the construction sites during normal working hours by using calibrated noise level meter. Noise level was measured in 1st quarter of 2020 from active construction sites during day time for 2 hours (**Figure 8**). Noise level was measured using a calibrated HTC Sound Level Meter set to A-weighting, slow response and statistical analysis settings. The values of noise levels at project sites are presented in **Table 17**. The details result is given in Appendix III of this report.

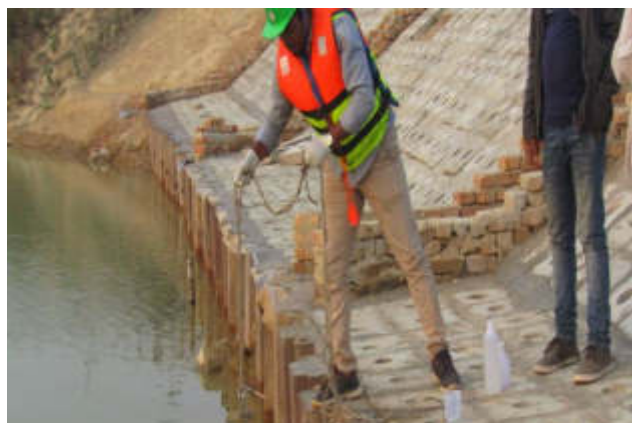
DPHE/W3/SW-1 in Camp 5

106 The surface water sample was collected in 1st quarter (January-June) 2020 from water bodies flows through the camps (**Figure 9**). The quality of surface water is to be monitored through laboratory analysis collected from at least 1m from the bank/shore of the waterways from the major streams along the project site. Polyethylene bottles (PET bottles) of 1 liter were recommended for samples to measure physical and chemical parameters. EZDO-8200 Multi-meter was used to conduct the on-site test of pH and EC for surface water. The collected samples were sent to different laboratories such as Department of Public Health Engineering (DPHE), NGO Forum etc. for other remaining parameters. Before collecting water sample, bottles were washed with distilled water. Results of the surface water quality at the project location are presented in **Table 18**. The Laboratory test result is given in Appendix III of this report.

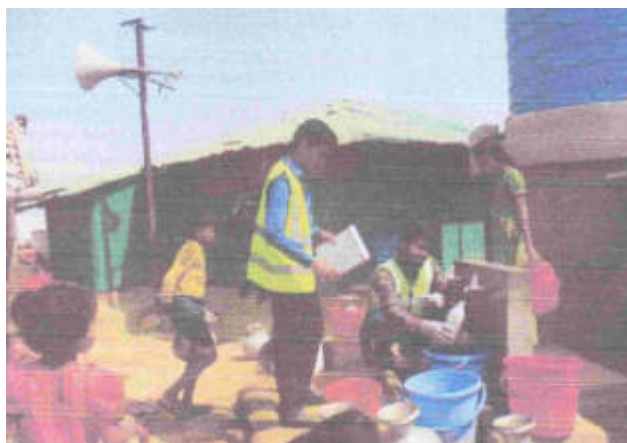
DPHE/W1/GW-1 in Camp 13

119 Groundwater samples are collected from tube well in located along the project sites in the first quarter of 2020 (**Figure 10**). Those tube wells are used for drinking and bathing purposes. Adoption of every possible precautions has been suggested to obtain representative samples in polyethylene bottles (PET bottles) of 1 liter for physical and chemical parameters by rinsing the bottles thrice before sampling and securely sealing them for avoiding aeration. EZDO-8200 Multi-meter was used the conduct the on-site test of pH, EC and TDS and for remaining parameters samples are sent to laboratories. Results of the ground water quality at the project location have been showed in **Table 19**. The Laboratory test result is given in Appendix III of this report.

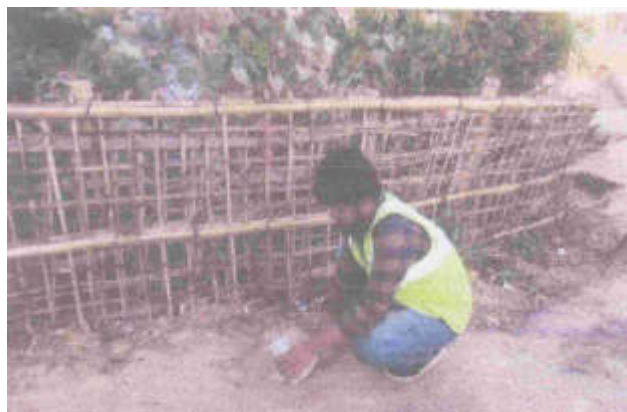
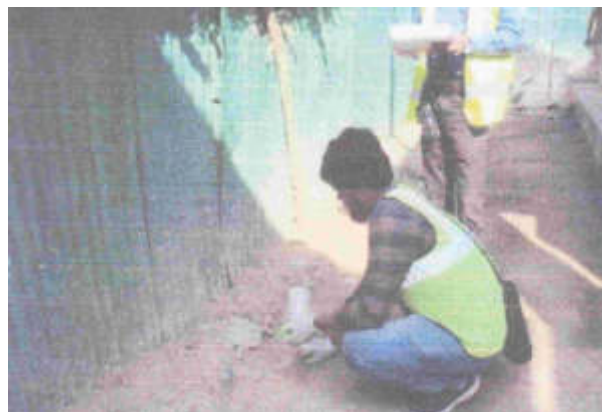
Figure 11 Soil sampling at different locations in project site

133 The soil samples were collected from 15 cm deep at different sampling points located along the project site (**Figure 11**). Appropriate analytical methods have been used for analyzed of the samples; the results are in **Table 20**. The Laboratory test result is given in Appendix III of this report. However, there is

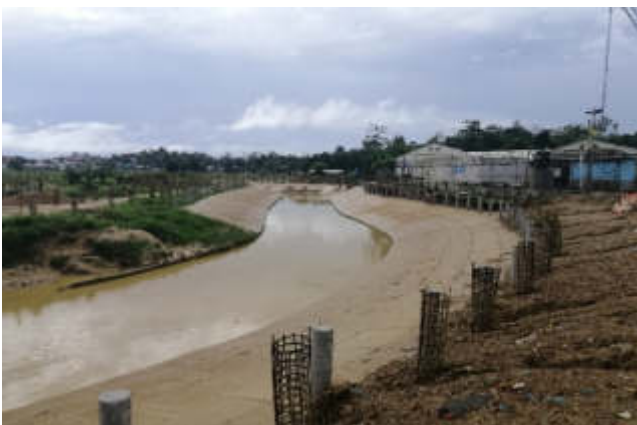
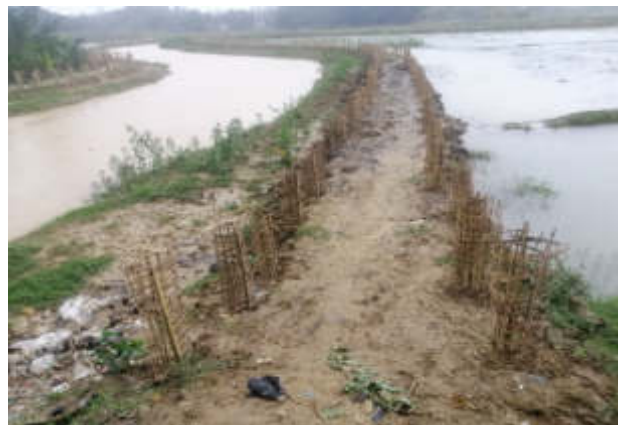
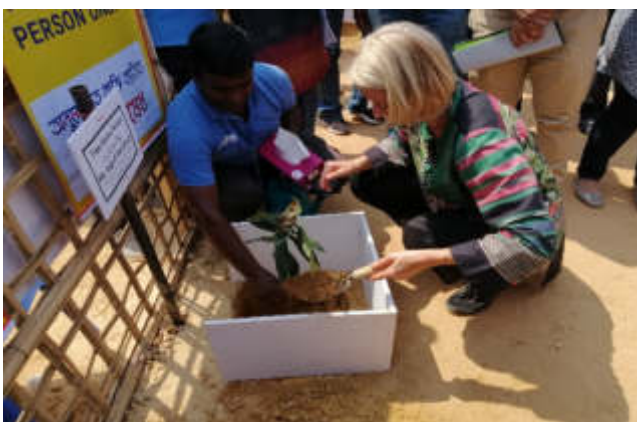
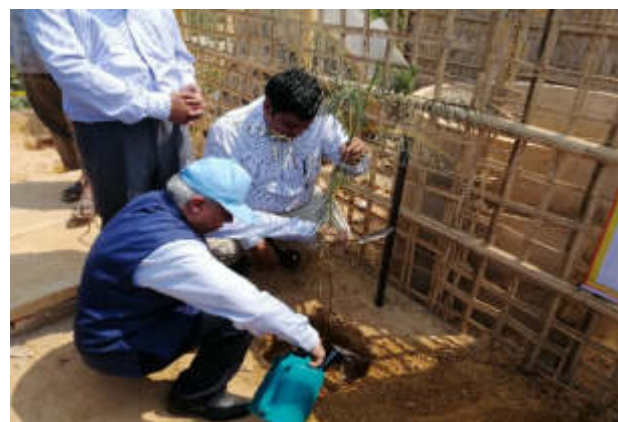
Figure 12 Tree plantation programme in the project sites

137 During 4th monitoring period, tree plantation is being carried out along storm water drainage canals in both LGED/20 and LGED/21 packages (**Figure 12**). The key objectives of this plantation are to stabilize the canal embankment, reduce risk of soil erosion and landslide, and improve biodiversity. Several observations on the plantation activity are:

139 Plantation has been done by the contractor in the mini pipe water supply package under DPHE component (DPHE/W2) where more than 100 saplings of various species such as Garjan, Telsur, Jhaw, Neem etc. were planted in 10 schemes inaugurated by the ADB' Vice-President on 5 March 2020 (**Figure 12**). The plantation will contribute to land stabilization, reduce risk of land slide, improve watershed, enrich micro-climatic condition. In addition, the planted native species will also enrich the ecosystem by providing food and shelter to wildlife and other microorganism, improving overall goods and services can attain from the ecosystem. However, contractor will responsible for the after care of the sampling and payment is to be made only when trees are fully grown.

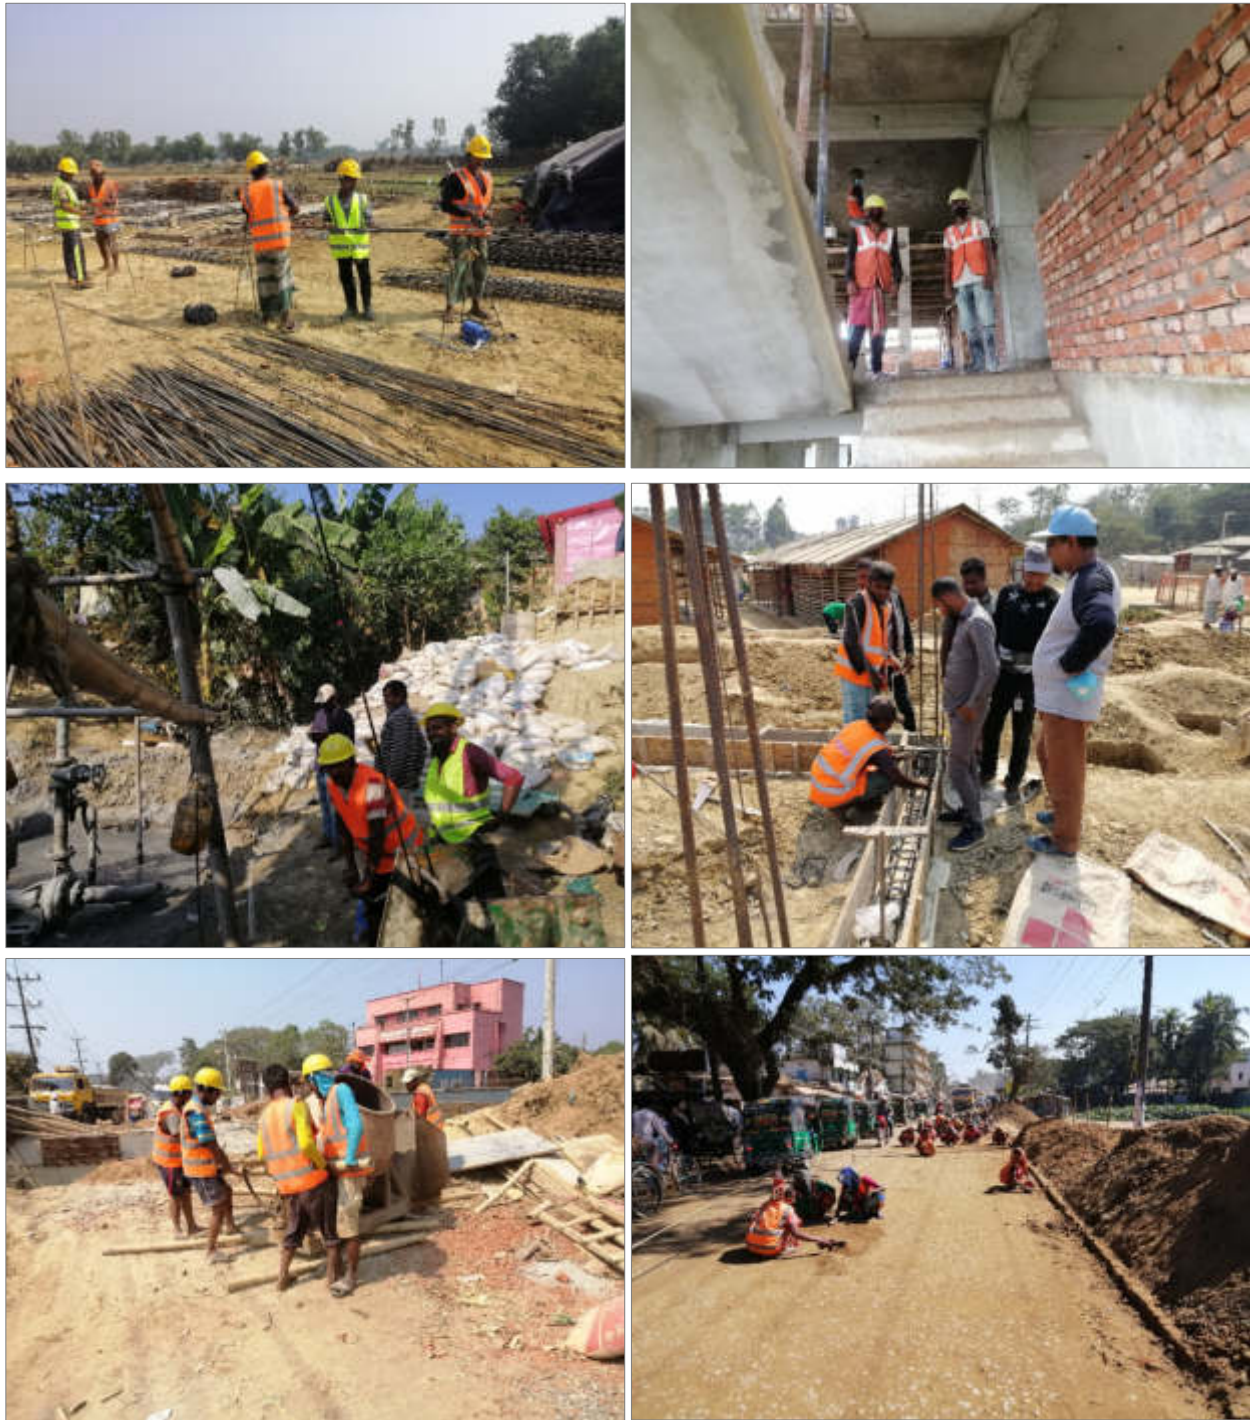
150 **Figure 15** later represents some currents safeguards photographs from various sites taken during field visits.

Figure 15 Safeguards status at various sites. Most of them found as partially to fully satisfactory

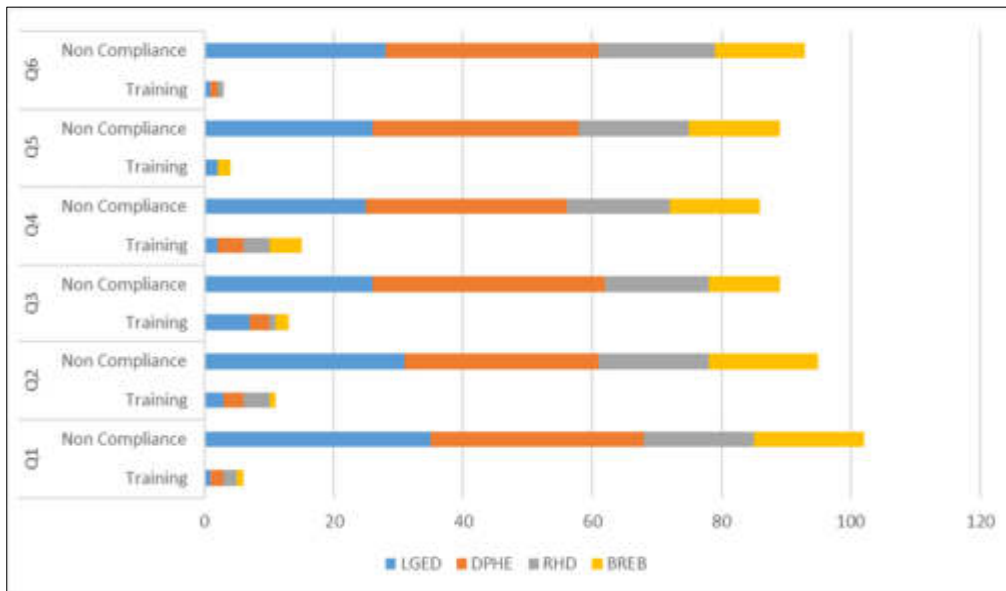
Figure 17 Training vs EMP non-compliance over time (information up to June 2020)

152 **Trend in performance:** A time trend analysis for EMP non-compliance has been studied against hands-on training provided to the workers for the time period of year 2020. It has been found that the non-compliance issue was decreasing over time with a steady input of hands-on training for workers until December 2019. Due to accessibility issues attributed to restrictions associated with Covid-19, safeguards monitoring activity has been hampered which reversed the trend and increases noncompliance issues. **Figure 17** and **Figure 18** explains the situation in detail. Given the comparative study, it can be concluded that steady and continuous training can improve the H&S situation at site and may produce better EMP compliance.

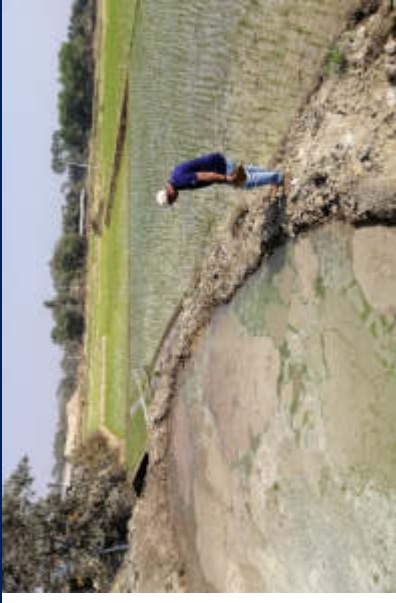
Issues	Observation	Corrective Action	Deadline	Responsibility	Photograph
Management of Concrete Batching Plant	Waste water from batching plant is being discharged directly to the nearby agricultural field which polluted soil as well as water.	<p>Contractor must prepare a waste water management plan and undertake the following measures:</p> <ul style="list-style-type: none"> • All runoff and wastewater is to be collected and contained onsite in a sufficiently large tank/sedimentation pit. • Wastewater to be reused as part of the dust suppression system at earliest possible opportunity to restore storage capacity. 	February 2020	Contractor and CSC

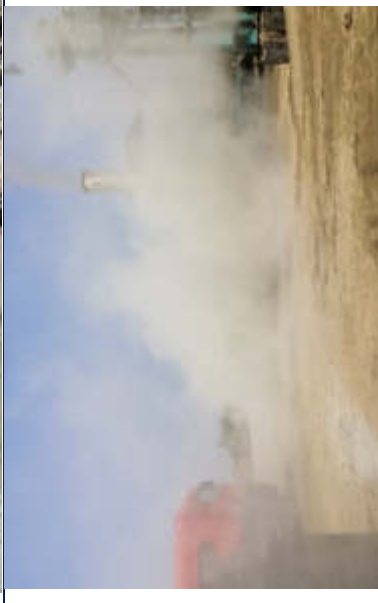
Asphalt Mix Plant	Severe dust pollution is observed at the camp site due to the operation of asphalt plant which affected the labors and surrounding environment badly where workers were observed without dust mask, ear plug etc.	<p>Contractor should use consult with supplier regarding dust issues and also install wet scrubber or other measures to reduce the dust level in the plant site.</p> <p>Dust mask and ear plug must be provided to the labors at the plant.</p>	February 2020	Contractor and CSC

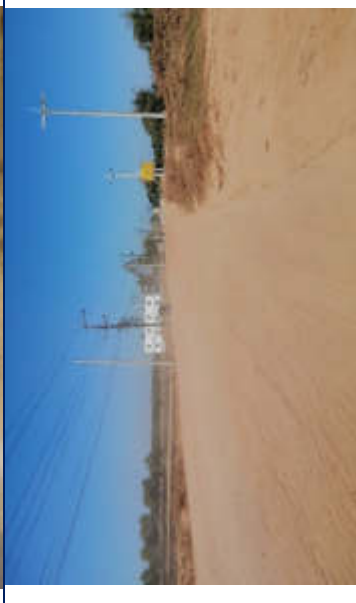
Dust Pollution	Due to lack of spraying water on the dry road dust is generated and affected local people.	Contractor should increase the frequency of watering (at least 4 times a day) to reduce the dust level on the road (special care should be taken for the access road to the camp).	February 2020	Contractor and CSC

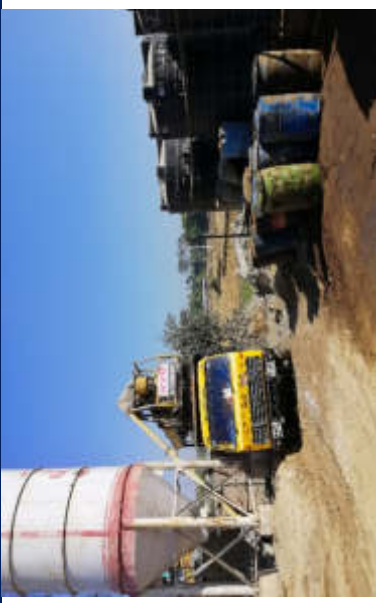
Issues	Observation	Corrective Action	Deadline	Responsibility	Photograph
Road Safety and traffic management	Warning signs and safety barrier is used at the road diversion section for traffic safety.	Rectified			 
Control of Petroleum Products	<ul style="list-style-type: none"> Petroleum products are stored in scattered way at different locations where no absorbent kit is kept. Storage of petroleum products is located adjacent to the batching plant where large amount of waste water generated and mixed with spillage and discharged to the cultivated land which contaminate soil as well as water. The fuel storage is not confined and mixing trucks are frequently moved along the fuel drums, therefore, accident may occur at any moment. No safety signage as well as fire extinguisher is placed at the storage area. 	<ul style="list-style-type: none"> Petroleum products must be stored in a designated storage location where any spillage can be safely maintained without contamination of the surrounding area. Spill absorbent must be kept at the refueling site. Storage should be confined and established away from haulage. Safety signs must be installed at the storage site. Fire protection measure must be arranged at storage area. 	February 2020	Contractor and CSC

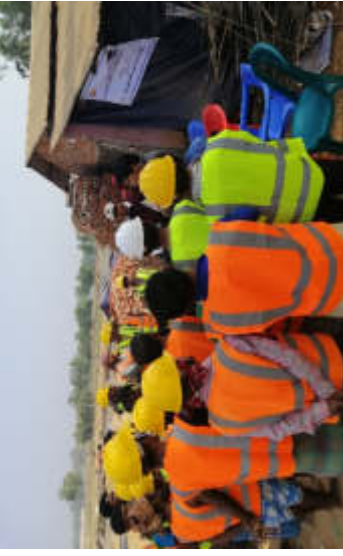
Issues	Observation	Corrective Action	Deadline	Responsibility	Photograph
Onsite Training on EHS	Onsite training on EHS was conducted on 10 February 2020 at the construction camp located in Balukhali where 25 workers including project engineers were participated. ADB Environmental Specialist has given a brief lecture to the participants majorly focused on: occupational health and safety including PPEs, safety signage, first aid, housekeeping, waste management, management of hazardous materials, emergency procedures. Moreover, explained about the importance of regular tool box meeting at the site. However, all the participants hold a very positive attitude towards the training program.

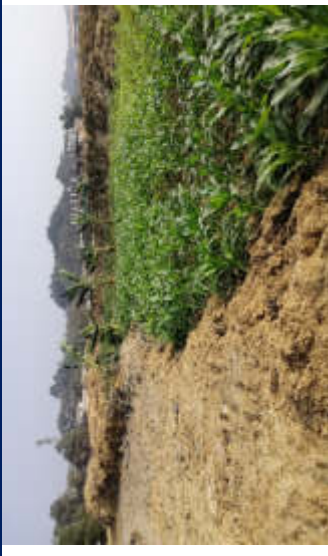
Management of Excavated Spoils	Excavated spoils from the drainage canal is stockpiled on the bank which affected the field crops in adjacent areas.	A management plan for excavated spoils should be prepared by the contractor. Spoils should not be stockpiled along the agricultural field. If require, storage areas must be protected by covering.	March 2020	Contractor

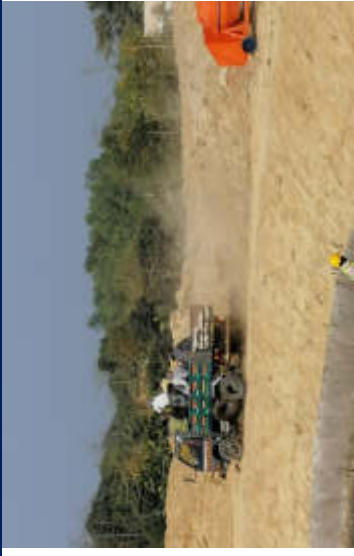
Dust pollution	Dust pollution is being occurred severely due to lack of dust suppression measure.	Contractor should spray water regularly on the open and loose surface of the stream bank.	March 2020	Contractor

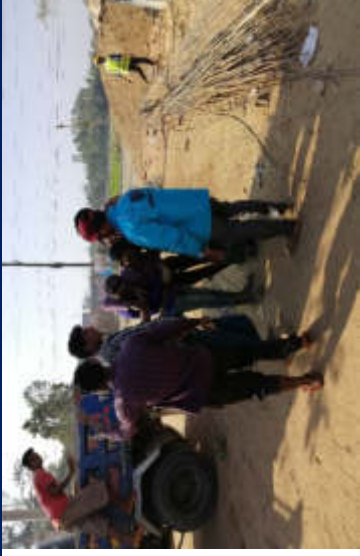
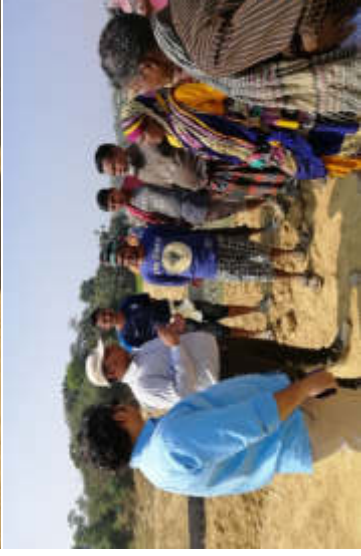
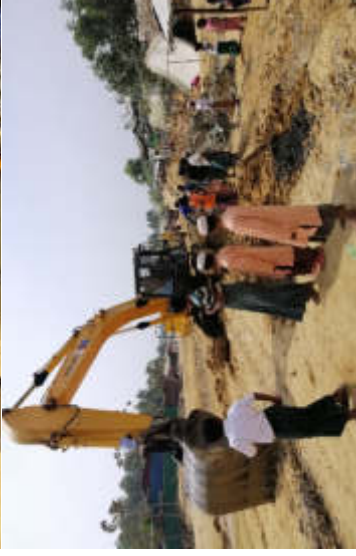
Issues	Observation	Corrective Action	Deadline	Responsibility	Photograph
Worker health and safety	<ul style="list-style-type: none"> Construction vehicles were moving without audible back-up alarms which resulted in an accident at the construction camp during site inspection. Canal excavation was undertaken along the densely populated area without signalman which may result in a fatal accident. Labors were observed to work without PPEs at the construction camp. No first aid box was found in the construction site. No proper egress and ingress is ensured at the construction site. No sanitation facility was arranged in the site where female worker was observed. Workers were observed in the dusty work site without respiratory protection. 	<ul style="list-style-type: none"> Construction should ensure moving equipment is outfitted with audible back-up alarms. Signal-man should be assigned for each excavator during excavation. PPEs need to be supplied to workers and enforced them to use at site. Provide first aid facilities that are readily accessible by workers. Proper egress and ingress must be ensured for the labors. Contractor must conduct tool box talk regularly at each site. Sanitation facility must be ensured at the working site. 	March 2020	Contractor

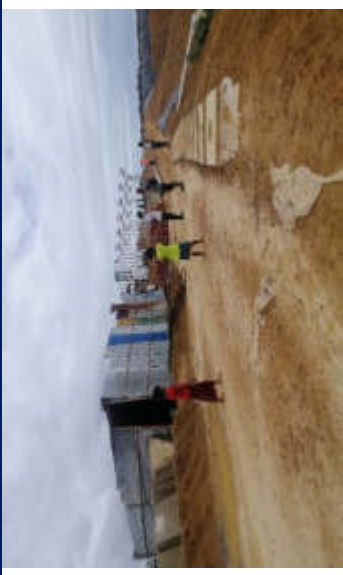
Issues	Observation	Corrective Action	Deadline	Responsibility	Photographs
Site Office	<ul style="list-style-type: none"> The construction site was confined but unauthorized access including children were observed in the site. Security guard yet to deploy at the site to ensure security of the project premise. No site safety signboards are placed in the site. Emergency procedure was not followed at site. 	<p>The work site should be confined using safety tape/fence and install a signage so that unauthorized movement can be restricted around the work site.</p>	15 July 2020	Contractor

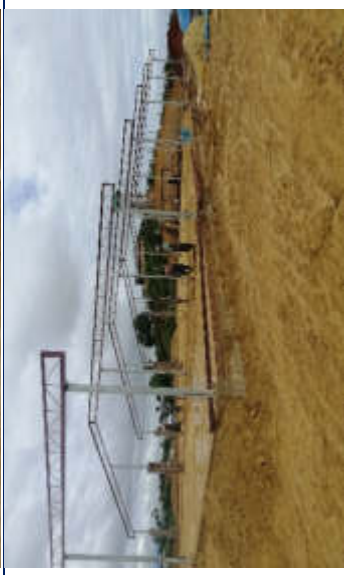
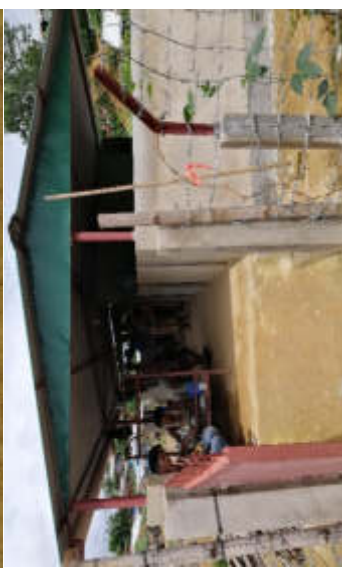
Worker Health and Safety	<ul style="list-style-type: none"> HSP is not followed at the site. Safety protocol for COVID-19 is not followed at the site. PPEs are not implemented at the site. No safety measure was taken to work at height. No first aid box not supplied at the site. No tool box meeting was conducted at site to educate the workers. 	<p>Proper PPEs should be provided at site.</p> <ul style="list-style-type: none"> Safety protocol set by government must be followed in the working site. Provide first aid facilities that are readily accessible by workers. Fire protection measures such as fire extinguisher should be available at the site. Contractor should conduct tool box meeting regularly at each site. 	15 July 2020	Contractor

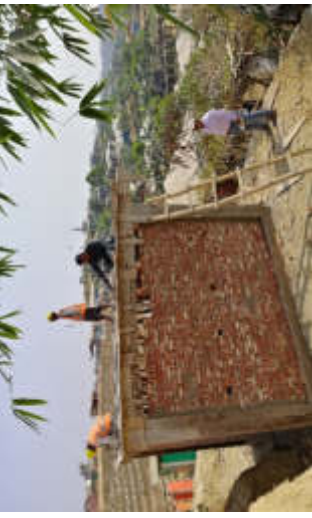
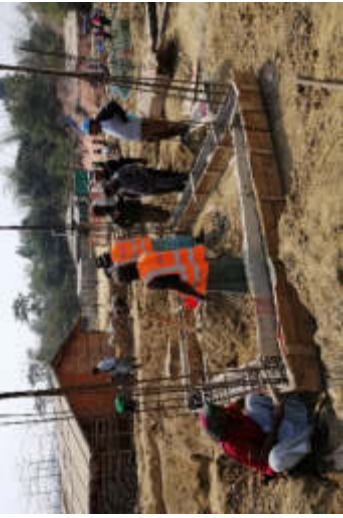
Issues	Observation	Corrective Action	Deadline	Responsibility	Photographs
Worker health and safety	<ul style="list-style-type: none"> • PPEs are partially addressed. • Standard ladder should be arranged to work at height. • Site safety signs are not placed in the site. • No first aid box is available at the site. • Tool box meeting is not conducted at site to educate the workers. • Emergency procedure for accident, fire incident is not maintained at the site. 	<ul style="list-style-type: none"> • Proper PPEs should be provided at site. • Contractor should conduct tool box meeting regularly. • The excavated pond/house should be confined using safety tape for fall prevention. • Fire protection measures such as fire extinguisher should be available at the site. 	28 February 2020	Contractor

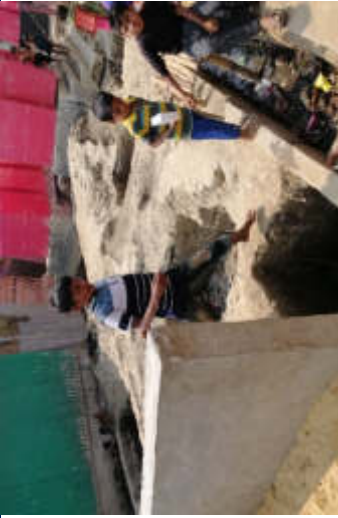
Community health and safety	<ul style="list-style-type: none"> • Foundation pits of solar panel, battery room are left open and causing trouble for locals • Excavated earth materials were left open. 	<ul style="list-style-type: none"> • Worksites are to be equipped with safety signs. • Work site should be confined with safety tape. • Excavated materials should be removed or properly stockpiled with cover at the site. 	28 February 2020	Contractor

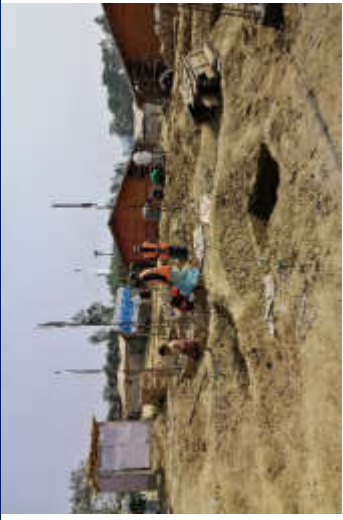
Issues	Observation	Corrective Action	Deadline	Responsibility	Photographs
Waste Management	<ul style="list-style-type: none"> Construction wastes were scattered around the work site due to absence of housekeeping at the site. There is no waste management facility in the site to manage construction waste. 	<ul style="list-style-type: none"> Contractor should clean the work site regularly and provide garbage bins for both organic and inorganic wastes. Construction wastes should be dumped in the designated place. 	28 February 2020	Contractor

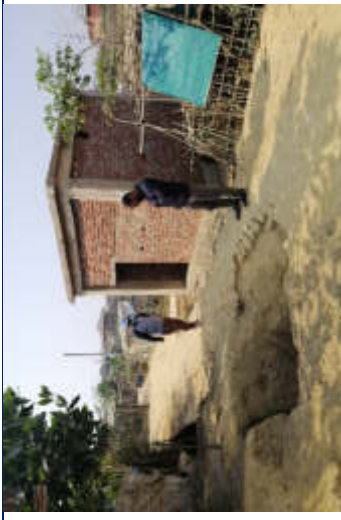
Disruption of Internal Road	<ul style="list-style-type: none"> Foundation pits for the solar panel is excavated adjacent to the internal road left open for long time which damaged the road. 	<ul style="list-style-type: none"> Foundation casting should be done immediately after excavation works. The damaged road must be repaired by the contractor. 	28 February 2020	Contractor
