Semi-annual Environmental Monitoring Report

BAN: Emergency Assistance Project

Fifth Semi-Annual Environmental Monitoring Report

July to December 2020

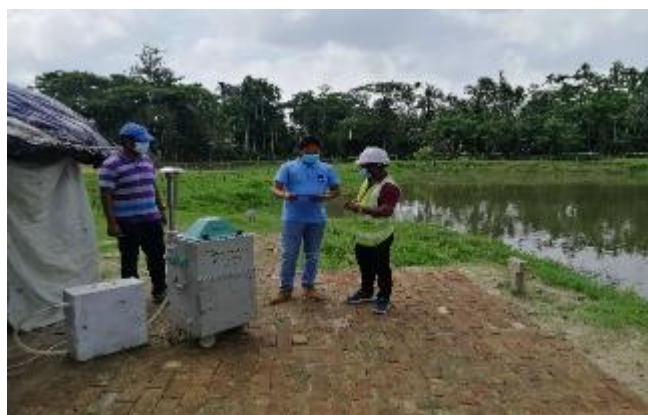
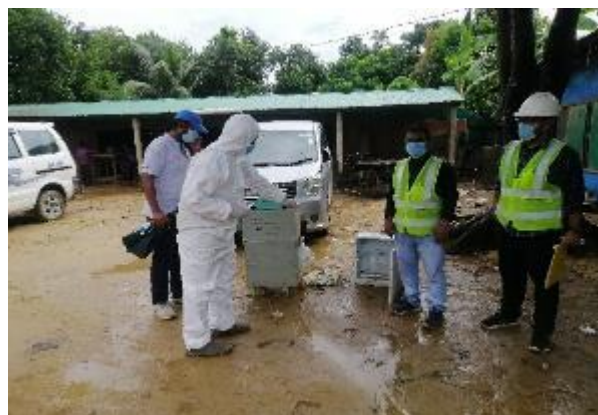
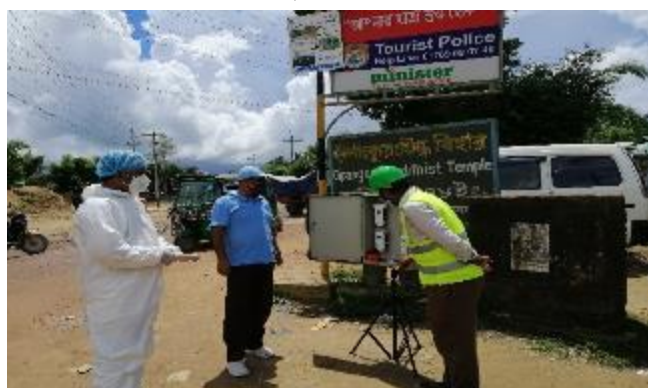
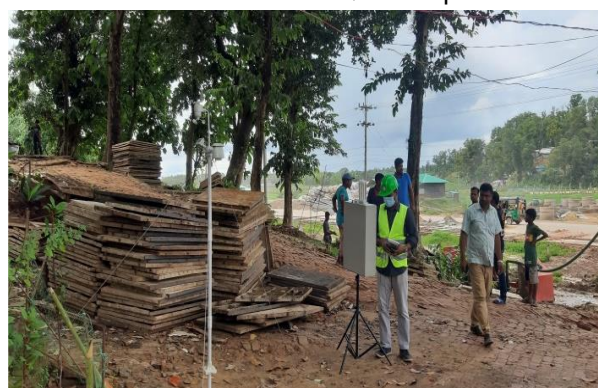
Figure 7 Air quality monitoring in EAP sites

83 Ambient air quality data at the project site measured to verify the current quality of air. The aim was to collect the existing air quality data and to compare the data with the air quality during project implementation phase to check if there is any high air pollution level due to the construction activities and to design adequate mitigation measures, as applicable. Dispersal of pollutants depends upon factors like prevailing wind direction and other weather conditions, atmospheric stability, height of the source. Ambient air quality testing was performed in Cox's Bazar Sadar (DPHE/W11) and Camp 26 (DPHE/W12A) in October 2020 for 8 hours (**Figure 7**). Filter and each chemical were measured before testing. Electro-Chemical Sensor device were calibrated before testing some other parameters. Results of the air quality monitored at the project location have been showed in **Table 14**.

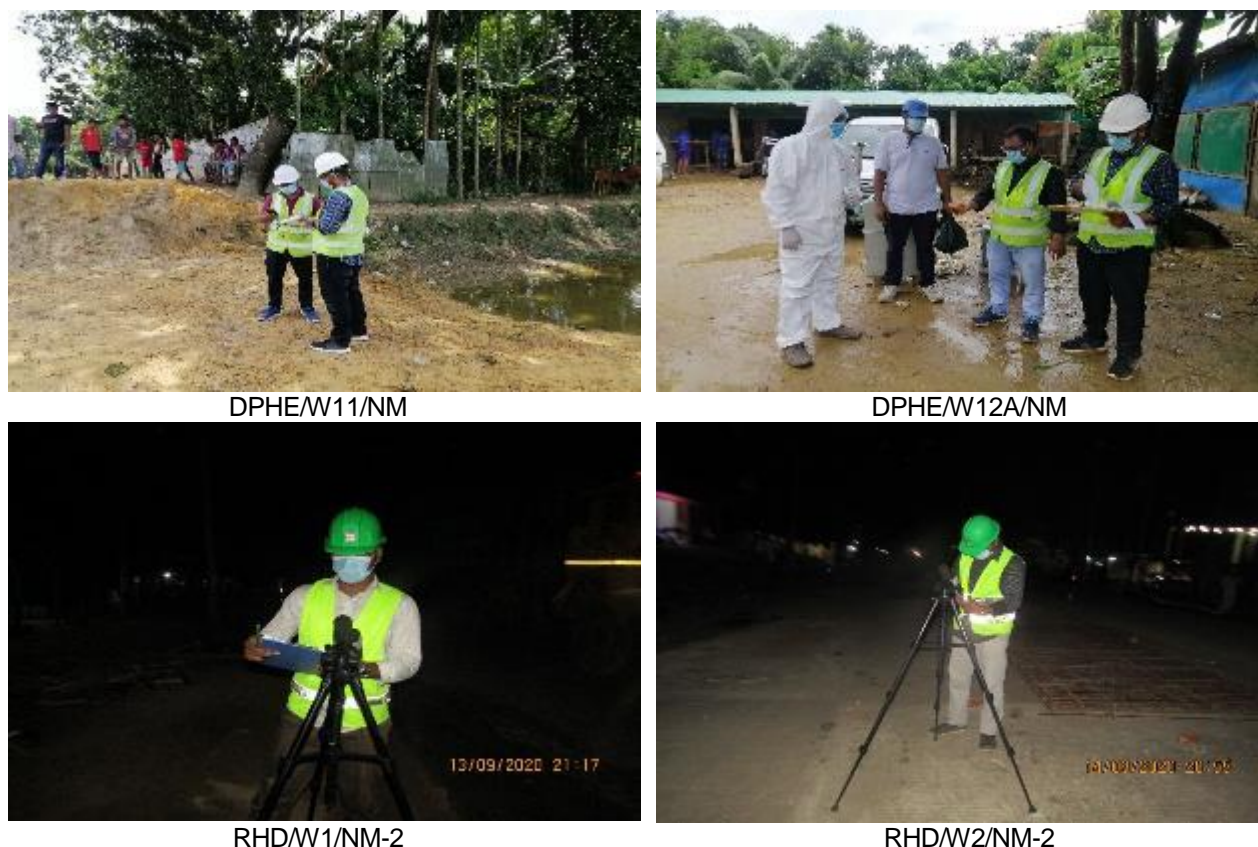
Figure 8 Noise level monitoring in project sites

87 A-weighted sound pressure level was measured at the construction sites during normal working hours by using calibrated noise level meter. Noise level was measured in October 2020 from active construction sites during day time for 2 hours (**Figure 8**). Noise level was measured using a calibrated HTC Sound Level Meter set to A-weighting, slow response and statistical analysis settings. The values of noise levels at project sites are presented in **Table 16**.

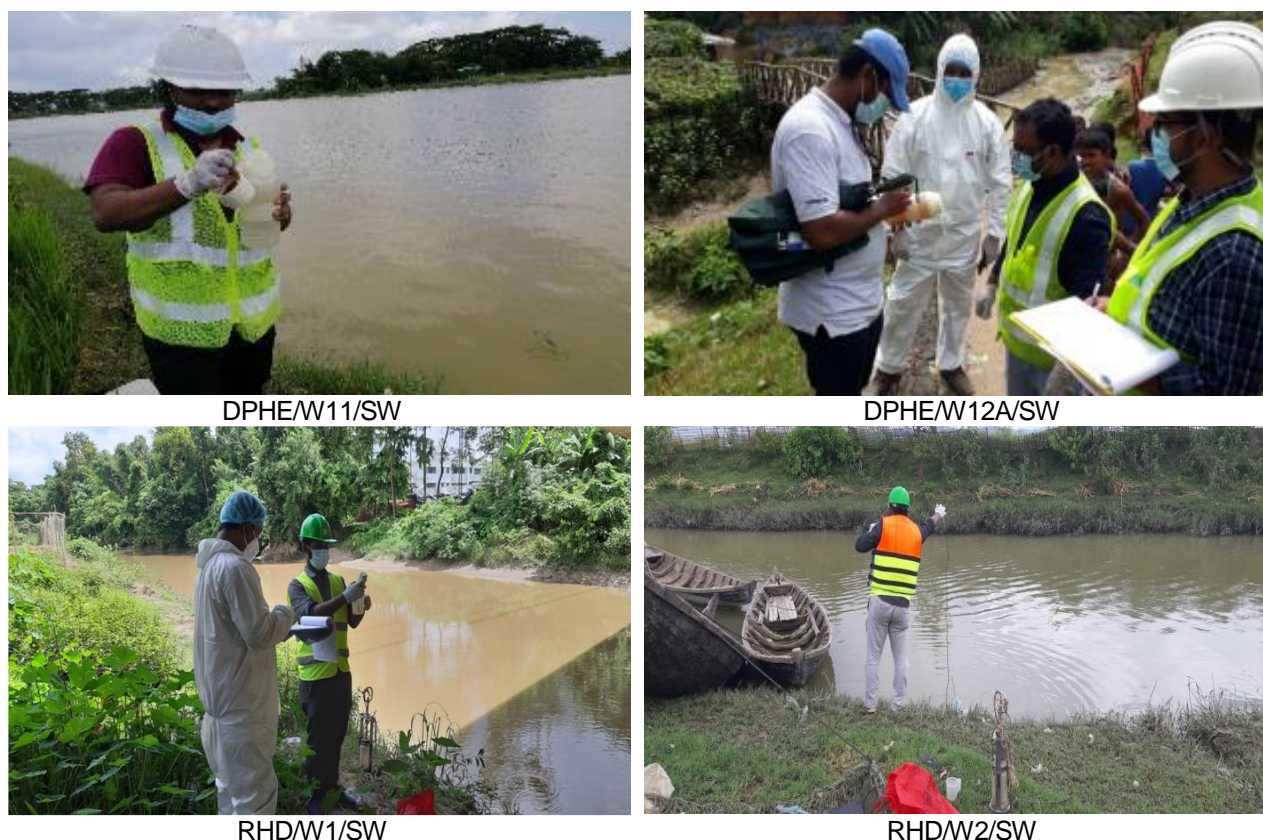
Figure 9 Surface water sampling and onsite testing in project sites

92 The surface water sample was collected in October 2020 from water body flows through the camp 26 and Bakkhali river in Cox's Bazar (**Figure 9**). The quality of surface water is to be monitored through laboratory analysis collected from at least 1m from the bank/shore of the river. Polyethylene bottles (PET bottles) of 1 liter were recommended for samples to measure physical and chemical parameters. EZDO-8200 Multi-meter was used to conduct the on-site test of pH and EC for surface water. The collected samples were sent to the DPHE laboratory. Before collecting water sample, bottles were washed with distilled water. Results of the surface water quality at the project location are presented in **Table 18**.

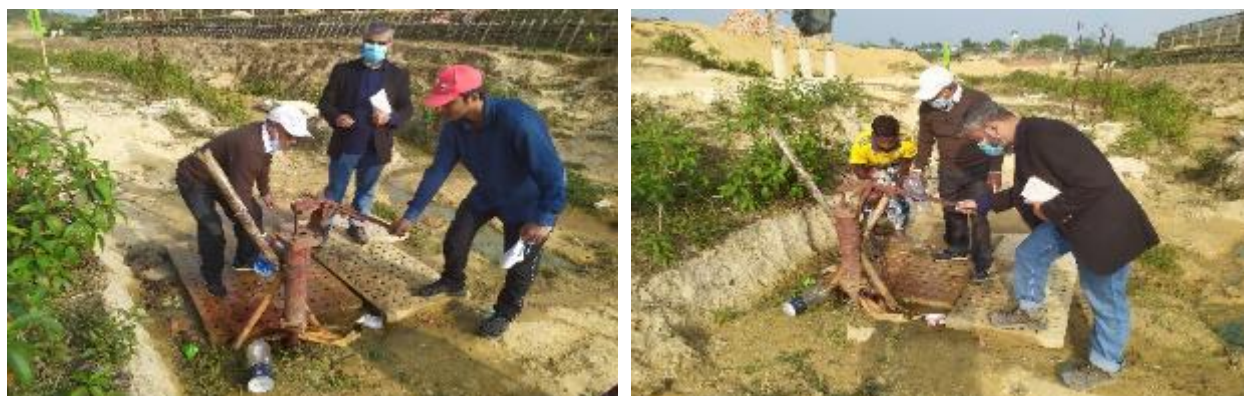
DPHE/W19/GW in Camp 4 ext.

96 The ground water sample was collected in December 2020 from a shallow tube-well of DPHE/W19 subproject site in Camp 4 ext. (**Figure 10**). The quality of ground water was collected properly by Polyethylene bottles (PET bottles) of 1 liter were recommended for samples to measure physical and chemical parameters. Iron content seems very high in the ground water which is not harmful for human health. Results of the ground water quality at the project location have been showed in **Table 20**.

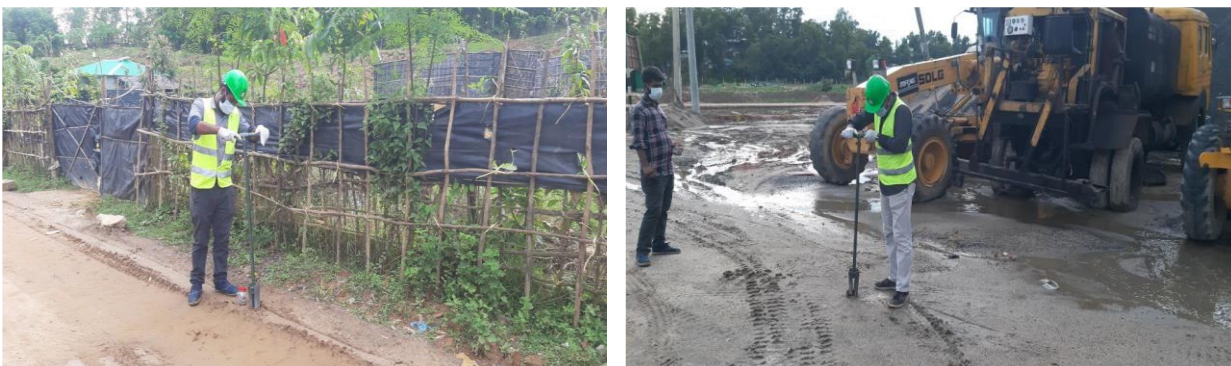
Figure 11 Soil sampling at different locations in RHD sites

collected soil sample were placed to the laboratory for further analysis. The results are in **Table 22** and laboratory test result is given in Appendix IV.

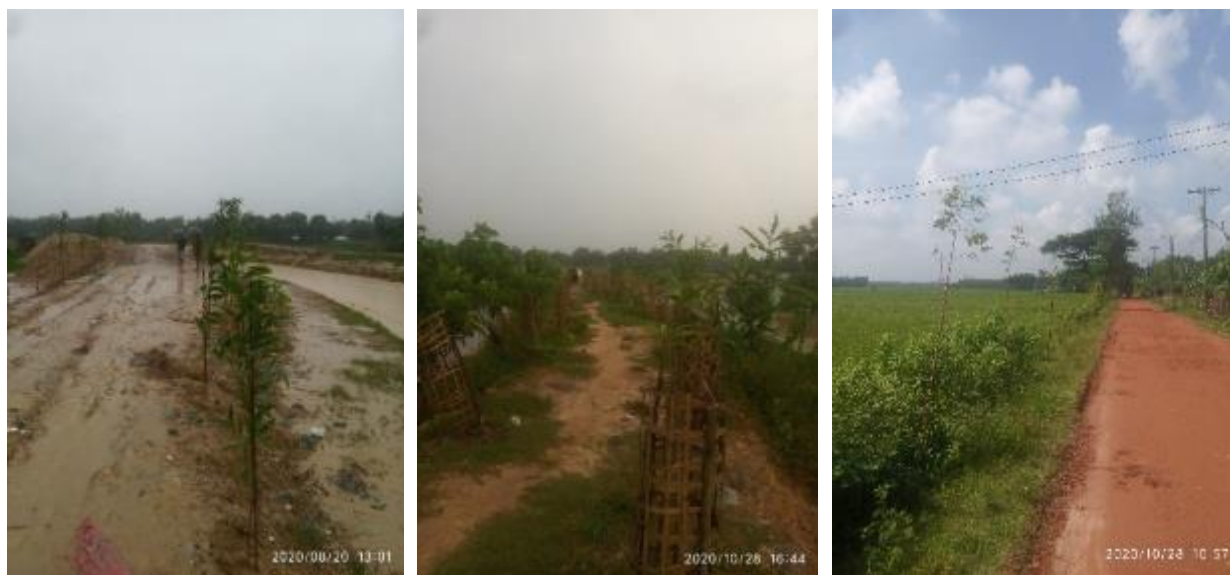
Figure 12 Tree plantation programme in the project sites

109 During 5th monitoring period, tree plantation is being carried out along storm water drainage canals in both LGED/20 and LGED/21 packages and access road package LGED/W4D (**Figure 12**). The key objectives of this plantation are to stabilize the canal embankment, reduce risk of soil erosion and landslide, and improve biodiversity.

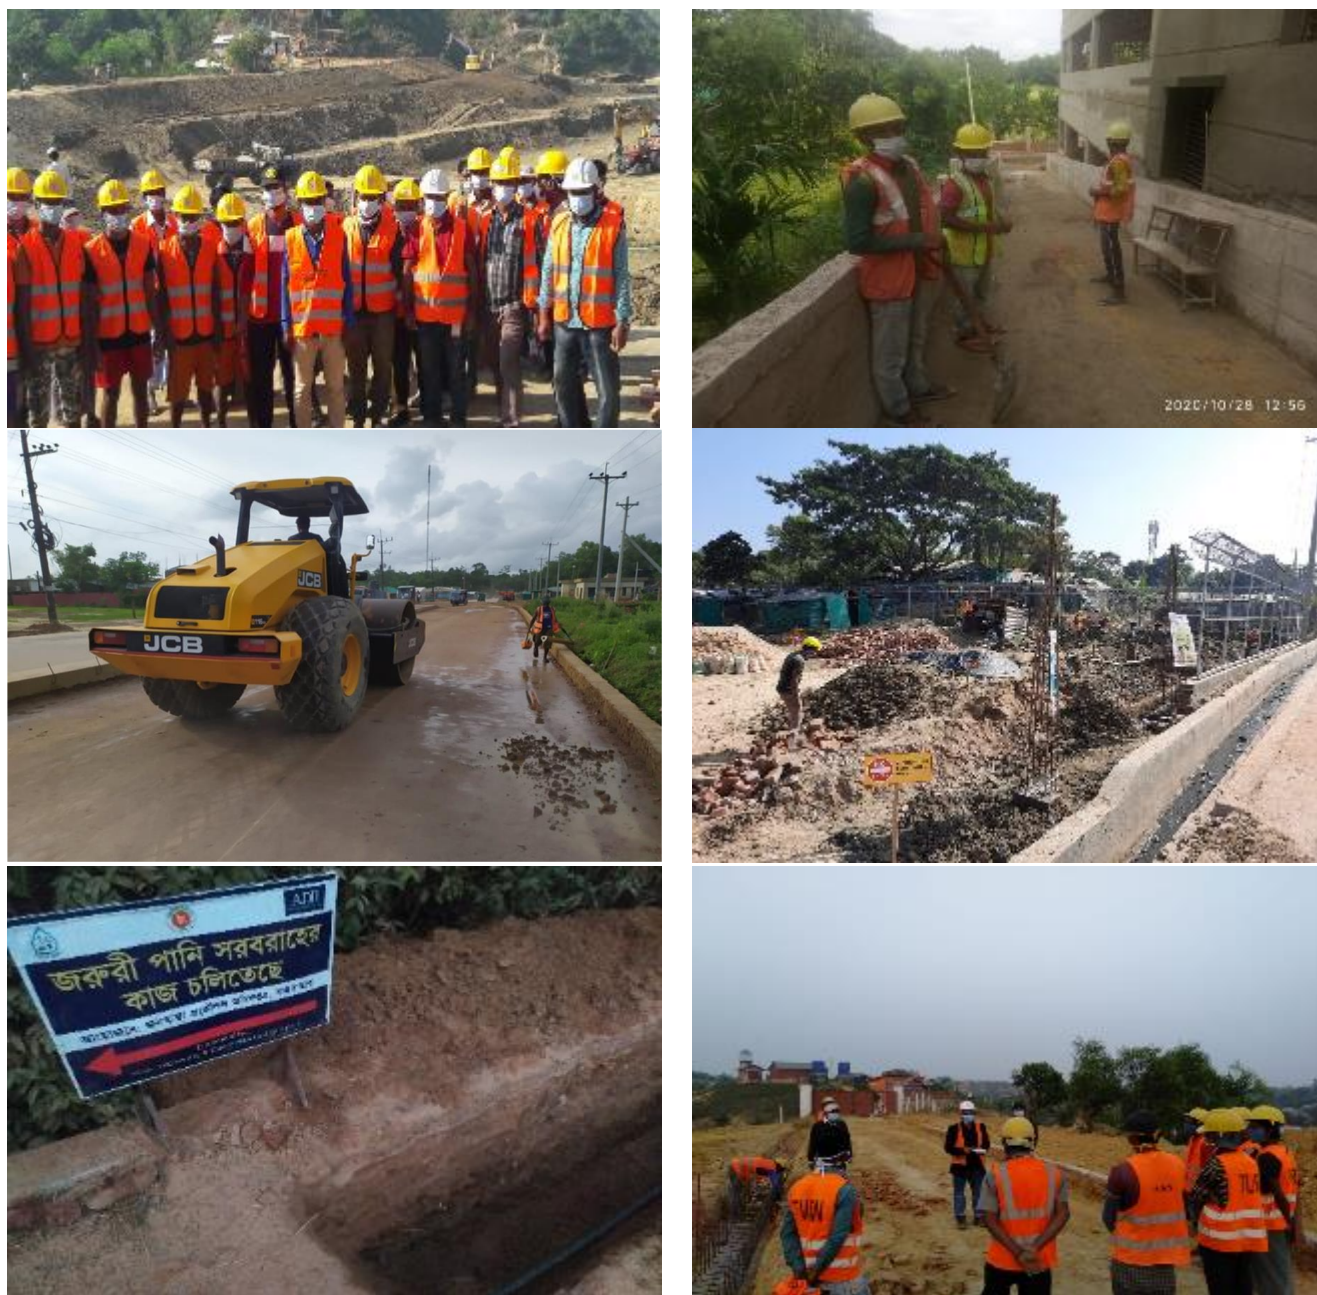
Figure 14 Safeguards status at various sites. Most of them found as partially to fully satisfactory

BREB G1, G2A, G2B, G5, W1A, W2B and G7		Construction is completed and the work site is reinstated prior to leaving the construction site.

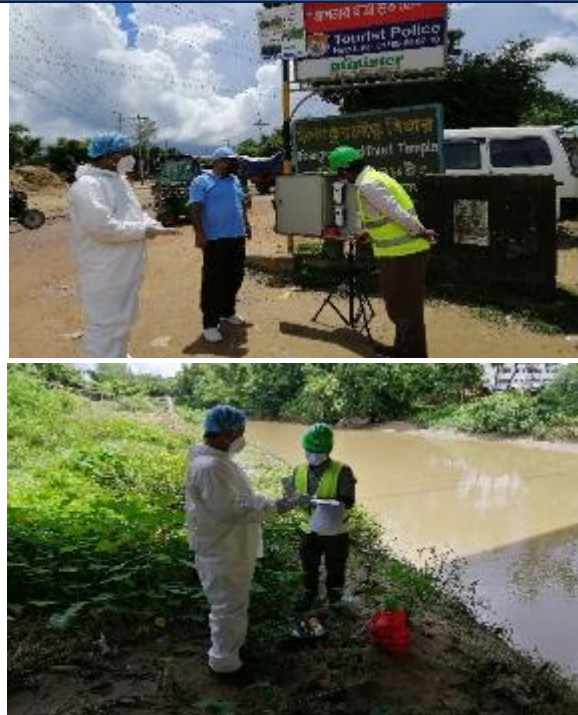
Issues	Observation	Corrective Action	Deadline	Responsibility	Photograph
Monitoring of Environmental Parameter	In order to ensure proper implementation of the environmental safeguard requirements, the Contractor has conducted air quality, noise measurement, surface water quality and groundwater quality testing and analysis through third party organization.	Rectified

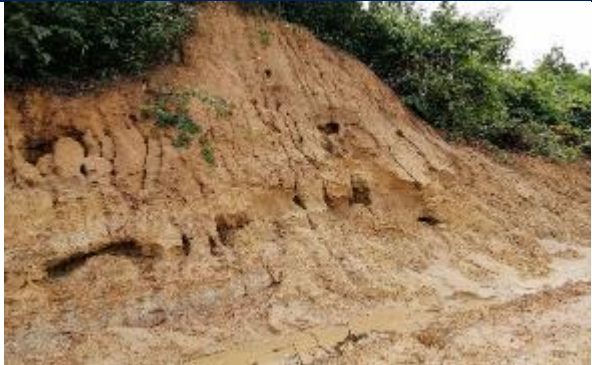
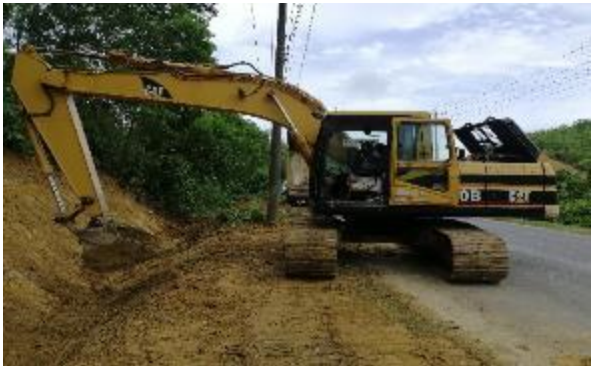
Issues	Observation	Corrective Action	Deadline	Responsibility	Photograph
Hill cutting and soil erosion	In order to achieve required road width, the hills located along the project alignment have been cut. Due to removal of topsoil from the highland, currently gully erosion is taking place at the disturbed slopes and no erosion control measures are taken to date. Consequently, the sediments discharged into the nearby surface water streams increasing the turbidity of the water which may affect the aquatic life living in the water body.	To mitigate these issues, adequate cross drainage as well as erosion control measures such as (i) cover disturbed slopes as soon as possible with grass turfing, vegetation or other materials (mulch) to reduce erosion potential; (ii) divert water from disturbed areas; (iii) maintain any structural control measures at the eroded sites should be applied immediately.	October 2020	Contractor and CSC

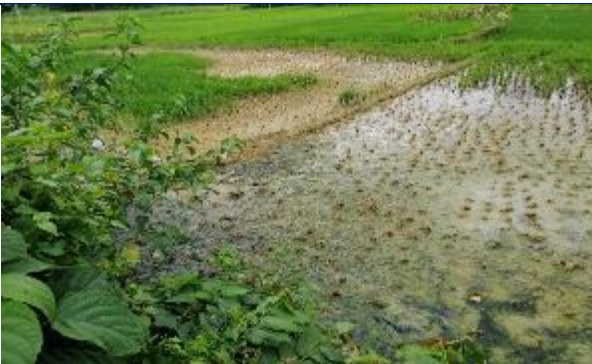
Management of Concrete Batching Plant	Waste water from batching plant is being discharged directly to the nearby agricultural field which polluted soil as well as water.	Contractor must prepare a waste water management plan and undertake the following measures: <ul style="list-style-type: none"> • All runoff and wastewater is to be collected and contained onsite in a sufficiently large tank/sedimentation pit. • Wastewater to be reused as part of the dust suppression system at earliest possible opportunity to restore storage capacity. 	October 2020	Contractor and CSC

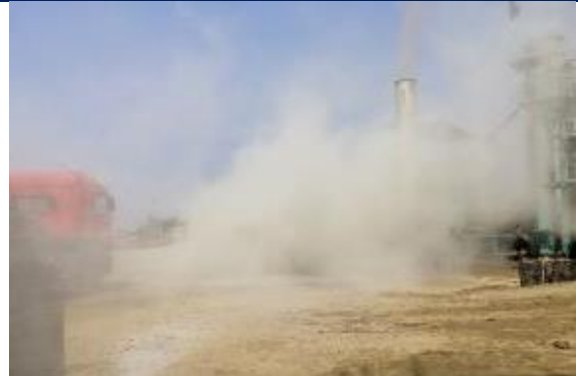
Issues	Observation	Corrective Action	Deadline	Responsibility	Photograph
Asphalt Mix Plant	Severe dust pollution is observed at the camp site due to the operation of asphalt plant which affected the labors and surrounding environment badly where workers were observed without dust mask, ear plug etc.	Contractor should use consult with supplier regarding dust issues and also install wet scrubber or other measures to reduce the dust level in the plant site. Dust mask and ear plug must be provided to the labors at the plant.	October 2020	Contractor and CSC

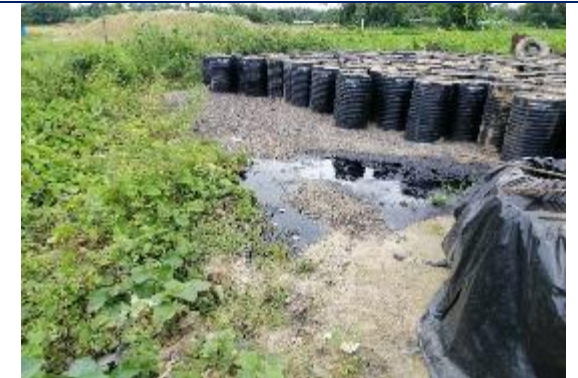
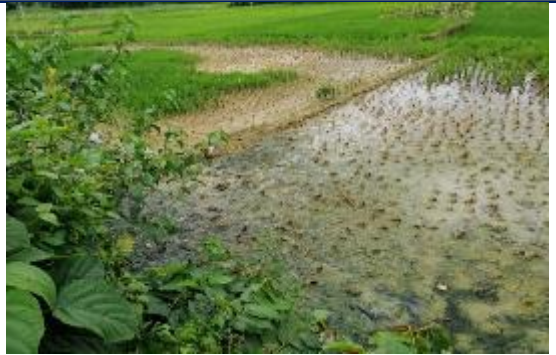
Control of Petroleum Products	<ul style="list-style-type: none"> Petroleum products are stored in scattered way at different locations where no absorbent kit is kept. Storage of petroleum products is located adjacent to the batching plant where large amount of waste water generated and mixed with spillage and discharged to the cultivated land which contaminate soil as well as water. The fuel storage is not confined and mixing trucks are frequently moved along 	<ul style="list-style-type: none"> Petroleum products must be stored in a designated storage location where any spillage can be safely maintained without contamination of the surrounding area. Spill absorbent must be kept at the refueling site. Storage should be confined and established away from haulage. Safety signs must be installed at the storage site. 	October 2020	Contractor and CSC

Issues	Observation	Corrective Action	Deadline	Responsibility	Photograph
	<p>the fuel drums, therefore, accident may occur at any moment.</p> <ul style="list-style-type: none"> No safety signage as well as fire extinguisher is placed at the storage area. 	<ul style="list-style-type: none"> Fire protection measure must be arranged at storage area.

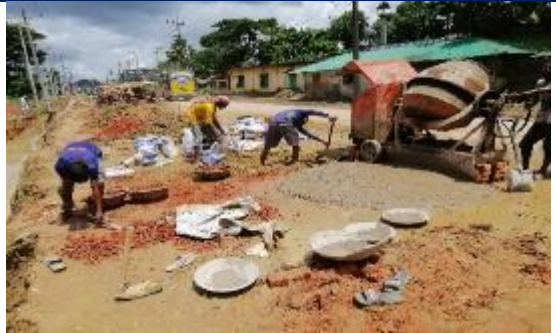
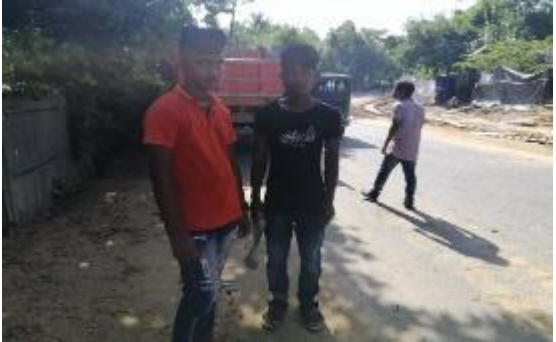
Worker Health and Safety	<ul style="list-style-type: none"> Labors were observed to work without PPEs at the site. Labors engaged in the noisy work site (more than 95dB) without ear protection. Workers were observed in the dusty work site without respiratory protection. Child labors are appointed and engaged in hazardous activity without PPEs. No health and safety checklist is followed at the work site. No first aid box was found in the construction site. 	<ul style="list-style-type: none"> PPEs need to be supplied to workers and enforced them to use at site. Contractor should comply with requirements of Government of Bangladesh Labour Law of 2006 (amended in 2013). Provide first aid facilities that are readily accessible by workers. Contractor must conduct tool box talk regularly at each site. 	October 2020	Contractor and CSC

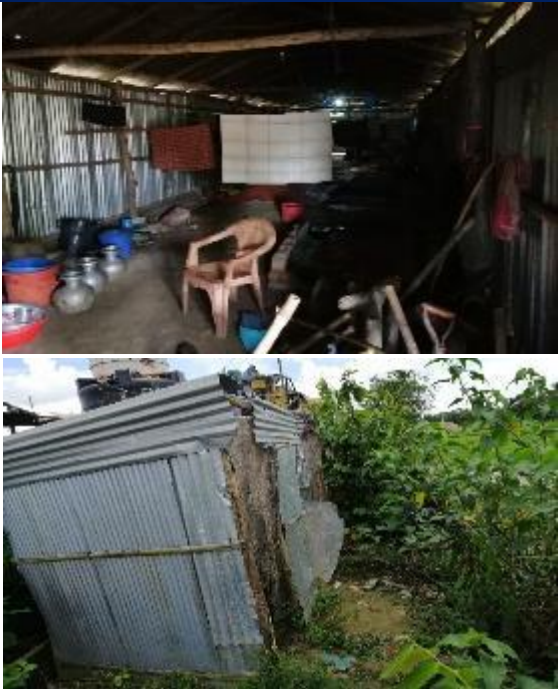
Issues	Observation	Corrective Action	Deadline	Responsibility	Photograph
Construction camp	<ul style="list-style-type: none"> Construction camp is not managed satisfactorily where no boundary fence with security is observed. No safety signs are placed in the construction camp. No housekeeping was observed there. Moreover, no waste management is found in the camp. Toilets for the labors are built without proper doors and septic tank is opened which emitted odor in the surrounding. No drainage network has been developed yet inside the camp where waste water management is not observed at all. Emergency procedure is not followed in the camp. 	<ul style="list-style-type: none"> Site safety signage must be placed at designated locations in the camp. Contractor should install garbage bins and construct a concrete waste disposal site which have the impermeable floor and wall and covered by shed to avoid air, soil and groundwater pollution. Emergency contact information should be displaced at the camp site. Sanitation facility should be improved. Drainage system must be developed inside the camp. 	February 2020	Contractor and CSC

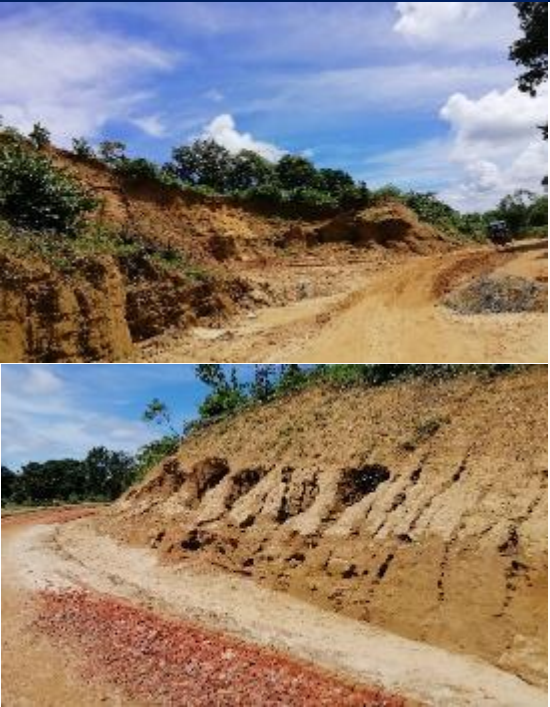
Issues	Observation	Corrective Action	Deadline	Responsibility	Photograph
Hill cutting and soil erosion	In order to achieve required road width, the hills located along the project alignment have been cut in Mocharkhloa. Due to removal of topsoil from the highland, currently gully erosion is taking place at the disturbed slopes and no erosion control measures are taken to date. Consequently, the sediments discharged into the nearby surface water streams increasing the turbidity of the water which may affect the aquatic life living in the water body.	To mitigate these issues, adequate cross drainage as well as erosion control measures such as (i) cover disturbed slopes as soon as possible with grass turfing, vegetation or other materials (mulch) to reduce erosion potential; (ii) divert water from disturbed areas; (iii) maintain any structural control measures at the eroded sites should be applied immediately.	October 2020	Contractor and CSC

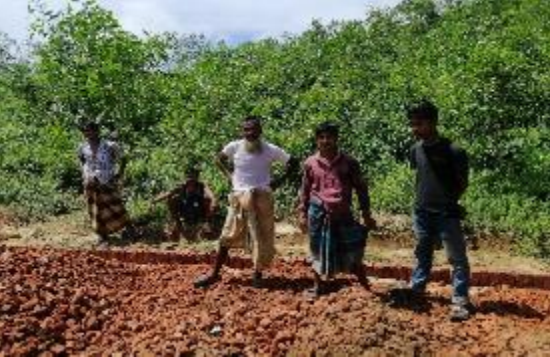
Worker health and safety	<ul style="list-style-type: none"> Access disturbance to the local community is occurred since no alternative route is being designated during construction activity. No road safety measure is followed at site. National labor standard was not followed to hire work force. PPEs are partially implemented in the working site. No first aid box is available at the site. Tool box meeting is not conducted at site to educate the workers. 	<ul style="list-style-type: none"> PPEs need to be supplied to workers and enforced them to use at site. Provide first aid facilities that are readily accessible by workers. Contractor must conduct tool box talk regularly at each site. Sanitation facility must be ensured at the working site. 	October 2020	Contractor

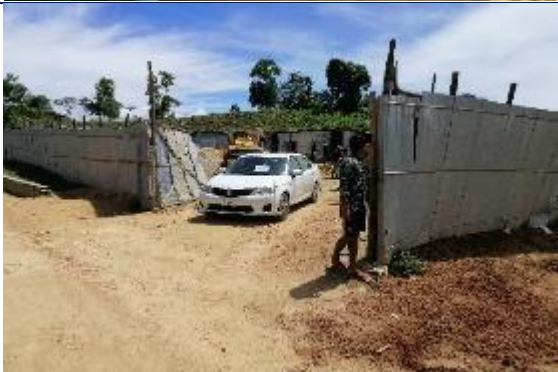
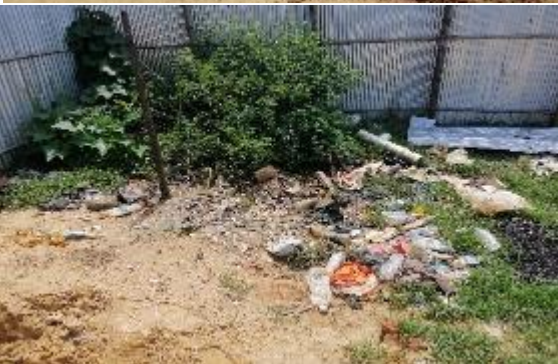
Construction camp	<ul style="list-style-type: none"> Construction camp is confined and secured by boundary fencing. Proper waste management yet to be implemented in the camp site. No safety signs are placed in the construction camp. No housekeeping was observed there. Moreover, no waste management is found in the camp. Emergency procedure is not followed in the camp. 	<ul style="list-style-type: none"> Site safety signage must be placed at designated locations in the camp. Separate garbage bins should be supplied for organic and inorganic wastes at the site and finally disposed at the designated location in the camp. Contractor should install garbage bins and construct a concrete waste disposal site which have the impermeable floor and wall and covered by shed to avoid air, soil and groundwater pollution. Emergency contact information should be displayed at the camp site. 	October 2020	Contractor

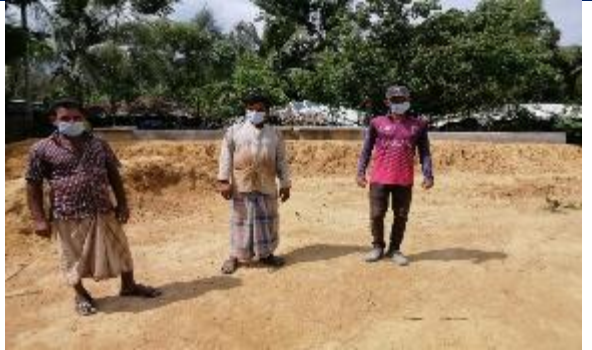
Issues	Observation	Corrective Action	Deadline	Responsibility	Photographs
Onsite Training on EHS	<p>Onsite training on EHS was conducted on 01 October 2020 where 4 a brief lecture to the participants majorly focused on: occupational health and safety including PPEs, safety signage, first aid, housekeeping, waste management, management of hazardous materials, emergency procedures. Moreover, explained about the importance of regular tool box meeting at the site</p> <p>On the other hand, participants were also explained the standard procedure for COVID-19 at the site such as appropriate PPEs, entry protocol to the worksite, hand washing protocol, discourage gathering at site and maintain physical distance, place signboard and posters at site on COVID response etc. However, all the participants hold a very positive attitude towards the training program.</p>

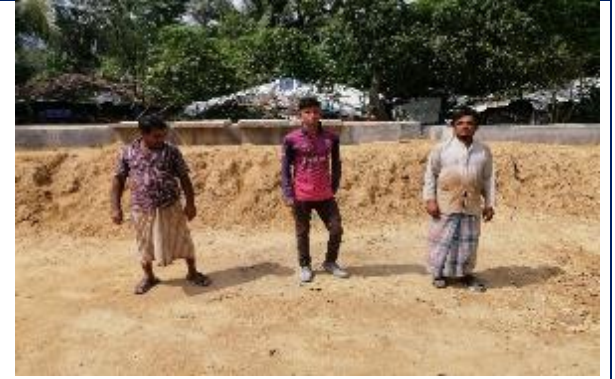
Issues	Observation	Corrective Action	Deadline	Responsibility	Photographs
	<ul style="list-style-type: none"> No tool box meeting was conducted at site to educate the workers. Emergency procedure was not followed at site.

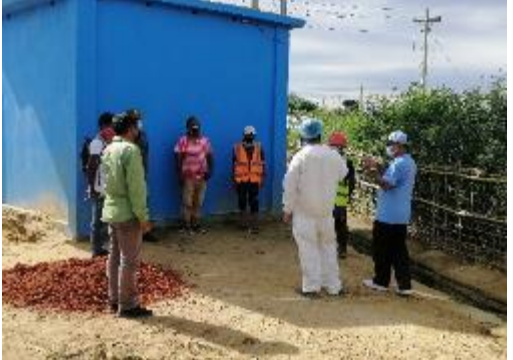
Issues	Observation	Corrective Action	Deadline	Responsibility	Photographs
Onsite Training on EHS	<p>Onsite training on EHS was conducted on 13 September 2020 where 8 workers were participated. ADB Environmental Specialist has given a brief lecture to the participants majorly focused on: occupational health and safety including PPEs, safety signage, first aid, housekeeping, waste management, management of hazardous materials, emergency procedures. Moreover, explained about the importance of regular tool box meeting at the site</p> <p>On the other hand, participants were also explained the standard procedure for COVID-19 at the site such as appropriate PPEs, entry protocol to the worksite, hand washing protocol, discourage gathering at site and maintain physical distance, place signboard and posters at site on COVID response etc. However, all the participants hold a very positive attitude towards the training program.</p>

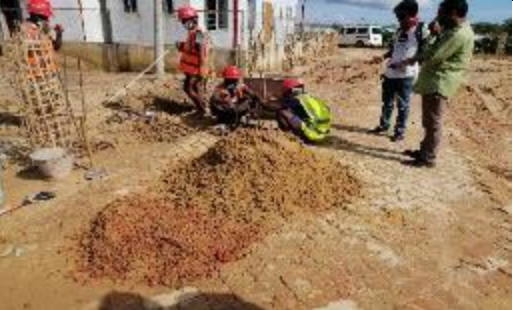
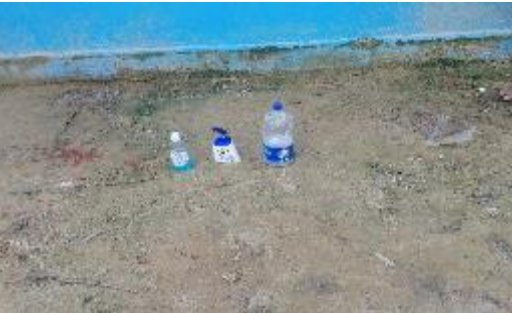
Worker health and safety	<ul style="list-style-type: none"> • PPEs were used at the site. • COVID-19 safety protocol is addressed at the site where hand sanitizer, mask and soap were supplied to the workers. • Site safety signs are absent in the site. • Tool box meeting is not conducted at site to educate the workers. • Emergency procedure for accident, fire incident is not maintained at the site. 	<ul style="list-style-type: none"> • Contractor should conduct tool box meeting regularly. • The excavated pond/house should be confined using safety tape for fall prevention. • Fire protection measures such as fire extinguisher should be available at the site. 	September 2020	Contractor

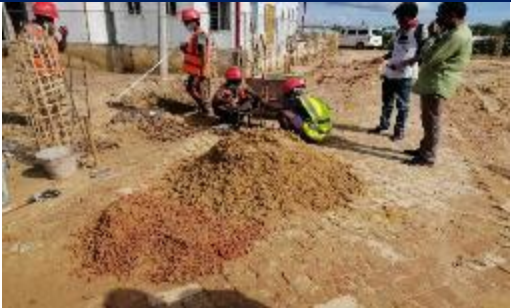
Issues	Observation	Corrective Action	Deadline	Responsibility	Photographs
Community health and safety	<ul style="list-style-type: none"> Foundation pits of solar panel, battery room are left open and causing trouble for locals Excavated earth materials were left open. 	<ul style="list-style-type: none"> Worksites are to be equipped with safety signs. Work site should be confined with safety tape. Excavated materials should be removed or properly stockpiled with cover at the site. 	September 2020	Contractor

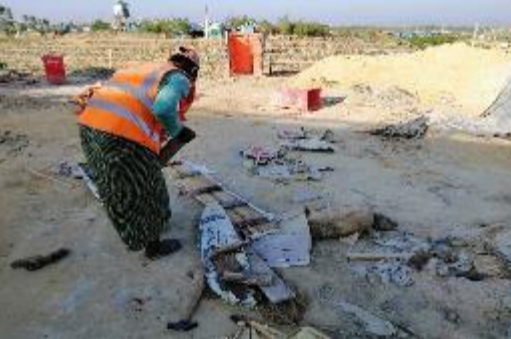
Waste Management	<ul style="list-style-type: none"> Construction wastes were scattered around the work site due to absence of housekeeping at the site. There is no waste management facility in the site to manage construction waste. 	<ul style="list-style-type: none"> Contractor should clean the work site regularly and provide garbage bins for both organic and inorganic wastes. Construction wastes should be dumped in the designated place. 	September 2020	Contractor
