## Environmental Monitoring Report

Project No. 52174-001

Reporting Period: January – June 2021  
October 2021

## Bangladesh: Emergency Assistance Project

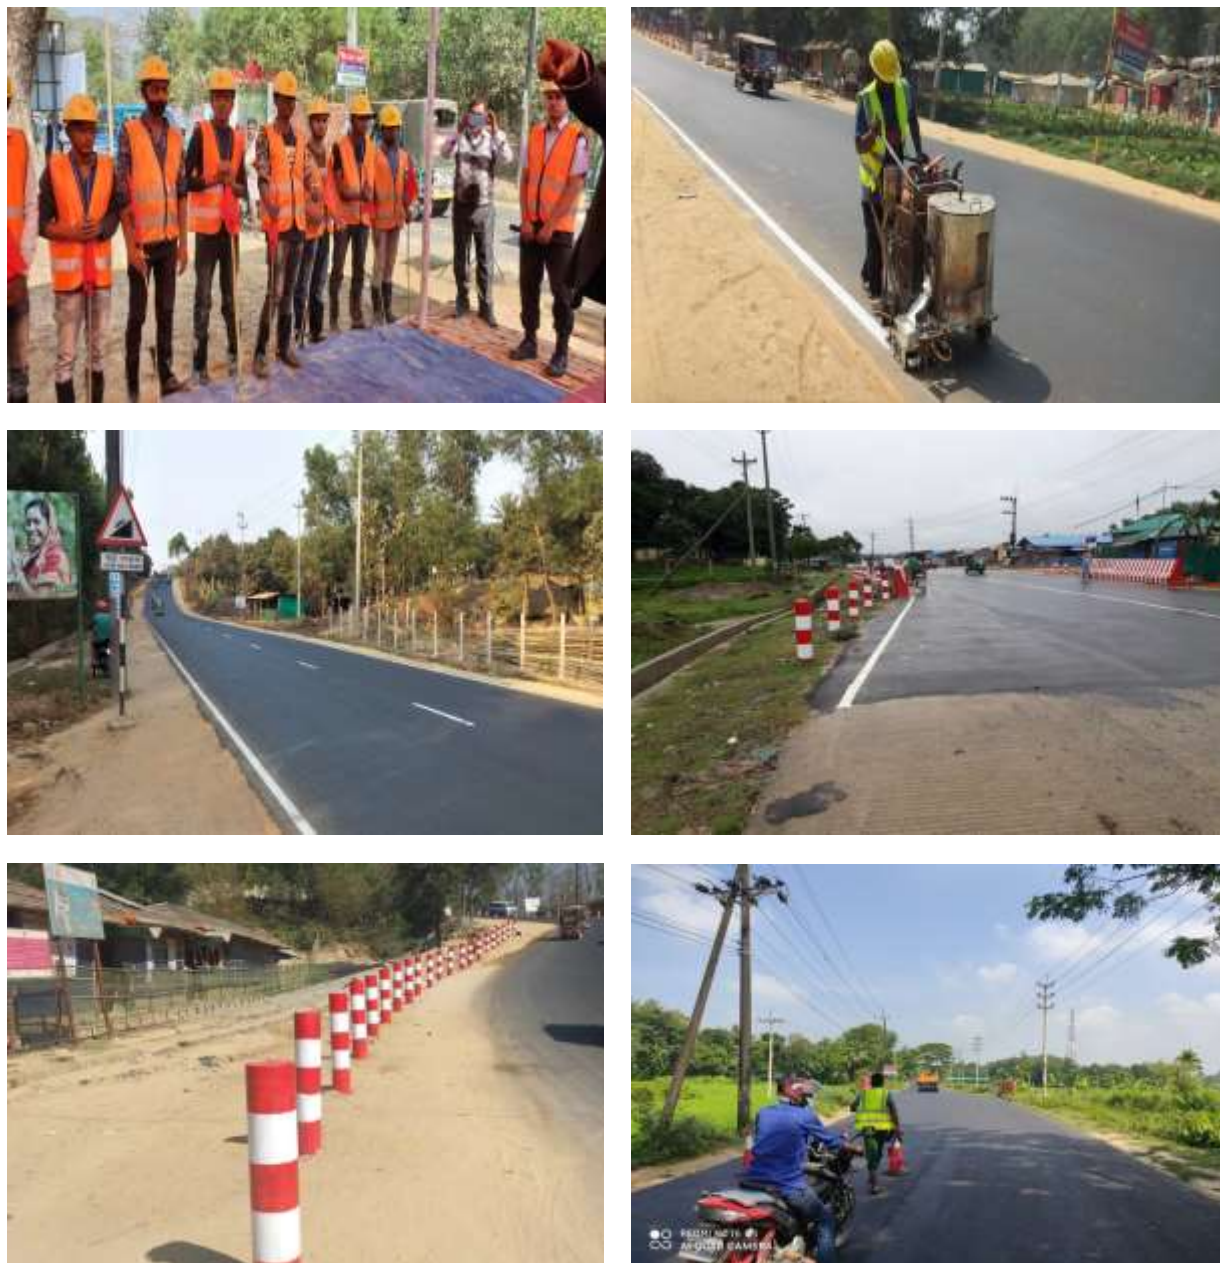
**Figure 9 Safeguards status at various sites. Most of them found as partially to fully satisfactory**

<b>BREB G1, G2A, G2B, G5, W1A, W2B and G7</b>		Construction is completed and the work site is reinstated prior to leaving the construction site.

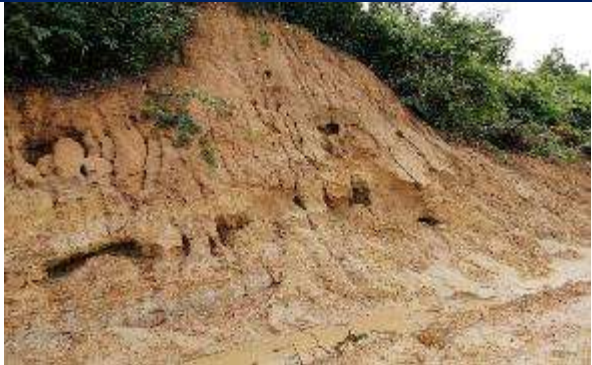
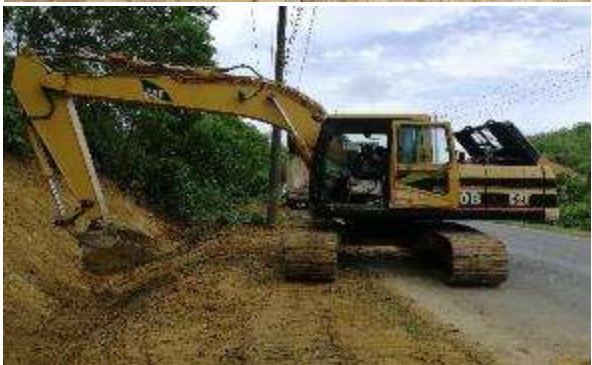
Issues	Observation	Corrective Action	Deadline	Responsibility	Photograph
<b>Hill cutting and soil erosion</b>	In order to achieve required road width, the hills located along the project alignment have been cut. Due to removal of topsoil from the highland, currently gully erosion is taking place at the disturbed slopes and no erosion control measures are taken to date. Consequently, the sediments discharged into the nearby surface water streams increasing the turbidity of the water which may affect the aquatic life living in the water body.	To mitigate these issues, adequate cross drainage as well as erosion control measures such as (i) cover disturbed slopes as soon as possible with grass turving, vegetation or other materials (mulch) to reduce erosion potential; (ii) divert water from disturbed areas; (iii) maintain any structural control measures at the eroded sites should be applied immediately.	October 2020	Contractor and CSC

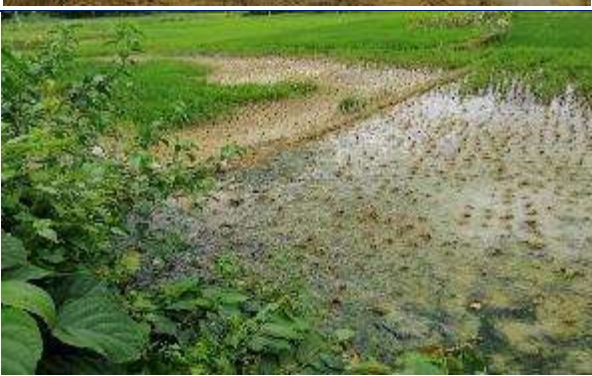
<b>Management of Concrete Batching Plant</b>	Waste water from batching plant is being discharged directly to the nearby agricultural field which polluted soil as well as water.	Contractor must prepare a waste water management plan and undertake the following measures: <ul style="list-style-type: none"> <li>• All runoff and wastewater is to be collected and contained onsite in a sufficiently large tank/sedimentation pit.</li> <li>• Wastewater to be reused as part of the dust suppression system at earliest possible opportunity to restore storage capacity.</li> </ul>	October 2020	Contractor and CSC

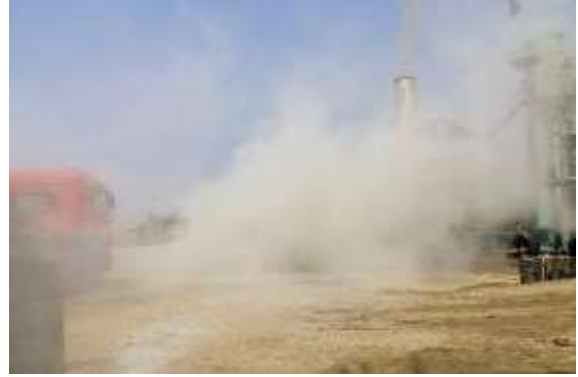
Issues	Observation	Corrective Action	Deadline	Responsibility	Photograph
<b>Asphalt Mix Plant</b>	Severe dust pollution is observed at the camp site due to the operation of asphalt plant which affected the labors and surrounding environment badly where workers were observed without dust mask, ear plug etc.	Contractor should use consult with supplier regarding dust issues and also install wet scrubber or other measures to reduce the dust level in the plant site. Dust mask and ear plug must be provided to the labors at the plant.	October 2020	Contractor and CSC

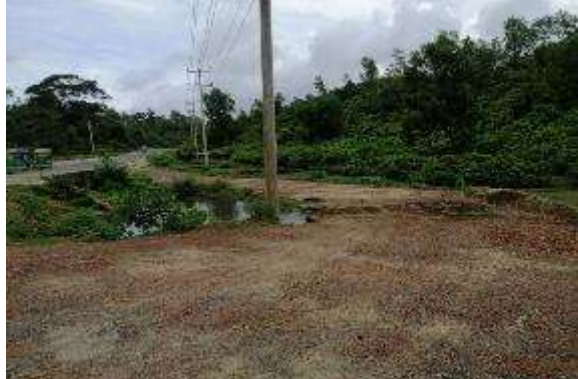
<b>Drainage congestion</b>	Waterlogging problems were occurred at the different locations especially at the road diversion sections along the culvert construction sites where cross drainage facility is not functioning, subsequently waterlogging problem is occurred near the road alignment.	Contractor should increase the frequency of watering (at least 4 times a day) to reduce the dust level on the road (special care should be taken for the access road to the camp).	October 2020	Contractor and CSC

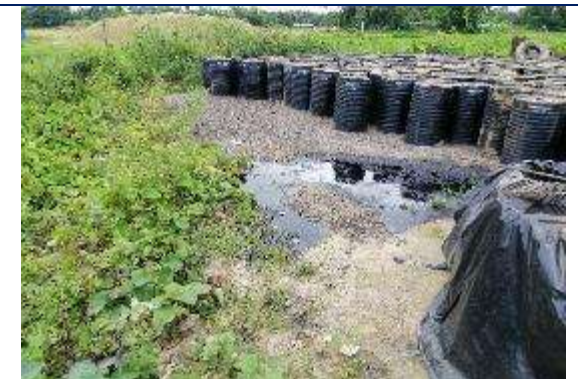
<b>Control of Petroleum Products</b>	<ul style="list-style-type: none"> <li>Petroleum products are stored in scattered way at different locations where no absorbent kit is kept.</li> <li>Storage of petroleum products is located adjacent to the batching plant where large amount of waste water generated and mixed with spillage and discharged to the cultivated land which contaminate soil as well as water.</li> <li>The fuel storage is not confined and mixing trucks are frequently moved along</li> </ul>	<ul style="list-style-type: none"> <li>Petroleum products must be stored in a designated storage location where any spillage can be safely maintained without contamination of the surrounding area.</li> <li>Spill absorbent must be kept at the refueling site.</li> <li>Storage should be confined and established away from haulage.</li> <li>Safety signs must be installed at the storage site.</li> </ul>	October 2020	Contractor and CSC

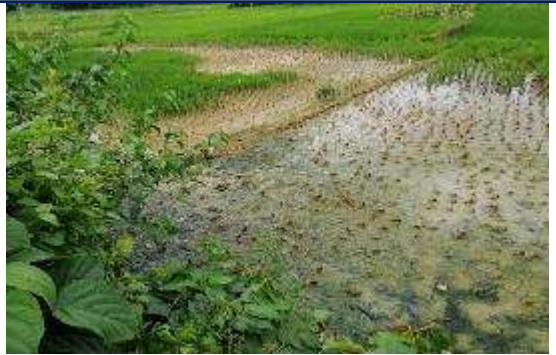
Issues	Observation	Corrective Action	Deadline	Responsibility	Photograph
	<p>the fuel drums, therefore, accident may occur at any moment.</p> <ul style="list-style-type: none"> <li>No safety signage as well as fire extinguisher is placed at the storage area.</li> </ul>	<ul style="list-style-type: none"> <li>Fire protection measure must be arranged at storage area.</li> </ul>

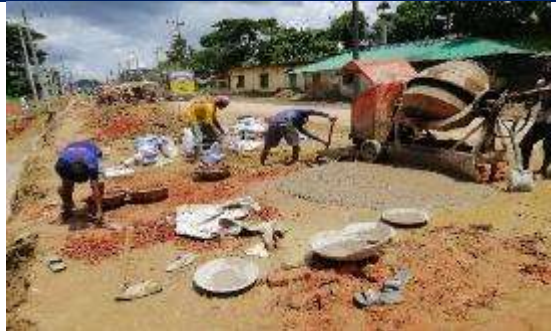
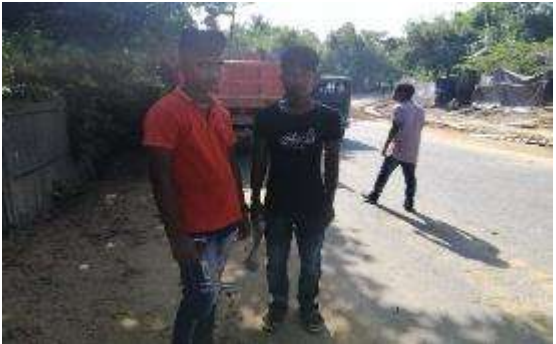
<b>Worker Health and Safety</b>	<ul style="list-style-type: none"> <li>Labors were observed to work without PPEs at the site.</li> <li>Labors engaged in the noisy work site (more than 95dB) without ear protection.</li> <li>Workers were observed in the dusty work site without respiratory protection.</li> <li>Child labors are appointed and engaged in hazardous activity without PPEs.</li> <li>No health and safety checklist is followed at the work site.</li> <li>No first aid box was found in the construction site.</li> </ul>	<ul style="list-style-type: none"> <li>PPEs need to be supplied to workers and enforced them to use at site.</li> <li>Contractor should comply with requirements of Government of Bangladesh Labour Law of 2006 (amended in 2013).</li> <li>Provide first aid facilities that are readily accessible by workers.</li> <li>Contractor must conduct tool box talk regularly at each site.</li> </ul>	October 2020	Contractor and CSC

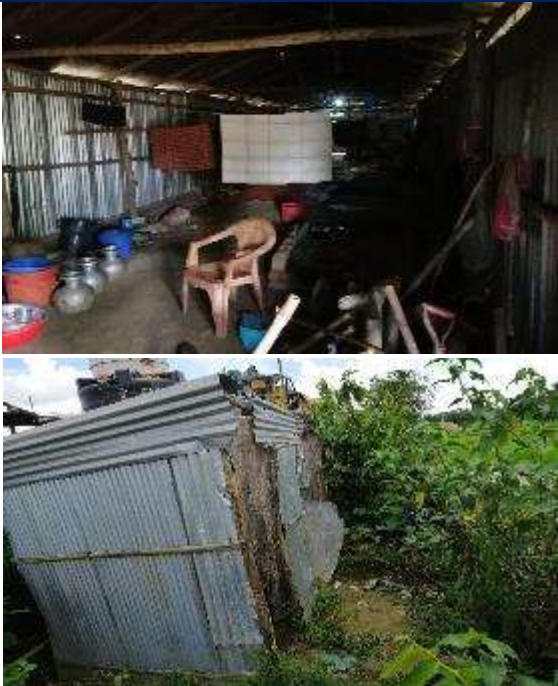
Issues	Observation	Corrective Action	Deadline	Responsibility	Photograph
Construction camp	<ul style="list-style-type: none"> <li>Construction camp is not managed satisfactorily where no boundary fence with security is observed.</li> <li>No safety signs are placed in the construction camp.</li> <li>No housekeeping was observed there. Moreover, no waste management is found in the camp.</li> <li>Toilets for the labors are built without proper doors and septic tank is opened which emitted odor in the surrounding.</li> <li>No drainage network has been developed yet inside the camp where waste water management is not observed at all.</li> <li>Emergency procedure is not followed in the camp.</li> </ul>	<ul style="list-style-type: none"> <li>Site safety signage must be placed at designated locations in the camp.</li> <li>Contractor should install garbage bins and construct a concrete waste disposal site which have the impermeable floor and wall and covered by shed to avoid air, soil and groundwater pollution.</li> <li>Emergency contact information should be displaced at the camp site.</li> <li>Sanitation facility should be improved.</li> <li>Drainage system must be developed inside the camp.</li> </ul>	February 2020	Contractor and CSC

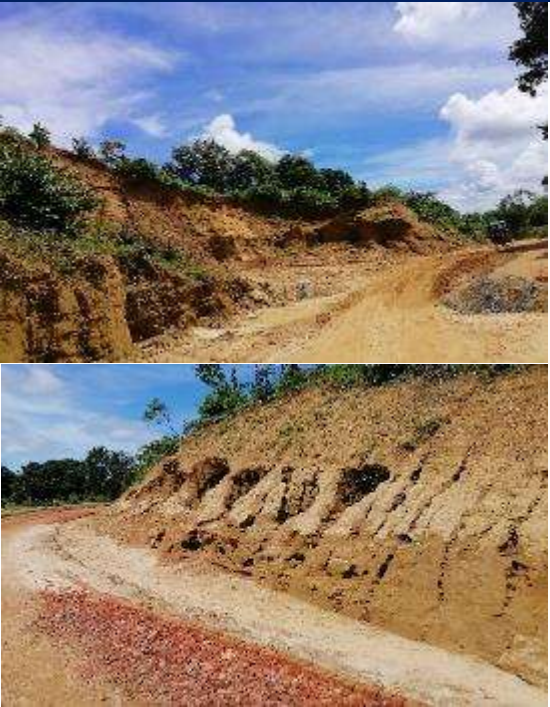
Issues	Observation	Corrective Action	Deadline	Responsibility	Photograph
<b>Hill cutting and soil erosion</b>	In order to achieve required road width, the hills located along the project alignment have been cut in Mocharkhloa. Due to removal of topsoil from the highland, currently gully erosion is taking place at the disturbed slopes and no erosion control measures are taken to date. Consequently, the sediments discharged into the nearby surface water streams increasing the turbidity of the water which may affect the aquatic life living in the water body.	To mitigate these issues, adequate cross drainage as well as erosion control measures such as (i) cover disturbed slopes as soon as possible with grass turfing, vegetation or other materials (mulch) to reduce erosion potential; (ii) divert water from disturbed areas; (iii) maintain any structural control measures at the eroded sites should be applied immediately.	October 2020	Contractor and CSC

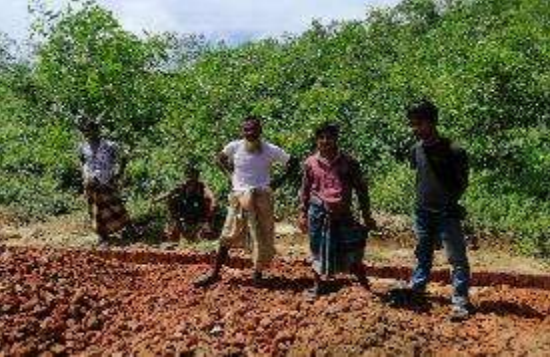
<b>Worker health and safety</b>	<ul style="list-style-type: none"> <li>Access disturbance to the local community is occurred since no alternative route is being designated during construction activity.</li> <li>No road safety measure is followed at site.</li> <li>National labor standard was not followed to hire work force.</li> <li>PPEs are partially implemented in the working site.</li> <li>No first aid box is available at the site.</li> <li>Tool box meeting is not conducted at site to educate the workers.</li> </ul>	<ul style="list-style-type: none"> <li>PPEs need to be supplied to workers and enforced them to use at site.</li> <li>Provide first aid facilities that are readily accessible by workers.</li> <li>Contractor must conduct tool box talk regularly at each site.</li> <li>Sanitation facility must be ensured at the working site.</li> </ul>	October 2020	Contractor

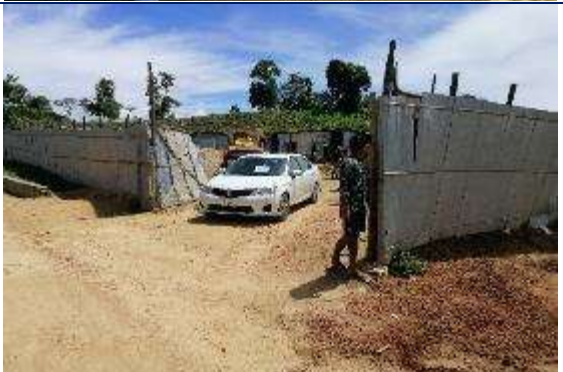
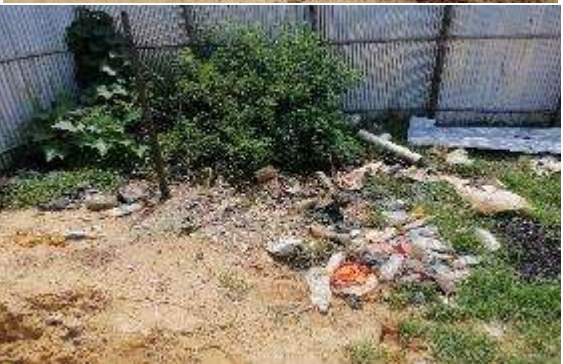
Construction camp	<ul style="list-style-type: none"> <li>Construction camp is confined and secured by boundary fencing.</li> <li>Proper waste management yet to be implemented in the camp site.</li> <li>No safety signs are placed in the construction camp.</li> <li>No housekeeping was observed there. Moreover, no waste management is found in the camp.</li> <li>Emergency procedure is not followed in the camp.</li> </ul>	<ul style="list-style-type: none"> <li>Site safety signage must be placed at designated locations in the camp.</li> <li>Separate garbage bins should be supplied for organic and inorganic wastes at the site and finally disposed at the designated location in the camp.</li> <li>Contractor should install garbage bins and construct a concrete waste disposal site which have the impermeable floor and wall and covered by shed to avoid air, soil and groundwater pollution.</li> <li>Emergency contact information should be displayed at the camp site.</li> </ul>	October 2020	Contractor

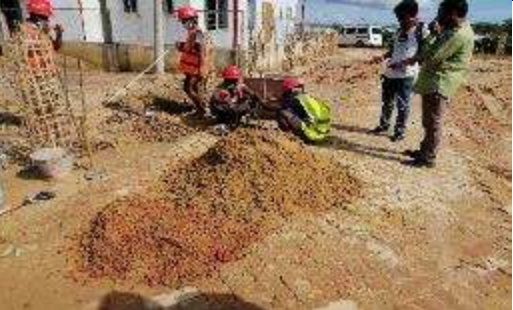
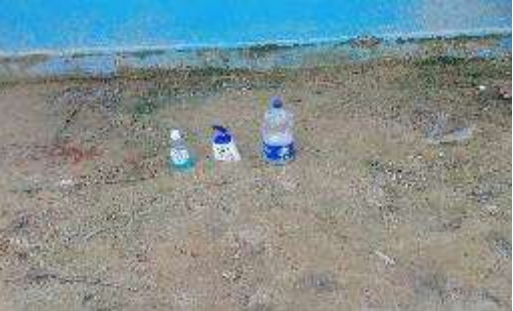
<b>Worker health and safety</b>	<ul style="list-style-type: none"> <li>• PPEs were used at the site.</li> <li>• COVID-19 safety protocol is addressed at the site where hand sanitizer, mask and soap were supplied to the workers.</li> <li>• Site safety signs are absent in the site.</li> <li>• Tool box meeting is not conducted at site to educate the workers.</li> <li>• Emergency procedure for accident, fire incident is not maintained at the site.</li> </ul>	<ul style="list-style-type: none"> <li>• Contractor should conduct tool box meeting regularly.</li> <li>• The excavated pond/house should be confined using safety tape for fall prevention.</li> <li>• Fire protection measures such as fire extinguisher should be available at the site.</li> </ul>	September 2020	Contractor

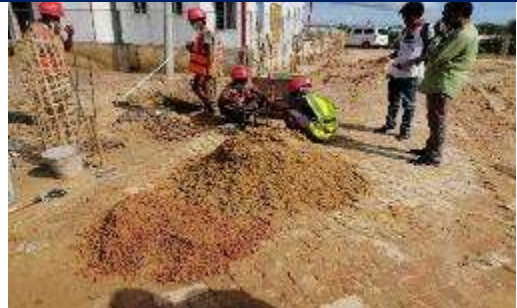
Issues	Observation	Corrective Action	Deadline	Responsibility	Photographs
<b>Community health and safety</b>	<ul style="list-style-type: none"> <li>Foundation pits of solar panel, battery room are left open and causing trouble for locals</li> <li>Excavated earth materials were left open.</li> </ul>	<ul style="list-style-type: none"> <li>Worksites are to be equipped with safety signs.</li> <li>Work site should be confined with safety tape.</li> <li>Excavated materials should be removed or properly stockpiled with cover at the site.</li> </ul>	September 2020	Contractor

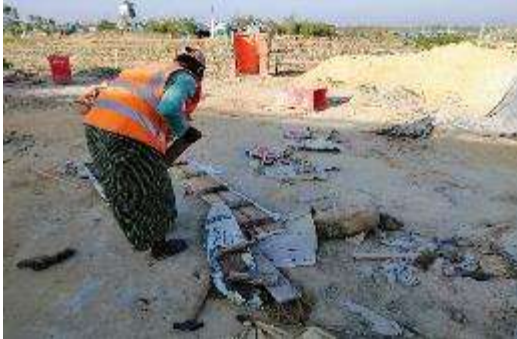
<b>Waste Management</b>	<ul style="list-style-type: none"> <li>Construction wastes were scattered around the work site due to absence of housekeeping at the site.</li> <li>There is no waste management facility in the site to manage construction waste.</li> </ul>	<ul style="list-style-type: none"> <li>Contractor should clean the work site regularly and provide garbage bins for both organic and inorganic wastes.</li> <li>Construction wastes should be dumped in the designated place.</li> </ul>	September 2020	Contractor
