**Semi-annual Environmental Monitoring Report  
On  
Emergency Assistance Project**

# Emergency Assistance Project

ADB Project 52174-001 | Grant 0582-BAN | TA 9546 BAN

Second Semi-Annual Environmental Monitoring Report

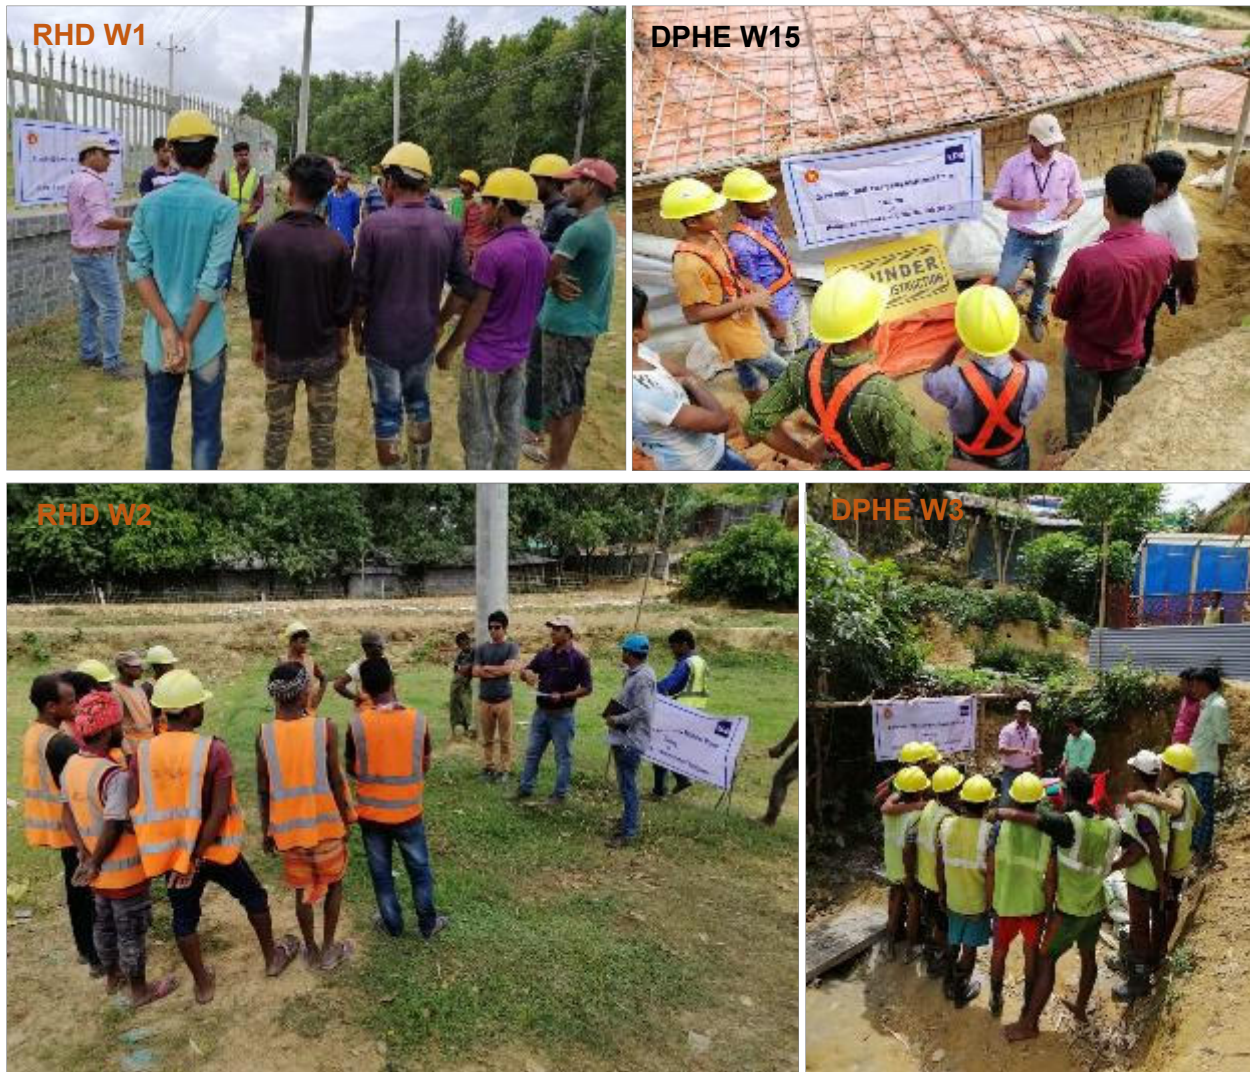
Figure 5 Onsite trainings conducted during monitoring visits

84 Besides monitoring visits, onsite trainings and meetings with EAs were conducted during the current monitoring period. The site-based trainings were arranged by the environmental specialists to sensitize the contractors on implementing the environmental safeguards according to the EMPs and other contracts. A total 18 onsite trainings were arranged to date. Besides one regional workshop was organized by ADB in Cox's Bazar with all EAs and contractors to train them so that they can better implement the EMPs and get aware about the environmental concerns. Besides trainings, regular meetings with EAs were conducted on frequent basis to better coordinate with all the EAs. To date 58 meetings have been conducted. Alongside meetings with EAs, 5 more meetings with various organizations like UNHCR, SMEP and ISCG were attended to understand the current coordination status in Cox's bazar. **Table 12** below represents the breakdown of meetings and onsite trainings arranged by the environmental specialists.

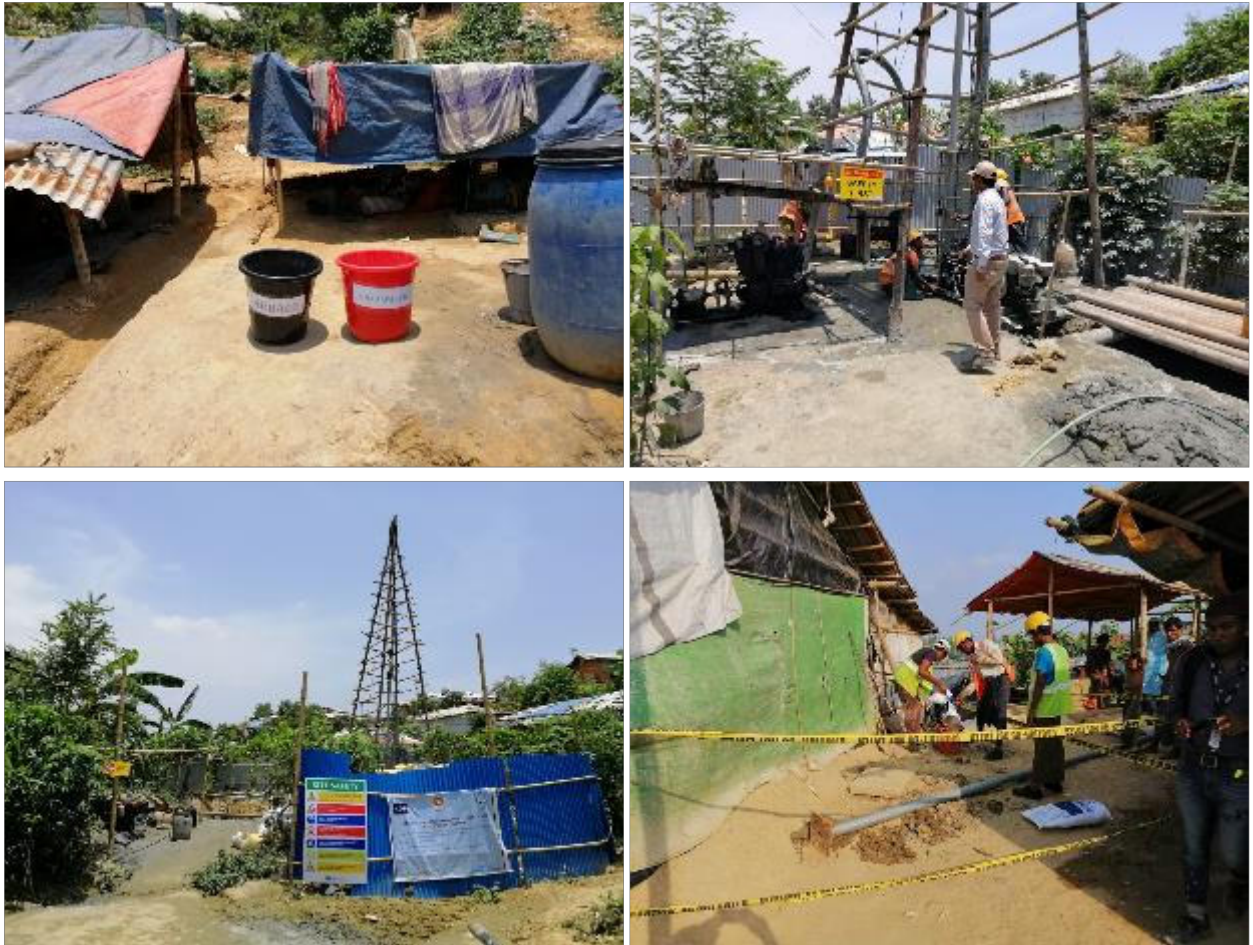
**Figure 7 Safeguards status at various sites. Most of them found as partially to fully satisfactory**

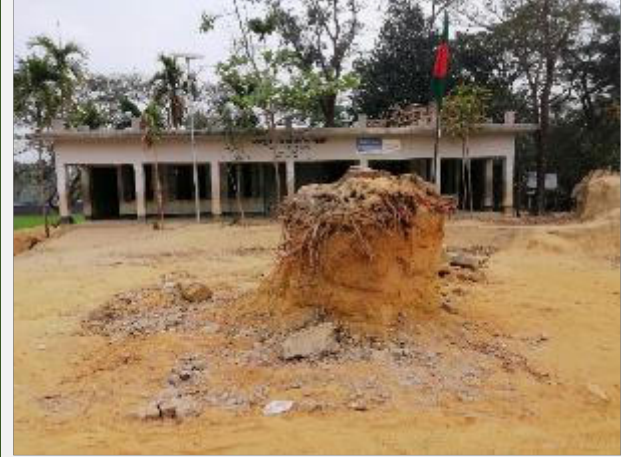
Plate 01: Total 08 matured trees were felled during site levelling

EMP Reference and Amendment	Audit find	Audit score	Action proposed	Photograph
Permissions need to be obtained from the existing School Authorities prior construction works.  EMP Reference 1.2	Evidence of verbal communication with the school authority was found, however no NOC was present at site	3	The NOC from the school authority should be kept at site all the time.	Photograph not required
Site preparation including tree cutting and levelling started  Excavator mobilized  EMP Reference: 2.5, 2.7	Site clearance involved felling of 8 matured trees  Proper PPEs were not found at site, stockpiles were left open and the site was found dusty  Sign posts and area demarcation was not found at site  The proposed cyclone shelter is located on the elevated land where the school toilets were located which are being demolished due to site clearance. Currently there is no sanitation facility for 350 students including female students. As a result, students are going to the nearby household to use the toilet.	2	As per suggestion of the EMP trees needs to replanted during the construction starts and maintain steady growth until the liability period expires  The workers need to wear the protective wears all the time.  Water spray needs to be frequent to avoid dust in the school area. Since people live nearby house, the approach road also needs to be water sprayed twice daily.  The area needs to be marked with signposts and protective fencing so that school going children

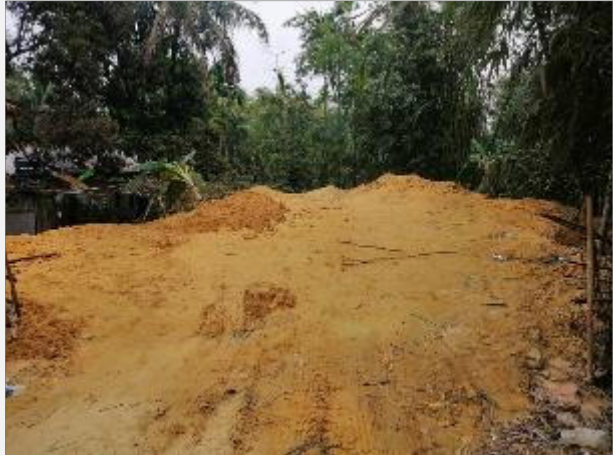
EMP Reference and Amendment	Audit find	Audit score	Action proposed	Photograph
			<p>nearby cannot enter into site. The area is also a playing ground for local children. Therefore, site safety marker and fencing need to be immediately employed</p> <p>Contractor should build sanitation facility immediately for the students.</p> <p>Plantation should take place immediately after site demarcation according to EMP Reference 2.5. EMP has been amended according to the current condition.</p>	  <p>Plate 02: Proper PPEs were not found at site</p>

<p>Plate 03: Stockpiles were left open and site was quite dusty</p>

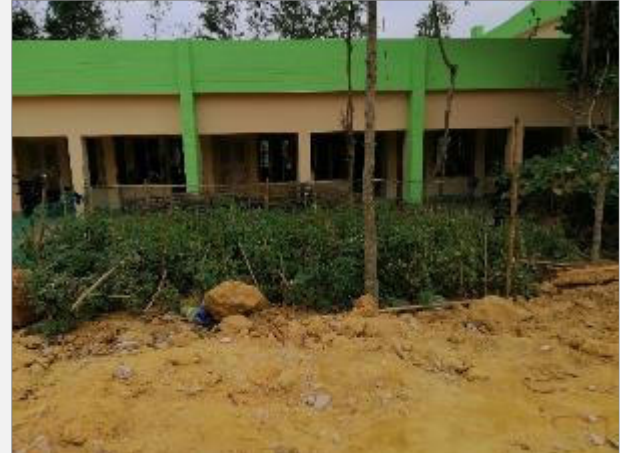
<p>Plate 06: Unsafe holes within the school compound and dust around the school was found</p>

EMP Reference and Amendment	Audit find	Audit Score	Action proposed	Photograph
<p>Burrow areas need to be marked properly so that workers may identify even in the dark. If after construction, burrow areas stay open, the areas need to be filled with local sand/silt and then revegetated with local bushes so that they can prevent erosion.</p> <p>EMP Reference 2.1</p>	<p>Site demarcation was not found, site levelling activities encroached to the school building compound. Children are playing on the compound who might get hurt due to some unsafe holes. The site was found quite dusty, water spray was absent.</p>	2	<p>Site needs to be demarcated properly so that school children do not enter the area and hurt themselves</p> <p>Water spray must be done twice daily, if requires more frequent during school time so that school children do not suffer from dust induced allergy and other discomfort.</p>

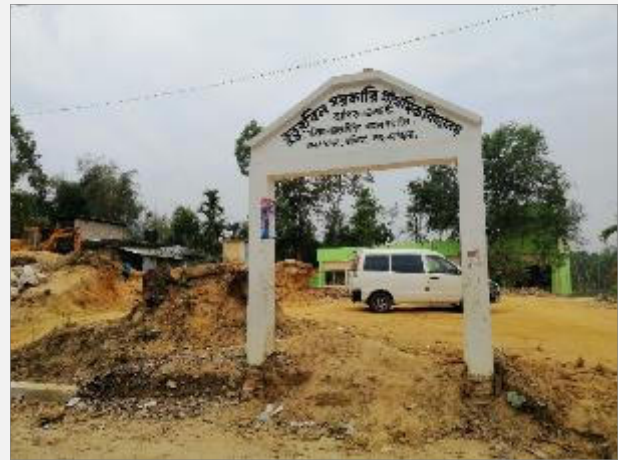
<p>Plate 07: No silt barrier was found at the edge of the site</p>

EMP Reference and Amendment	Audit find	Audit Score	Action proposed	Photograph
<p>During Construction: create silt barriers to prevent sudden runoff of eroded materials during rains, keep an eye for certain rains and continuously maintain the silt barrier</p> <p>EMP Reference Table 3</p>	<p>The coming month of March may surprise with couple of showers. The site is located at the edge of a hilly area and is prone to certain erosion-laden runoff downstream towards foothill local community if any shower occurs. But no silt barrier has been installed to date.</p>	2	<p>Installation of silt barriers is necessary before the rainy season comes</p>

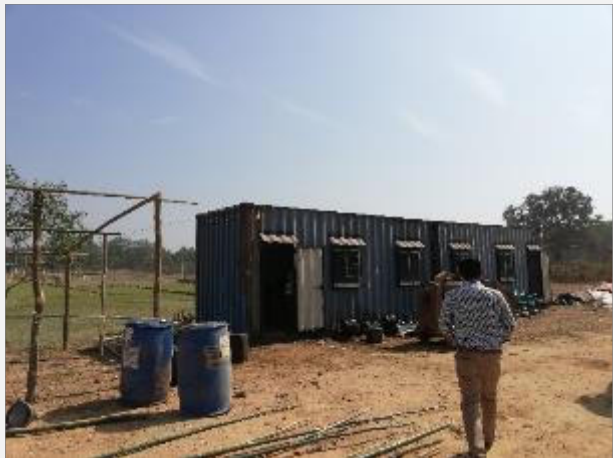
<p>Plate 01: Temporary Site office and labor camp was in place</p>

EMP Reference and Amendment	Audit find	Audit score	Action proposed	Photograph
<b>[Amendment] Permissions need to be obtained from the existing Authorities prior construction works.</b>  EMP Reference 1.4	The contractor is using RHD's facilities in Balukhali as Camp area. The camp area is, therefore, well established with designated conference room, toilet facilities, site office, vehicle garage and stockpile area	5	None at the moment	
<b>[Amendment] Site office, labor camp needs to be established with health and safety facilities installed for worker as well as local communities</b>  EMP reference 2.13	<p>Site just started the set-up process. Temporary site office cum labour shed was found</p> <p>Excavator mobilized</p> <p>Toilet and water sources are about to be established.</p> <p>Construction materials were found to be stockpiled in open with no protective measure</p> <p>Plastic Oil/fuel barrels were found in open in scattered way</p> <p>Signboards with project description were under preparation</p> <p>Proper PPEs were not found in site. Workers are working without protection.</p>	4	<ul style="list-style-type: none"> <li>Plastic oil/fuel barrels need to be kept at a safe place and empty barrels need to be kept at a place for safe disposal</li> <li>Drinking water source needs to be examined to see if it is safe for drinking purposes.</li> <li>Proper PPEs need to be provided at site by force. Any occurrence will trigger H&amp;S issue that might make a bad impression of the project.</li> <li>Stock pile areas were found dusty. Water spray is needed intermittently to suppress dust at the stockpile area</li> </ul>

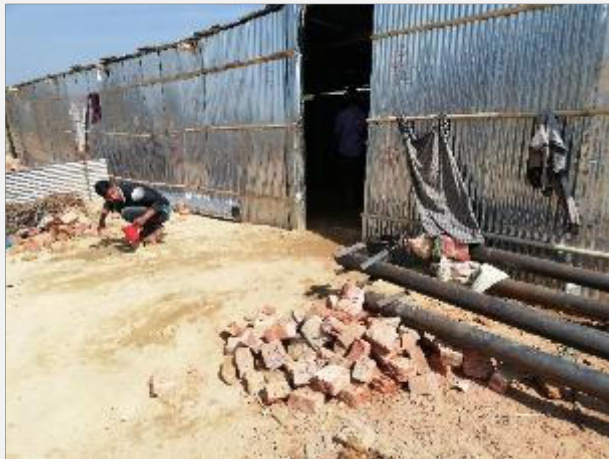
<p>Plate 02: Construction materials were left open and unsafe</p>

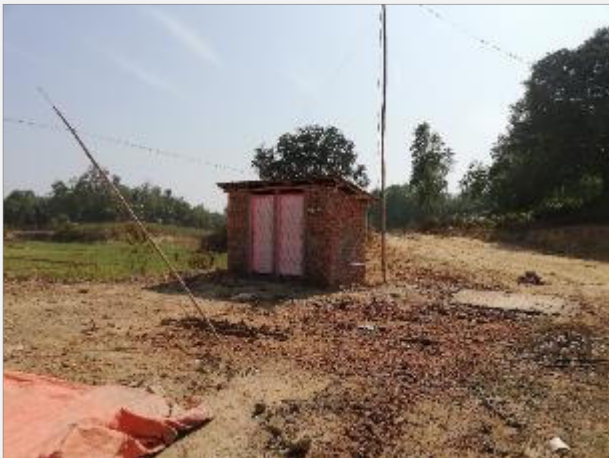
<p>Plate 04: Separate toilets were under construction</p>
		4

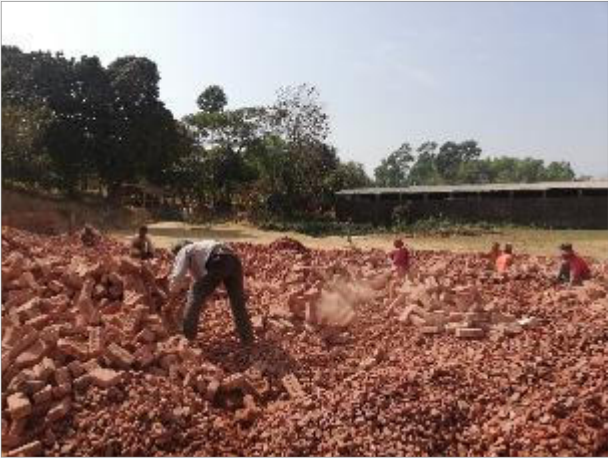
<p>Plate 05: Proper PPEs were not found at site</p>

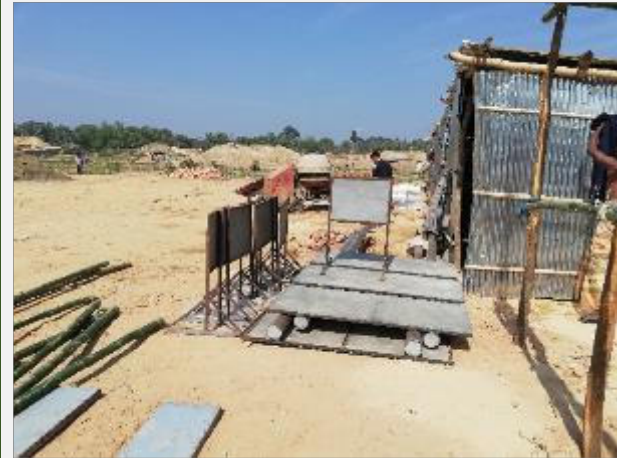
<p>Plate 06: Signborads with project information were under preparation</p>
<ul style="list-style-type: none"> <li>Watering access road, especially in the dry season</li> </ul> <p>EMP Reference 2.2</p>	The access road to the site office and stockpile area was found to be water sprayed twice a day. However, locals are complaining that the road still gets dusty during mid-day.	4	Suggested water spray 3 time daily

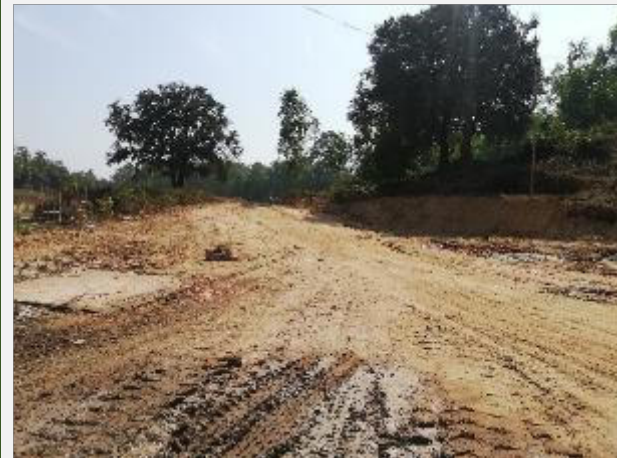
<p>Plate 07: Dust supression measures needs to be more frequent</p>

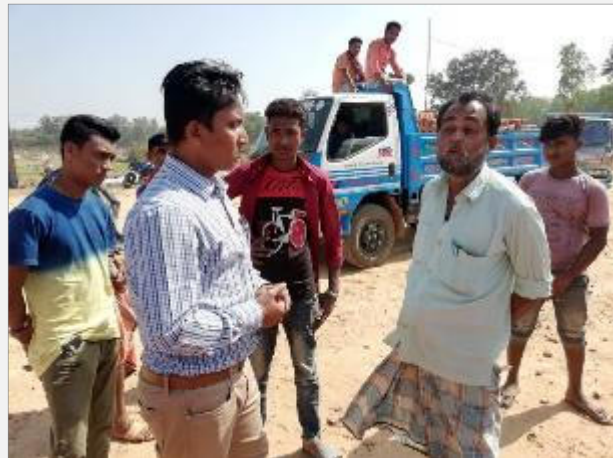
<p>Plate 08: Locals demand more frequent water spray measures</p>

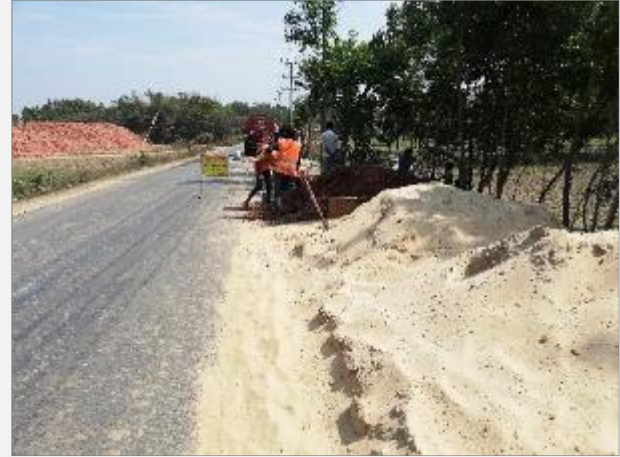
<p>Plate 09: Dust cover were not found</p>

EMP Reference and Amendment	Audit find	Audit Score	Action proposed	Photograph
<ul style="list-style-type: none"> <li>Watering access road, especially in the dry season</li> <li>Using cover sheets on trucks for the transportation of soil</li> <li>Periodic maintenance and management of all the construction machinery and vehicles, [amendment] spray water on stock material to avoid dusty environment. The existing road is already broken and severely dusty due to heavy vehicle movement</li> <li>[amendment] Use plastic cover/or similar cover to restrict dust from spreading</li> </ul> <p>EMP Reference 2.2</p>	<p>Dust cover/ stockpile cover was not found. Road/site was found severely dusty.</p> <p>Vehicle for water carrying was found. However, regular water spray was not found.</p>	2	<p>Site needs to be demarcated properly so that school children do not enter the area and hurt themselves</p>

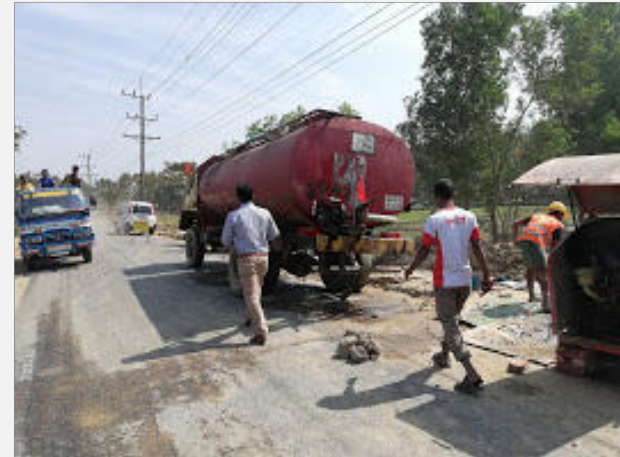
<p>Plate 10: Water carrying vehicle was found on site, however regular water spray was not found</p>

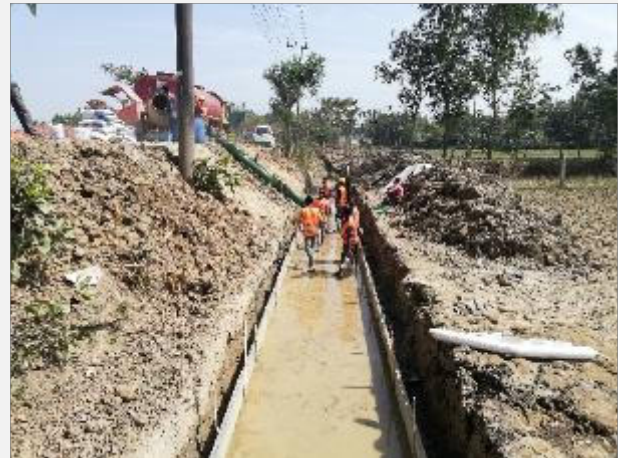
<p>Plate 11: No silt barrier was found at the edge of the site</p>

EMP Reference and Amendment	Audit find	Audit Score	Action proposed	Photograph
<ul style="list-style-type: none"> <li>Ensure all earthworks are done according to design and specifications;</li> <li>Wastes, effluents and other contaminant materials at camp/work sites to be stored, handled, transported and disposed in planned manners;</li> <li>Garbage disposal service to be provided, Concrete refuse reused or disposed of without habitat loss;</li> <li>All other effluents not to be disposed of directly into natural waters, but via settling basins to allow suspended sediment to settle out.</li> <li>Install silt protection curtain</li> <li>Monitoring water quality in the water bodies regularly</li> </ul> <p>EMP Reference 2.3</p>	<p>No silt barrier was found. There is an agricultural land right next to the site. The excavated material is also being stockpiled on this agricultural land which might lead into sedimentation if it rains.</p>	2	<p>This March will show couple of showers in the country. Already a moisture laden air (meteorologically known as Jui 4) is moving across the country. It is possible it will shower next week. Therefore, installation of silt barriers is necessary before the rainy season comes.</p> <p>Stockpiling excavated materials on the nearby agricultural land needs to be avoided.</p>

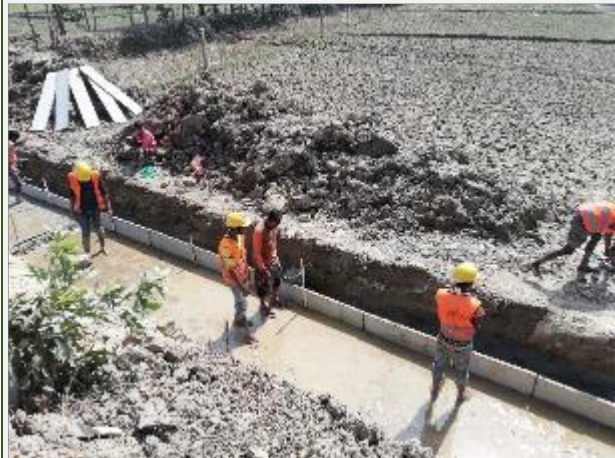
<p>Plate 12: Excavated materials were dumped into agricultural land nearby</p>

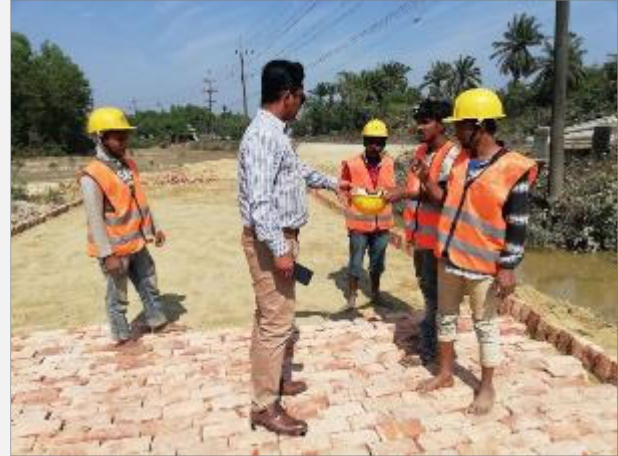
<p>Plate 13: Full-fledged proper PPEs were not found</p>

EMP Reference and Amendment	Audit find	Audit Score	Action proposed	Photograph
<ul style="list-style-type: none"> <li>Ensure that all site personnel have a basic level of environmental awareness training. If necessary, the environmental management specialist and/or a translator shall be called to the sites to further explain aspects of environmental or social behavior that are unclear.</li> <li>Produce and implement a site H&amp;S plan which include measures as: (i) excluding the public from worksites; (ii) ensuring all workers are provided with and required to use personal protective equipment (reflectorized vests, footwear, gloves, goggles and masks) at all times; (iii) providing H&amp;S training for all site personnel; (iv) documenting procedures to be followed for all site activities; and (v) maintaining accident reports and records.</li> <li>Arrange for readily available first aid unit including an adequate supply of sterilized dressing materials and appliances</li> </ul> <p>EMP Reference 2.13</p>	<p>Implementation of PPEs for all workers were found to be partial</p> <p>Proper signages of site safety was found only at one end</p>	3	<ul style="list-style-type: none"> <li>Proper PPEs needs to be impeded at site by force. Any occurrence will trigger H&amp;S issue that might make a bad impression of the project.</li> <li>Proper signages needs to be displayed at both ends</li> </ul>

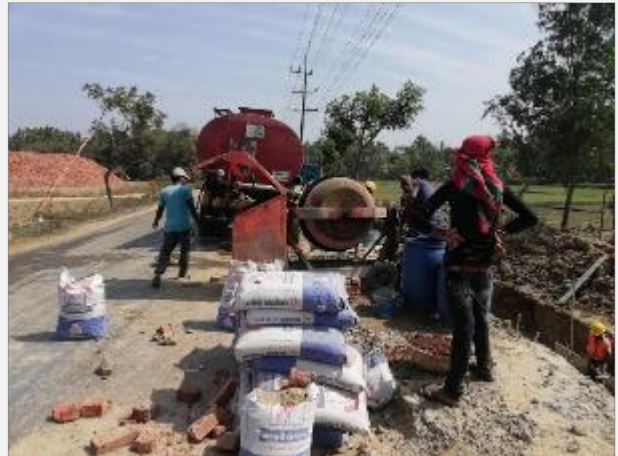
<p>Plate 14: Site safety posted/signboards were not found at both ends</p>

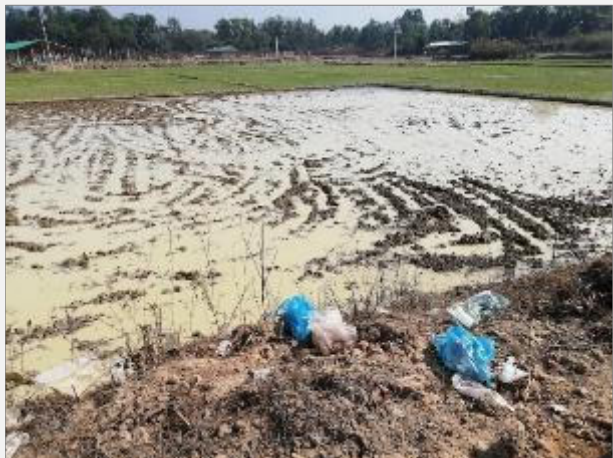
<p>Plate 15: Solid waste was found to be thrown into nearby agricultural land</p>

EMP Reference and Amendment	Audit find	Audit Score	Action proposed	Photograph
<ul style="list-style-type: none"> <li>• Conduct separate waste collection, promote recycling and reuse.</li> <li>• Appropriate disposal of non-recyclable waste according to rules</li> <li>• Hazardous waste should be treated under the related regulation</li> </ul> <p>EMP reference 2.15</p>	Solid waste was found to be thrown into the agricultural land	3	<ul style="list-style-type: none"> <li>• Throwing solid waste into agricultural land is strictly prohibited. A designated area for solid waste dumping has been recommended. A idea on local solid waste management process has been conveyed to the contractor</li> </ul>

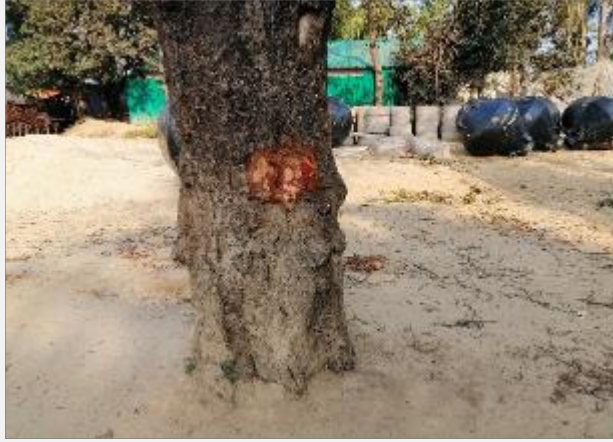
<p>Plate 16: RHD marked about 400 trees for felling</p>

EMP Reference and Amendment	Audit find	Audit Score	Action proposed	Photograph
<p>According to the IEE report, no tree cutting is expected due to the improvement of the road. “No tree cutting is expected due to the improvement of the road. However, some saplings within the RoW of proposed alignment, and workers camp setting areas will be felled and removed during pre-construction period resulting in very minimal ecological and economic loss”.</p> <p>IEE/EMP Reference 1.1</p>	<p>The Arboriculture Circle of RHD has marked more than 400 trees along the project road from Cox’s Bazar to Unchiprang. During site visit it was observed that significant number of trees have been cut for instance about 25 trees have been cut from 50m road section which was located near Nijerpara Primary School. Trees has been stolen by the local people mentioned by RHD representative.</p>	NA	<ul style="list-style-type: none"> <li>RHD should update the IEE report as per design regarding tree felling issue and also take immediate action against illegal tree cutting.</li> </ul>

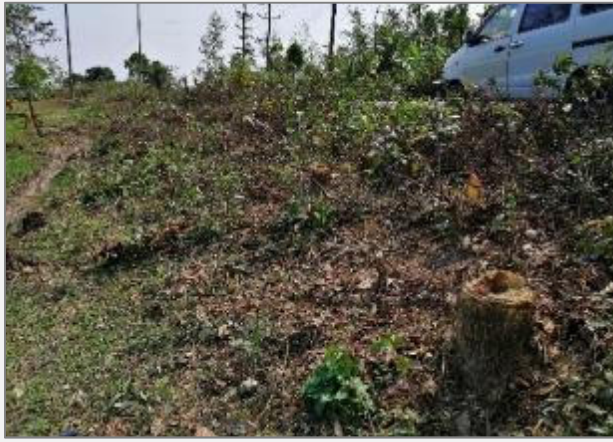
<p>Plate 17: RHD contractor is already in process of felling trees</p>

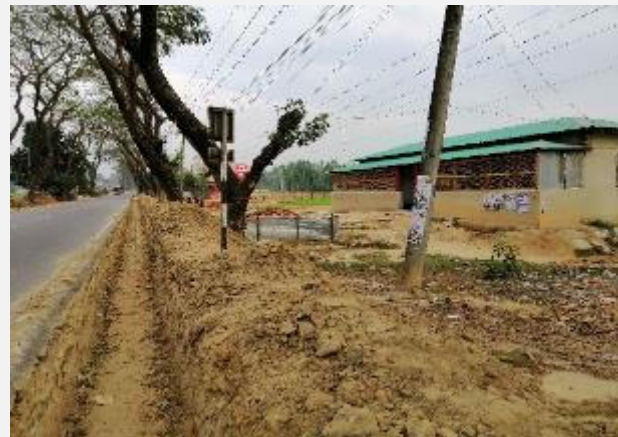
<ul style="list-style-type: none"> <li>Visual intrusion will be due to large piles of embankment materials obstructing views.</li> </ul>	<p>Contractor have excavated the road side and left open without any protection except red flag which is not visible at night. As a result, road</p>	NA	<ul style="list-style-type: none"> <li>Excavated tranches should be filled as soon as possible, otherwise, confined by the safety tape along the tranches.</li> </ul>

<p>Plate 18: Excavation along the alignment has left unsafe hole, there is no demarcation or warning sign</p>   <p>Plate 19: Access to several houses has been blocked due to excavation works</p>

EMP Reference and Amendment	Audit find	Audit Score	Action proposed	Photograph
<ul style="list-style-type: none"> <li>Excavation along the edge of the alignment will leave large unsafe holes.</li> </ul> <p>EMP Reference CP 02 2.1</p>	<p>accident might occur at any moment especially at night. Few accidents were reported by the local people since the children were fallen in the excavated tranches. At several locations in the package 1, the access to the household as well as mosque has been impeded since no support is provided on the excavated tranches, complained by the local inhabitants who lives nearby the road side. Appropriate disposal of non-recyclable waste according to rules</p> <p>EMP reference</p>		<ul style="list-style-type: none"> <li>Proper access should be ensured to the nearby household as well as sensitive infrastructures.</li> </ul>

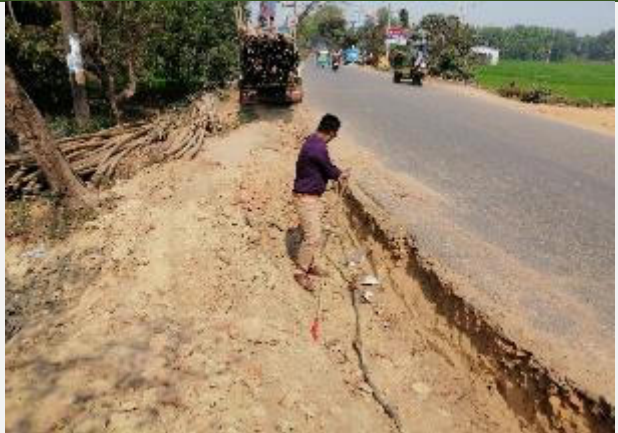
<p>Plate 20: Utility services were not removed</p>

EMP Reference and Amendment	Audit find	Audit Score	Action proposed	Photograph
	No utility services such as electric poles and fiber cables have not been removed prior starting construction activity, since fiber cables were observed to split due to construction activity.	NA	<ul style="list-style-type: none"> <li>RHD should inform the respective authorities to relocate the utility services as soon as possible.</li> </ul>
