Environmental Monitoring Report

**Forth Semi-Annual Report
January – June 2015**

Loan 2789-VIE: Transport Connections in Northern Mountainous Provinces

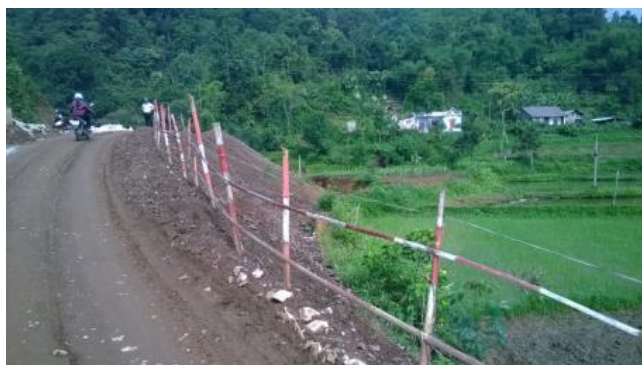
Photo 1. Barrier in Na Tum Bridge of Contract No. BK-R255-01; April 2015

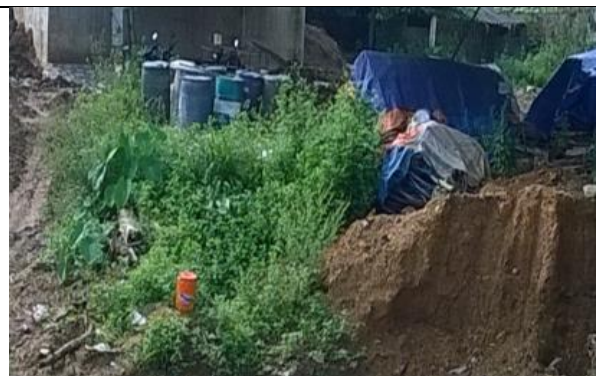
Photo 2. Fuel and material stored outdoor, right beside the stream where Na Tum Bridge is under construction, April 2015

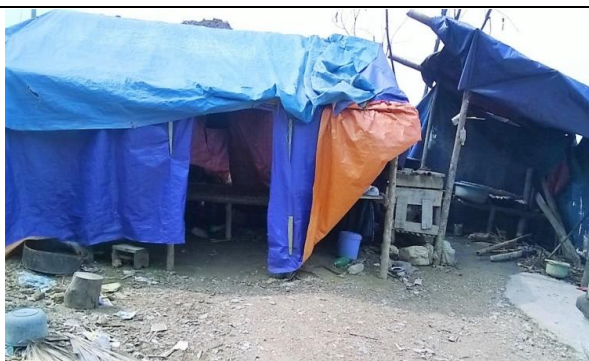
Photo 3. Temporary workers' camp along the road in Km 7+400 (Contract No. BK-PR255-02, April 2015)

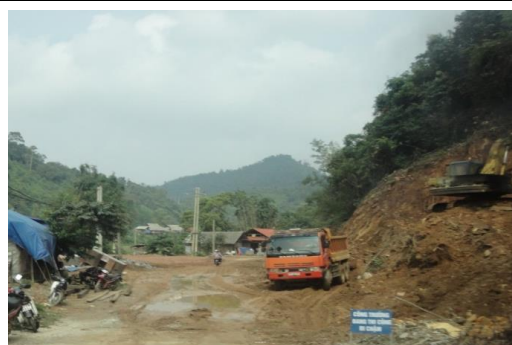
Photo 4. Construction site sign in Km 13+500 (Contract No. BK-PR255-03, April 2015)

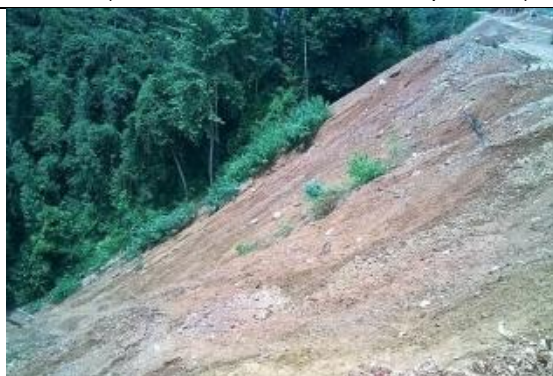
Photo 5. Spoil site on embankment slope in Km17+200 (Contract No. BK-PR255-04, April 2015)

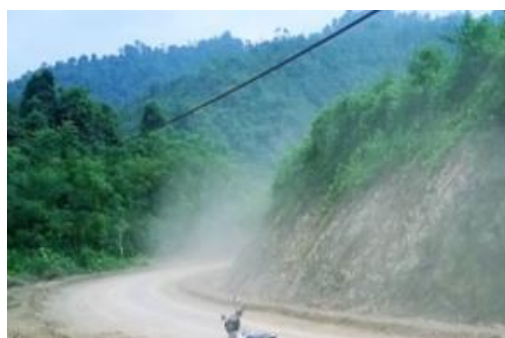
Photo 6. Dust when vehicles cross by in Km 20+500 (Contract No. BK-PR255-04, April 2015)

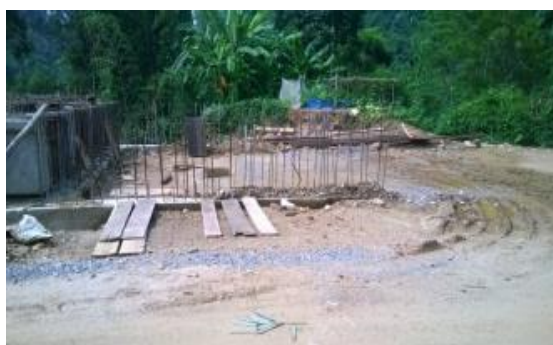
Photo 7. Lack of warning sign in construction site of Ban Vay Bridge (Km 22+300) Contract No. BK-PR255-01 May 2015

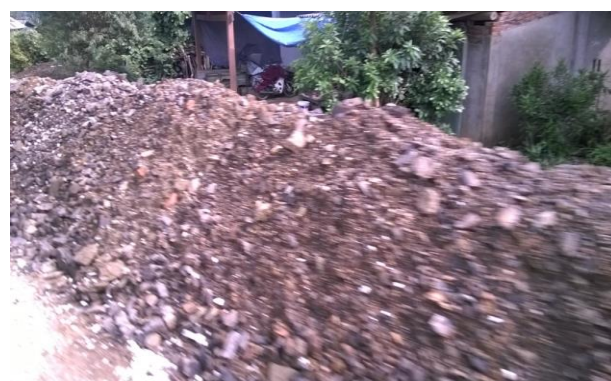
Photo 8. Materials gathered along the road generating dust (Km 0+250) Contract No. BK-PR255-01, May 2015

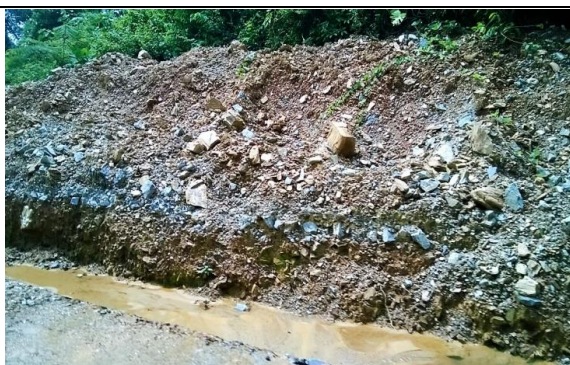
Photo 9. Spoil site with temporary drainage ditch (Km 1+400) Contract No. BK-PR255-02 in May 2015

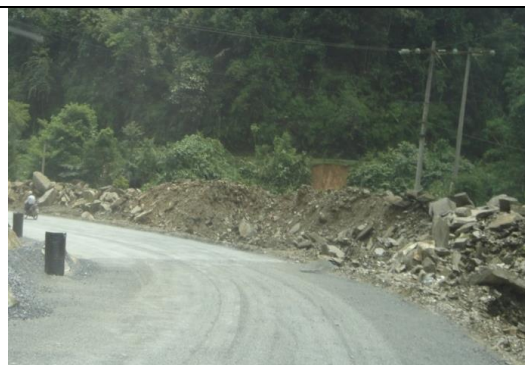
Photo 10. Materials gathered along the road (Km23) Contract No. BK-PR255-04 May 2015

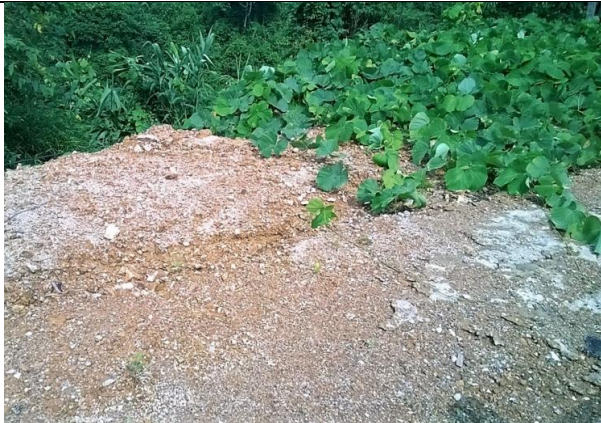
Photo 11. A spoil site disposing out of its scope, the Contractor has stopped disposing and it has been covered by wild weeds have cover (Km 24+100) Contract No. BK-PR255-04 June 2015

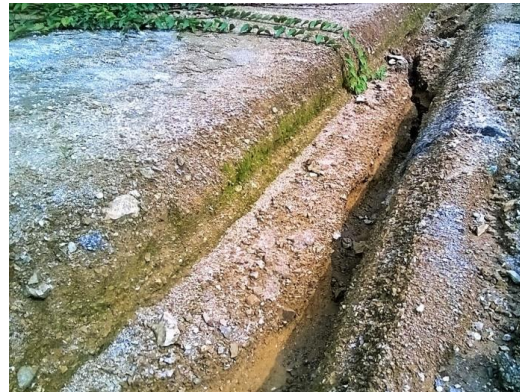
Photo 12. Erosion rill appeared after rains in section Km 4, Contract No. BK-PR255-02, June 2015

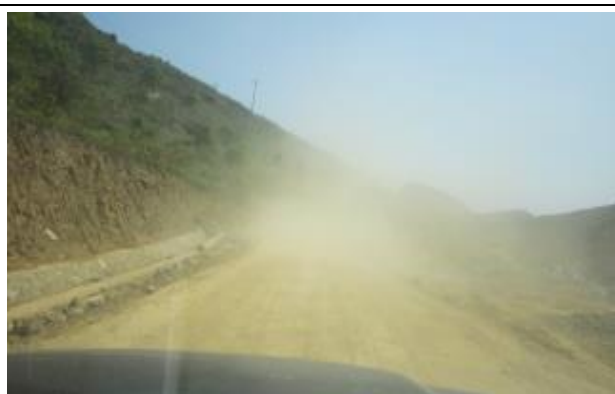
Photo 13. Dust when vehicles cross by work site of Contract No. CB-R202-01, May 2015

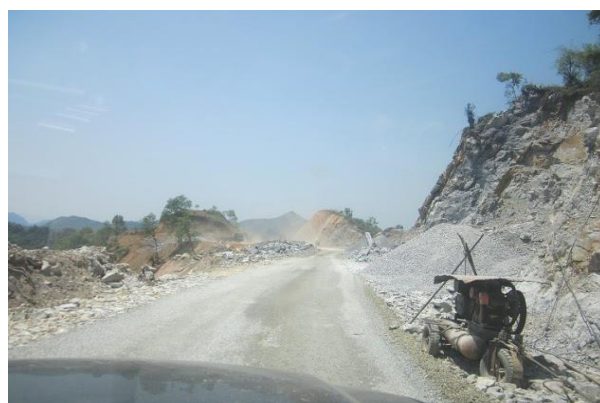
Photo 14. The Contractor performed watering on work site of Contract No. CB-R202-02, May 2015

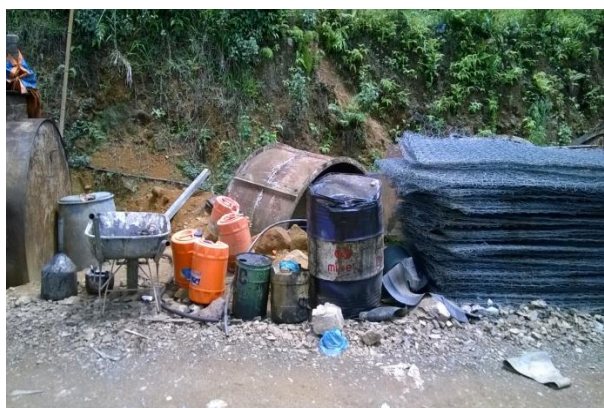
Photo 15. Fuels have been gathered outdoor on ground in Contract No. CB-R202-01, May 2015

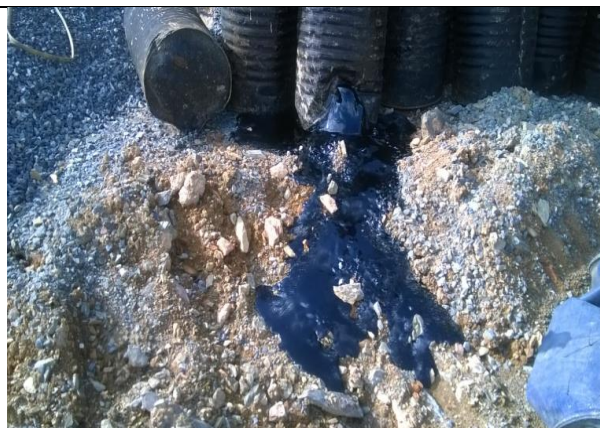
Photo 16. Bitumen has been gathered outdoor on ground in Contract No. CB-R202-02, May 2015

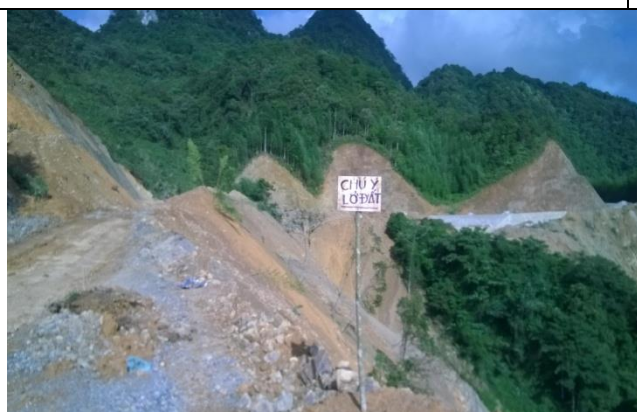
Photo 17. Landslide warning sign of Contract No. CB-R202-02, July 2015

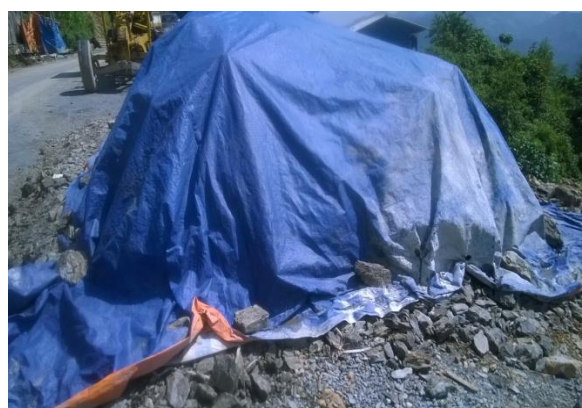
Photo 18. Bitumen has been gathered along the road covered by canvas in Contract No. CB-R202-03, April 2015

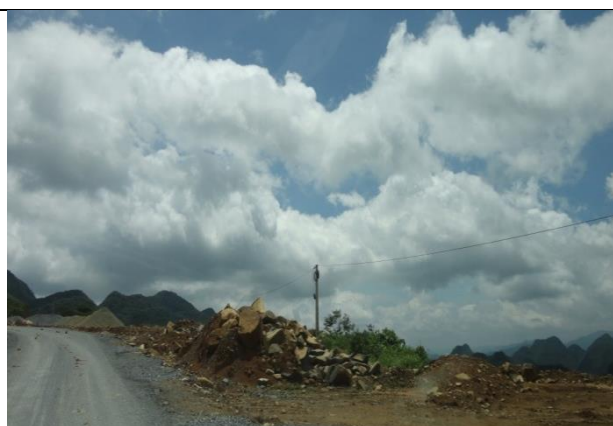
Photo 19. Waste spoil disposed along the road of Contract No. CB-R202-02, May 2015

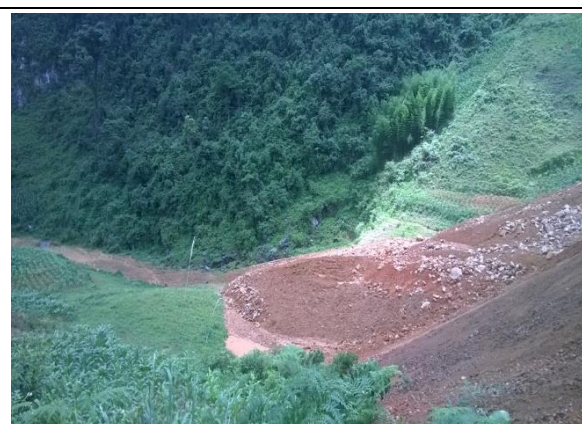
Photo 20. Disposal has not complied with regulations causing spoil spilled to agricultural land of local people in Km 6+ 700 of Contract No. CB-R202-01, June 2015

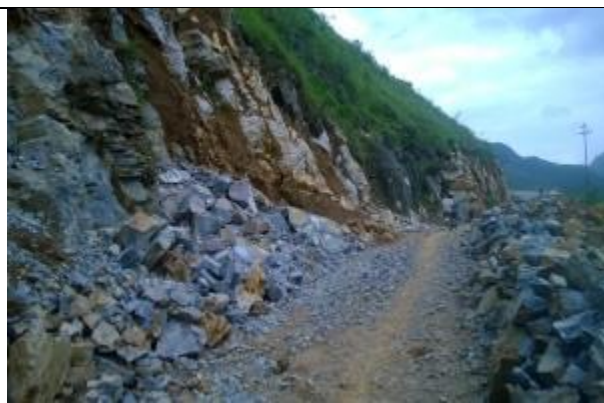
Photo 22. Rock after blasting lined along the road, no warning signs, Package HG-PR176-01, May 2015

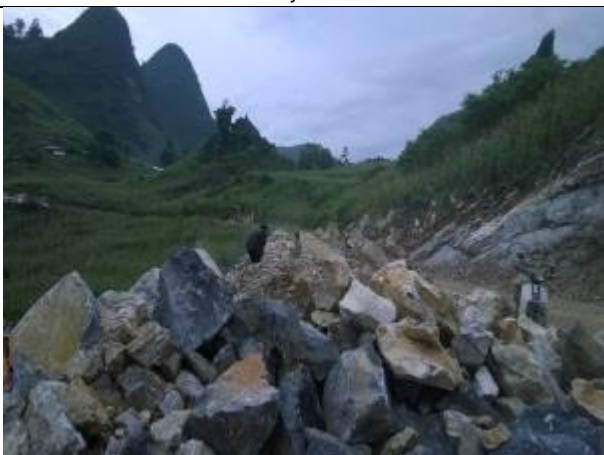
Photo 25. Workers do not use PPE, Package HG-PR 176A-02, June 2015

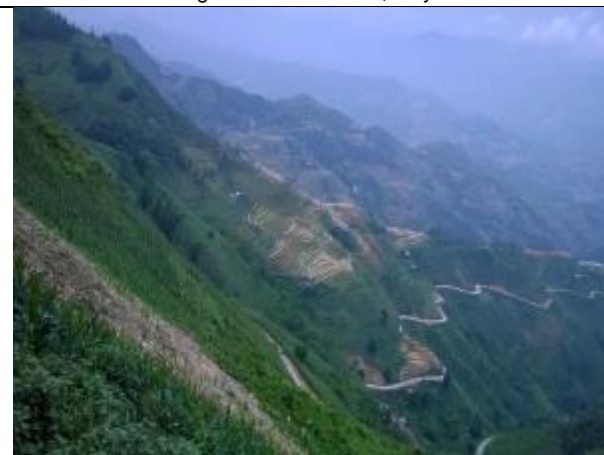
Photo 26. Local people plant corn on the slope of a disposal site, Package HG-PR 176A-02, June 2015

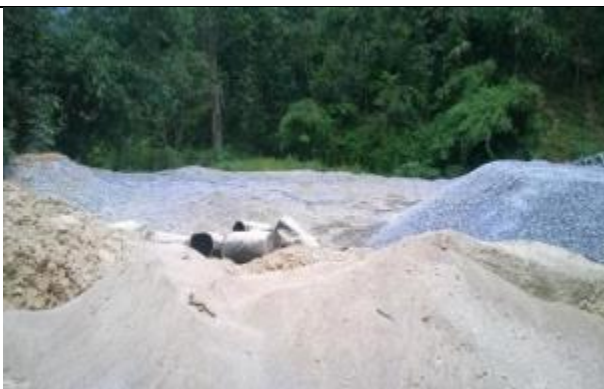
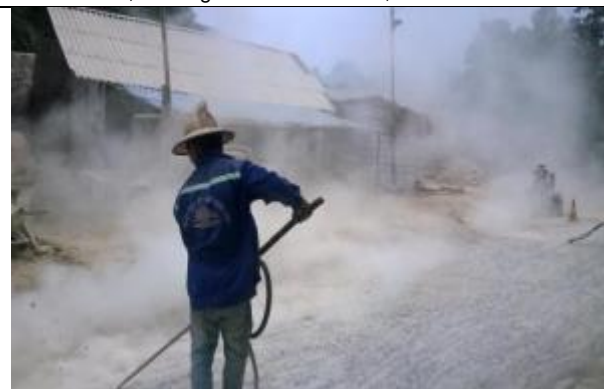
Photo 27. Materials gathered on the roadside , Package HG-PR 183A-01, June 2015	Photo 28. Worker is blowing dust, Package HG-PR 183A-01, June 2015

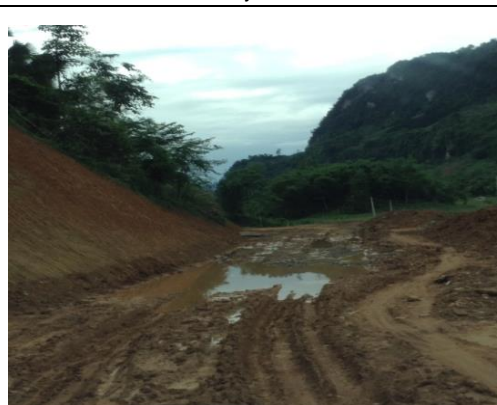
Photo 36 Muddy roads make it difficult for people in traffic (Km 55), PackageTQ-PR189-03, April 2015

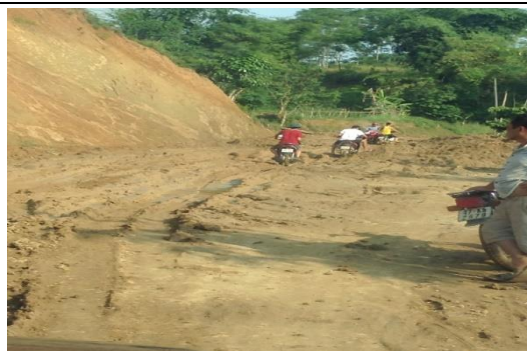
Photo 37 Muddy roads make it difficult for people in traffic, PackageTQ-PR189-03, June 2015

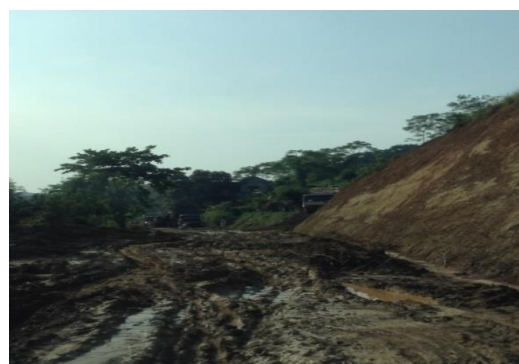
Photo 38 Muddy roads make it difficult for people in traffic, PackageTQ-PR189-03, June 2015.

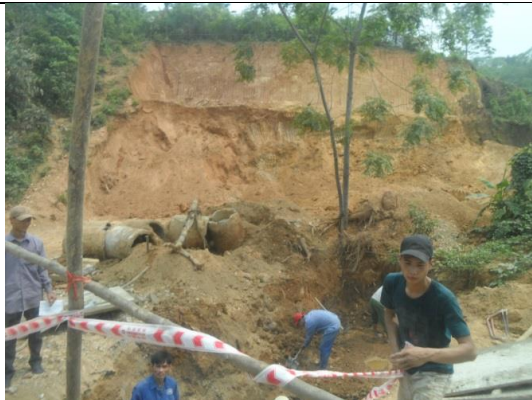
Photo 43. Workers do not use PPE as required, package No. YB-PR163-02, April 4/2015

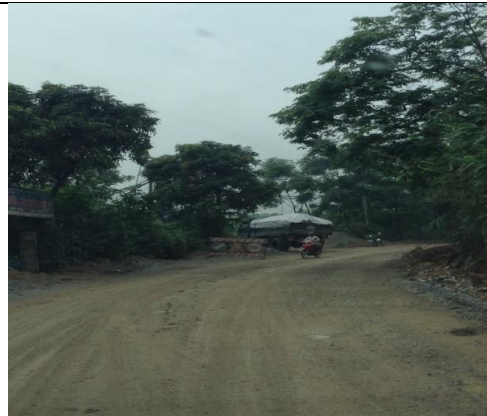
Photo 44. Truck with cover, package No. YB-PR163-02, April 2015

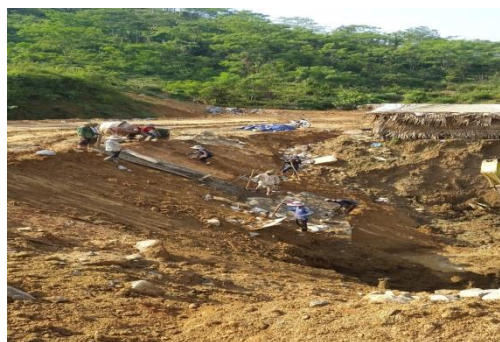
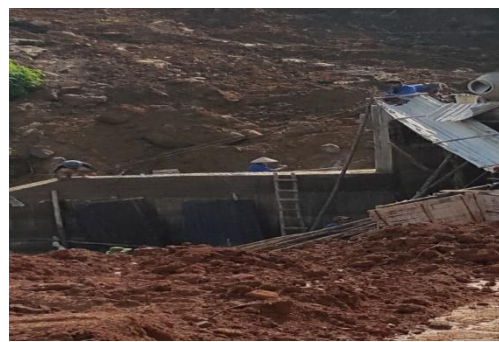
Pictures 49, 50: Workers have not used standard PPE at Km 7-Km10 of package LC-PR151B, May 2015

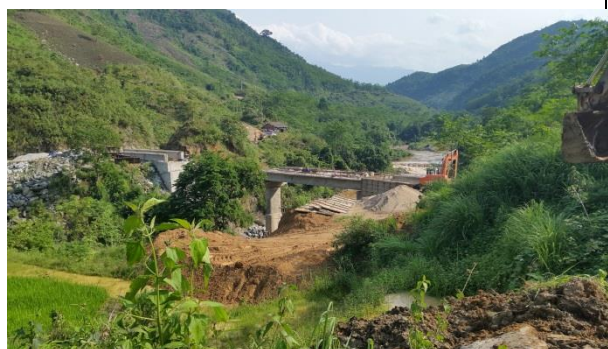
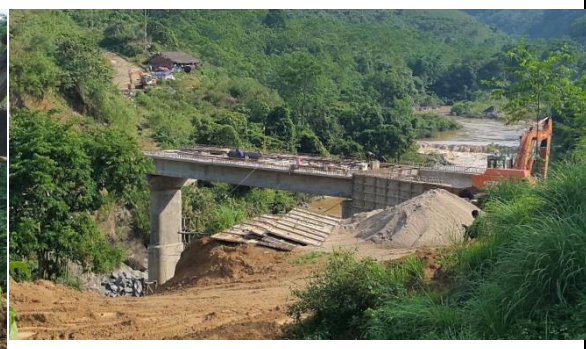
Picture 51.52. Overall view of Suoi Chan Bridge construction (km 10) of package LC-PR151, May 2015

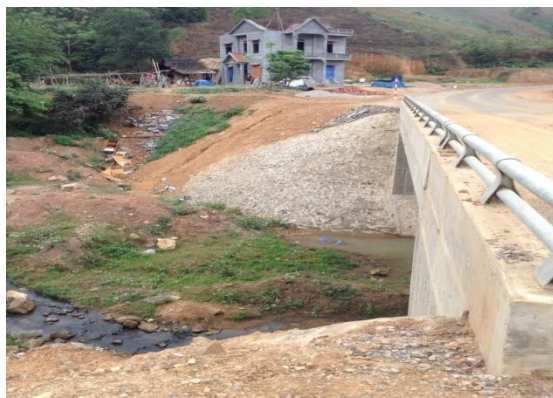
Picture 53. Need to perform rock clearance at upstream Nga Quan Bridge of package LC-PR151, May 2015

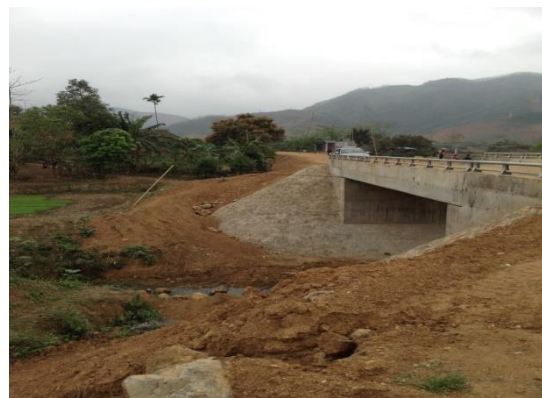
Picture 54. Need to perform rock clearance at construction site of Quan Hong Bridge of package LC-PR151, May 2015

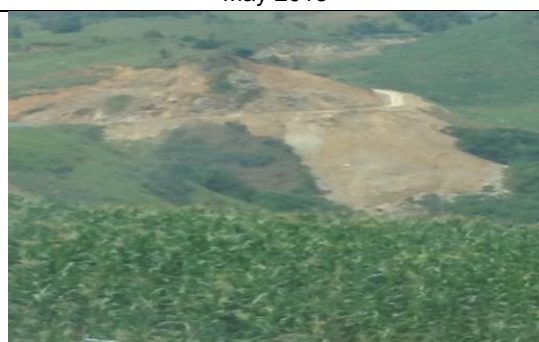
Picture 55. Disposal site slope at Km 0+500 need to be levelled to prevent land slide, package LC-PR154, May 2015

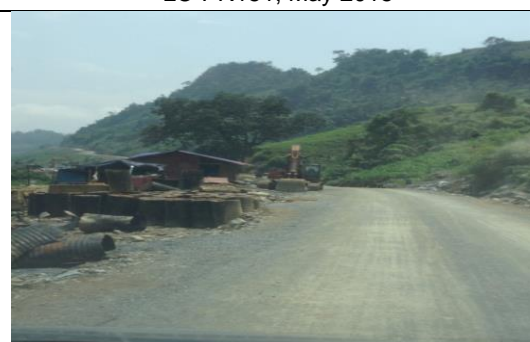
Picture 56. Construction materials have been stored outside at package LC-PR154, May 2015

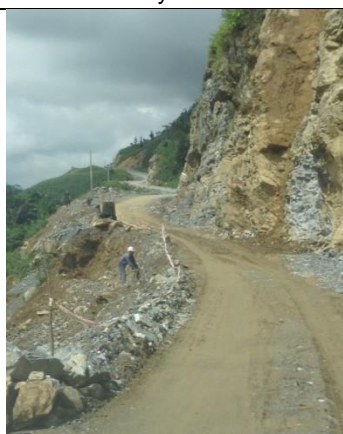
Picture 57. Lack warning signs and barriers to ensure safety at steep slope (km 0+900), package LC-PR154, June 2015

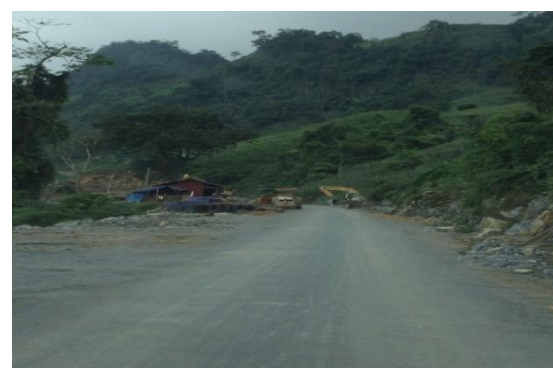
Picture 58. Lack warning sign (km 0+900), package LC-PR154, June 2015

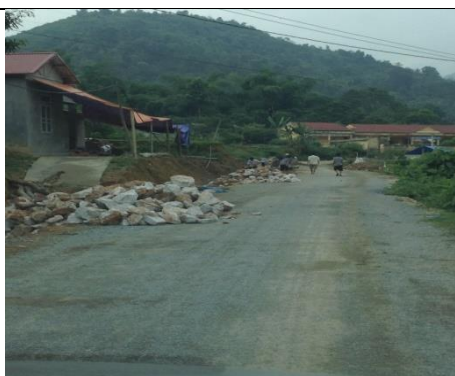
Picture 59. Lack construction site warning sign at km 10+300, package LC –PR156, May 2015

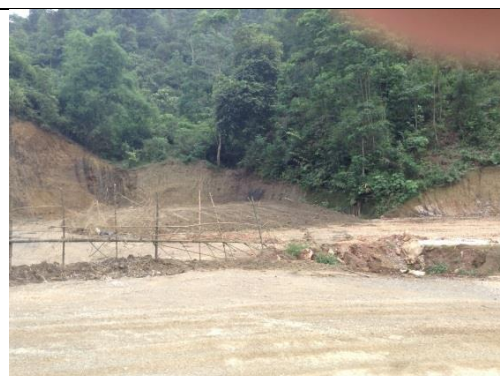
Picture 60. Camp ground has been returned to local people (11+800), package LC –PR156, June 2015

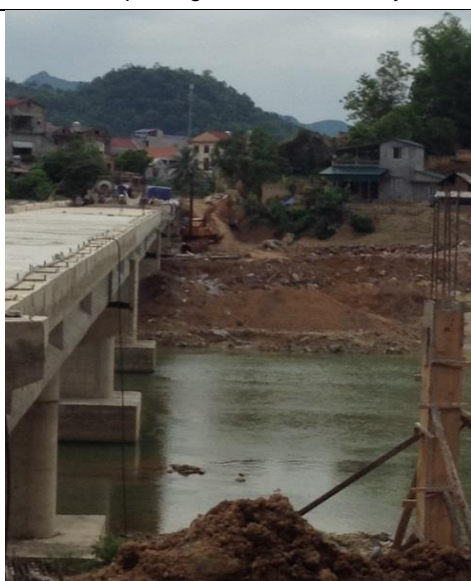
Picture 61. Waste soil was gathered within river bed (0+400), package LC –PR160, June 2015

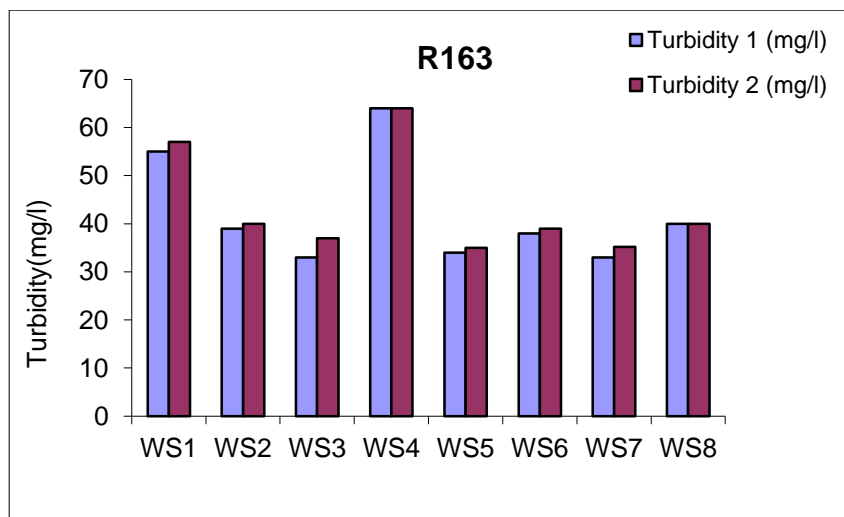
Figure II-2.3.1. Actual Turbidity values of water in Yen Bai

Generally, at the monitoring positions along R163 in Yen Bai province, turbidity values are quite high. At position R163-WS4 (Ngoi Hop village, Bao Dap commune, Tran Yen), the highest 64 mg/l is obtained and the lowest 10 mg/l is obtained at position R163-WS7 (Quach village, Mau Dong village, Van Yen) (Figure II-2.3.1).

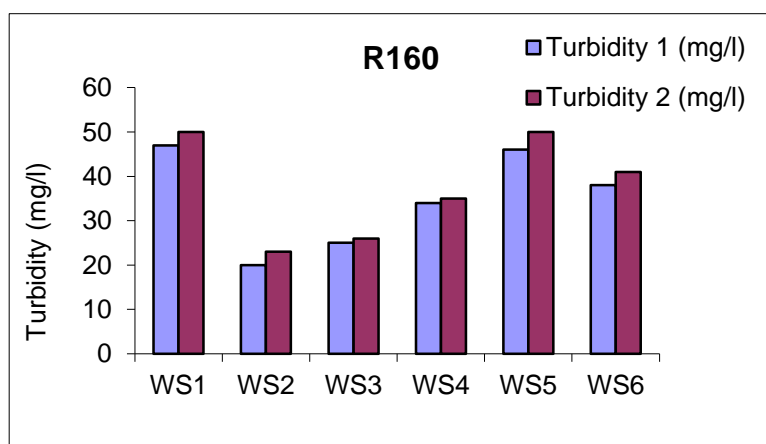
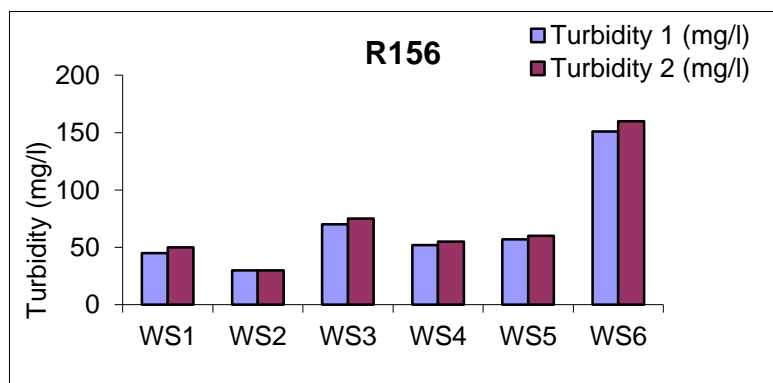
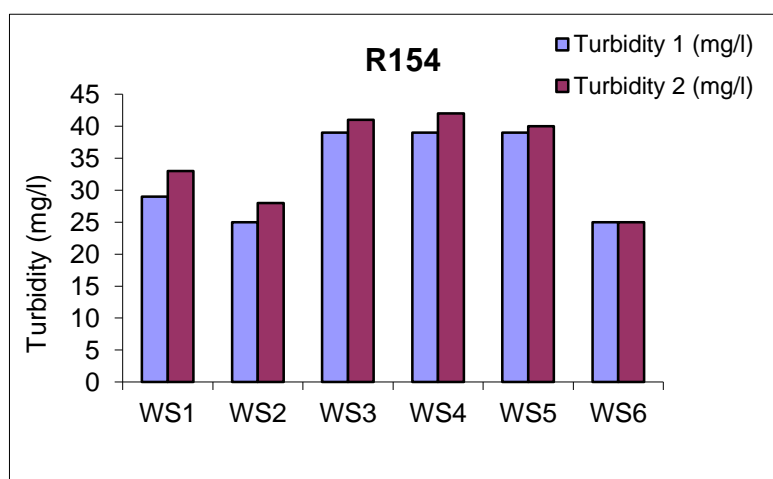
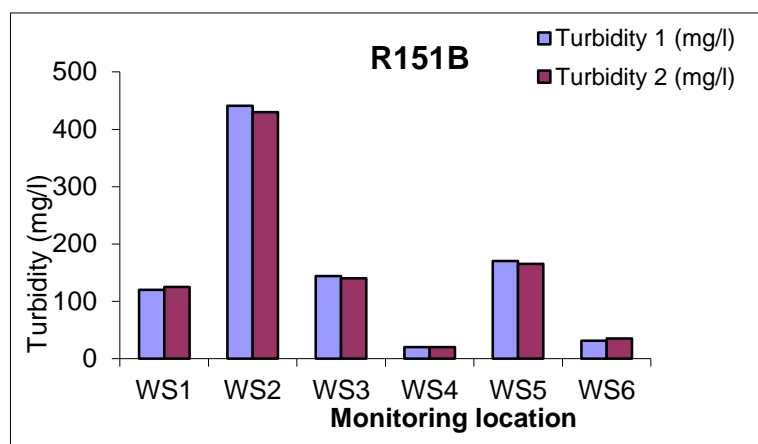
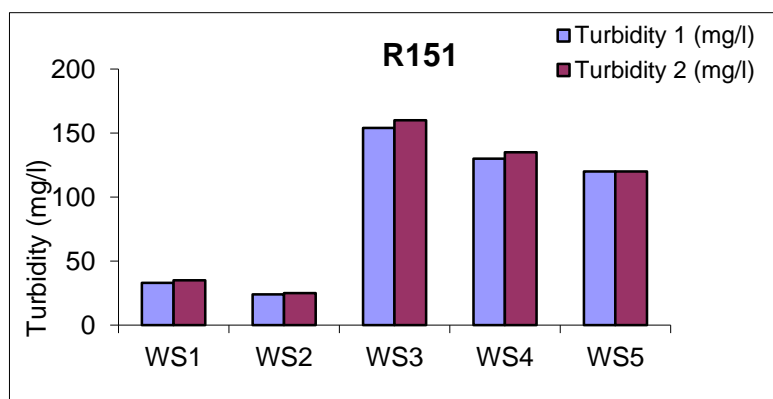
Figure VI-2.3.2. Actual Turbidity values of water in Lao Cai

In Lao Cai province, Turbidity values are relatively high, the highest is 441 mg/l, the values obtained at R151-WS3, R151-WS4, R151-WS5, R156-WS6, R151B-WS3, R151B-WS5 over 100 mg/l, especially R151B-WS2 are considerably high (Figure II- 2.3.2), at other positions, turbidity values range from 20 to 75 mg/l.

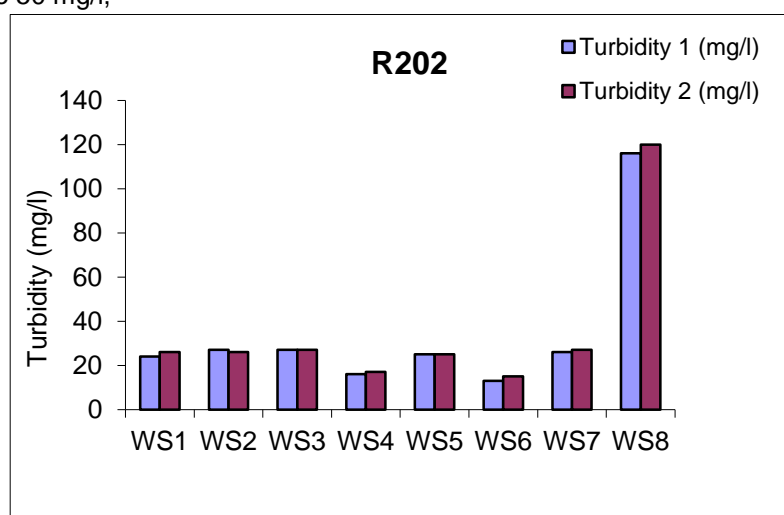
Figure II-2.3.5. Actual Turbidity values of water in Cao Bang

Turbidity values at the monitoring positions along R202 in Cao Bang are shown in Figure II- 2.3.5. The noticeable values 120 mg/l is obtained at R202-WS8. Almost values measured are not high in the range of 13-27 mg/l, the highest is obtained at R202-WS3 (Luong Sung village, Yen Lac commune, Bao Lac) and the lowest is obtained at R202-WS6 (Nam Lin village, Dinh Phung commune, Bao Lac).

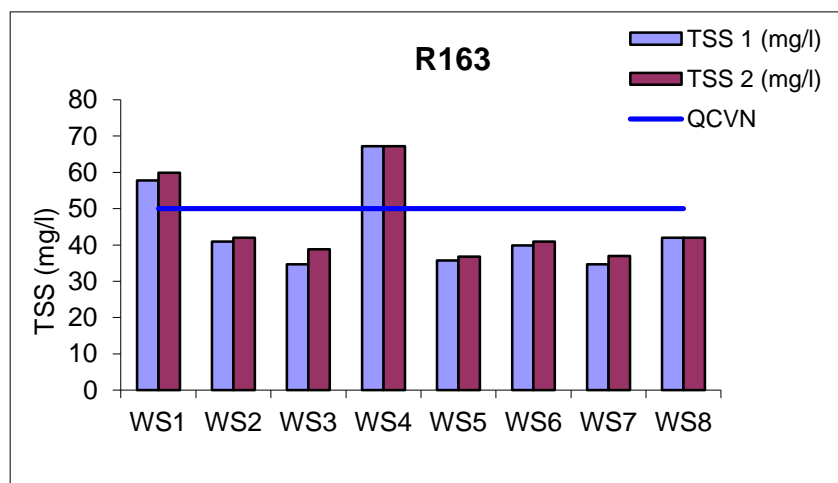
Figure II-2.4.1. Actual TSS values of water in Yen Bai

At the monitoring positions along R163 in Yen Bai province, excepting the TSS concentration at R163-WS1, R163-WS2 over the permissible limitation, almost values range from 35 mg/l to 42 mg/l (Figure II- 2.4.1) and meet the standard of column B1 (QCVN 08:2008/BTNMT).

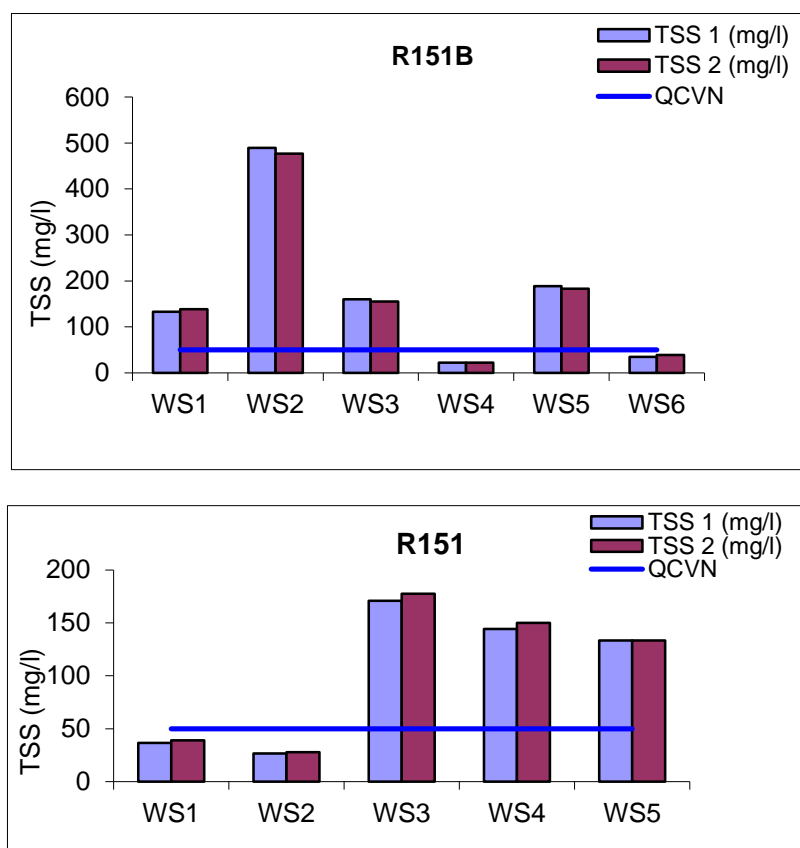
Figure II-2.4.2. Actual TSS values of water in Lao Cai

Based on Figure II-2.4.2, it can be found that in Lao Cai province, TSS values at monitoring positions at R154 are below the permissible limitation of QCVN 08:2008/BTNMT (column B1), ranging from 27,7 mg/l to 46,6 mg/l. At the other routes, TSS values are relatively high. The TSS concentrations at R156-WS6, R151-WS3 are over 3 times as high as permissible limitation. Particularly, at the position R151B-WS2, TSS concentrations obtained is 489,5 mg/l, nearly 10 times as high as permissible limitation. The other positions at which TSS values over permissible limitation include: vị trí R156-WS1, R156-WS3, R156-WS4, R156-WS5, R160-WS1, R160-WS5, R151B-WS1, R151B-WS3, R151B-WS5, R151-WS3, R151-WS4, R151-WS5.

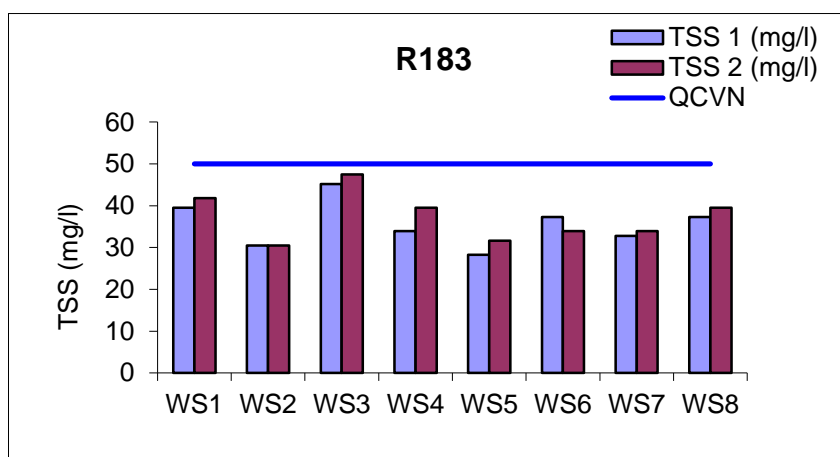
Figure II-2.4.3. Actual TSS values of water in Ha Giang

TSS concentration at R183 are relative high in the range of 28,3 -47,4 mg/l, not exceeding 50 mg/l- the permissible limitation of B1 column (TCVN 08:2008/BTNMT). TSS values at the monitoring positions along R176A are higher at 2 monitoring positions R176A-WS5, R176A-WS6, turbidity values are higher the permissible limitation of QCVN (Figure II-2.4.3).

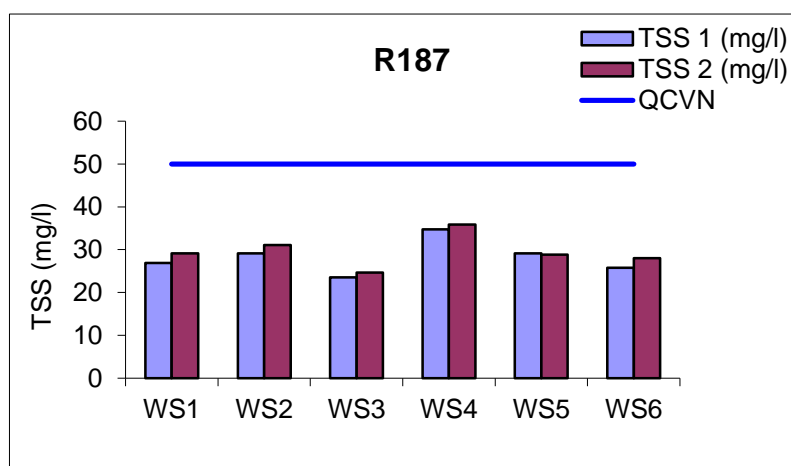
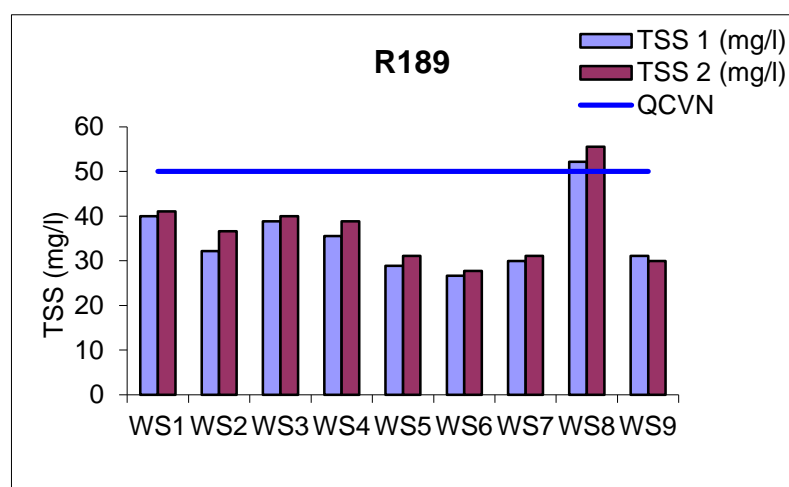
Figure II-2.4.4. Actual TSS values of water in Tuyen Quang

Figure II- 4.4.4 presents TSS values of water of the locations along two roads R187 and R189 in Tuyen Quang. The remarkable TSS value found at R189-WS8 (Tan Thinh village, Yen Thuan, Ham Yen) is higher than the value of the stipulated limitation. TSS values of water of the other positions are relatively high, from 14 to 42 mg/l meeting the standard of B1 column.

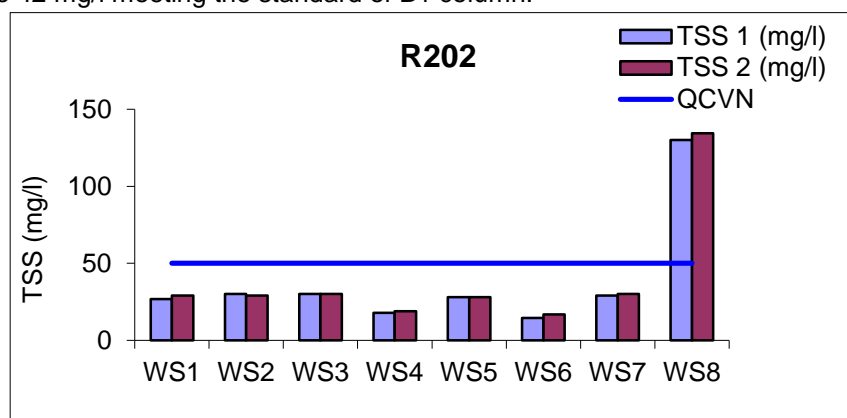
Figure II-2.4.5. Actual TSS values of water in Cao Bang

Figure II- 2.4.5 shows TSS values monitored at the positions along R202 in Cao Bang. The noticeable TSS value at R202-WS8 (Mo Din village, Huy Giap commune, Bao Lac) is nearly 3 times as high as the permissible limitation B1 of QCVN. The other TSS values are under the limitation of QCVN, the lowest is of 14,6 mg/l at R202- WS6 (Nam Lin village, Dinh Phung commune, Bao Lac).

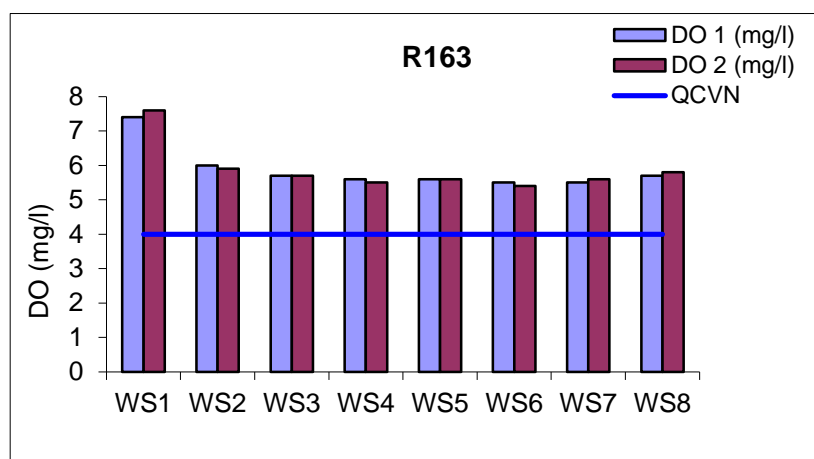
Figure II-2.5.1. Actual DO concentrations of water in Yen Bai

All DO measured values at the positions along R163 in Yen Bai meet the limits of QCVN 08:2008/BTNMT. Range of values is from 5.4 mg/l to 7.6 mg/l (Figure II- 2.5.1).

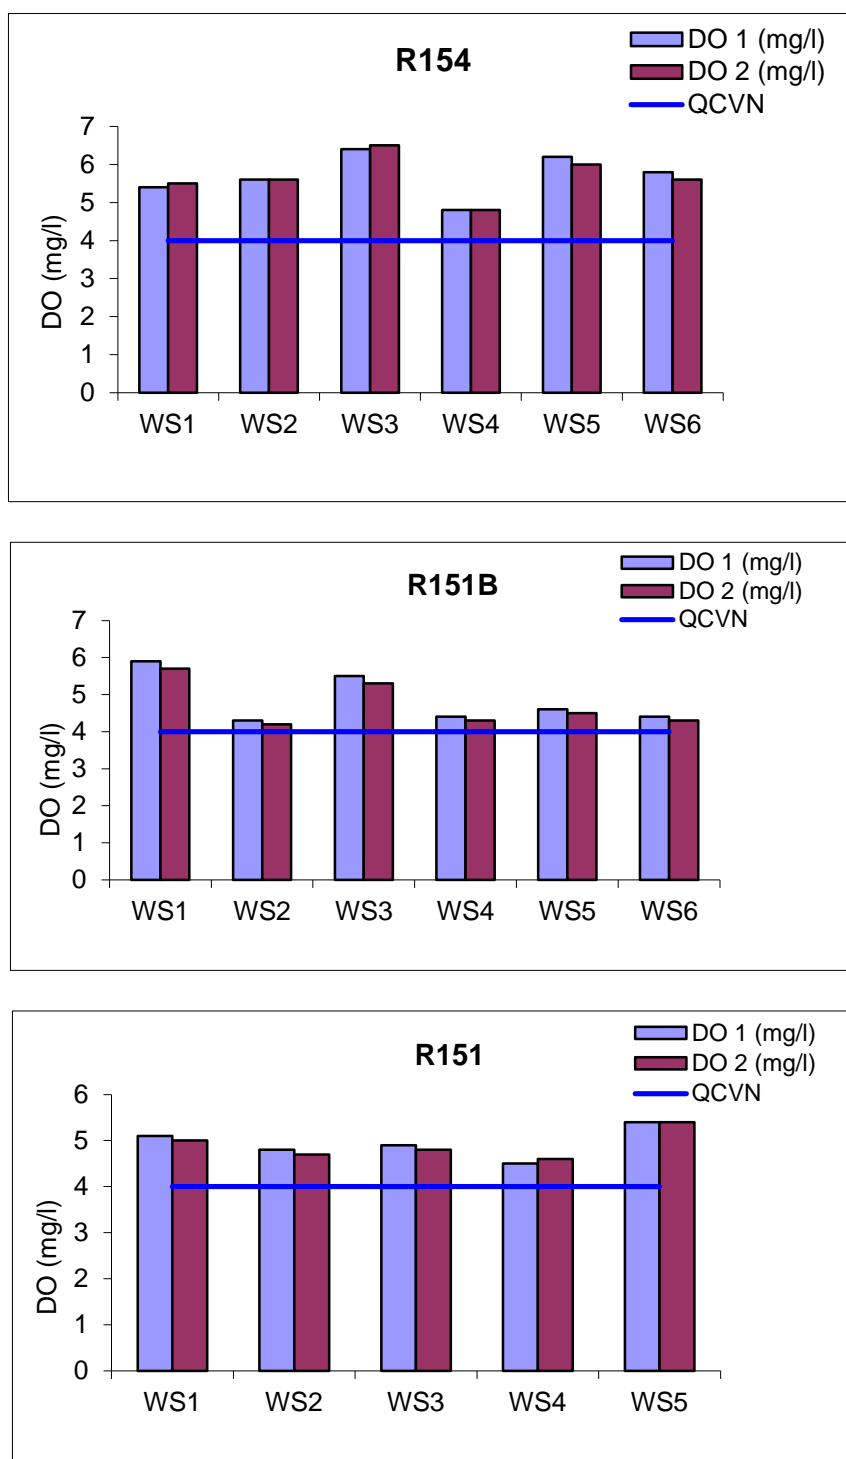
Figure II-2.5.2. Actual DO concentrations of water in Lao Cai

Figure II- 2.5.2 presents the graphs of the measured DO values at the monitoring positions along 5 roads R151, R151B, R154, R156 and R160 in Lao Cai area. Most of the values above the limitation 4 mg/l of column B1 of QCVN 08:2008/BTNMT. Particularly, DO concentrations at the positions R156-WS4 do not meet the QCVN 08:2008/BTNMT (B1), the value of 3,6 mg/l. is lower than the permissible limitation

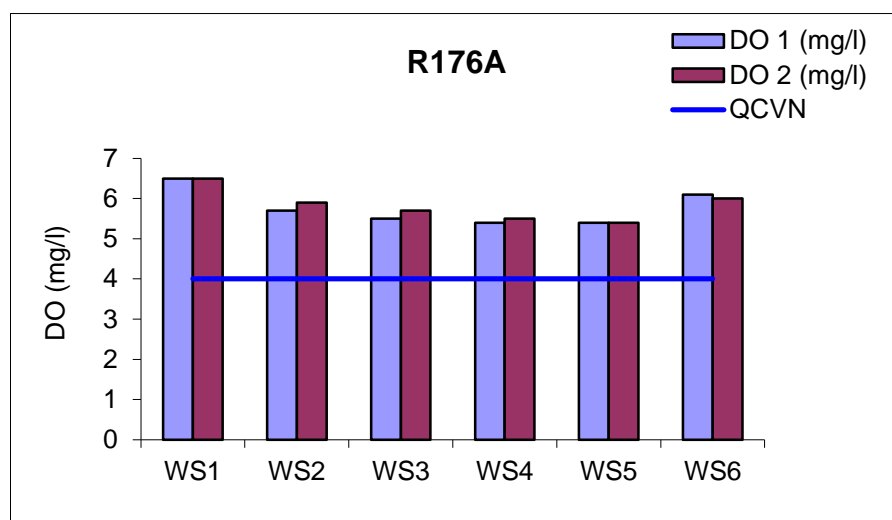
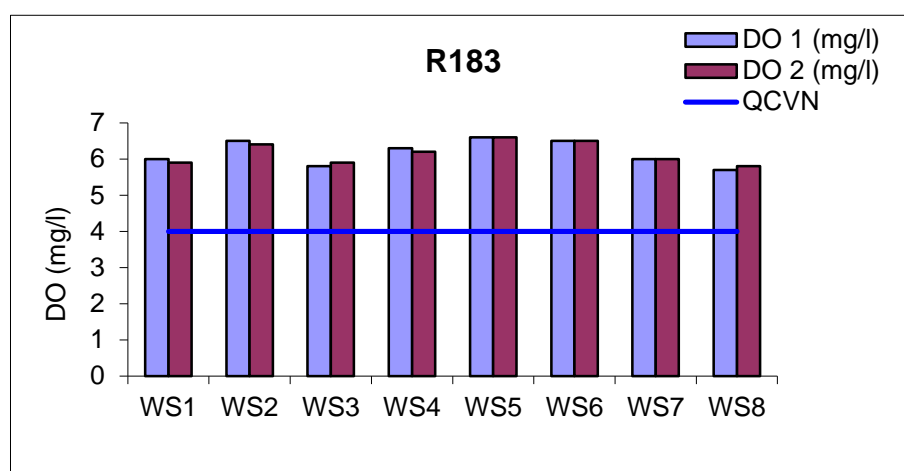
Figure II-2.5.3. Actual DO concentrations of water in Ha Giang

Figure II- 2.5.3 displays graphs of the DO results of the water bodies along the two roads R176A and R183 in Ha Giang. All values satisfy the permissible limit of QCVN 08:2008/BTNMT. The DO concentrations at R176A-WS4, R176A- WS5 are the lowest, 5.8 mg/l.

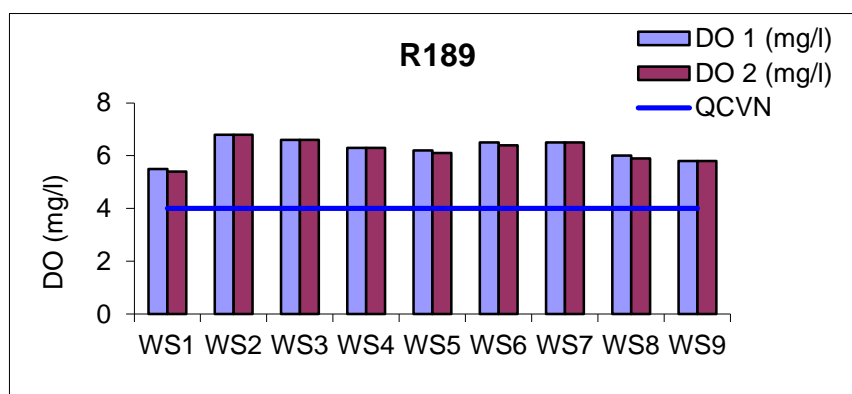
FigureII-2.5.4. Actual DO concentrations of water in Tuyen Quang

Figure II- 2.5.4 shows the DO concentrations at the monitoring positions along R187 and R189 in Tuyen Quang province. All values here meet well QCVN for DO. DO obtains at R187-WS1(Dai Thi village, Yen Lap, Chiem Hoa) is the lowest, 4.9 mg/l.

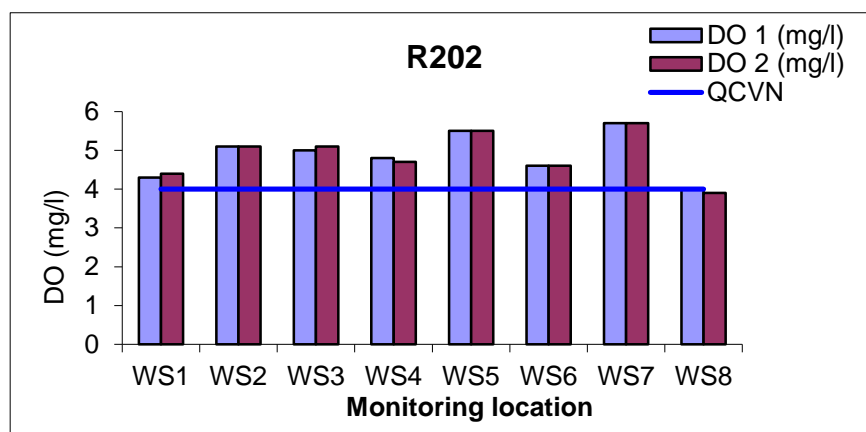
FigureII-2.5.5. Actual DO concentrations of water in Cao Bang

The obtained DO results at location along R202 in Cao Bang province are presented in Figure II- 2.5.5. At position R202- WS8 (Mo Din village, Huy Giap commune, Bao Lac) DO value observed is lower than the permissible standard, 3.9mg/l. Other DO values satisfy QCVN 08:2008/BTNMT.

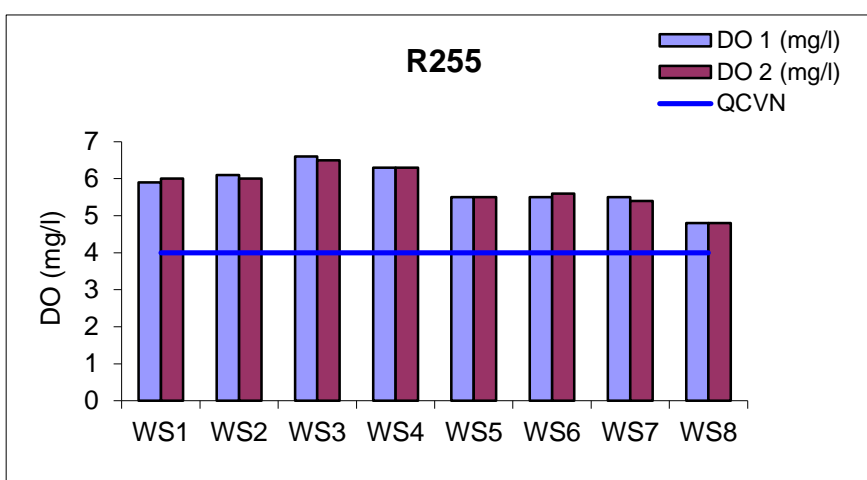
FigureII-2.5.6. Actual DO concentrations of water in Bac Kan

DO results at the monitoring positions along R255 in Bac Kan province are shown on Figure II- 2.5.6. DO values at all positions are above the permissible limitation of QCVN 08:2008/BTNMT and range from 4.8 mg/l to 6.6 mg/l.

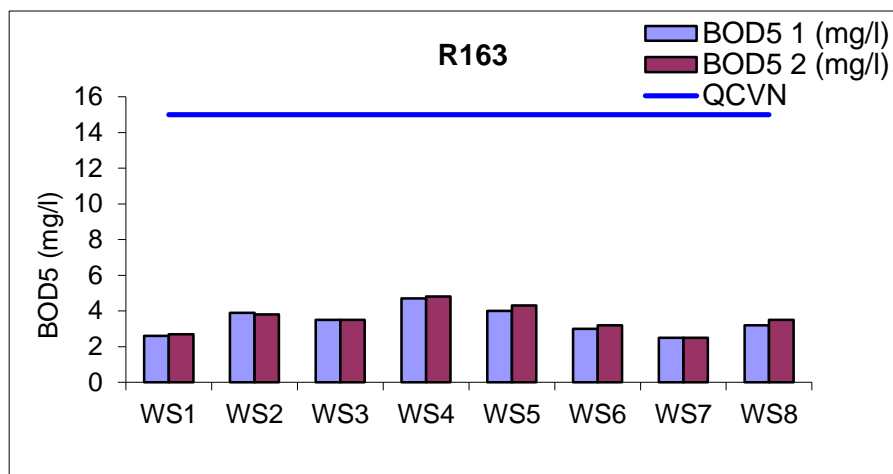
Figure II-2.6.1. BOD5 concentrations of water in Yen Bai

The BOD5 values of the water body along R163 ranging from 2.5 to 4.8 mg/l are lower than the limitation of QCVN 08:2008/BTNMT. It can be seen that the pollution level with respect to BOD5 is insignificant. (excepting BOD5 at R163-WS4 and R163-WS5-2, the values at the other positions meet the standard of column A1 (4mg/l) for domestic water supply.

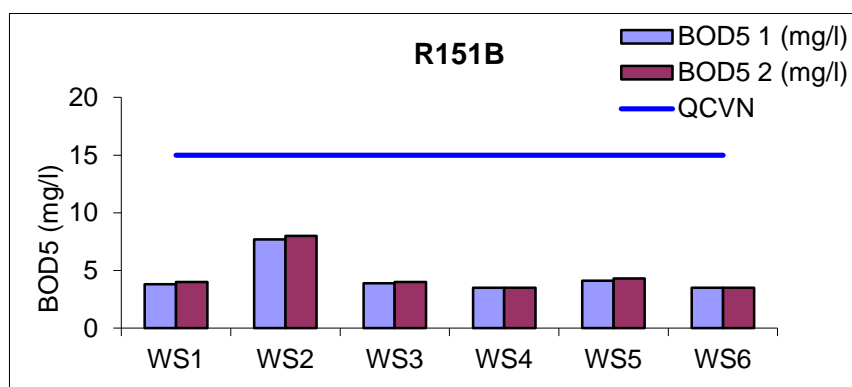
Figure II-2.6.2. BOD5 concentrations of water in Lao Cai

Figure II-2.6.2 displays the graphs of the measured BOD5 values at the positions along 5 roads R151, R151B, R154, R156 and R160 in Lao Cai province. None of the measured BOD5 values of the water bodies do not meet the standard of column B1 of QCVN 08:2008/BTNMT. Those at R160, R154 even meet the standard of column A1 (4mg/l). It is noticed that BOD5 values at R151-WS4, R151B-WS2, R156-WS6 are relative high, respectively 8 mg/l, 8 mg/l, 12,5 mg/l.

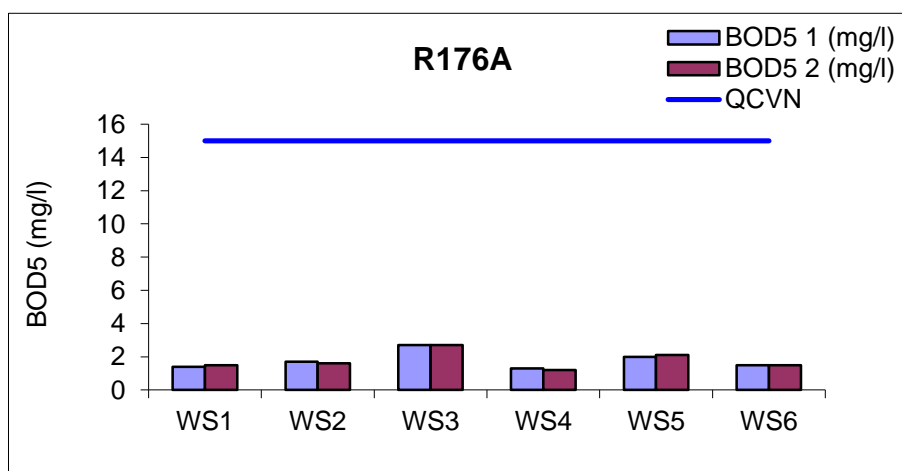
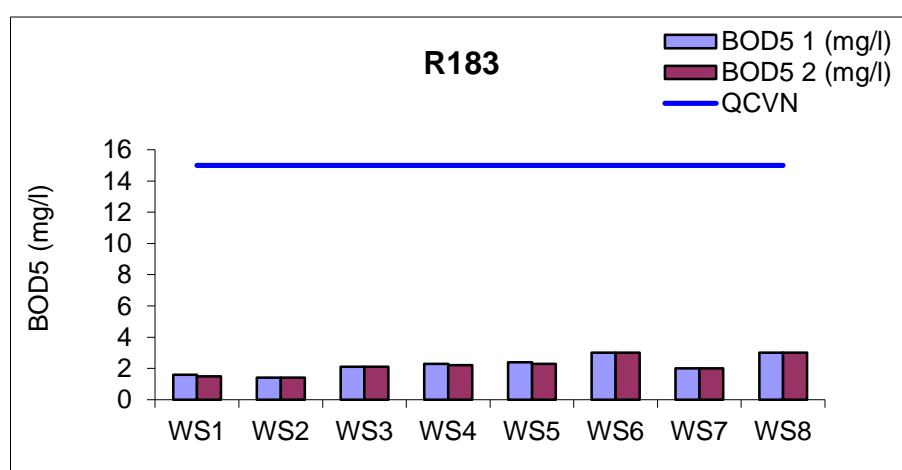
Figure II-2.6.3. BOD5 concentrations of water in Ha Giang

The actual BOD5 values at the monitoring positions along two roads in Ha Giang province are presented in Figure II- 2.6.3. The pollution level with respect to BOD5 is low, values range from 1.5 to 3.0 mg/l, lower than the standard of column A1 (QCVN 08:2008/BTNMT).
