Environmental Monitoring Report

**Forth Semi-Annual Report
January – June 2015**

Loan 2789-VIE: Transport Connections in Northern Mountainous Provinces

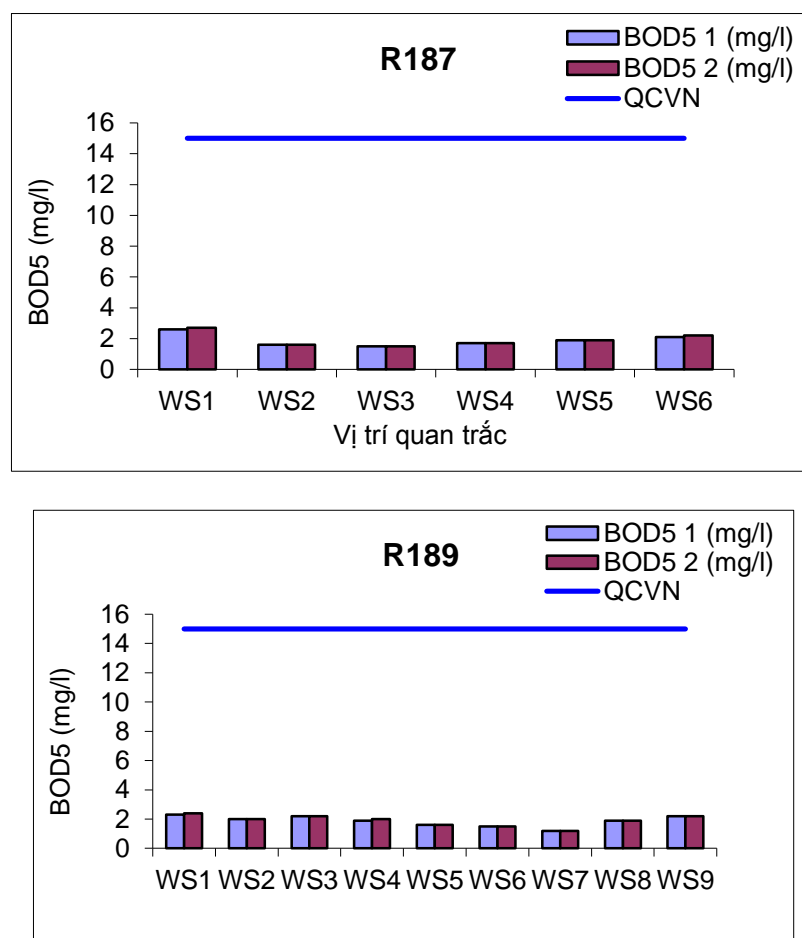
Figure II-2.6.4. BOD5 concentrations of water in Tuyen Quang

Project area in Tuyen Quang includes two roads R187 and R189. The BOD5 values are represented graphically in Figure II- 2.6.4. The pollution level with respect to BOD5 is low, actual values fluctuated from 1.2 to 2.7 mg/l, lower than the limit of column A1 (QCVN 08:2008/BTNMT).

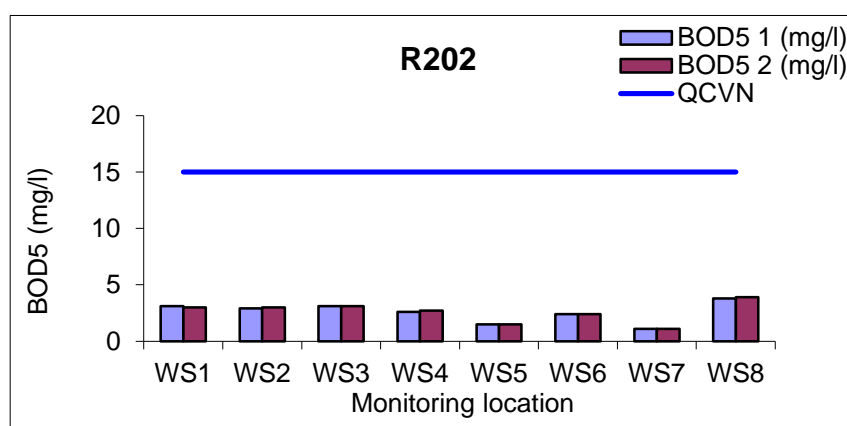
Figure II-2.6.5. BOD5 concentrations of water in Cao Bang

The BOD5 values at the positions along R202 in Cao Bang ranging from 1.1 mg/l to 3.9 mg/l, are under the limitation of column A1 of QCVN 08:2008/BTNMT. Based on Figure II-2.6.5. the lowest BOD5 is obtained at R202-WS7 (Lung Vai village, Dinh Phung commune, Bao Lac).

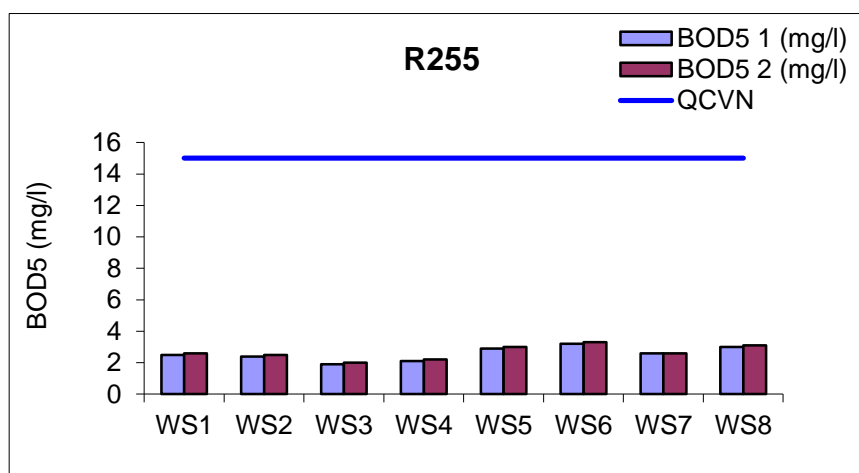
FigureII-2.6.6.BOD5 concentrations of water in Bac Kan

Figure II-2.6.6 shows that all BOD5 values monitored at the locations along R255 are below the limitation of A1 column (4mg/l).

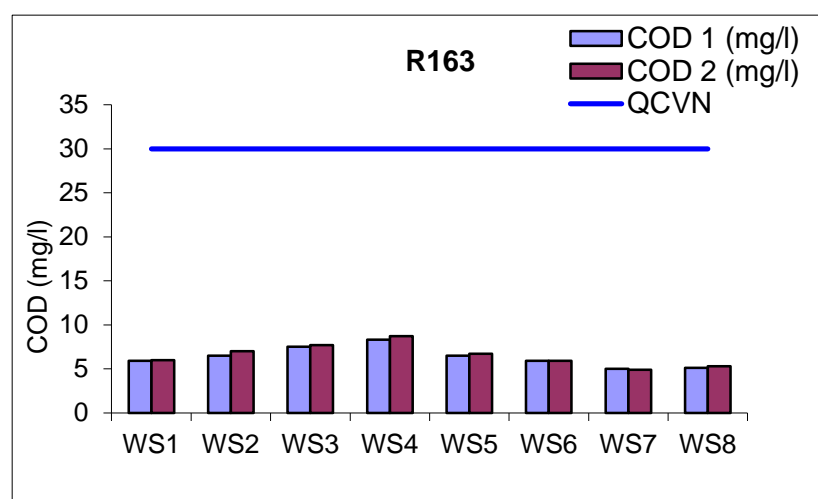
FigureII-2.7.1. COD concentrations of water in Yen Bai

The COD values at the monitoring positions along R163 ranging from 4.9 to 8.7 mg/l are lower than QCVN 08:2008/ BTNMT column A1 (10mg/l). It can be seen that pollution level respect to COD here are insignificant. Figure II-2.7.1.

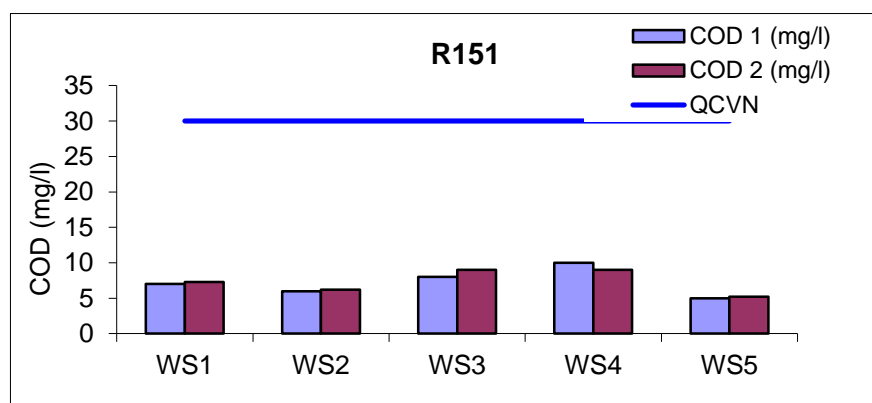
Figure II-2.7.2. COD concentrations of water in Lao Cai

Figure II-2.7.2. displays the graphs of the measured COD values at the monitoring position along 5 roads R151, R151B, R154, R156 and R160 in Lao Cai province. Almost actual COD values are below the limitation of column B1 of QCVN 08:2008/BTNMT, some even meet the limitation of column A1, including those obtained at R154, R160. . 3 positions at which COD values are relatively higher, are R156-WS6 (13,2mg/l), R151B- WS2 (28mg/l), R151-WS4 (10mg/l). .

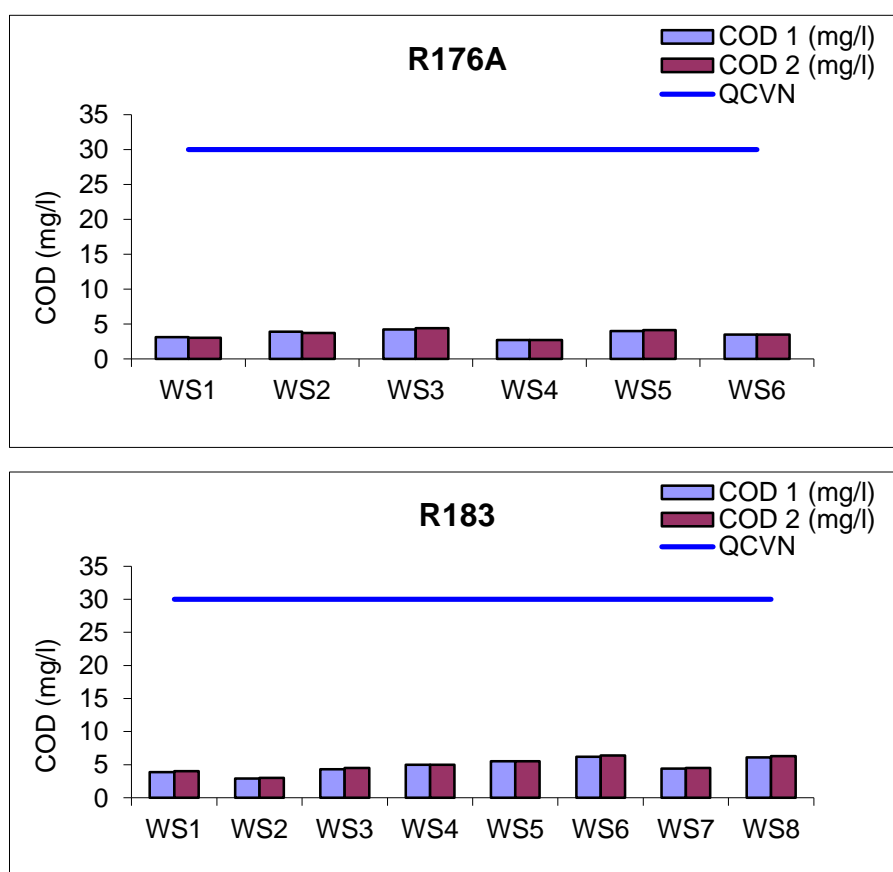
Figure II-2.7.3. COD concentrations of water in Ha Giang

The actual COD values at the positions along two roads in Ha Giang province are presented in Figure II.2.7.3. The pollution level with respect to COD is low, lower than permissible limit, the values range from 2.7 to 6.4 mg/l. The position at which the highest COD is obtained is R183- WS6.

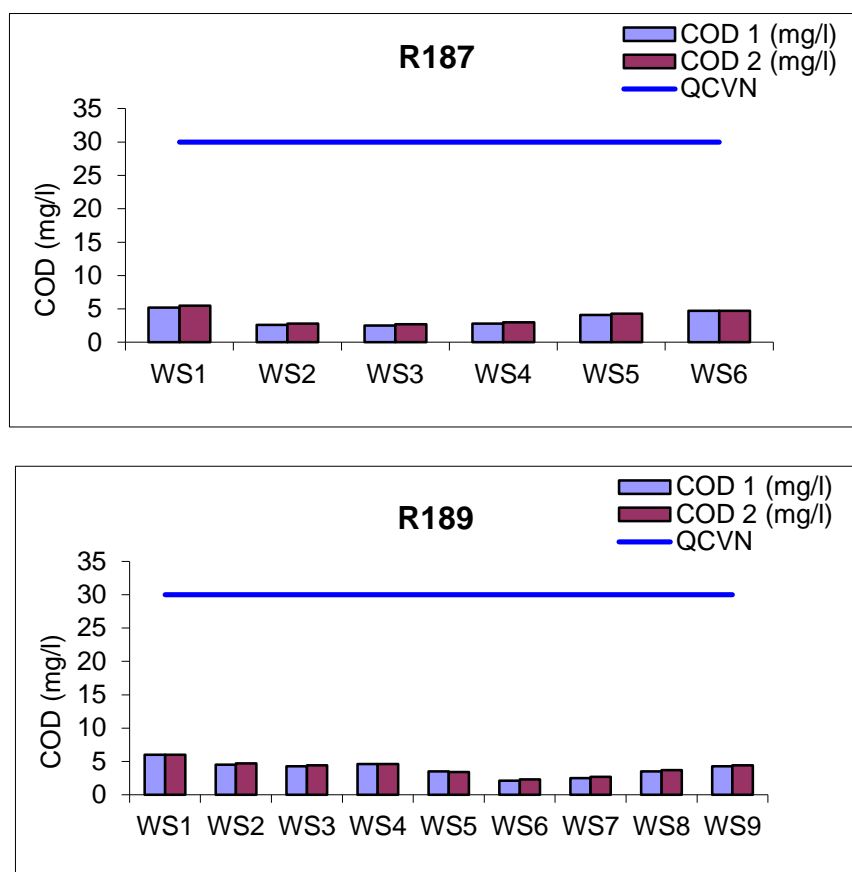
Figure II-2.7.4. COD concentrations of water in Tuyen Quang

Project area in Tuyen Quang includes two roads R187 and R189. The COD values are presented graphically in Figure II-2.7.4. It can be found that the pollution level respect to COD is low, actual values fluctuate from 2.1 to 6.0 mg/l, are much lower than QCVN 08:2008/BTNMT column B1, even meet limitation column A1.

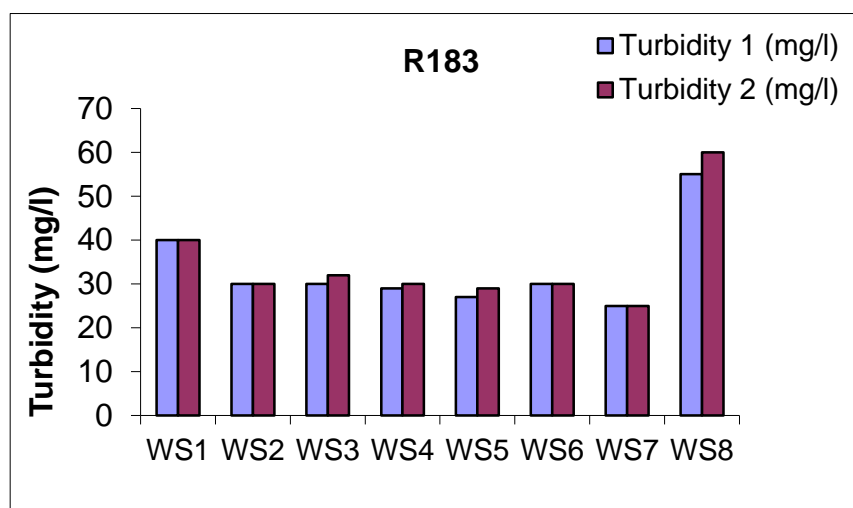
Figure II-4.3.3. Actual turbidity values of water in Ha Giang

Almost of the turbidity values of water at the monitoring positions along 176A and 183 are low, in range of 20-50 mg/l. at R183-WS8, the turbidity are remarkably higher with the values of 55 and 60 mg/l(Figure II.4.3.3).

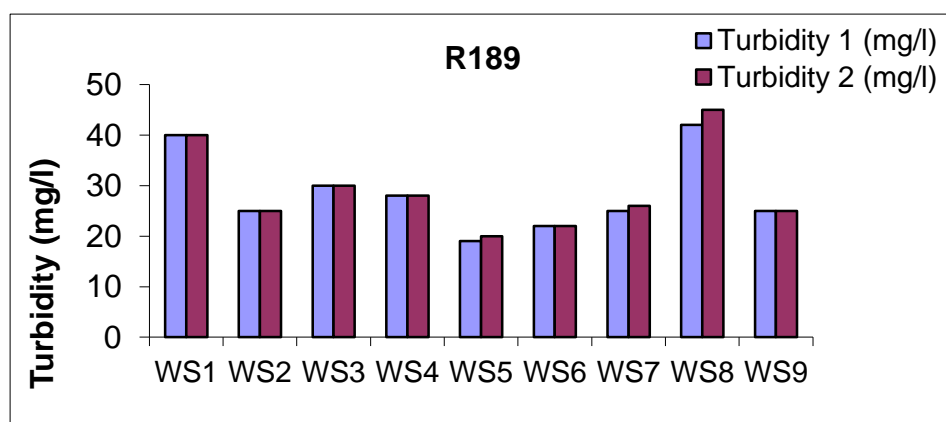
Figure II-4.3.4. Actual turbidity values of water in Tuyen Quang

The turbidity at the positions along R187, R189 in Tuyen Quang depicted in Figure II-4.3.4 are not high, ranging from 20 to 45 mg/l,

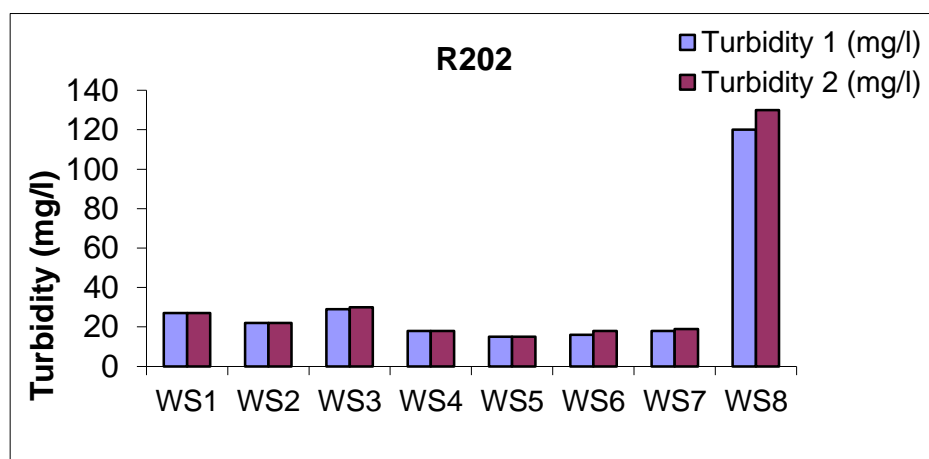
Figure II-4.3.5. Actual Turbidity values of water in Cao Bang

Turbidity values at the monitoring positions along R202 in Cao Bang are shown in Figure II- 2.3.5. The noticeable values 130 mg/l is obtained at R202-WS8. Almost values measured are not high in the range of 15-30 mg/l, the highest is obtained at R202-WS3 (Luong Sung village, Yen Lac commune, Bao Lac) and the lowest is obtained at R202-WS5 (underground stream Km 12, Nam Pap village, Dinh Phung commune, Bao Lac).

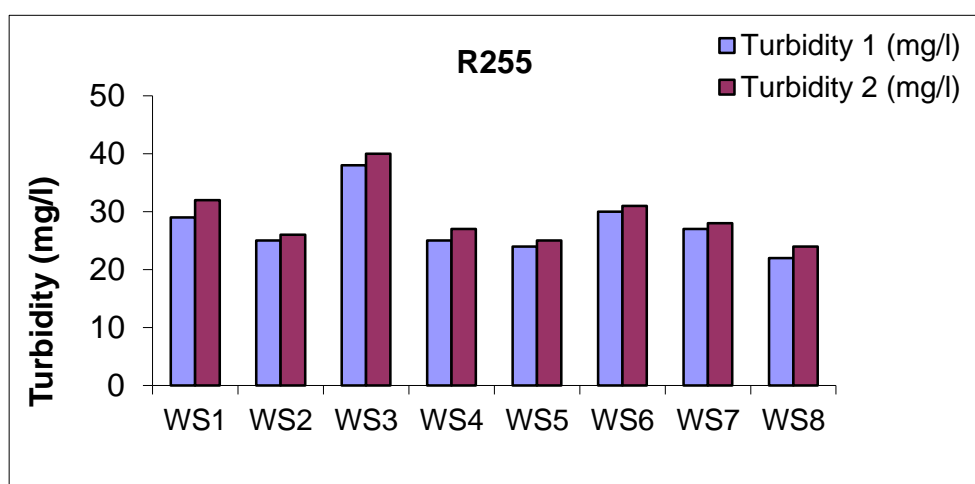
Figure II-4.3.6. Actual Turbidity values of water in Bac Kan

Turbidity values at the monitoring positions along R255 in Bac Kan are demonstrated on the graph in Figure II- 4.3.6. Turbidity concentrations fluctuate in the range from 24 to 40 mg/l.

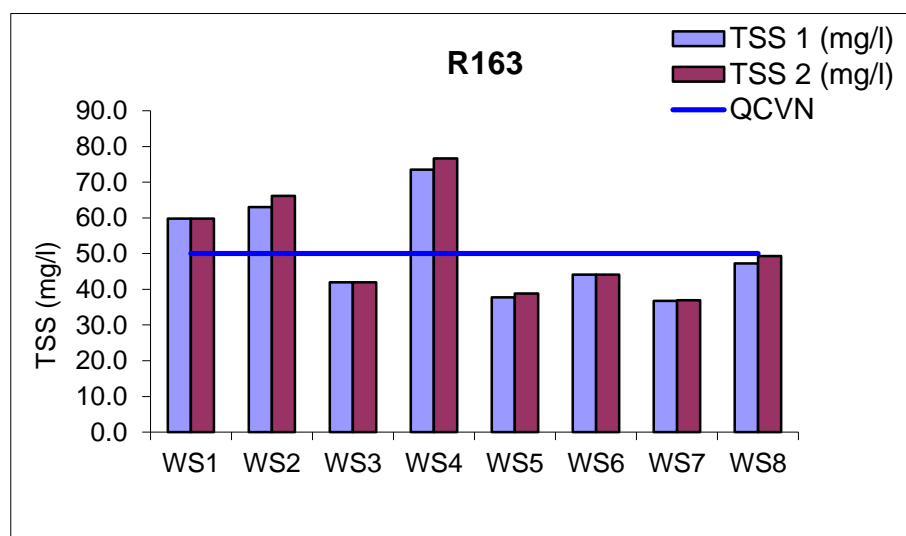
Figure II-4.4.1. Actual TSS values of water in Yen Bai

At the monitoring positions along R163 in Yen Bai province, excepting the TSS concentration at R163-WS1, R163-WS2, R163-WS3 over the permissible limitation, (Figure II-4.4.1) the others meet the standard of column B1 (QCVN 08:2008/BTNMT).

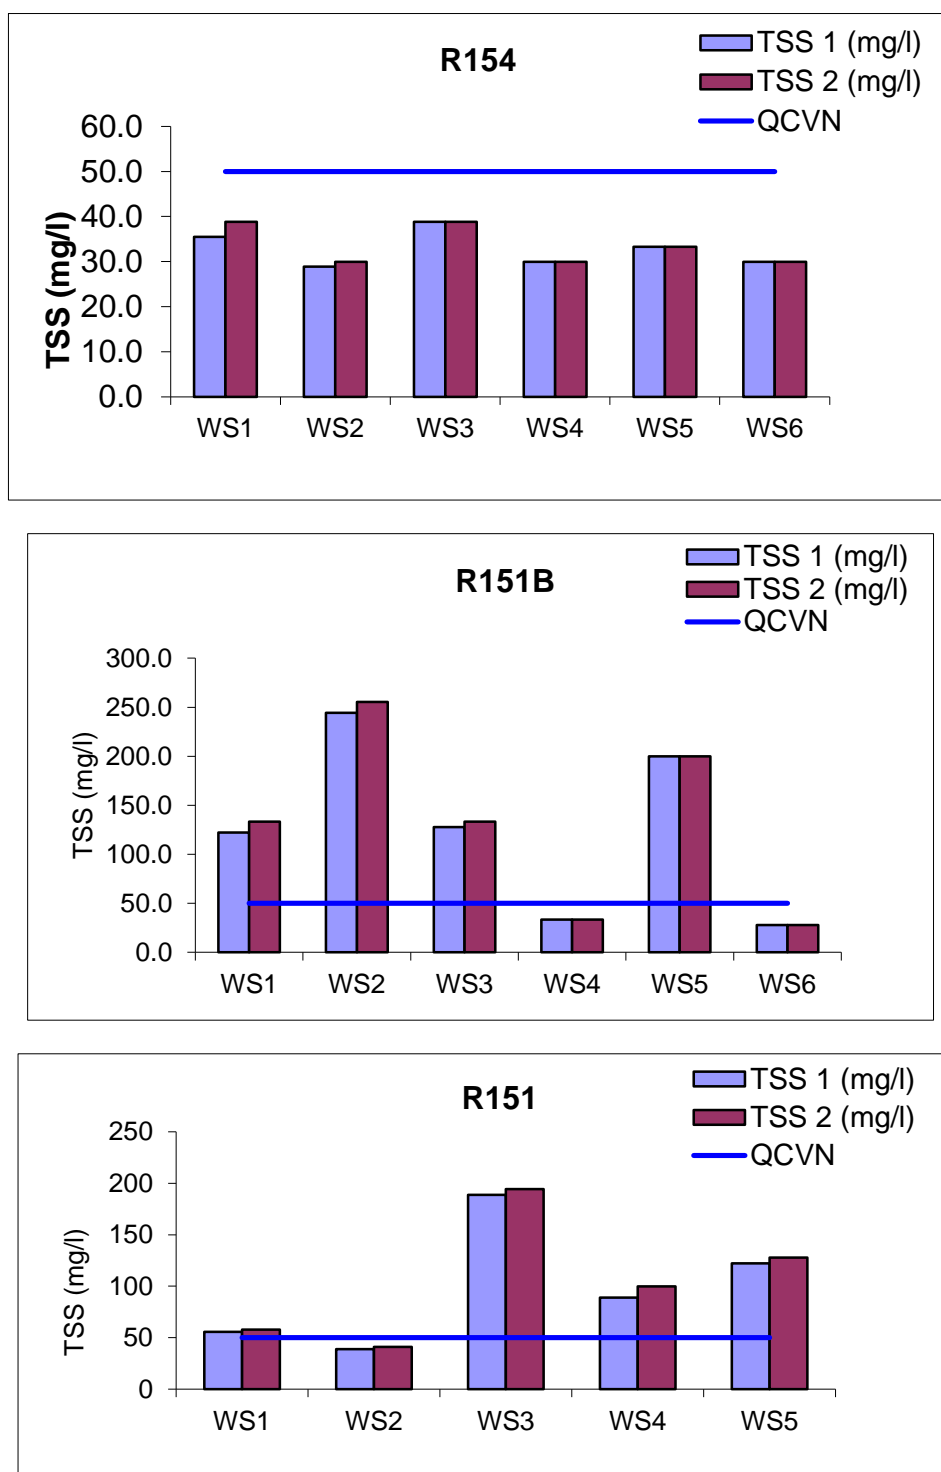
Figure II-4.4.2. Actual TSS values of water in Lao Cai

Based on Figure II-4.4.2, it can be found that in Lao Cai province, TSS values at monitoring positions at R154 are below the permissible limitation of QCVN 08:2008/BTNMT (column B1), ranging from 28,9 mg/l to 38,9 mg/l. At the other routes, TSS values are relatively high. The positions at which TSS values over permissible limitation include: vị trí R156-WS1, R156-WS3, R156-WS4, R156-WS6, R160-WS1, R151B-WS1, R151B-WS2, R151B-WS3, R151B-WS5, R151-WS3, R151-WS4, R151-WS5.

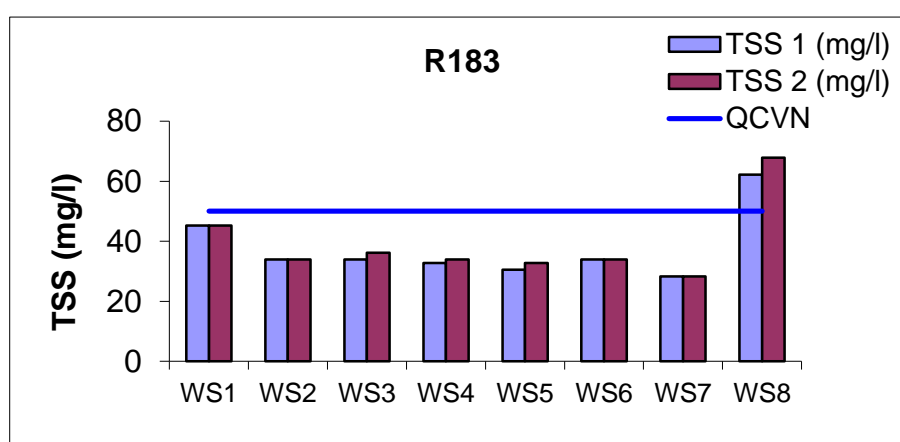
Figure II-4.4.3. Actual TSS values of water in Ha Giang

TSS values at the monitoring positions along R176A are high at 2 monitoring positions R176A-WS5, R183-WS8, turbidity values are higher the permissible limitation of QCVN (Figure II-4.4.3). TSS concentration at the other positions in the range of 23 -45 mg/l, not exceeding 50 mg/l- the permissible limitation of B1 column (TCVN 08:2008/BTNMT).

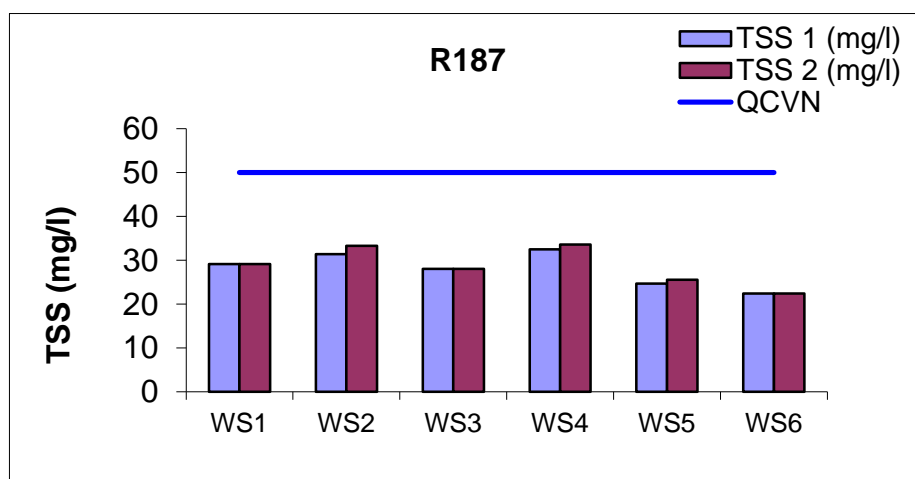
Figure II-4.4.4. Actual TSS values of water in Tuyen Quang

Figure II- 4.4.4 presents TSS values of water of the locations along two roads R187 and R189 in Tuyen Quang. The remarkable TSS value found at R189-WS8 (Tan Thinh village, Yen Thuan, Ham Yen) reaches the stipulated limitation of QCVN 08:2008/BTNMT. TSS values of water at the other positions are from 22 to 44 mg/l meeting the standard of B1 column.

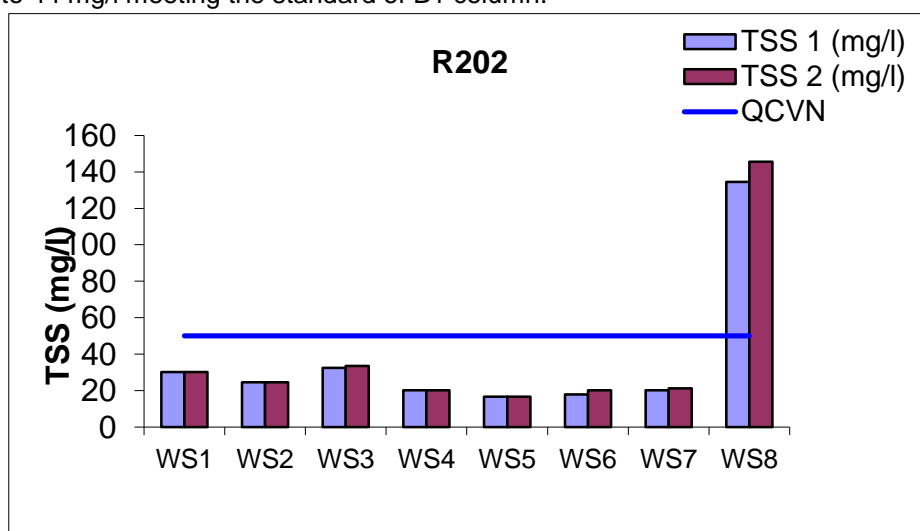
Figure II-4.4.5. Actual TSS values of water in Cao Bang

Figure II- 4.4.5 shows TSS values monitored at the positions along R202 in Cao Bang. The noticeable TSS value at R202-WS8 (Mo Din village, Huy Giap commune, Bao Lac) is nearly 3 times as high as the permissible limitation B1 of QCVN. The other TSS values are under the limitation of QCVN, the lowest is of 16,8 mg/l at R202- WS5 (underground stream Km15, Nam Pap village, Dinh Phung commune).

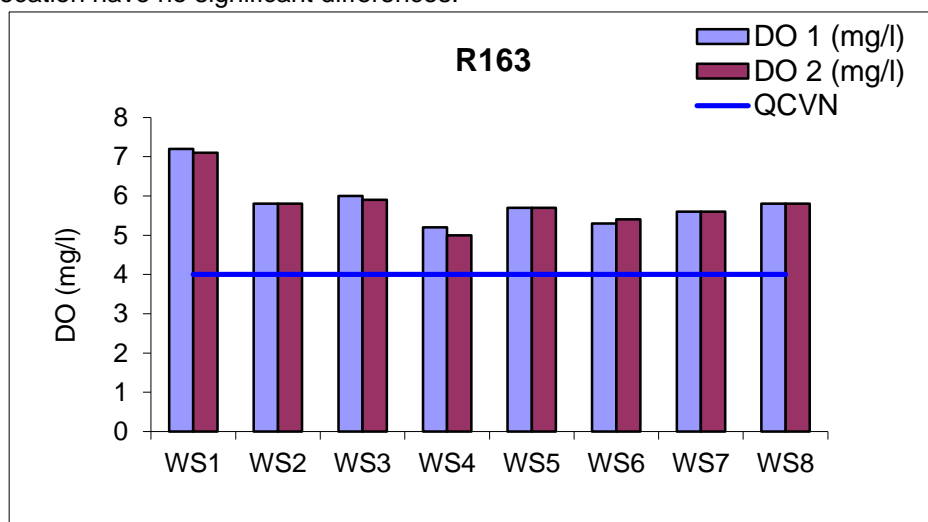
Figure II-4.5.1. Actual DO concentrations of water in Yen Bai

All DO measured values at the positions along R163 in Yen Bai meet the limits of QCVN 08:2008/BTNMT. Range of values is from 5.0 mg/l to 7.2 mg/l (Figure II- 4.5.1).

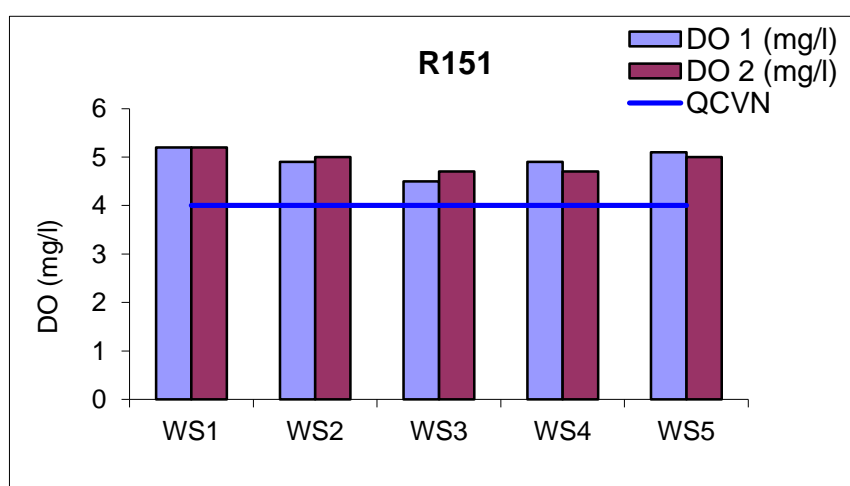
FigureII-4.5.2. Actual DO concentrations of water in Lao Cai

Figure II- 4.5.2 presents the graphs of the measured DO values at the monitoring positions along 5 roads R151, R151B, R154, R156 and R160 in Lao Cai area. Most of the values above the limitation 4 mg/l of column B1 of QCVN 08:2008/BTNMT. Particularly, DO concentrations at the position R156-WS6 does not meet the QCVN 08:2008/BTNMT (B1), is of 3,8 mg/l.

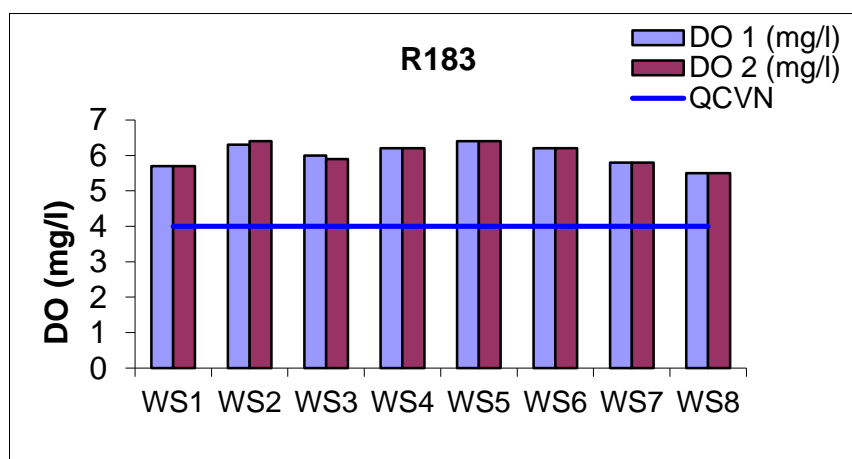
FigureII-4.5.3. Actual DO concentrations of water in Ha Giang

Figure II- 4.5.3 displays graphs of the DO results of the water bodies along the two roads R176A and R183 in Ha Giang. All values fluctuating in the range of 5,3 – 6,7 mg/l, satisfy the permissible limit of QCVN 08:2008/BTNMT.

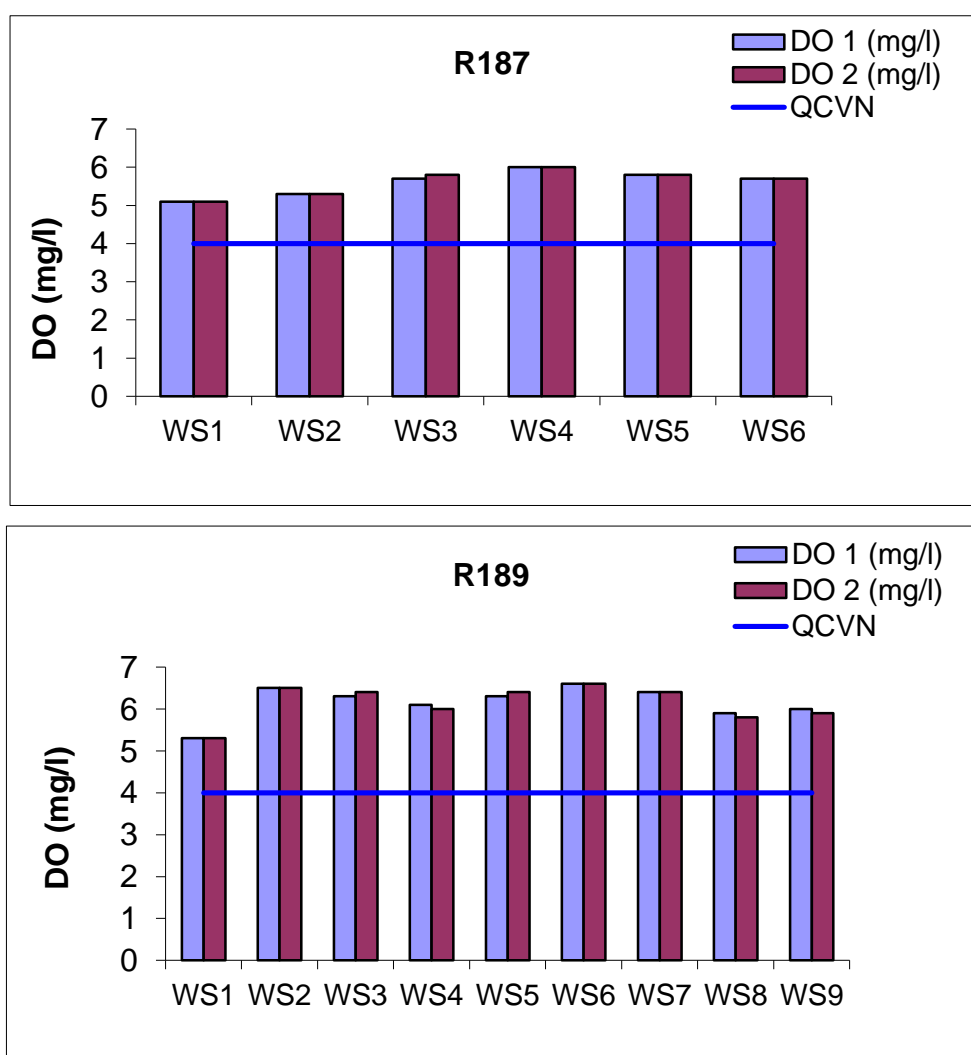
FigureII-4.5.4. Actual DO concentrations of water in Tuyen Quang

Figure II- 4.5.4 shows the DO concentrations at the monitoring positions along R187 and R189 in Tuyen Quang province. All values here meet well QCVN for DO. DO obtains at R187-WS1(Dai Thi village,

Yen Lap, Chiem Hoa) is the lowest, 5.1 mg/l and DO obtained at R189-WS6 (Kem village, Phu Luu, Ham Yen) is the highest, 6.6 mg/l

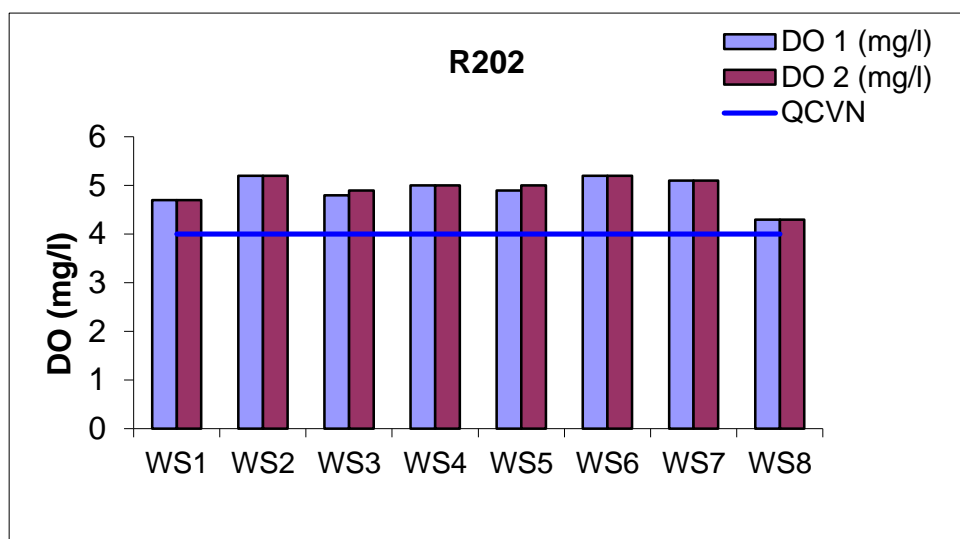
FigureII-4.5.5. Actual DO concentrations of water in Cao Bang

The obtained DO results at location along R202 in Cao Bang province are presented in Figure II- 4.5.5. All DO values satisfy QCVN 08:2008/BTNMT, fluctuating from 4.3 to 5.2 mg/l.

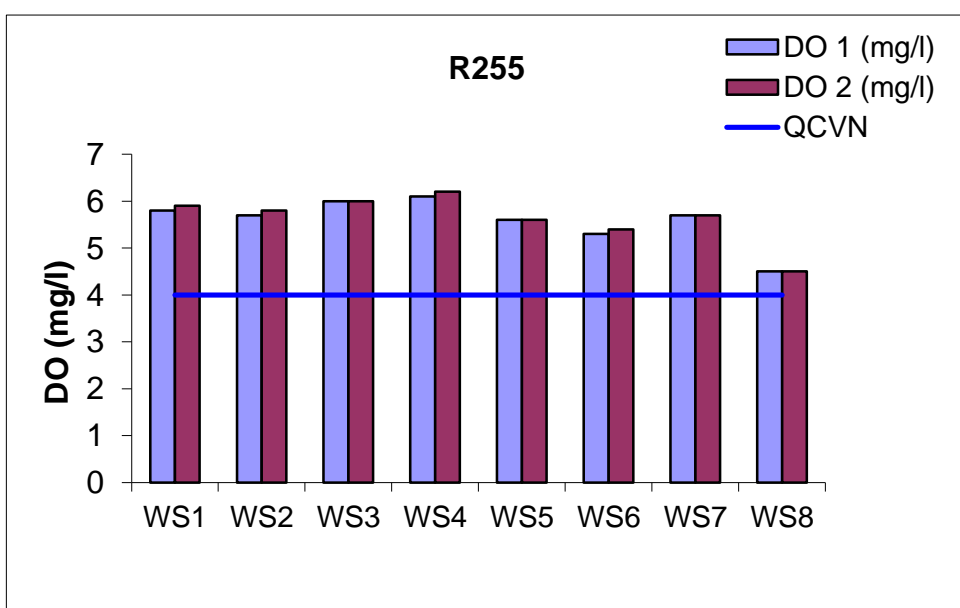
FigureII-4.5.6. Actual DO concentrations of water in Bac Kan

DO results at the monitoring positions along R255 in Bac Kan province are shown on Figure II- 4.5.6. DO values at all positions are above the permissible limitation of QCVN 08:2008/BTNMT and range from 4.5 mg/l to 6.2 mg/l.

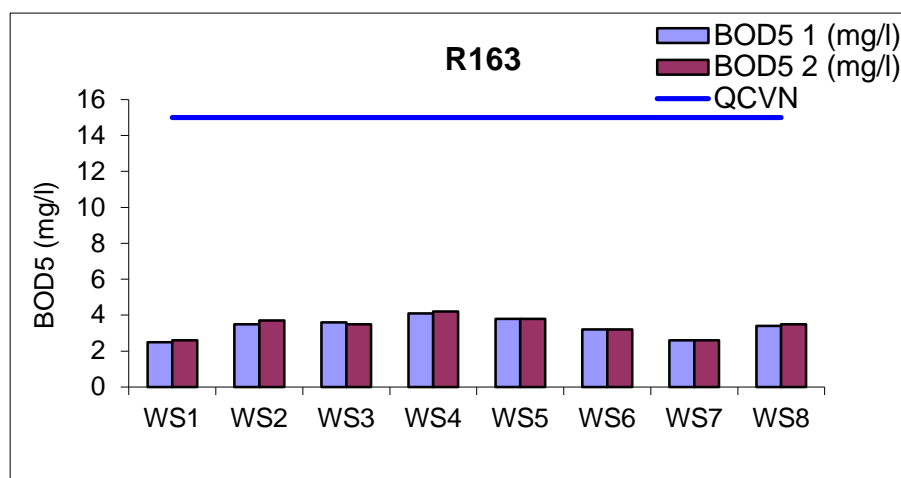
Figure II-4.6.1. BOD5 concentrations of water in Yen Bai

The BOD5 values of the water body along R163 ranging from 2.5 to 4.8 mg/l are lower than limitation of QCVN 08:2008/BTNMT. It can be seen that pollution level respect to BOD5 is insignificant. (, excepting BOD5 at R163-WS4 the values at the other positions meet the standard of column A1 (4mg/l) for domestic water supply.

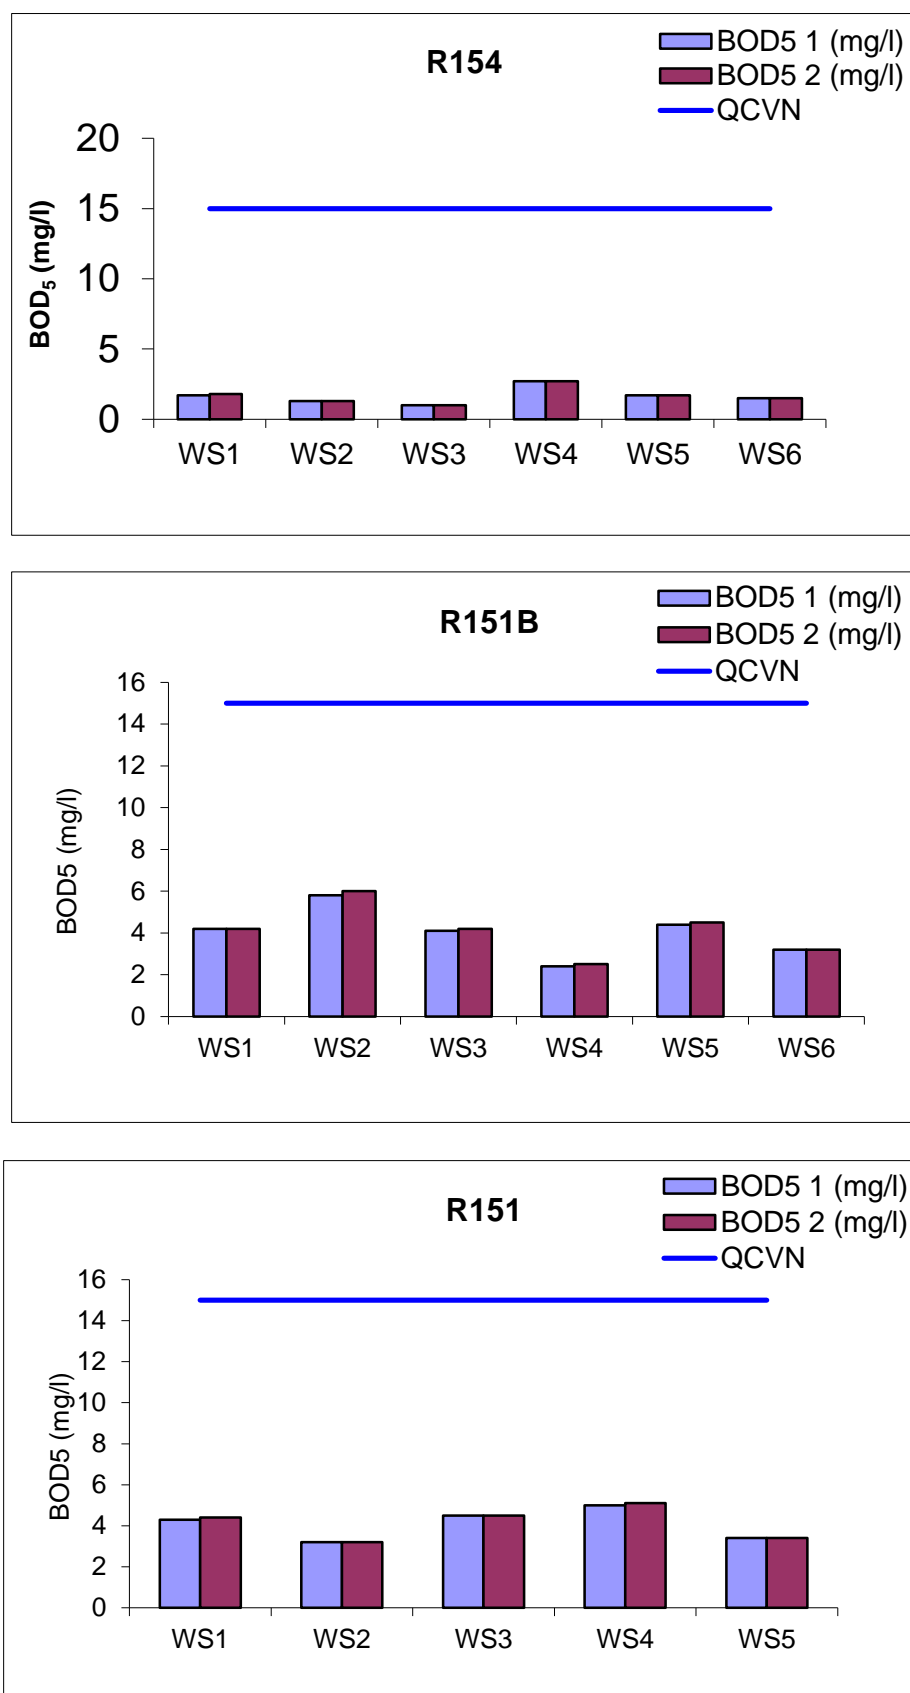
Figure II-4.1.1. BOD5 concentrations of water in Lao Cai

Figure II-4.1.1 displays the graphs of the measured BOD5 values at the positions along 5 roads R151, R151B, R154, R156 and R160 in Lao Cai province. None of the measured BOD5 values of the water

bodies do not meet the standard of column B1 of QCVN 08:2008/BTNMT. All values obtained at the positions of R160, R154 even meet the standard of column A1 (4mg/l). It is noticed that BOD₅ values at R156-WS6 (Phoi village, Ta Phoi commune, Lao Cai) are relative high, 10 mg/l.

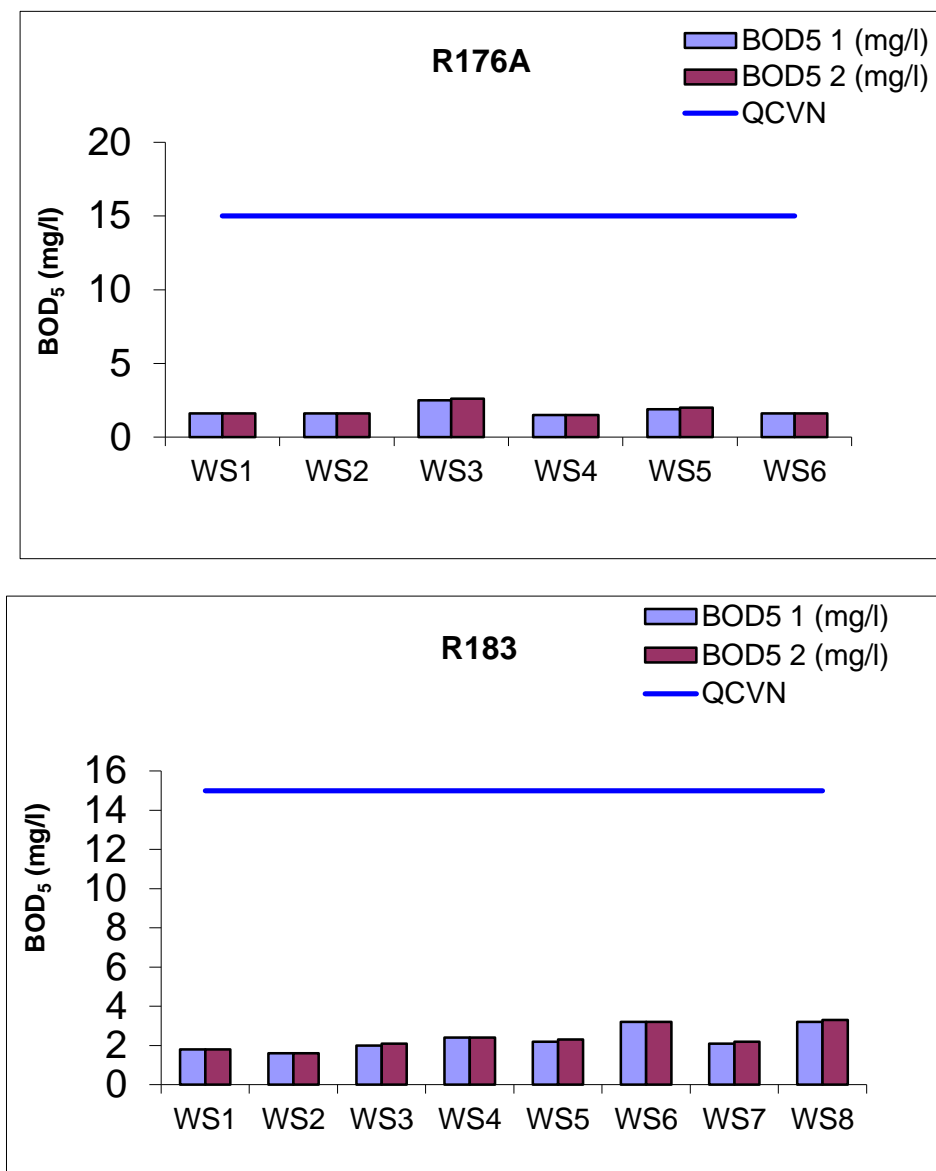
Figure II-4.6.3. BOD₅ concentrations of water in Ha Giang

The actual BOD₅ values at the monitoring positions along two roads in Ha Giang province are presented in Figure II- 4.6.3. The pollution level with respect to BOD₅ is low, values range from 1.6 to 3.3 mg/l, lower than the standard of column A1 (QCVN 08:2008/BTNMT).

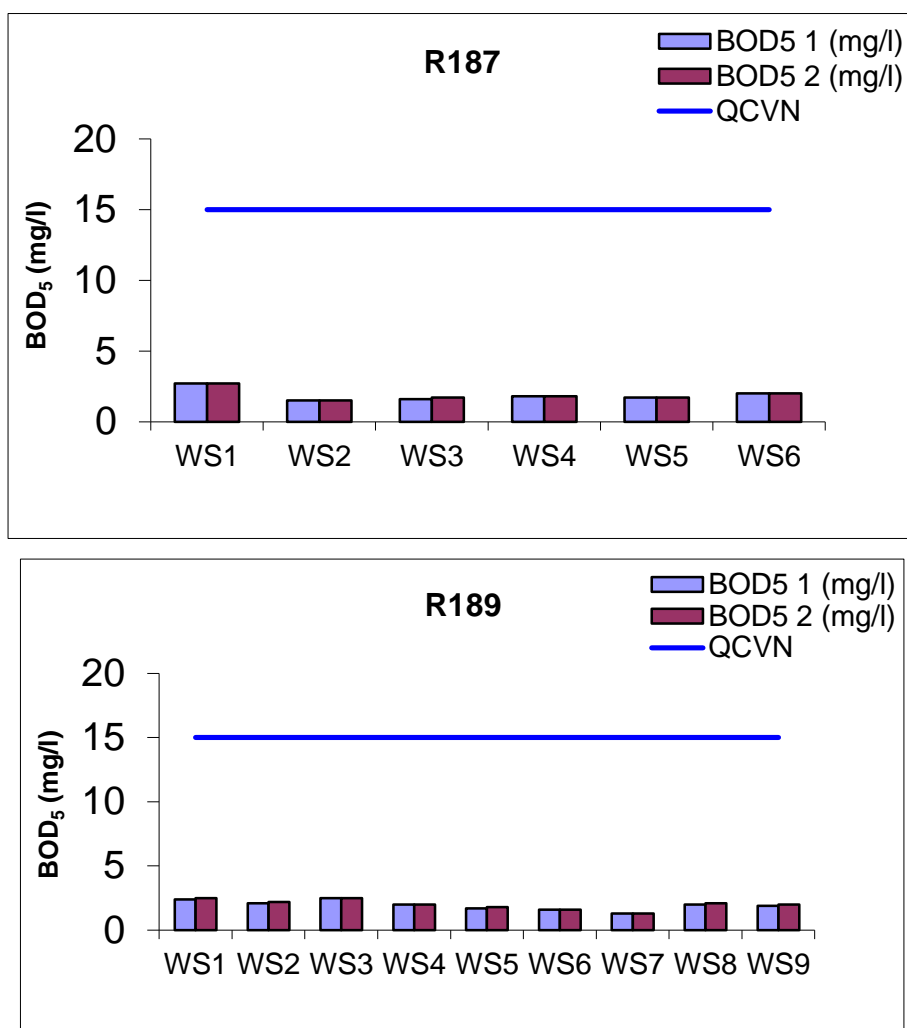
Figure II-4.6.4. BOD5 concentrations of water in Tuyen Quang

Project area in Tuyen Quang includes two roads R187 and R189. The BOD5 values are represented graphically in Figure II- 4.6.4. The pollution level with respect to BOD5 is low, actual values fluctuated from 1.3 to 2.7 mg/l, lower than the limit of column A1 (QCVN 08:2008/BTNMT).

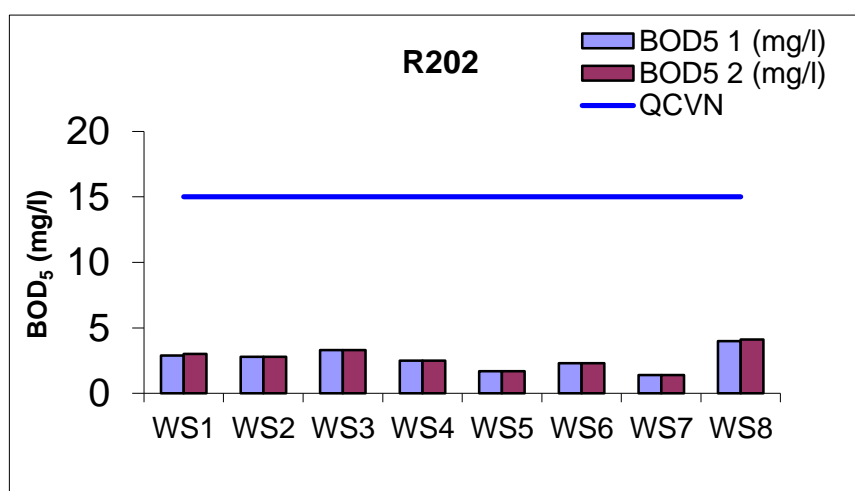
Figure II-4.6.5. BOD5 concentrations of water in Cao Bang

The BOD₅ values at the positions along R202 in Cao Bang ranging from 1.4 mg/l to 4.1 mg/l, are under the limitation of column A1 of QCVN 08:2008/BTNMT. Based on Figure II-4.6.5. the lowest BOD₅ is obtained at R202-WS7 (, Lung Vai village, Dinh Phung commune, Bao Lac).

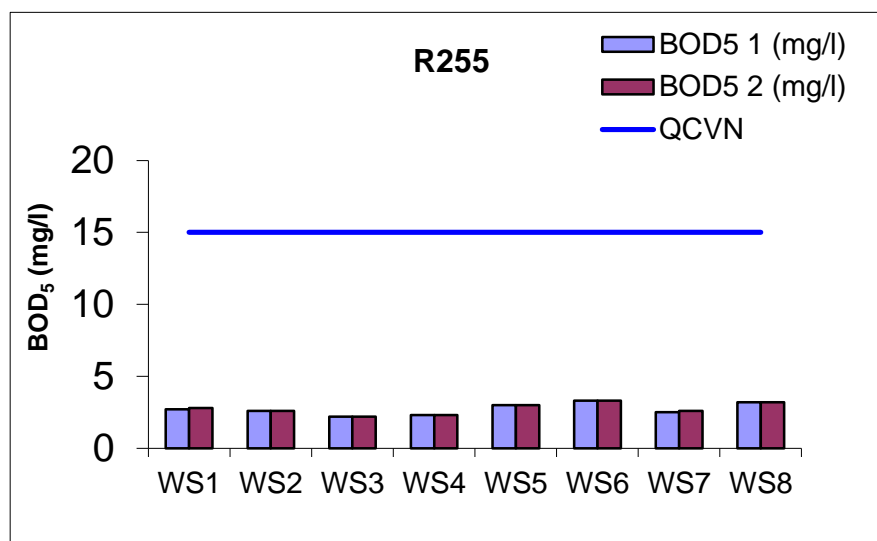
Figure II-4.6.6. BOD₅ concentrations of water in Bac Kan

Figure II-4.6.6 shows that all BOD₅ values monitored at the locations along R255 are below the limitation of A1 column (4mg/l), ranging from 2.2 – 3.3 mg/l..

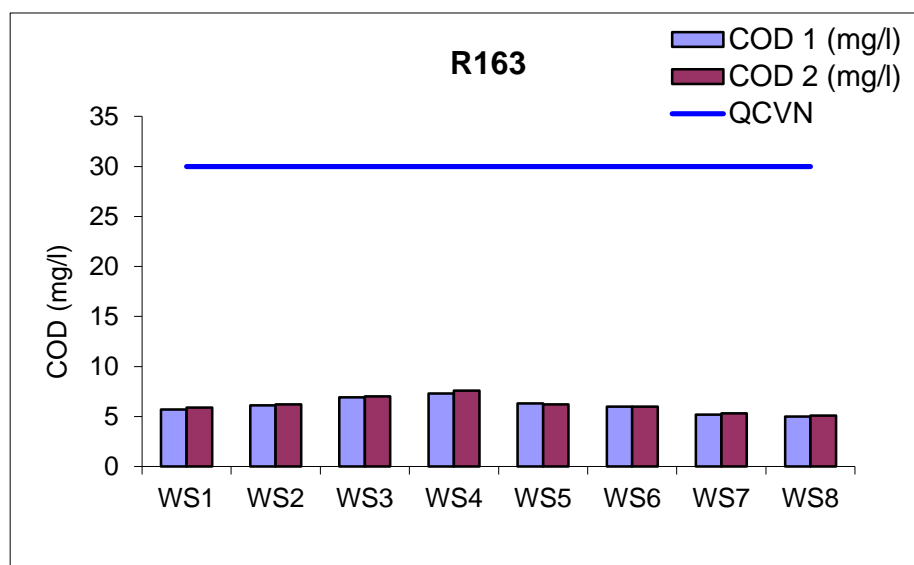
Figure II-4.7.1. COD concentrations of water in Yen Bai

The COD values at the monitoring positions along R163 ranging from 5,0 to 7,6 mg/l are lower than QCVN 08:2008/ BTNMT column A1 (10mg/l). It can be seen that pollution level respect to COD here are insignificant. Figure II-4.7.1.

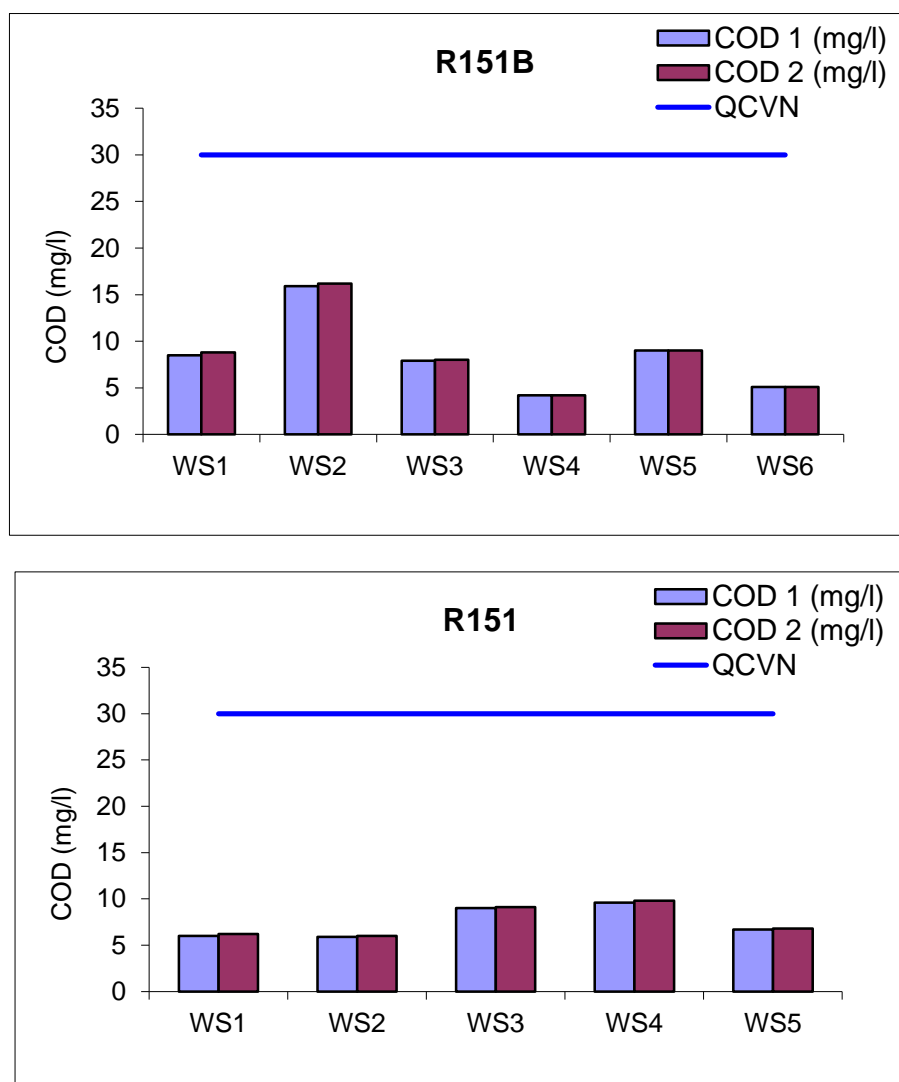
Figure II-4.7.2. COD concentrations of water in Lao Cai

Figure II-4.7.2. displays the graphs of the measured COD values at the monitoring position along 5 roads R151, R151B, R154, R156 and R160 in Lao Cai province. All actual COD values are below the limitation of column B1 of QCVN 08:2008/BTNMT, some even meet the limitation of column A1(10mg/l), including those obtained at R151, R154, R160. The lowest COD values obtained at position R154-WS3, (water source Sa Lung Phin, Nam Chay, Muong Khuong) are 2.9 mg/l. 2 positions at which COD values are relatively higher, are R151B-WS2 (Lu village, Vo Lao commune, Van Ban), R156- WS6 (Phoi village, Ta Phoi commune, Lao Cai), with COD values are 16.2 and 19.0 mg/l, respectively. .

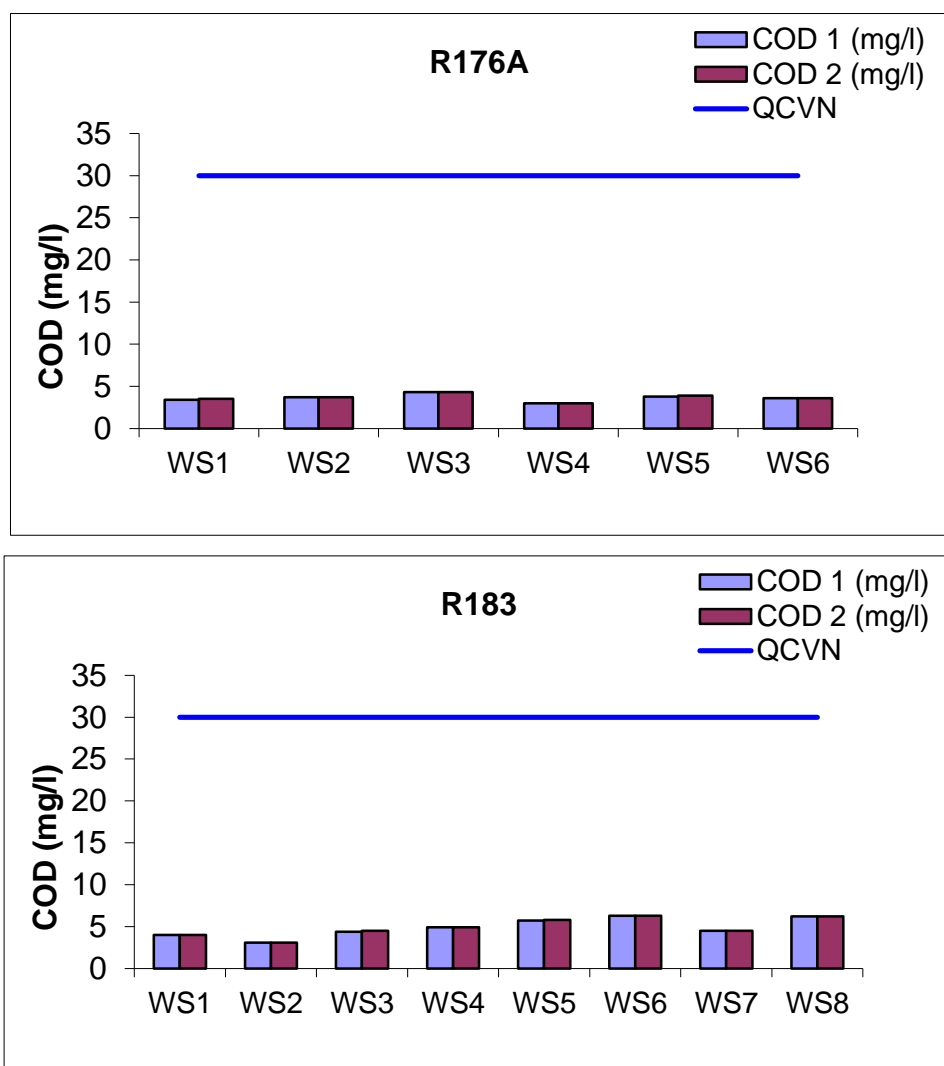
Figure II-4.7.3. COD concentrations of water in Ha Giang

The actual COD values at the positions along two roads in Ha Giang province are presented in Figure II-4.7.3. The pollution level with respect to COD is low, lower than permissible limit, the values range from 3.0 to 6.3 mg/l satisfying the limitation of column A1 (10mg/l) of QCVN 08:2008/BTNMT.
