Environmental Monitoring Report

**Forth Semi-Annual Report
January – June 2015**

Loan 2789-VIE: Transport Connections in Northern Mountainous Provinces

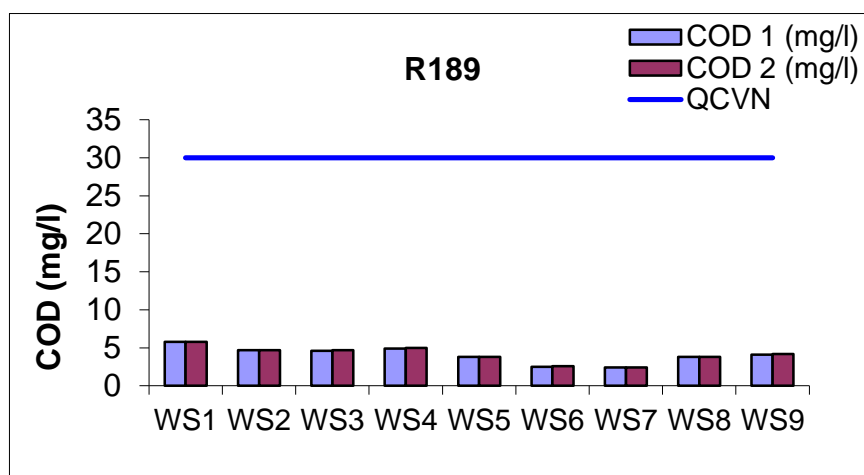
Figure II-4.7.4. COD concentrations of water in Tuyen Quang

Project area in Tuyen Quang includes two roads R187 and R189. The COD values are presented graphically in Figure II-4.7.4. It can be found that the pollution level respect to COD is low, actual values fluctuate from 2.4 to 5.8 mg/l, are much lower than QCVN 08:2008/BTNMT column B1, even meet limitation column A1.

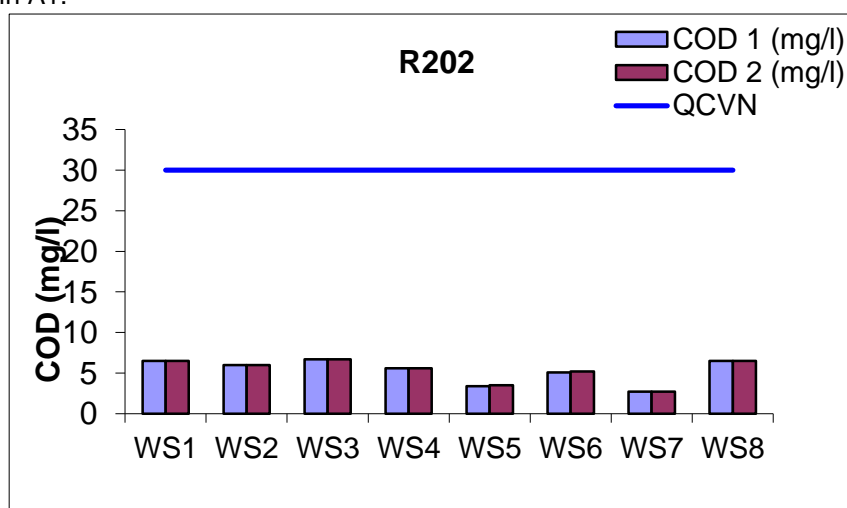
Figure II-4.7.5. COD concentrations of water in Cao Bang

The COD values at the positions along R202 in Cao Bang are much lower than the limitation value in column B1, the range of values from 2.7 to 6.7mg/l (Figure II-4.7.5). The highest COD is obtained at R202- WS3 (Ban Bay village, Yen Thuong, Cho Don).

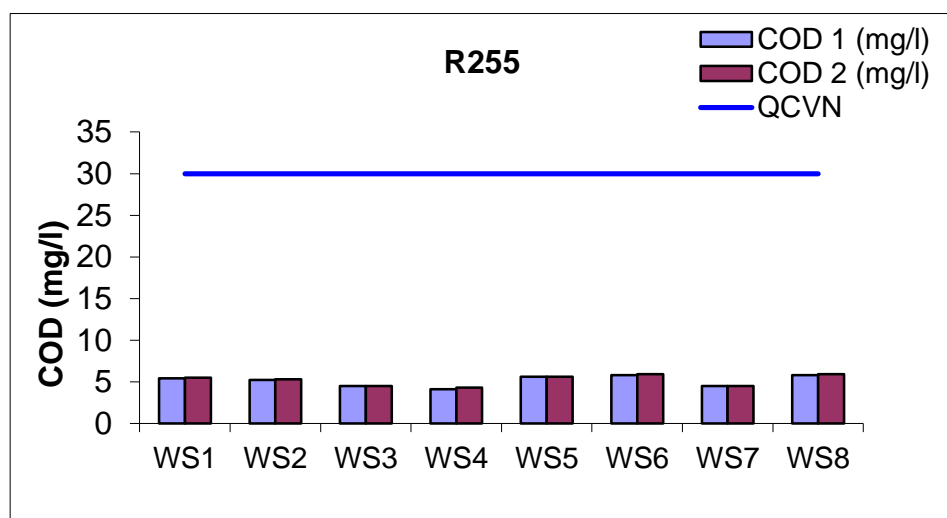
Figure II-4.7.6. COD concentrations of water in Bac Kan

Figure II-4.7.6 shows the COD values monitored at the monitoring positions along R255. It can be seen that most values fluctuated in the range from 4.1 to 5.9 mg/l are below the permissible limit (column A1), QCVN 08:2008/BTNMT.

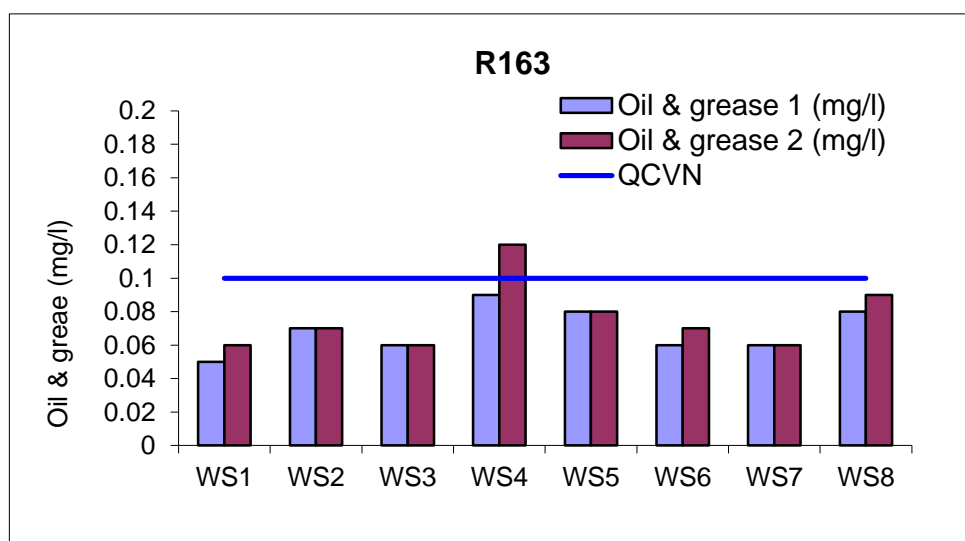
Figure II-4.8.1. Oil/grease concentrations of water in Yen Bai

The position at which oil/grease concentrations exceeds the limitation of QCVN 08:2008/BTNMT B1 column is: R163-WS4-2 (Ngoi Hop village, Bao Dap commune, Tran Yen) with the value of 0.12 mg/l (Figure II-4.8.1). It is noticed that there is difference between the values obtained at 2 positions upstream and downstream from the construction site of R163-WS4.

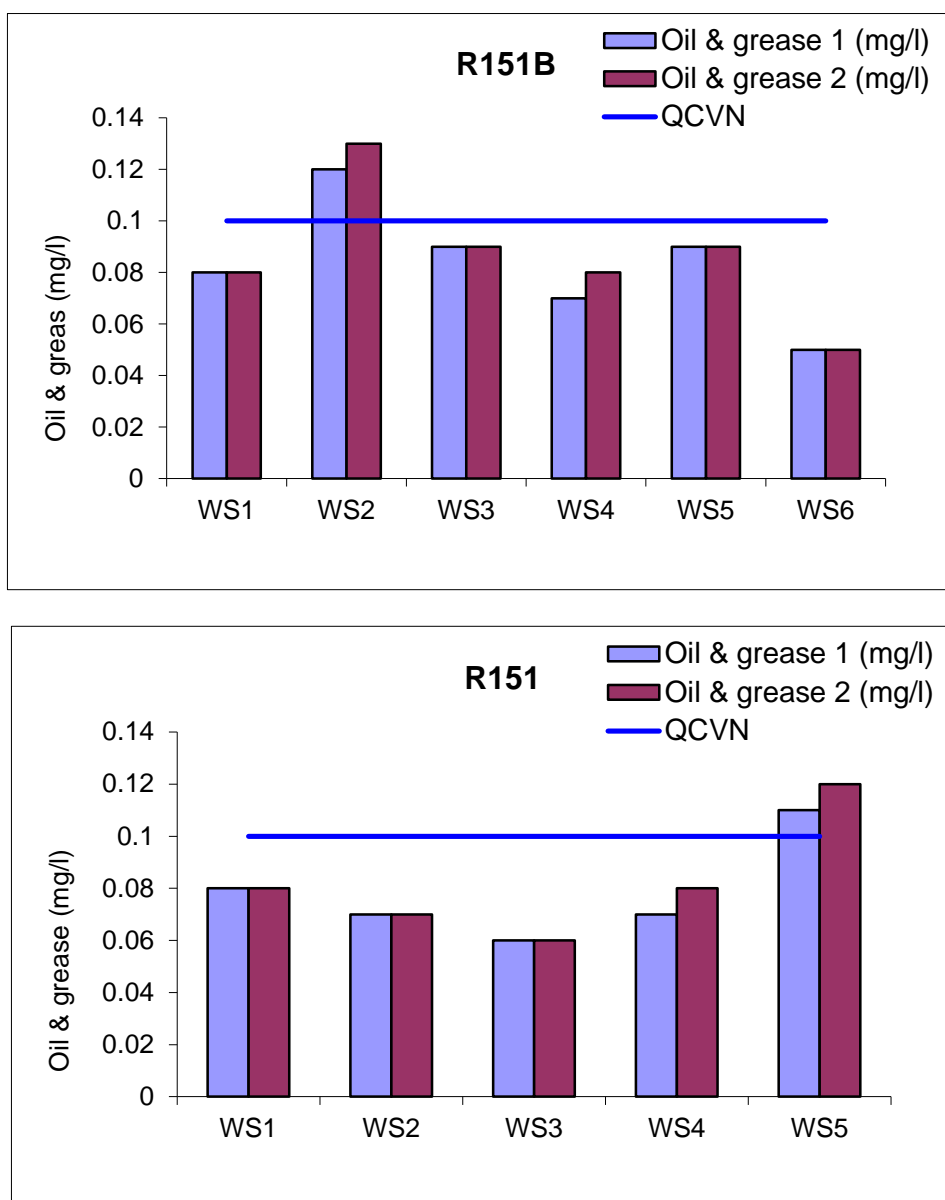
Figure II-4.8.2. Oil/grease concentrations of water in Lao Cai

Figure II-4.8.2 is the graph presenting the oil/grease values measured at the monitoring positions at 5 roads R151, R151B, R154, R156 and R160 in Lao Cai province. Most of the values measured are below permissible limitation B1 of QCVN 08:2008/BTNMT. At the positions R151-WS5(Khe Sang village, Tan An, Van Ban) R151B-WS2 (Lu village, Vo Lao commune, Van Ban), R156-WS6 (Phoi village, Ta Phoi commune) oil and grease concentrations are over the limitation

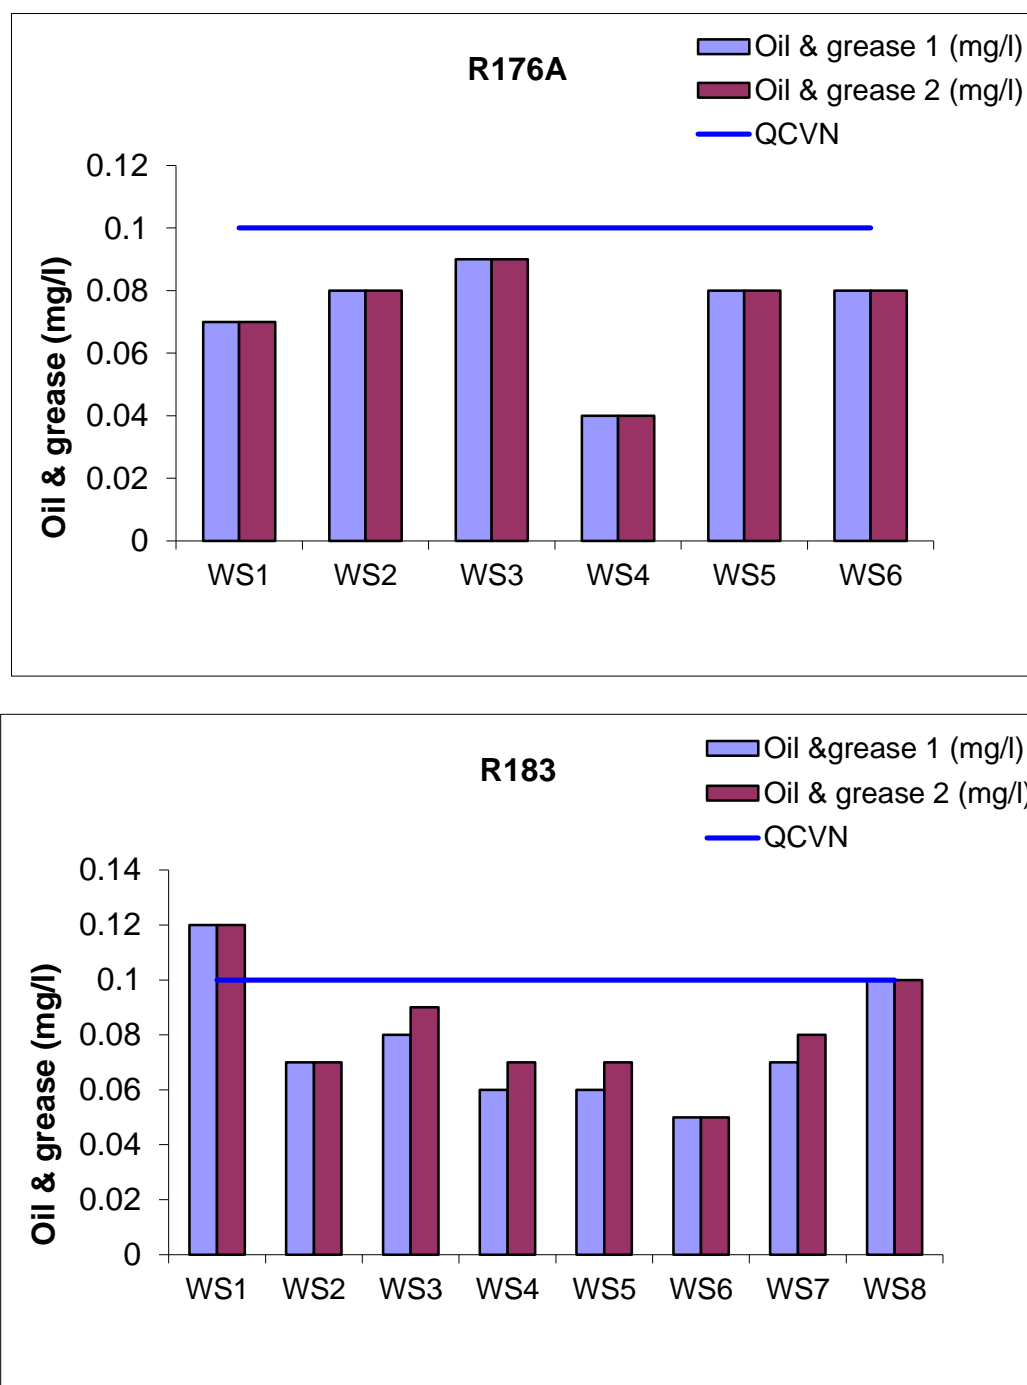
FigureII-4.8.3. Oil/grease concentrations of water in Ha Giang

The oil/grease concentrations measured at the positions along two roads R176A and R183 in Ha Giang province are shown on graphs in **Error! Reference source not found.**. In this area, at R183-WS1, monitoring positions at which oil/grease contents was over the limitation B1 of QCVN 08:2008/BTNMT , while at R183-WS8 (Xuân Chang village, Xuân Giang, Quang Binh) the values reached the limitation

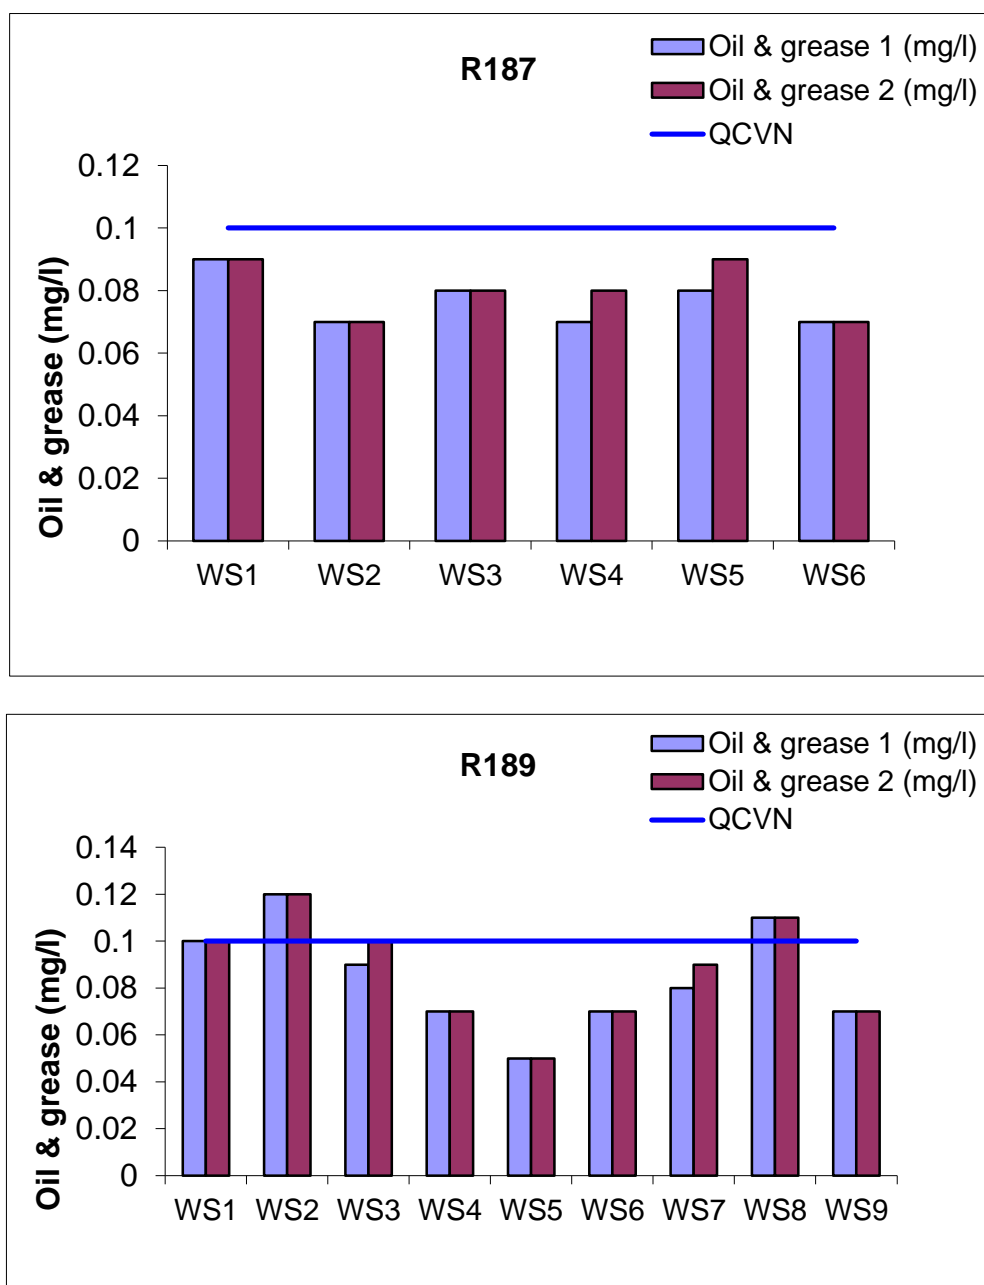
Figure II-4.8.4. Oil/grease concentrations of water in Tuyen Quang

The oil/grease values at the monitoring position along R187 and R189 (Tuyen Quang province) are presented graphically in Figure II-4.8.4.. The only position at which the measured value exceeds the limitation of QCVN is R189-WS2(Village 3, Viet Thanh, Tan Thanh, Ham Yen). R189-WS8 (Lang En village, Bach Xa, Ham Yen). In addition the values obtained at R189-WS1 (Ninh Binh, Binh Xa, Ham Yen) and at R189- WS3-2 (village 1, Tan Thanh, Ham Yen) reach the limitation of QCVN.

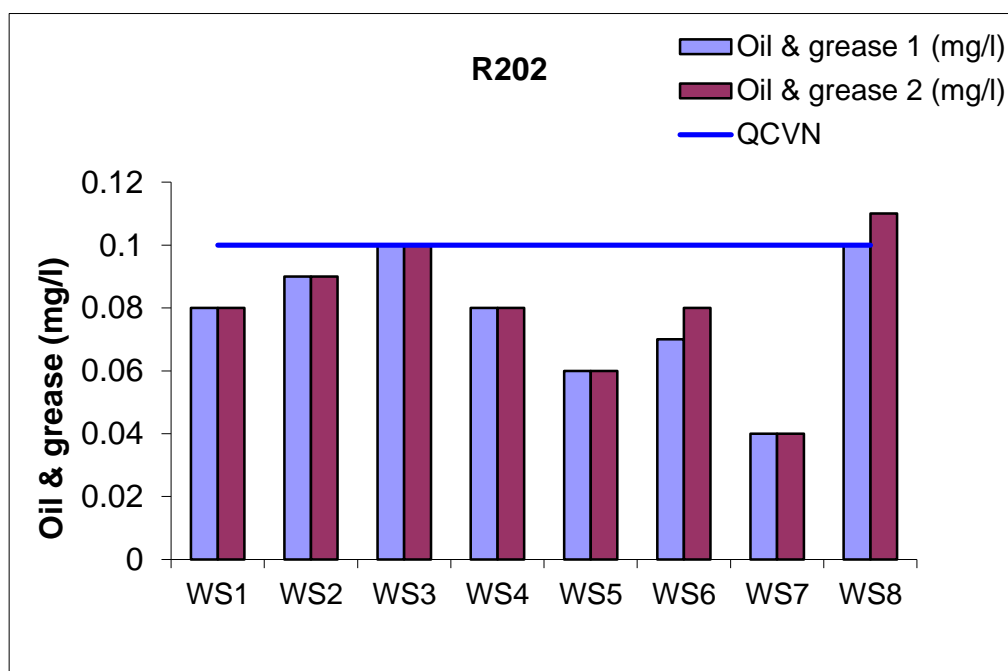
Figure II-4.8.5. Oil/grease concentrations of water in Cao Bang

As shown In Figure II-4.8.5, the positions at which oil/grease concentrations was over the limitation of column B1 of QCVN 08:2008/BTNMT are R202- WS8-2(Strema Km 26, Mo Din village, Huy Giap), the value at R202-WS3 (Crossing stream Km 11+300, Cao Lu). reached the permissible limitation.

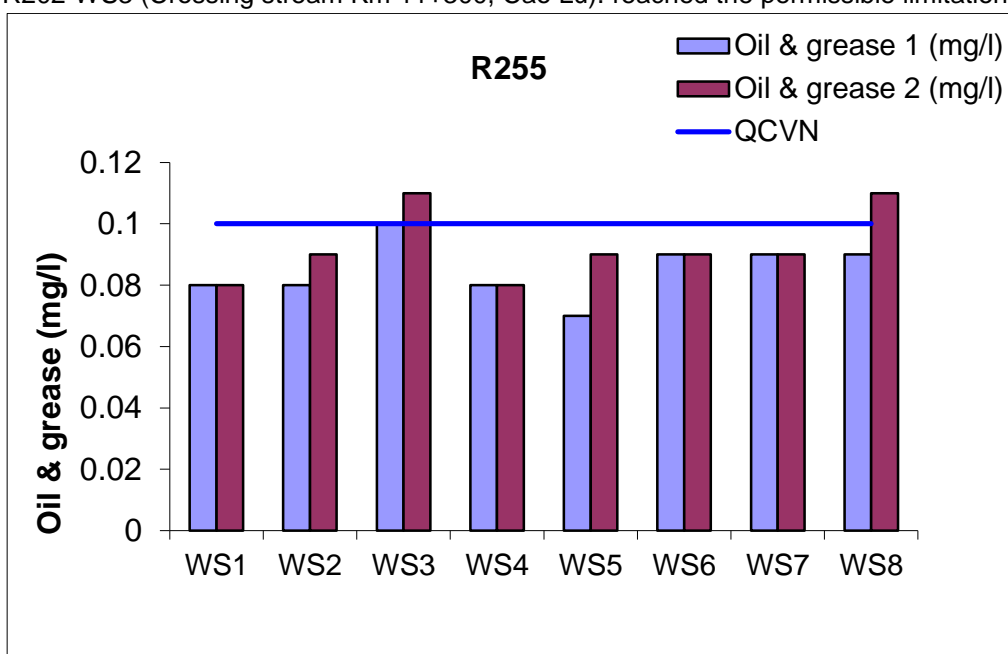
FigureII-4.8.6. Oil/grease concentrations of water in Bac Kan

Graph in FigureII-4.8.6. shows the latively high oil/grease values at R255. There are 2 positions at which measured values exceed the limitation of column B1 of QCVN08:2008/BTNMT are R255- WS3-2 (Stream Sm 9+900, Ban Bay village), and R255-WS8-2 (Vay village, Km 22+350). .

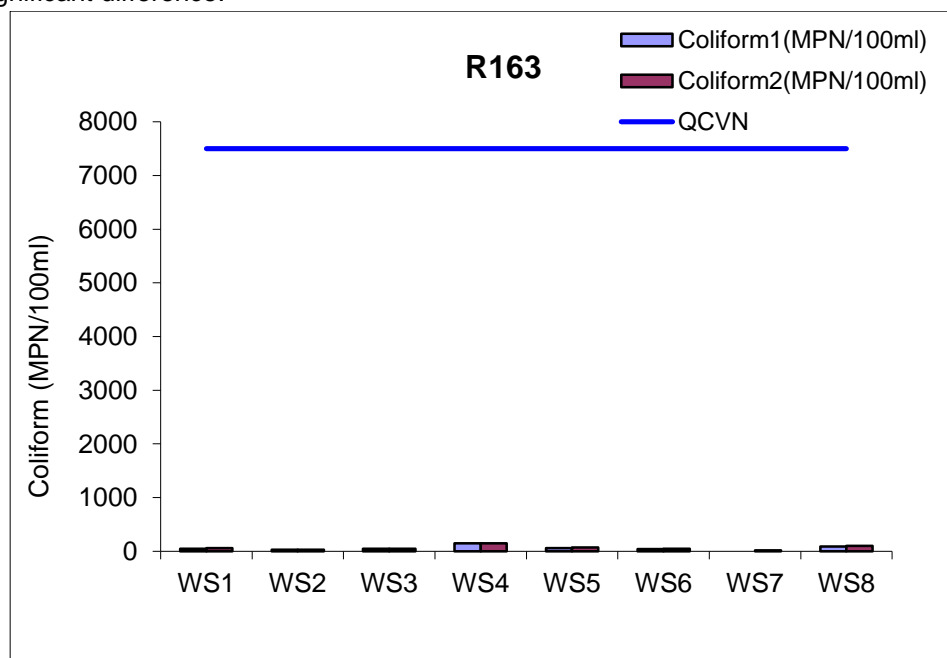
Figure II-4.9.1. Coliform concentrations of water in Yen Bai

Figure II-4.9.1. presents Coliform concentrations at R163 in Yen Bai province. It can be seen that Coliform contents here ranging from 20 MPN/100ml to 150 MPN/100ml are much lower than permissible limitation of column A1 of QCVN 08:2008/BTNMT. at R163-WS7 (Tran Quach, Mau Dong commune) there are no Coliform detected and the highest is obtained at R163- WS4 (Ngoi Hop bridge, Bao Đap).

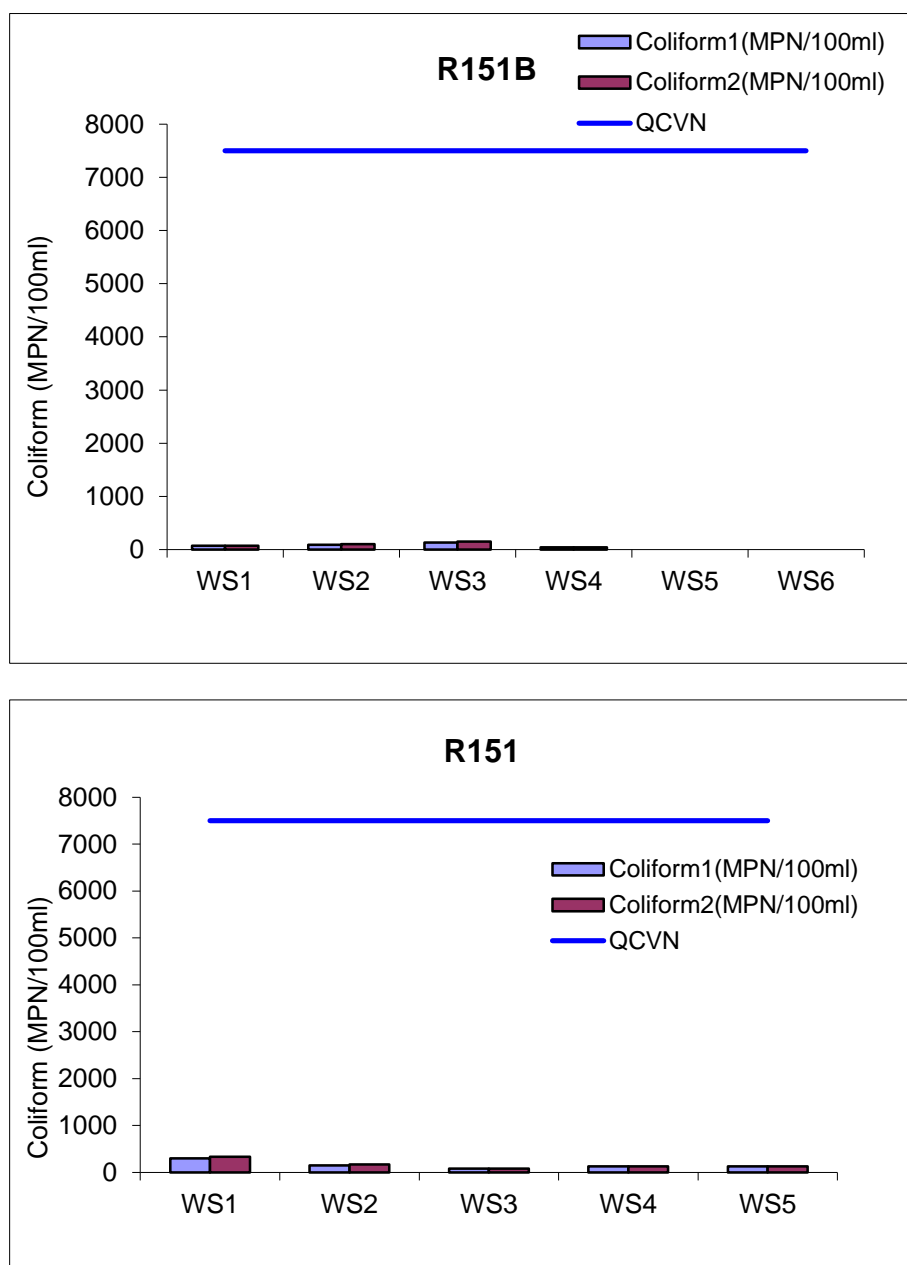
Figure II-4.9.2. Coliform concentrations of water in Lao Cai

Generally, coliform values at the monitoring positions along 5 roads 151, 151B, 154, 156, and 160 are lower than the limit of QCVN 08: 2008/BTNMT (column A1). even at R160-WS1, R154-WS1, R154-WS2, R154-WS3, R154-WS5, R151B-WS5, R151B-WS6 no coliform is detected. At the position R156-WS6 (Phoi village, Ta Phoi village) Coliform concentrations are significantly higher than those at other positions along R156 and also higher than those at the positions of the other roads in the area, the respective values are 32200 MPN/100ml (Figure II-4.9.2.). At R156-WS6, .

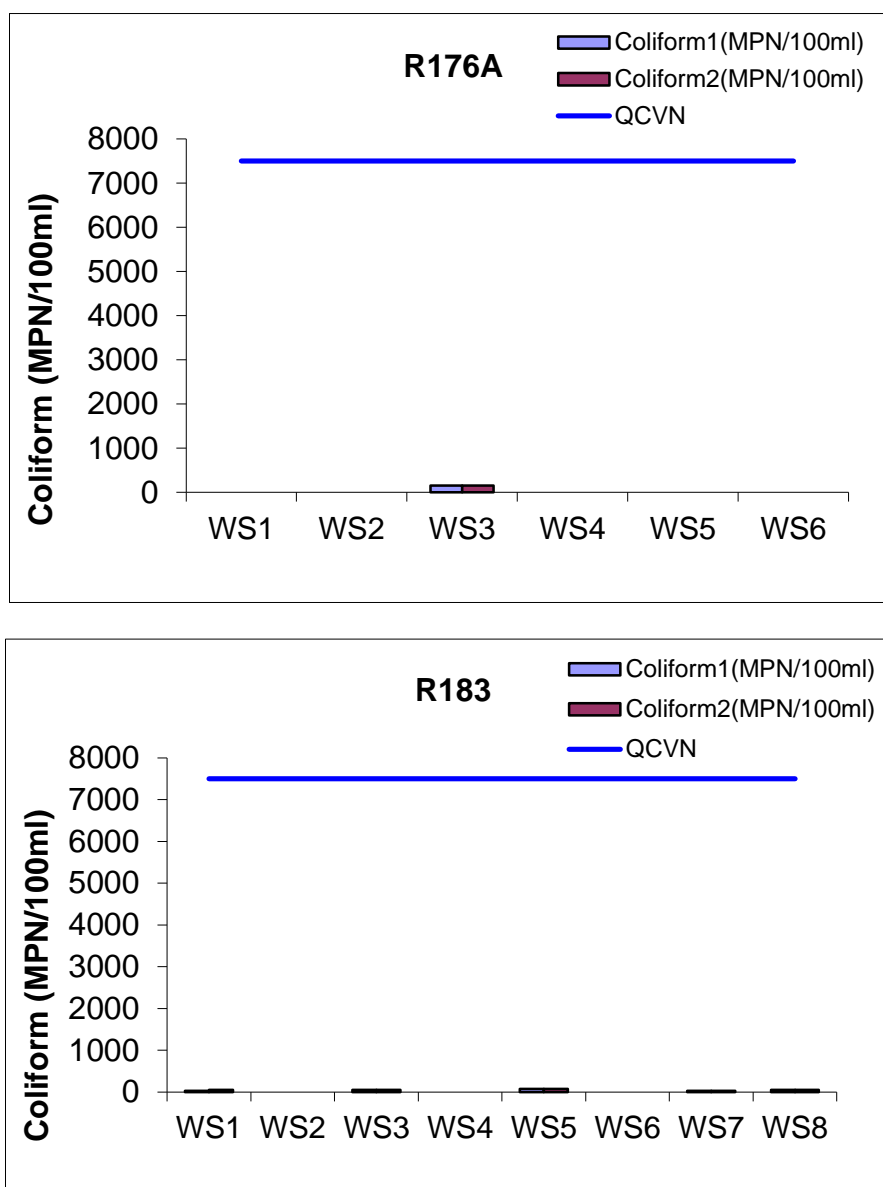
Figure II-4.9.3. Coliform concentrations of water in Ha Giang

Coliform results in Ha Giang province are presented in Figure II-4.9.3. Coliform concentrations are much lower than limit of column A1 of QCVN 08:2008/BTNMT. Excepting R176A-WS3, and R183-WS1, R183-WS3, R183-WS5, at the other positions no Coliform is detected

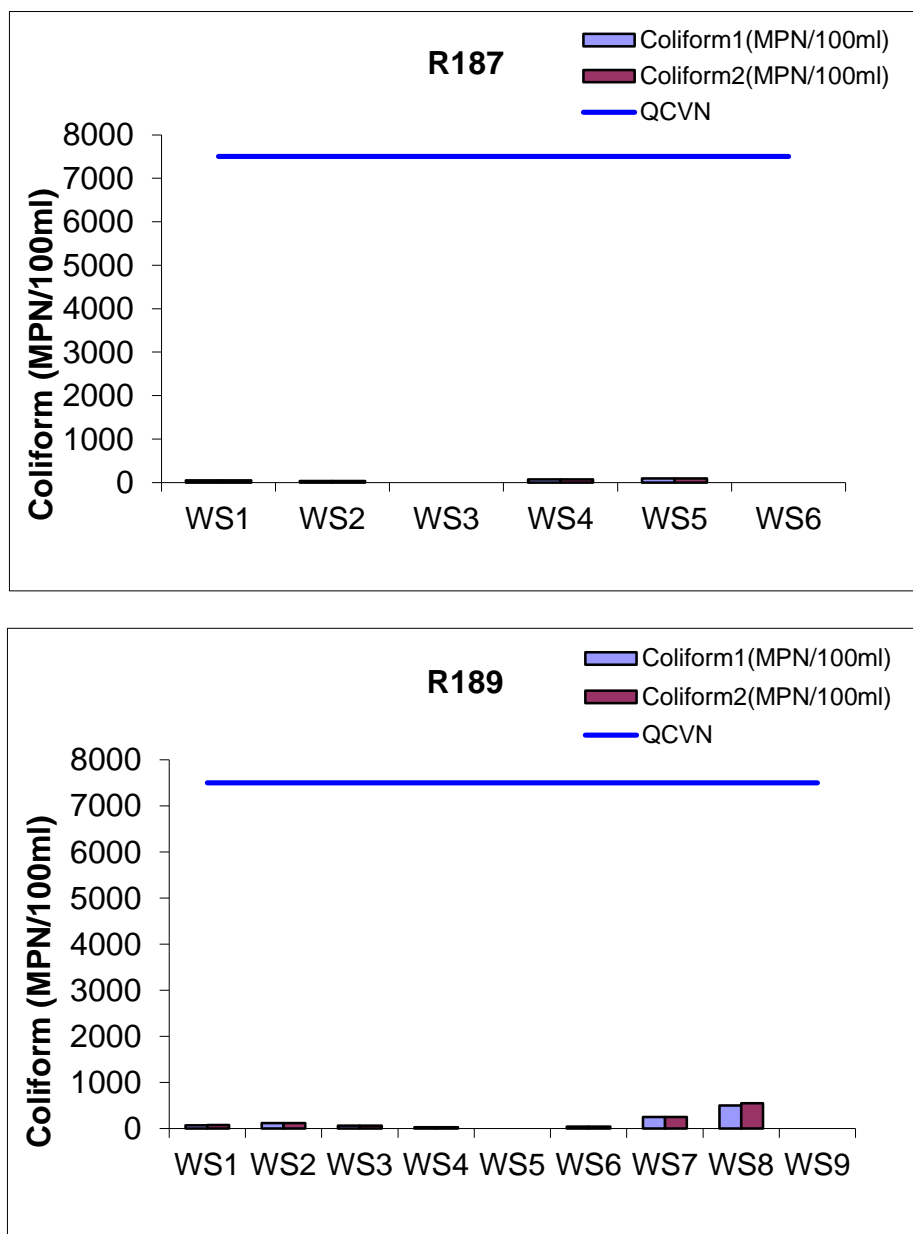
Figure II-4.9.4. Coliform concentrations of water in Tuyen Quang

The graph presents monitoring results at the water bodies along two roads 187 and 189 in Tuyen Quang. Coliform concentrations are low. The highest value obtained at position R189- WS8 (Lang Ęn village, B ch Xa, Ham Yen) is of 550 MPN/100ml. At R187-WS3, R187-WS6, R189-WS5, R189-WS9, no Coliform is detected.

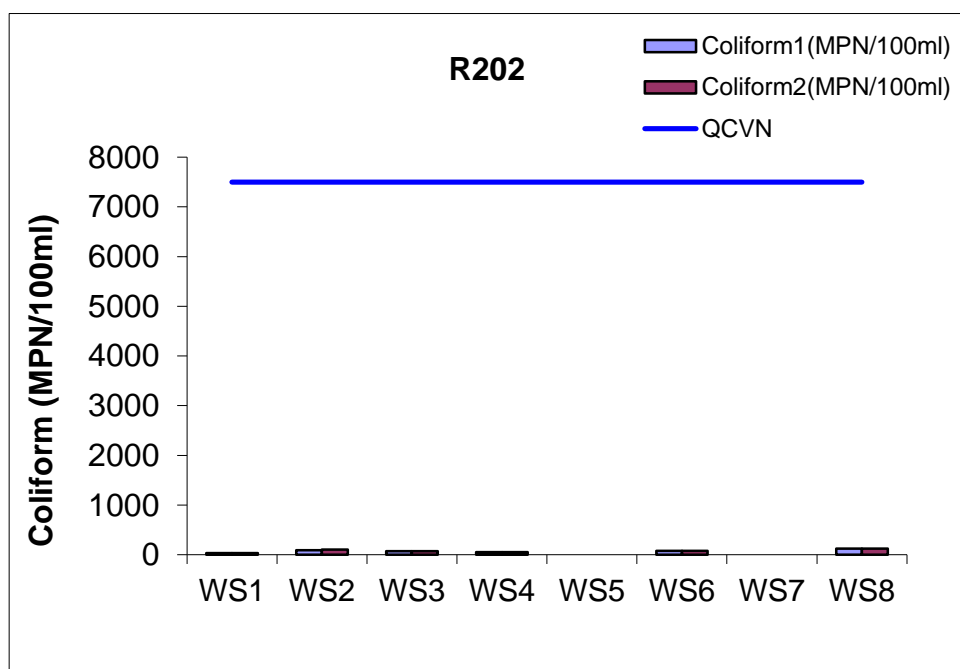
Figure II-4.9.5. Coliform concentrations of water in Cao Bang

Coliform concentrations at the positions along R202 (Cao Bang) are lower than limitation in column A1 of QCVN 08:2008/BTNMT. At the position including R202-WS7 (Lung Vai village, Dinh Phung commune, Bao Lac), and at R202-WS5 (Nam Pap village, Dinh Phung commune, Bao Lac) there is no coliform detected (Figure II-4.9.5.).

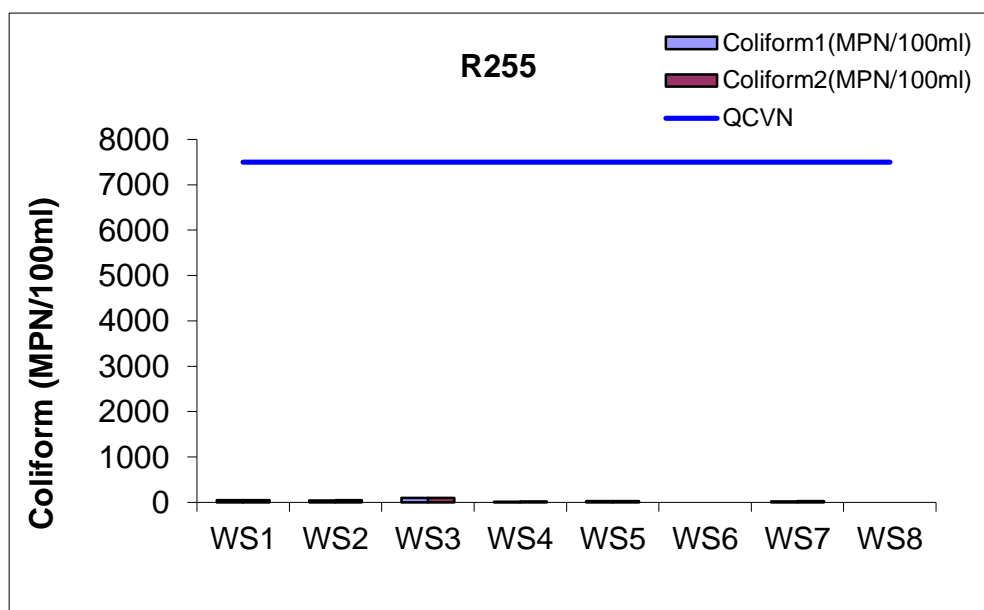
Figure II-4.9.6. Coliform concentrations of water in Bac Kan

Figure II-4.9.6. shows the results of coliform measured at the monitoring positions along road R255 in Bac Kan province. Graphically, Coliform concentrations are not over 100 MPN/100 ml and much lower than limitation in column A1 of QCVN 08:2008/BTNMT(2500 MPN/100ml). The highest is obtained at the position R255-WS3 (Ban Bay village, Yen Thuong, Cho Don). At R255-WS6 (Pho Cau village, Yen Thinh, Cho Don) and R255-WS8 (Vay village, Yen Thinh, Cho Don) no Coliform is detected

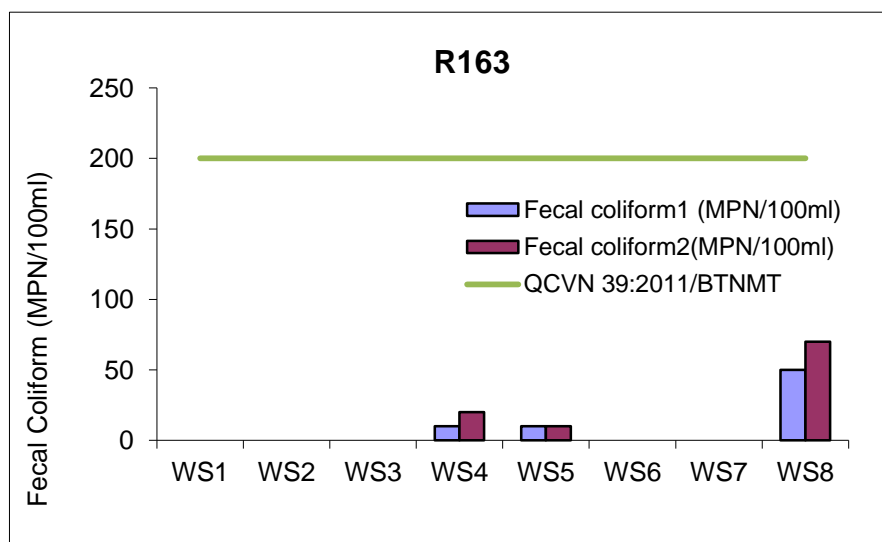
FigureII-4.10.1. Fecal coliform concentrations of water in Yen Bai

FigureII-4.10.1. presents Fecal Coliform concentrations at the monitoring positions along R163 in Yen Bai province. It can be seen that Fecal Coliform concentrations here are low. There are 3 positions R163-WS4, R163-WS5, R163-WS8 at which fecal coliform is detected. The highest values obtained at R163-WS4 (Ngoi Hop village, Ngoi Hop village, Bao Dap commune) is of 50-70 MPN/100ml, much lower than the limitation in QCVN 39:2011/BTNMT.

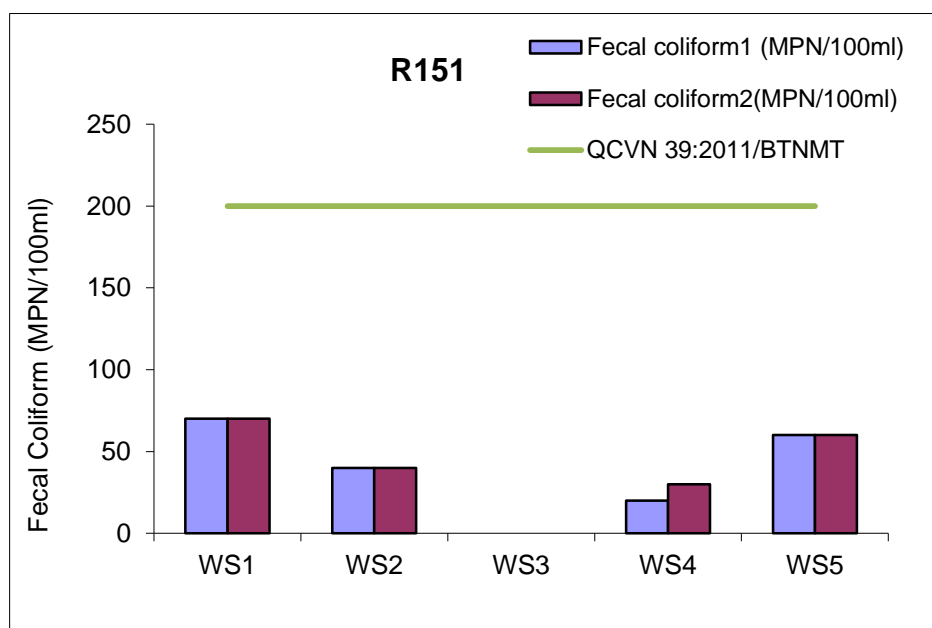
Figure II-4.10.2. Fecal coliform concentrations of water in Lao Cai

along 5 roads 151, 151B, 154, 156, 160, the only position at which Fecal Coliform concentration exceed QCVN 39:2011/BTNMT is R156-WS6 (Phoi village, Ta Phoi commune) with the highest value of 400-500 MPN/100ml (Figure II-4.10.2.). No Fecal Coliform is detected at all the positions along R154, and the other positions including R160-WS1, R160-WS2, R160-WS3, R160-WS4, R160-WS6, R156-WS4, R151B-WS4, R151B-WS5, R151B-WS6, R151-WS3.

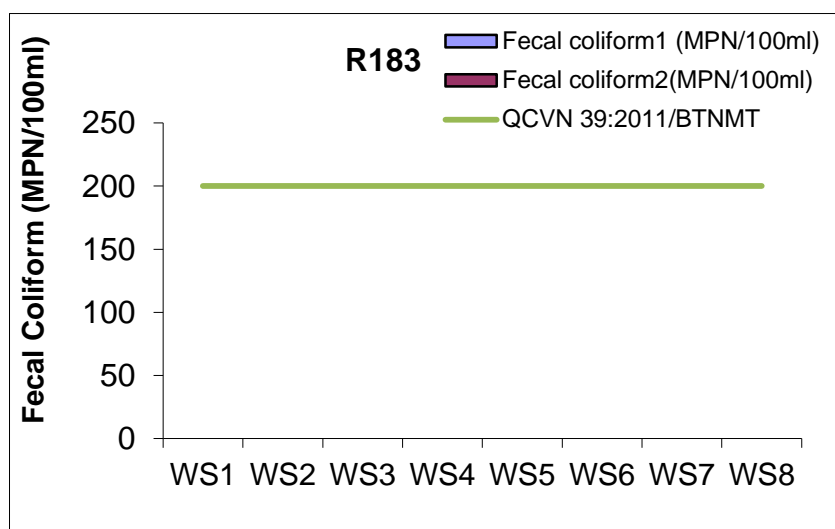
Figure II-4.10.3. Fecal coliform concentrations of water in Ha Giang

Monitoring results of Fecal Coliform in Ha Giang province are presented in Figure II-4.10.3. At the water bodies along R176A, R183, the only position at which Fecal coliform is detected is R176A-WS3 with the concentrations of 30, MPN/100ml, much lower than the limitation of QCVN 39:2011/BTNMT.

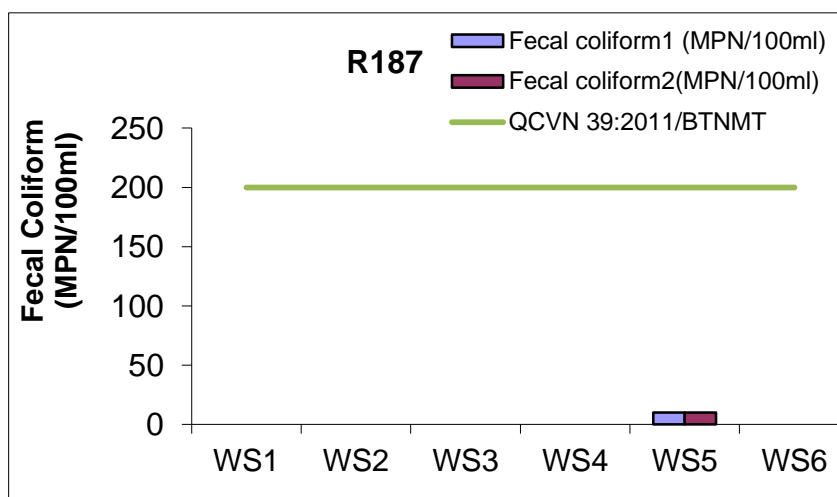
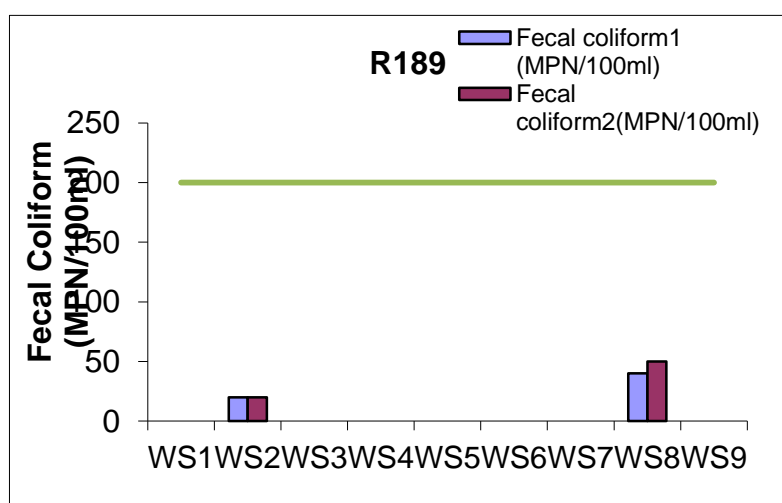
Figure II-4.10.4. Fecal coliform concentrations of water in Tuyen Quang

Figure II-4.10.4. graphically presents Fecal Coliform results at the monitoring positions along two roads 187 and 189 in Tuyen Quang. It can be seen that Fecal Coliform concentrations are lower than the limitation of QCVN, Fecal coliform is detected at the 3 positions including R187-WS5, R189-WS2, R189--WS8, with the respective values of 10, 20, 50 MPN/100ml and still meet the permissible limitation of QCVN 30:2011/BTNMT.

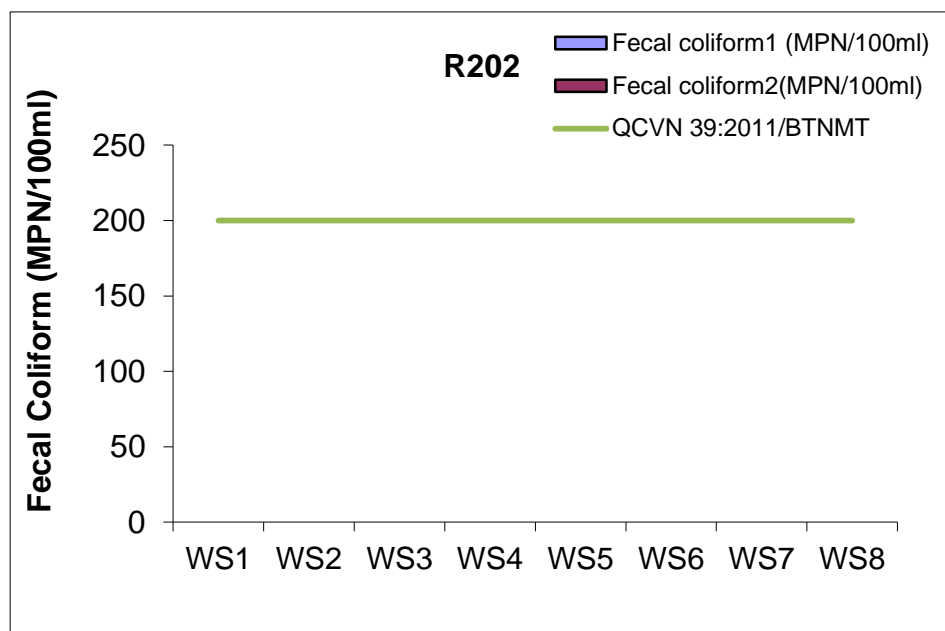
Figure II-4.10.5. Fecal coliform concentrations of water in Cao Bang

Based on Figure II-4.10.5, It can be seen that, at all positions along R202, no Fecal Coliform is detected.

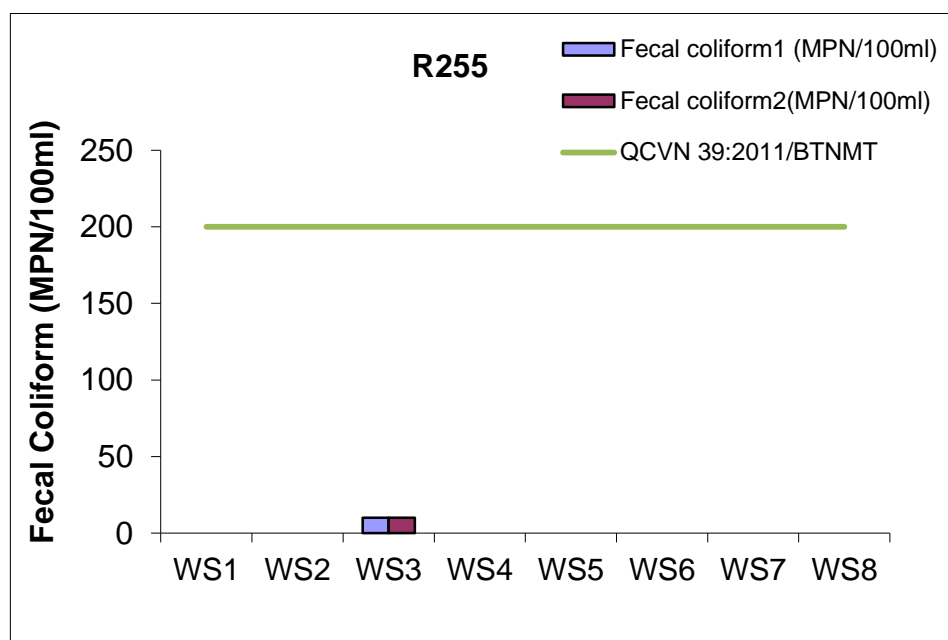
Figure II-4.10.6. Fecal coliform concentrations of water in Bac Kan

Figure II-4.10.6. shows the results of Fecal coliform values measured at the monitoring positions along the road R255 in Bac Kan province. Graphically, the only position at which Fecal Coliform is detected is R255-WS3 (stream Km 9+900, Ban Bay village, Yen Thuong) with the value of 10 MPN/100ml satisfying the limitation of QCVN 39:2011/BTNMT. .
