Environmental Monitoring Report

Quarterly Report
July - September 2013

VIE: Greater Mekong Subregion Kunming–Hai Phong Transport Corridor Noi Bai– Lao Cai Highway Project

Prepared by Getinsa for the Vietnam Expressway Corporation, the Ministry of Transport,
the Government of Viet Nam, and the Asian Development Bank

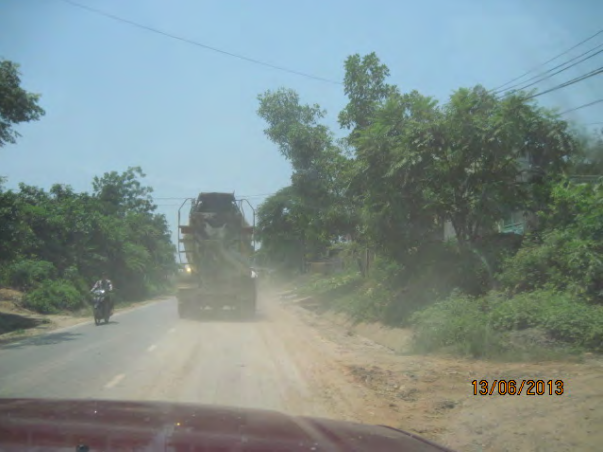
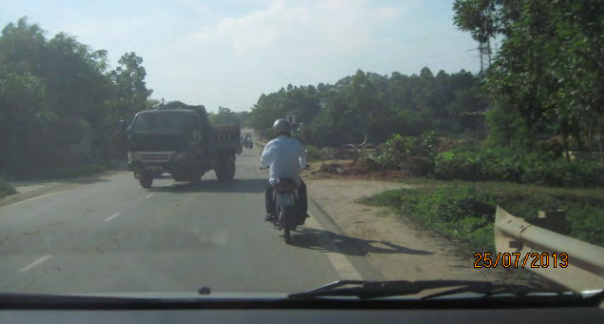
Location: QL2 Bridge
13/6/2013	Site visit: 04, 08, 11, 15, 18, 25/7; 07, 14, 21, 28/8/2013; 04, 10, 11, 18, 24, 25/9/2013

Date first observed: 13/6/2013
25/7/2013	There is much dust on the exist road

Recommendation and Action taken by Engineer: The contactor is requested to spray water frequently in order to decrease dust concentration on the exist road. Refer to the letters GET2-POS-A3-1982; GET2-POS-A3-1985
14/8/2013

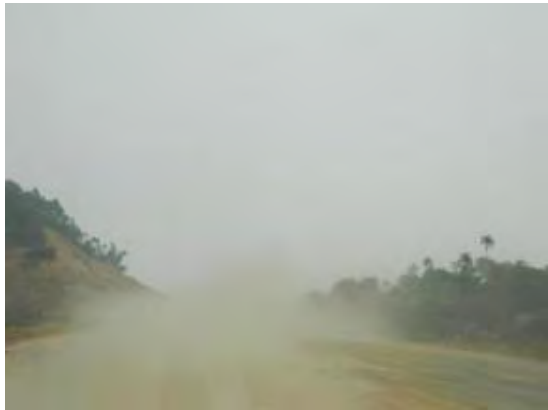
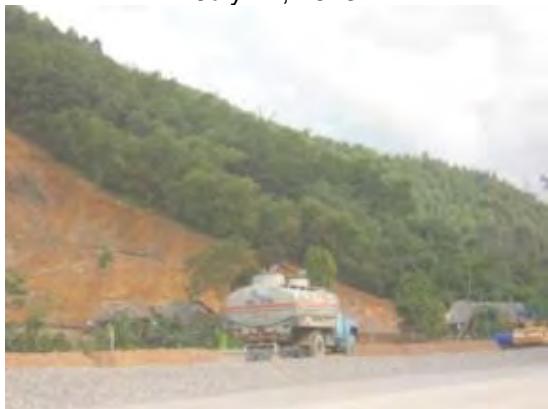
Location: Construction site Km110 – Km111
	Site visit: 11 and 26 July, 2013

Date first observed: 11 th July, 2013
	Problems description and cause: The Contractor's construction activities and material transportation caused dust at this location. This situation caused impact to air quality.
	Recommendation and Action taken by Engineer: The Engineer requested the Contractor to apply measures in order to minimize dust during construction and material transportation.
	Responsible Party: Keangnam Contractor
Deadline: 18-July-2013	
Current status: The contractor is spraying water on construction site in order to minimize dust during material transportation.

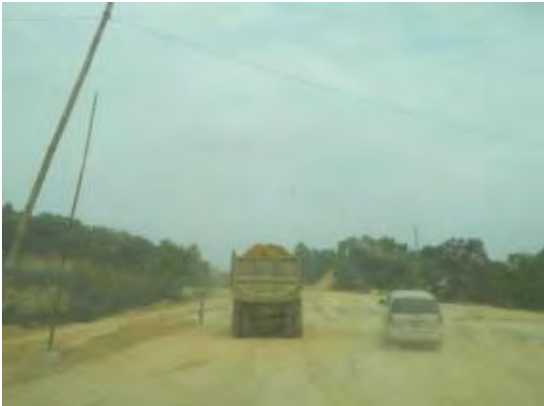
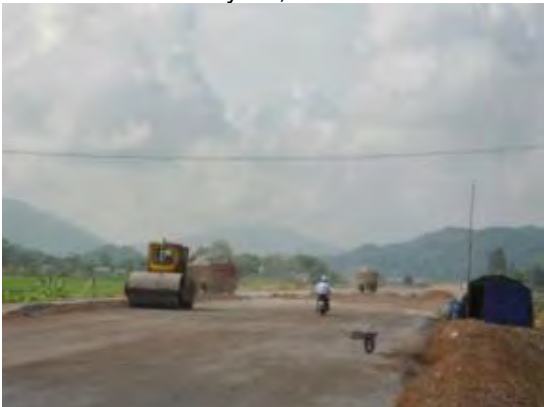
<p>July 26, 2013</p>	Location: Construction site Km110
	Site visit: 11 and 26 July, 2013
	Date first observed: 11 th July,2013
	Problems description and cause: The Contractor's trucks were not covered with canvas during material transportation. This situation cause the dust.
	Recommendation and Action taken by Engineer: The whole contractor's trucks must be covered with canvas during material transportation, at the same time, the Contractor must apply suitable measures in order to minimize dust during material transportation.
	Responsible Party: KeangnamContractor
	Deadline: 18-July-2013
	Current status: Mitigation measures have been implemented

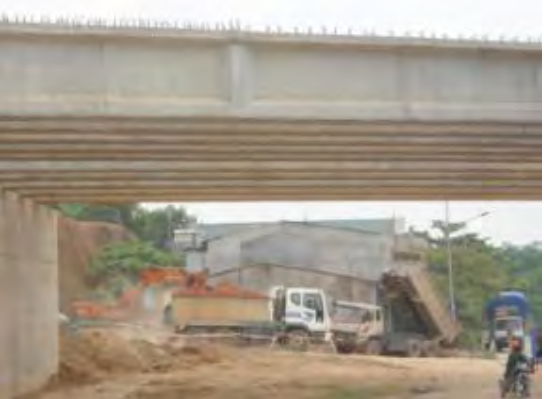
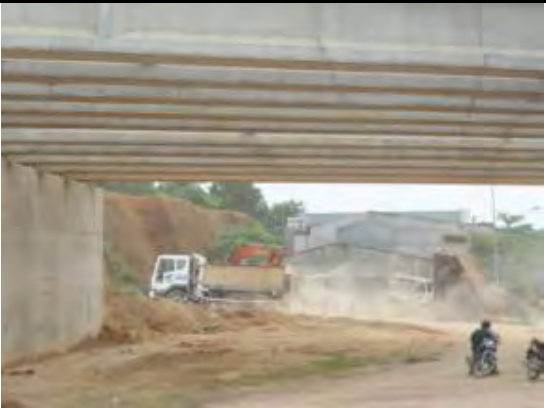
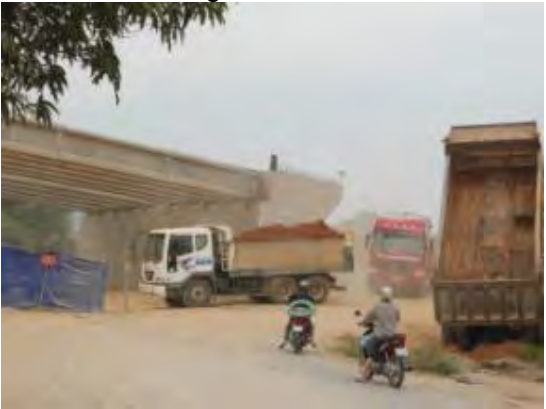
<p>August 16, 2013</p>	Location: Hop Minh My bridge's construction site
	Site visit: 16 and 26 August, 2013
	Date first observed: 16 th August,2013
	Problems description and cause: The Contractor's construction activities and material transportation caused dust at this location. This situation caused impact to air quality.
	Recommendation and Action taken by Engineer: The Engineer requested the Contractor to apply measures in order to minimize dust during construction and material transportation (referring to the letter: No. GET3-KEANGNAM-13-A5-642)

<p>August 26, 2013</p>	<p>Deadline: 22-August-2013</p> <p>Current status: Not yet implemented.</p>

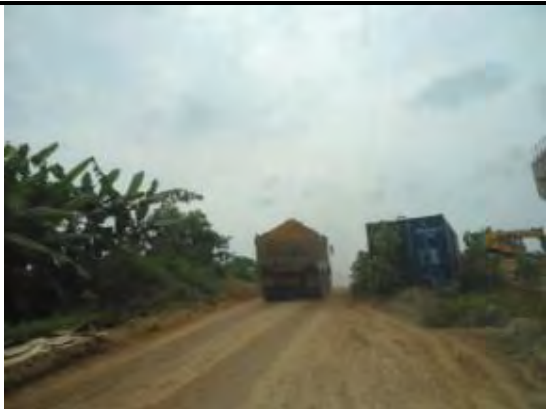
<p>August 16, 2013</p>	<p>Location: Construction site Km116 – Km117</p> <p>Site visit: 16 and 27 August, 2013</p> <p>Date first observed: 16th August, 2013</p> <p>Problems description and cause: The Contractor's trucks were not covered with canvas during material transportation. This situation caused the dust.</p> <p>Recommendation and Action taken by Engineer: The whole contractor's trucks must be covered with canvas during material transportation, at the same time, the Contractor must apply suitable measures in order to minimize dust during material transportation.</p> <p>Responsible Party: Keangnam Contractor</p>

Deadline: 22-August-2013
	Current status: Mitigation measures have been implemented

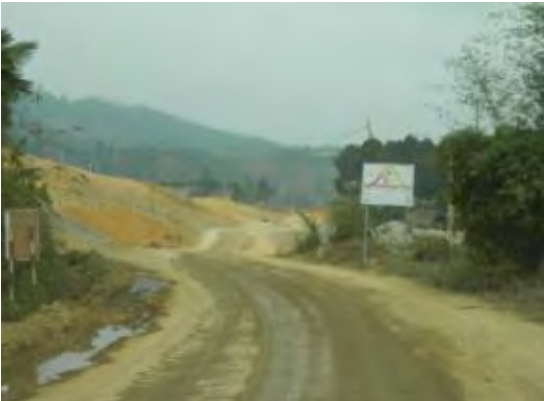
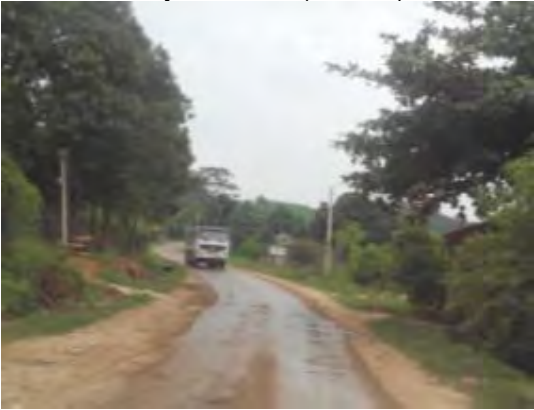
Location: Construction site and Public roads and access road Km169, Km162, Km161, Km157, Km156.
	Site visit: 12 and 26 July, 2013
	Description: The contractor is spraying water on public roads and access roads in order to minimize dust during material transportation.

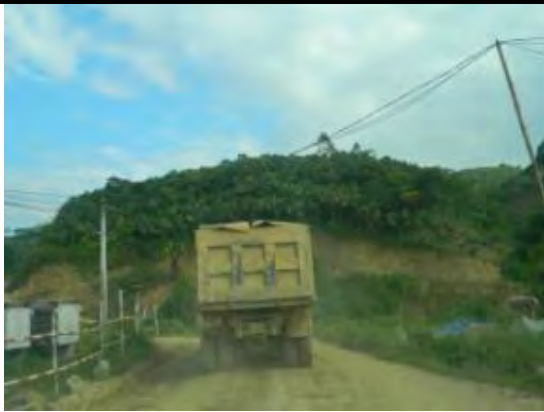
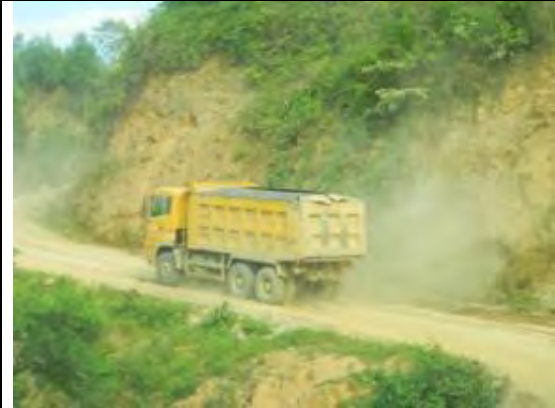
<p>July 4, 2013 (Km157)</p>   <p>July 4, 2013 (Km159)</p>	<p>Location: Station Km157; Km159</p>
	<p>Site visit: 4 and 18 July, 2013</p>
	<p>Date first observed: 4th July, 2013</p>
	<p>Problems description and cause: The Contractor's trucks are not covered with canvas during material transportation. This situation cause the dust, especially on sunny and windy days.</p>
	<p>Recommendation and Action taken by Engineer: The whole contractor's trucks must be covered with canvas during material transportation, at the same time, the Contractor must apply suitable measures in order to minimize dust during material transportation.</p>
	<p>Responsible Party: Doosan Contractor</p>
	<p>Deadline: 10-July-2013</p>

Current status: Mitigation measure has been implemented by the Contractor (trucks are fully covered with canvas during material transportation).

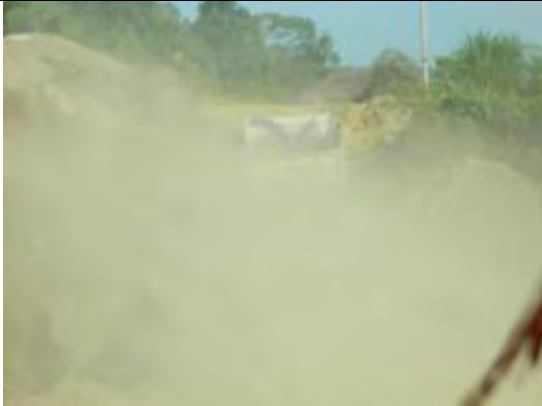
<p>August 20, 2013 (Km157)</p>	<p>Location: Station Km157; Km160</p>
	<p>Site visit: 20 and 29 August, 2013</p>
	<p>Date first observed: 20th August, 2013</p>
	<p>Problems description and cause: The Contractor's construction activities and material transportation were caused dusty at this location. This situation is caused impact to air quality.</p>
	<p>Recommendation and Action taken by Engineer: The Engineer requested the Contractor to apply measures in order to minimize dust during construction and material transportation.</p>

<p>August 20, 2013 (Km160)</p>   <p>August 29, 2013 (Km160)</p>	Responsible Party: Doosan Contractor
	Deadline: 27-August-2013
	Current status: The contractor is spraying water on public roads and access roads in order to minimize dust during material transportation.
	  <p>August 29, 2013 (Km157)</p>
  <p>September 4, 2013 (Km165+800)</p>	Location: Construction site and Public roads and access road Km165, Km169, Km170, Km172, Km168
	Site visit: 4, 10 and 16 September, 2013
	Description: The contractor is spraying water on public roads and access roads in order to minimize dust during material transportation.

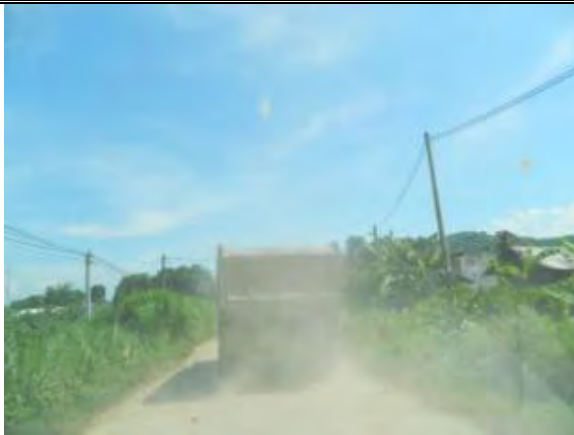
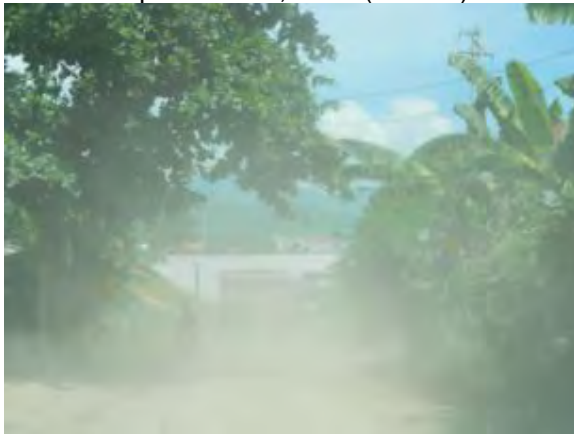
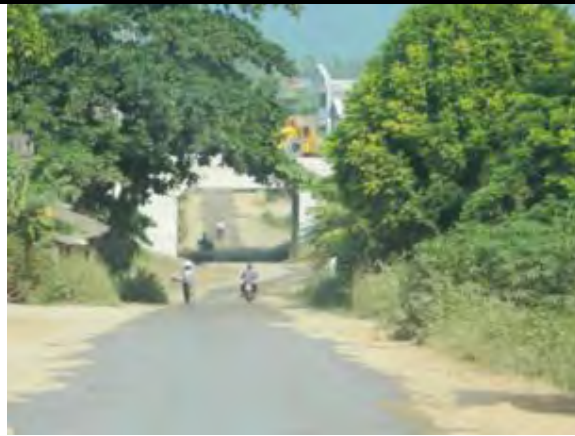
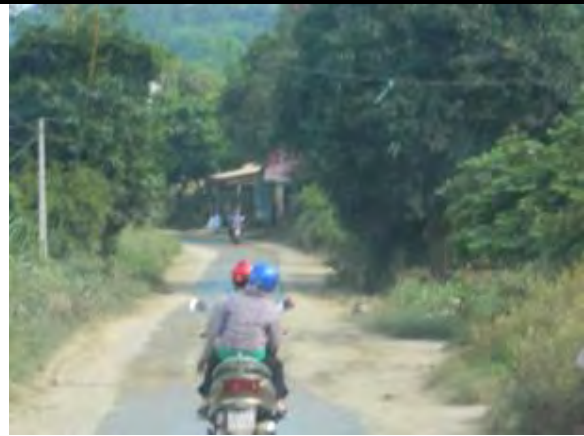
Location: Station Km165, Km166

Problems description and cause: The Contractor's construction activities and material transportation were caused dusty at this location. This situation is caused impact to air quality.

Current status: The contractor is spraying water on public roads and access roads in order to minimize dust during material transportation.

Recommendation and Action taken by Engineer: The Engineer requested the Contractor to apply measures in order to minimize dust during construction and material transportation.

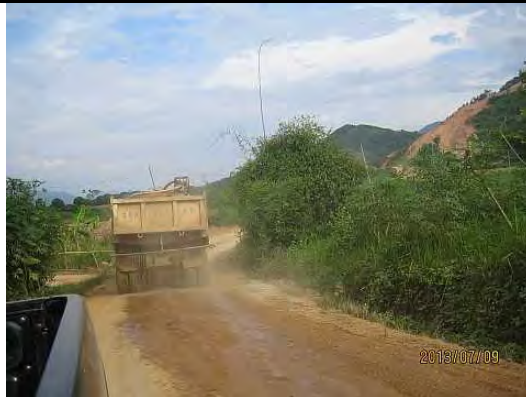
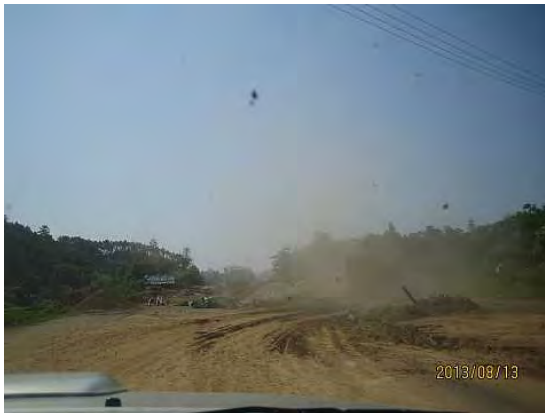
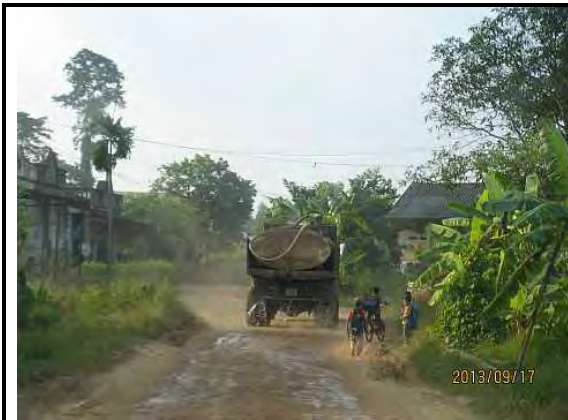
Location: Km209+329

Problems description and cause: There is much dust on the exist road

In August: Again not enough watering

In September: Increased watering

Recommendation and Action taken by Engineer: The contractor is requested to spray water frequently in order to decrease dust concentration on the exist road

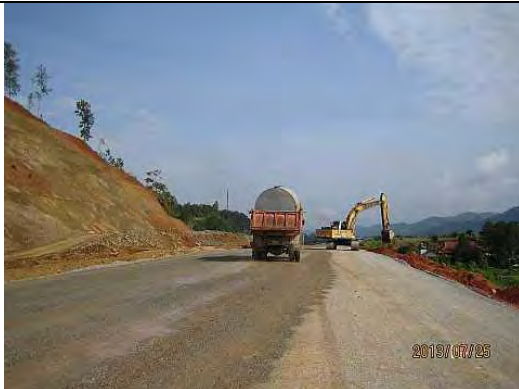
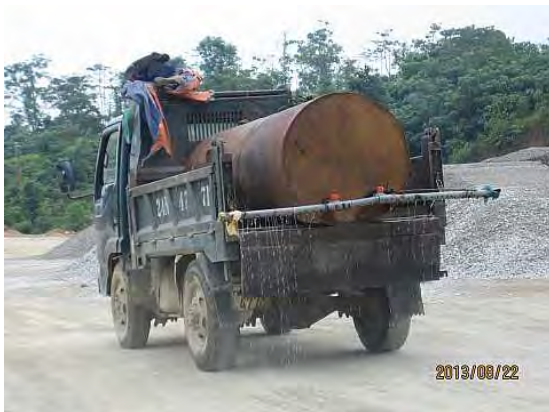
Location: Km242+580

Problems description and cause: There is a lot of dust on the exist road

Current status: The contractor has mobilized the watering trucks to spray water

Recommendation and Action taken by Engineer: The contractor is requested to spray water frequently (2 times/day) in order to decrease dust concentration on the exist road

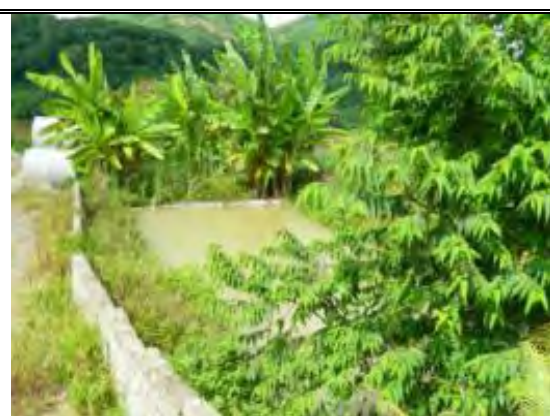
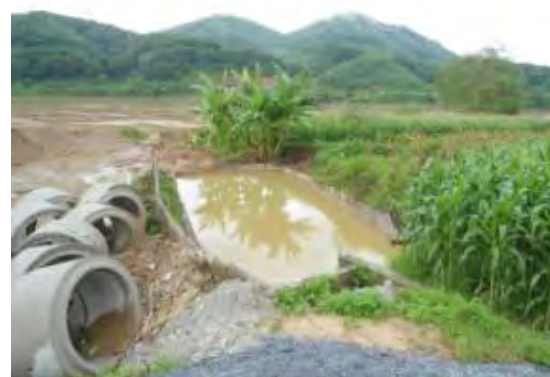
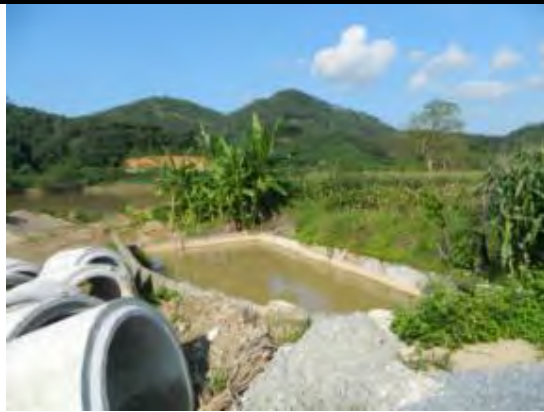
Location: Batching plant No.3, Km145

In August: The Contractor has already dredged the settling pond and ensure the canal to the settling pond to be free from obstruction.

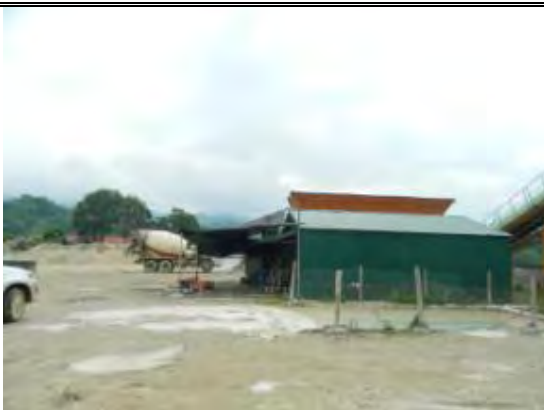
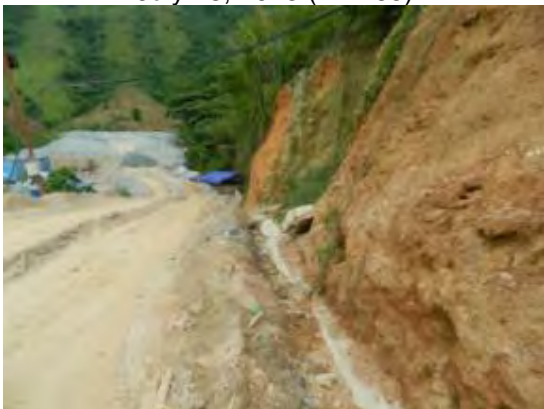
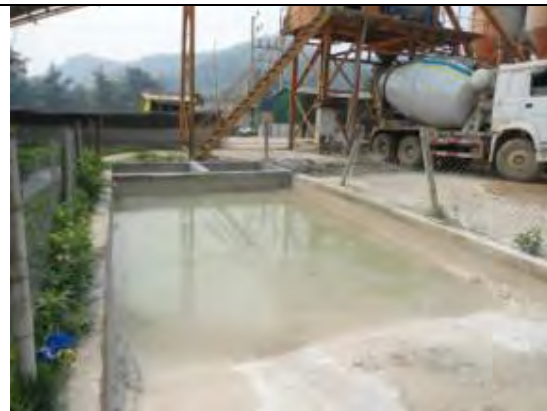
Location: Batching plants Km180, Km165, tunnel construction site Km186+720

Description: The trap basins in order to treat waste water at batching plants, tunnel construction site.

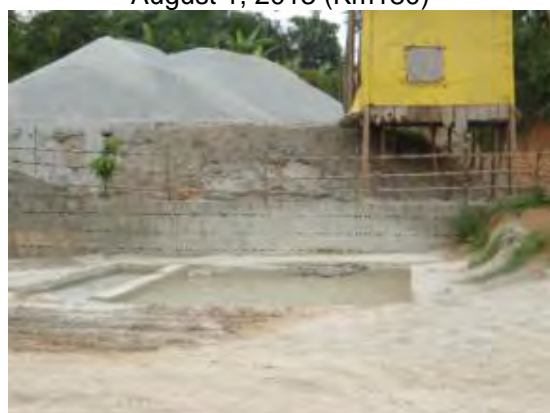
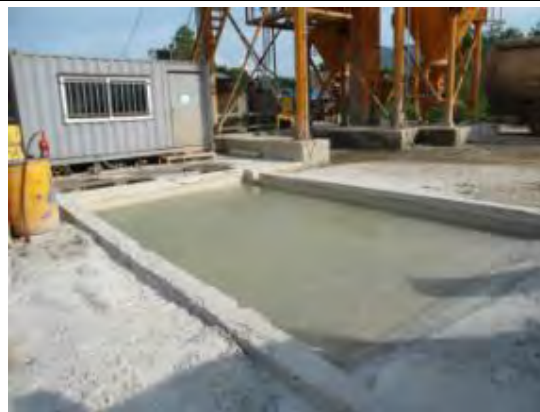
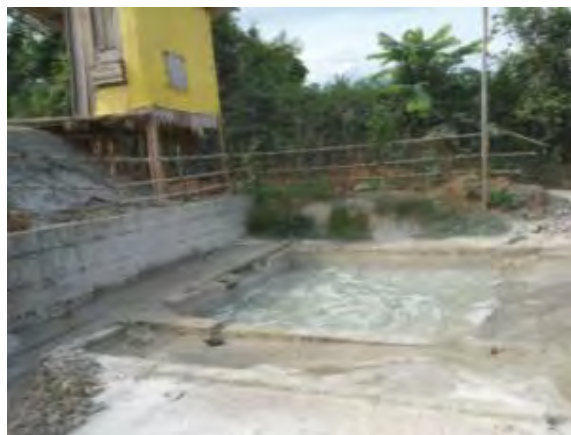
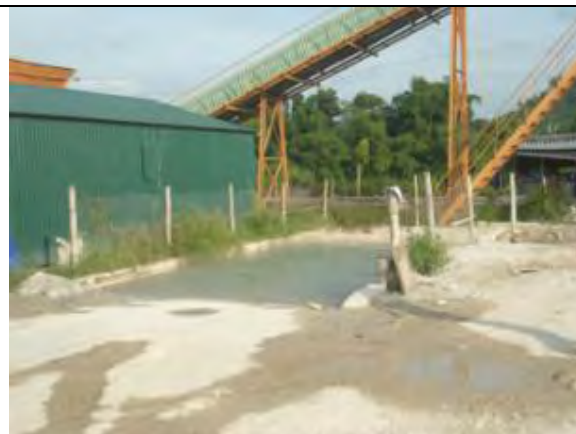
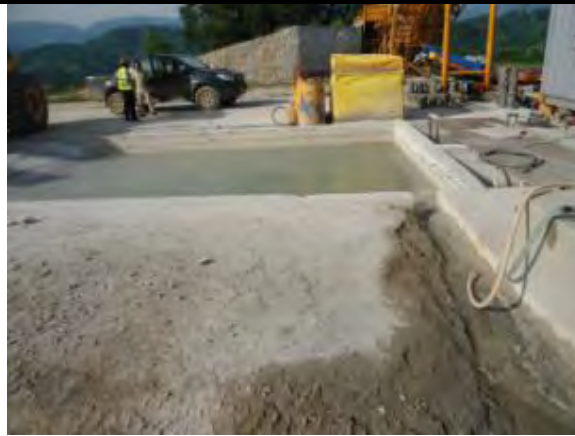
Description: The trap basins in order to to treat waste water at batching plants, tunnel construction site.

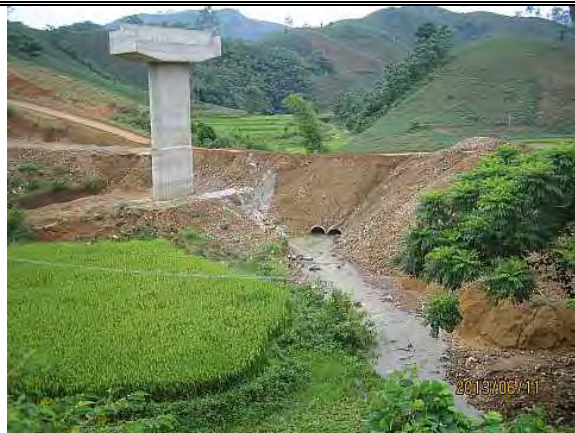
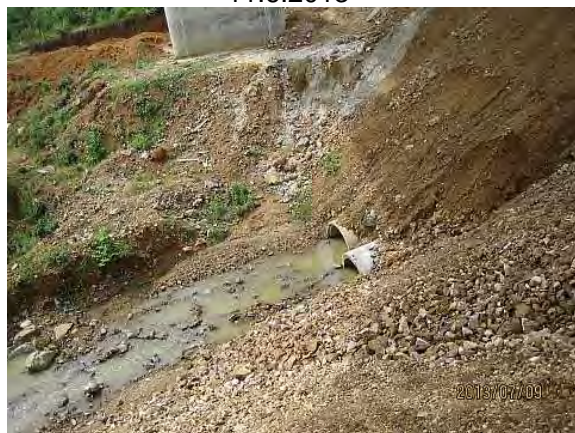
Location: Km193+379

Problems description and cause: The contractor dumped soil near water source. This affected water quality

Recommendation and Action taken by Engineer: Required the contractor to remove the soil and to ensure slope and plant grass to avoid erosion and landslide.

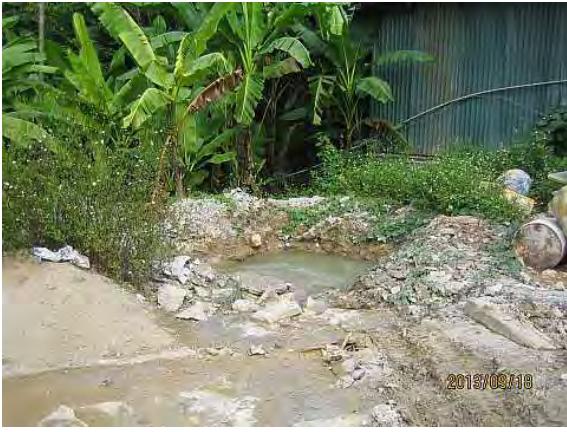
<p>17.7.2013</p>	<p>Location: Suoi Nhu concrete batching plant Km218+040</p>
	<p>Site visit: 25.6 and 17.7.2013; 15.8.2013; 17.9.2013</p>
	<p>Date first observed: 15.3.2013</p>
	<p>Problems description and cause: The wastewater of CBP is not guided into settling pond before discharging surrounding water source</p> <p>Recommendation and Action taken by Engineer: The contractor has to clean the pond and remove the sediments, as well as to</p>

<p>17.9.2013</p>	Current status: The contractor had cleared the pond and prepared a rudimentary canal

<p>15.8.2013</p>	prepare a canal to collect waters into the pond
	Responsible Party: Deadline: Immediately

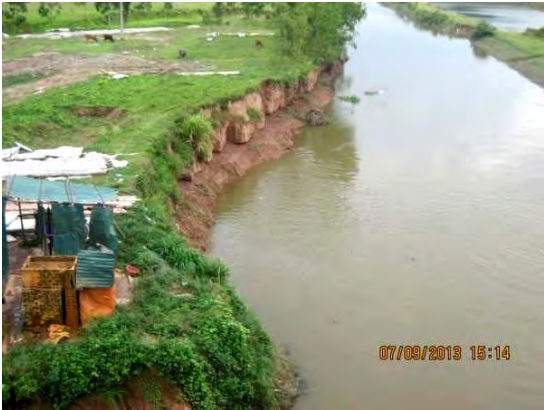
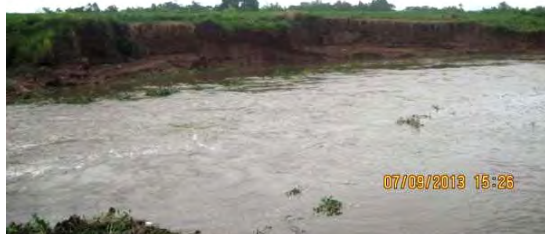
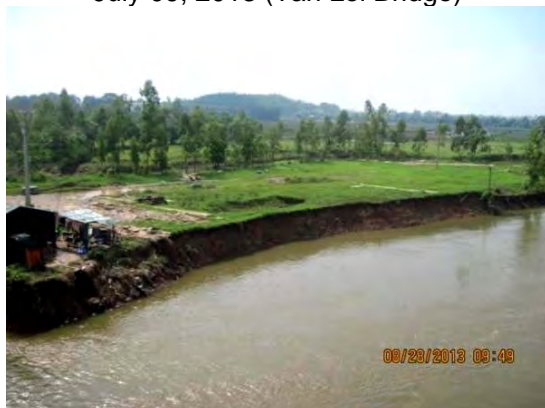
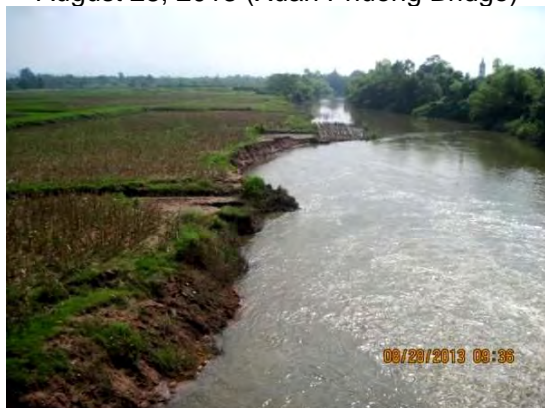
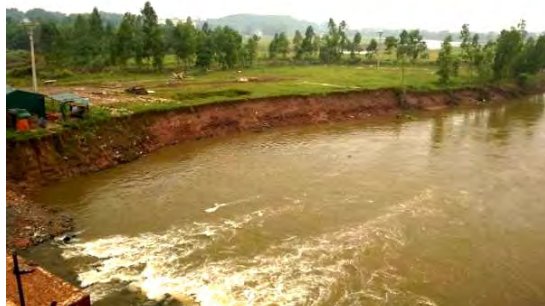
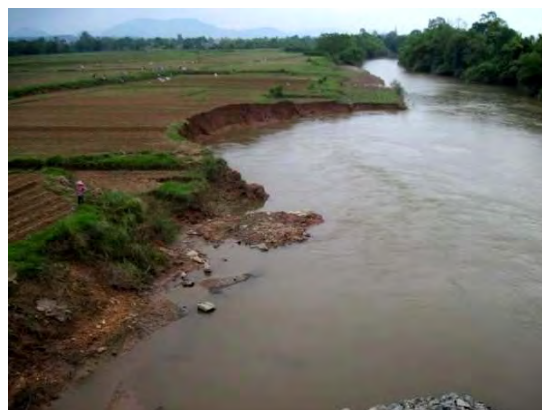
<p>July 09, 2013 (Xuan Phuong Bridge)</p>	Location: Tan Loi Bridge, Xuan Phuong Bridge
	Site visit: 2, 9, 19, 25 July; 13, 16, 20, 26, 28 August; 10, 13, 17, 24 September
	Date first observed:
	Problems description and cause: due to the unsuitable working methods, the riversides were undermined and this caused landslide on them.
	Recommendation and Action taken by

In August: Restoration work has not been carried out

In September: Restoration work has not been carried out

In July: Request the Contractor to submit the plan to restore these areas through the letter GET/POS/A1/196, 204, 2016, 2091

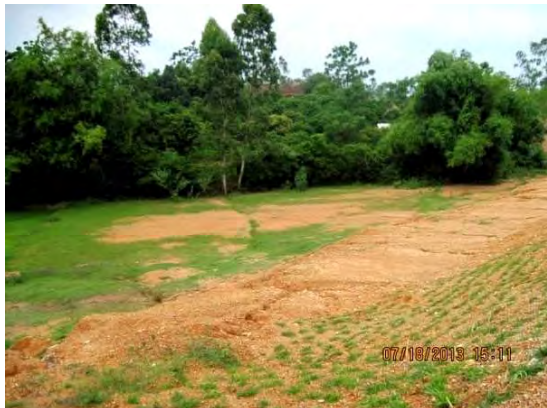
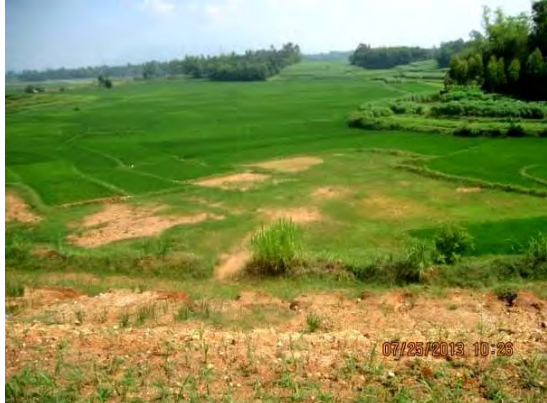
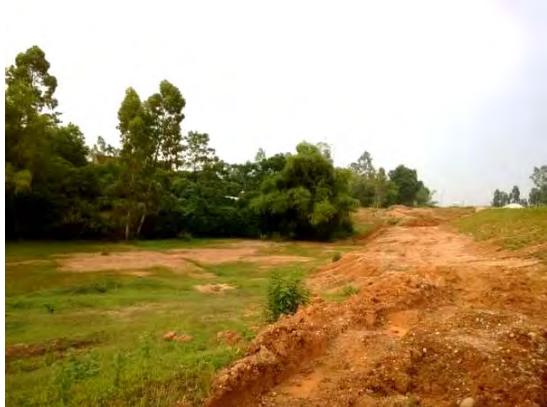
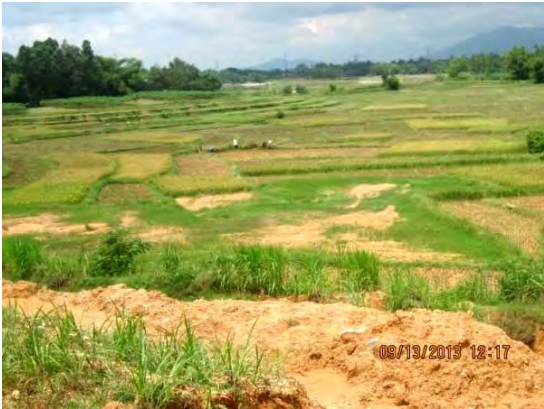
<p>Date first observed: 05-June-2013</p>
<p>July 25, 2013</p>	<p>Problems description and cause: Uncontrolled erosion leaded sediment into croplands and damaged the crop of local people</p> <p>Recommendation and Action taken by Engineer: Apply erosion and sediment control measures; contact local people and authority to negotiate to compensate for the damaged assets and restore affected areas. Refer to letter GET1/POS/A2/2090, 2101, 2176, GET/MISC/361, 363</p>

<p>Responsible Party: Contractor</p>
<p>August 13, 2013</p>	<p>Deadline: 30-July-2013</p>
	<p>Current status: Mitigation measures have not been implemented</p>

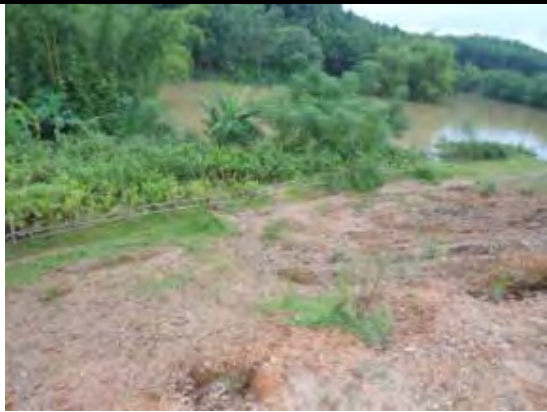
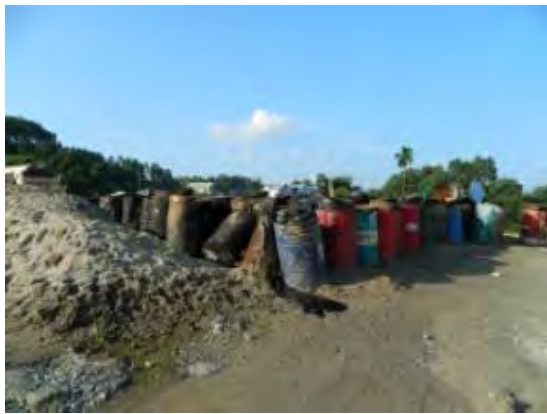
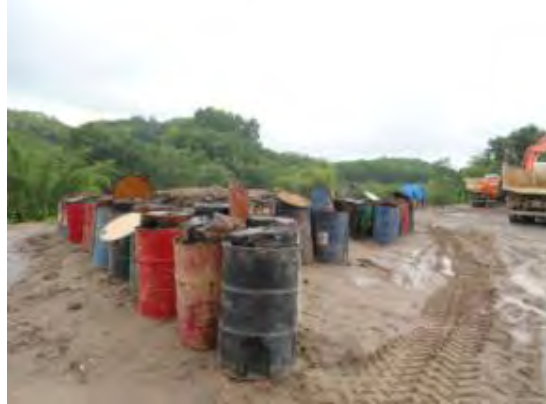
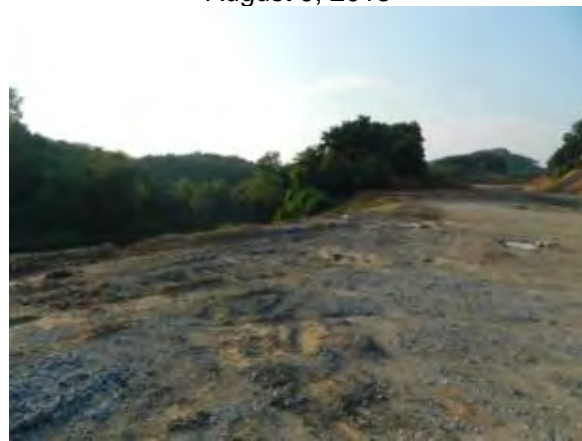
Location: Construction site Km131+130
 	Site visit: 22 Jun, 11 Jul, 2, 9, 27 August, 16 September, 2013
 	Date first observed: 22 nd June, 2013
<p>July 11, 2013</p>	Problems description and cause: From the embankment where more than 100 drums of bitumen drums are placed, leaks/spills of bitumen have spread onto the embankment slope and adjacent land. The bitumen was used for waterproofing the underpass structure at km 131+130
	Recommendation and Action taken by Engineer: The Engineer required the Contractor to implement the tasks as follows: <ol style="list-style-type: none"> 1. Remove spilled bitumen and properly dispose contaminated soil. Place bitumen drums in adequately protected areas such that these are not exposed to the elements and leaks/spills are avoided; 2. Stop repeating similar case;
	Responsible Party: Keangnam Contractor
	Deadline: 20-Apr-2013
	Current status: <p>In July: No important changes done</p> <p>In August: The Contractor removed spilled bitumen and dispose contaminated soil, Beside, the Contractor applying measure in order to avoid bitumen leaks (bitumen tanks were put in iron tanks). But these measures are not enough, the Engineer still seen spilled bitumen at this location though site visit on 29th August, 2013.</p> <p>In September: The Contractor removed spilled bitumen and disposed contaminated soil. Besides, the Contractor also removed all</p>

bitument tanks to Km117.

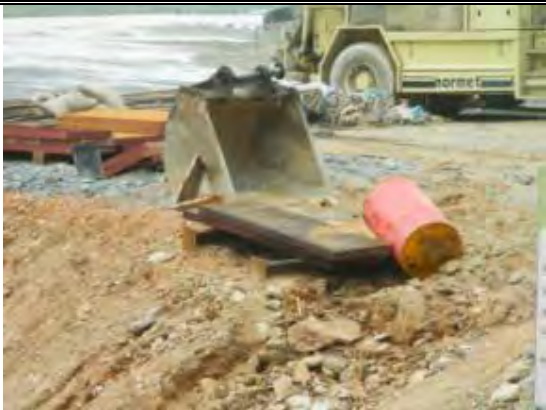
Location: Tunnel Construction site Km186+200
	Site visit: 4 and 18 July, 2013
	Date first observed: 4 th July, 2013
	Problems description and cause: Fuel control is not performed well. This situation cause the leak of oil and soil pollution.

Recommendation and Action taken by Engineer: The Engineer required the Contractor to improve fuel control at this location, at the same time, the Engineer also provided the instruction for this issues through the letter Ref. GET3-DOOSAN-12-A6-300.

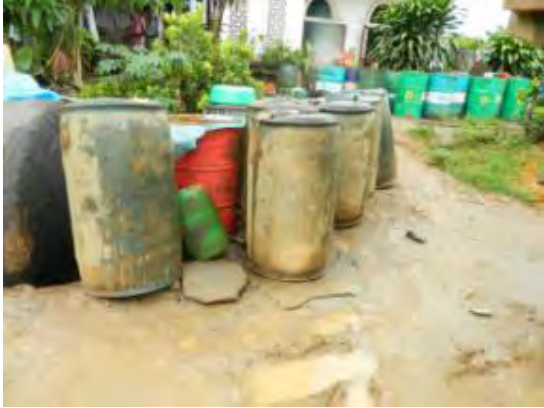
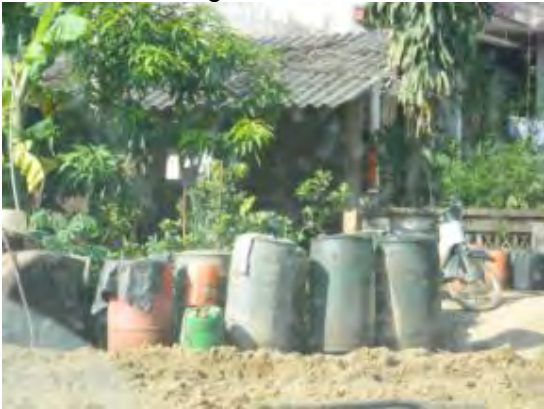
<p>September 10, 2013 (Km166+900)</p>	<p>Location: Km166+900</p>
	<p>Site visit: 13 and 20 August, 10 September</p>
	<p>Date first observed: 13th August, 2013</p>
	<p>Problems description and cause: Fuel control is not well performed. this situation is caused the leak of oil and soil pollution.</p>
	<p>Recommendation and Action taken by Engineer: The Engineer required the Contractor to improve fuel control at this location, at the same time, the Engineer also provided the instruction for this issues through the letter Ref. GET3-DOOSAN-12-A6-300.</p>
	<p>Responsible Party: Doosan Contractor</p>
	<p>Deadline: 20-August-2013</p>
	<p>Current status:</p> <p>In Aug.: Not yet implemented</p> <p>In Sep.: The Contractor improved fuel control at this location.</p>

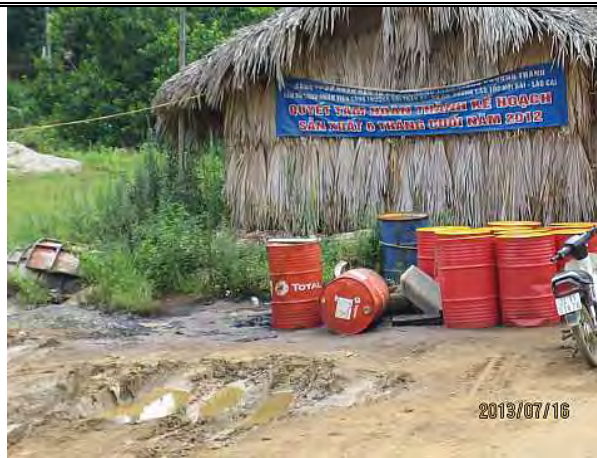
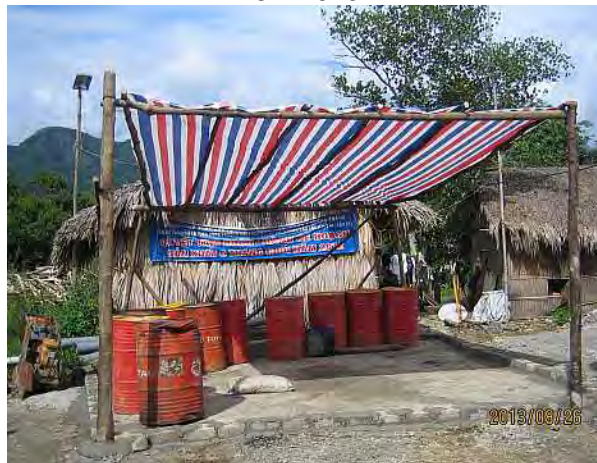
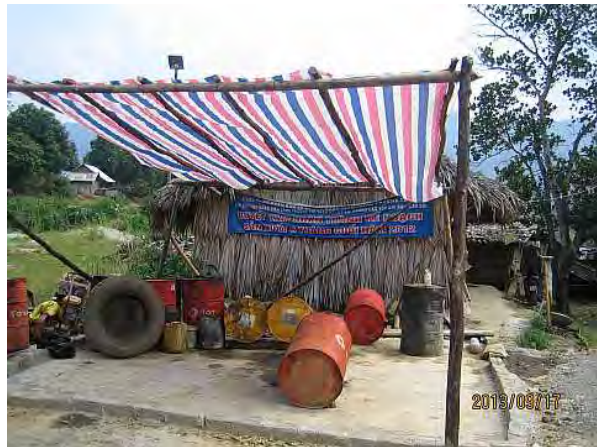
Location: Store place Km197+080

Problems description and cause: Oil and waste oil tanks are put directly on the ground. This can affect soil quality

In August: Improved

In September: Improved but not as required by Consultant

Recommendation and Action taken by Engineer: Required the contractor to keep oil tanks and waste oil tanks on the concrete floor inside store.

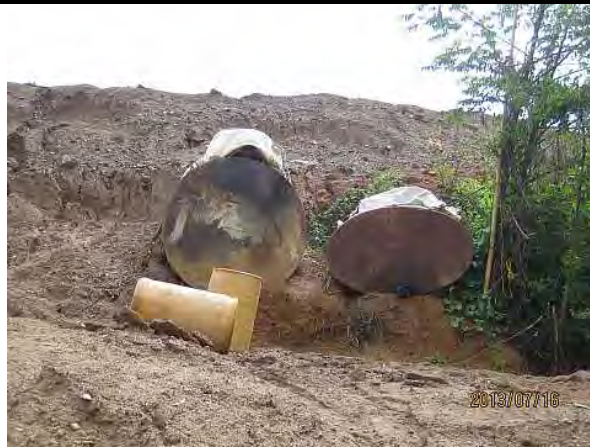
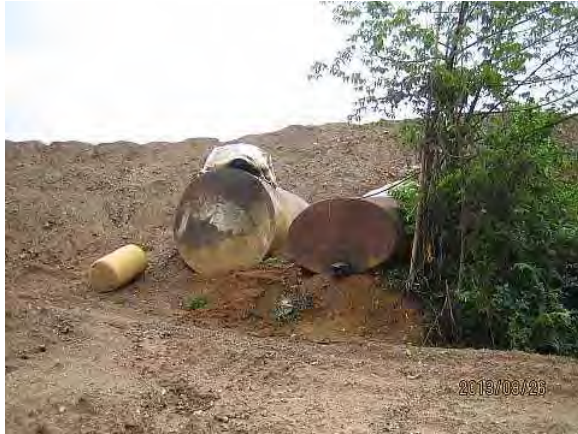
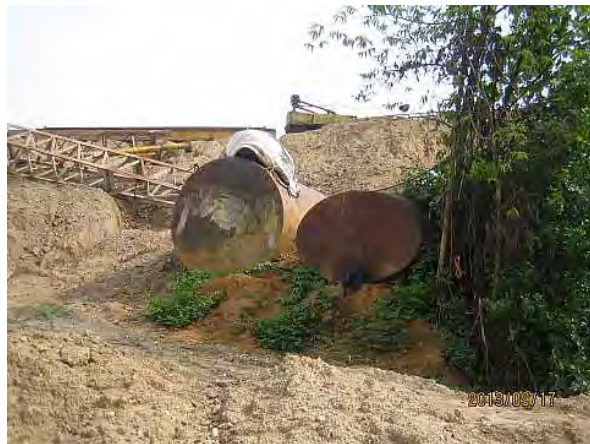
Location: Store place Km209+329

Problems description and cause: Oil and waste oil tanks are put directly on the ground. This can affect soil quality

Recommendation and Action taken by Engineer: Required the contractor to keep oil tanks and waste oil tanks on the concrete floor inside store.

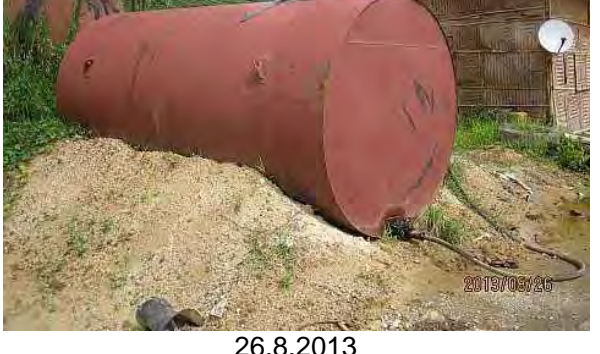
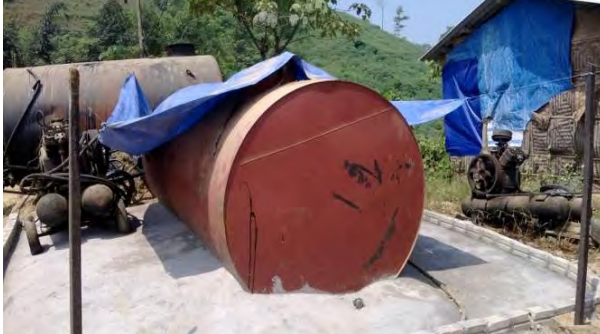
Date first observed: 21.6.2013
26.8.2013	Problems description and cause: Oil and waste oil tanks are put directly on the ground. This can affect soil quality

Deadline: 15.7.2013
17.9.2013	<p>Current status:</p> <p>In July and August: The contractor has not yet improved</p> <p>In September: The contractor is improving this issue but the improvement is not as required by Consultant</p>

Recommendation and Action taken by Engineer: Required the contractor to keep oil tanks and waste oil tanks on the concrete floor inside store.
17.9.2013	Responsible Party: GRBCC

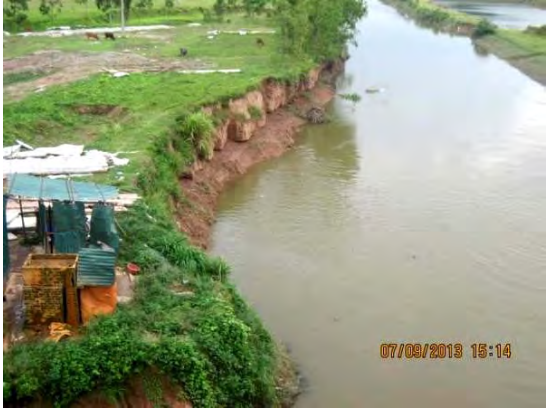
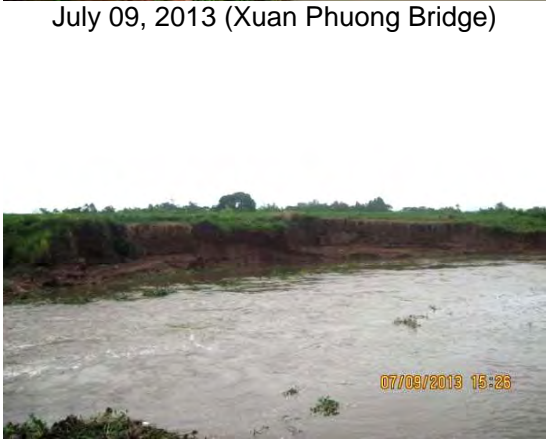
Location: Tan Loi Bridge, Xuan Phuong Bridge

Date first observed:
<p>July 09, 2013 (Xuan Phuong Bridge)</p>	Problems description and cause: due to the unsuitable working methods, the riversides were undermined and this caused landslide on them.
<p>July 09, 2013 (Tan Loi Bridge)</p>	Recommendation and Action taken by Engineer:
<p>August 28, 2013 (Xuan Phuong Bridge)</p>	In July: Request the Contractor to submit the plan to restore these areas through the letter GET/POS/A1/196, 204, 2016, 2091
	In August: Having reviewed, the Engineer already approved the restoration plans of the Contractor and requested the Contractor to comply with the schedules in restoration plans. Refer to letter GET/POS/A1/219
	In September: Having reviewed, the Engineer already approved the restoration plans of the Contractor and requested the Contractor to comply with the schedules in restoration plans. Refer to letter GET/POS/A1/219; GET/MISC/361, 363

<p>In August: Restoration work has not been carried out</p> <p>In September: Restoration work has not been carried out</p>
<p>August 28, 2013 (Tan Loi Bridge)</p>	  <p>September 17, 2013 (Tan Loi Bridge)</p>
  <p>September 17, 2013 (Xuan Phuong Bridge)</p>

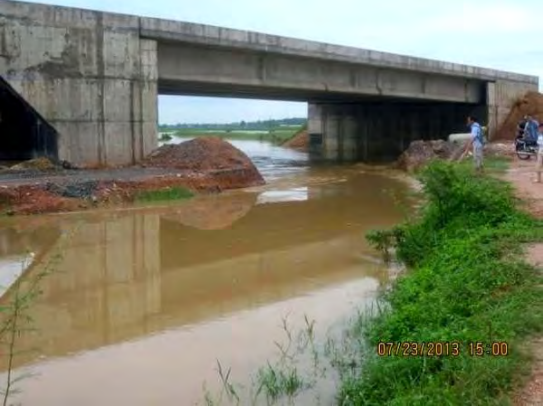
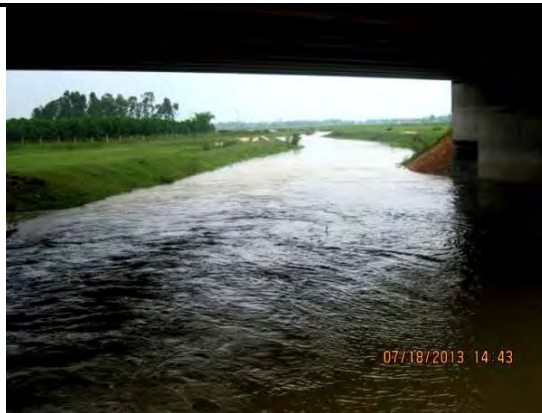
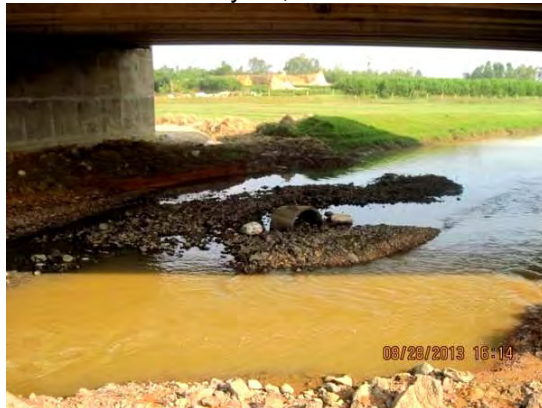
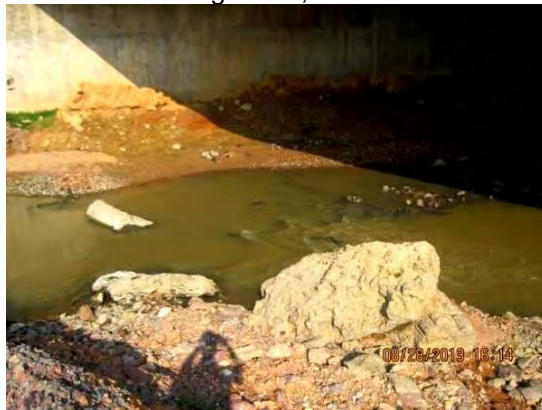
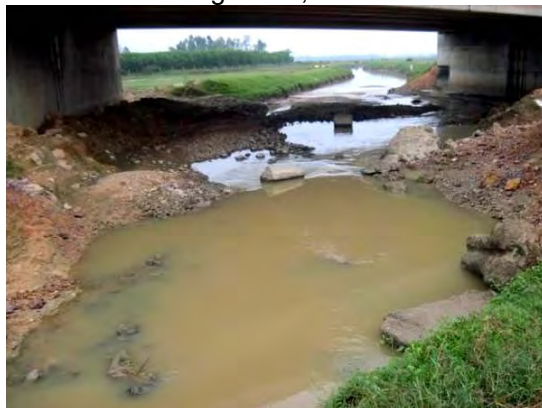
<p>Location: Muong Dao Bridge</p> <p>Site visit: 3, 10, 18, 23, 25 July; 13, 15, 22, 28 August; 13, 17, 24 September</p> <p>Date first observed: 24-Oct-2012</p> <p>Problems description and cause: Streams are blocked by sedimentation and obstructions from project</p> <p>Recommendation and Action taken by Engineer:</p> <p>In July: Comply with the approved restoration plan. Refer to letter GET1/POS/A2/1873, 1907 The Engineer also requested the Contractor to install more temporary pipe culverts to ensure</p>
<p>July 23, 2013</p>

water flow when it rains in this area

In August and September: The Engineer has requested the Contractor to remove all the sediment to ensure the water flow in this area

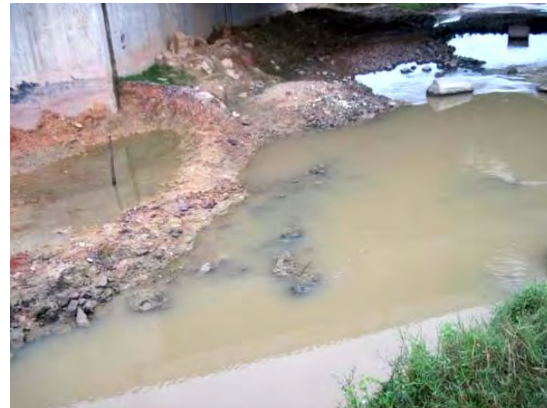
September 17, 2013

In July: The Contractor has removed temporary stream crossing with pipe culverts to ensure water flow during heavy rain

In August and September: Mitigation measure has not been implemented

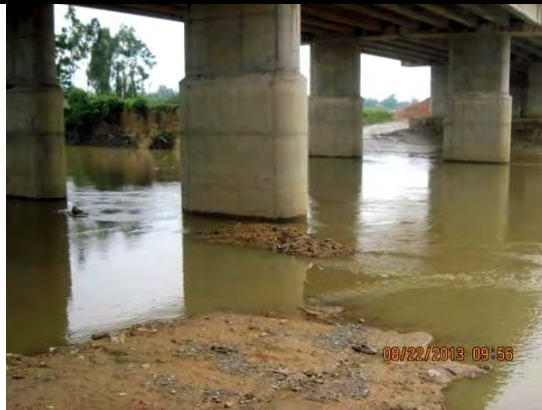
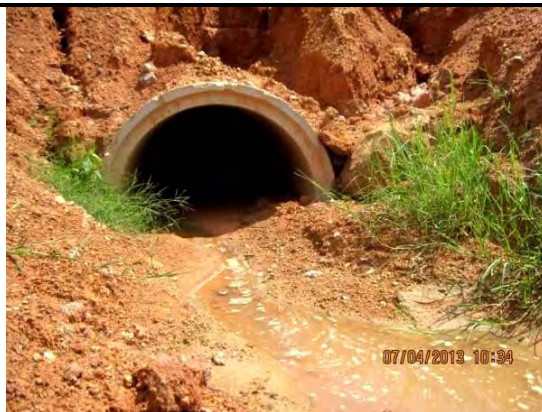
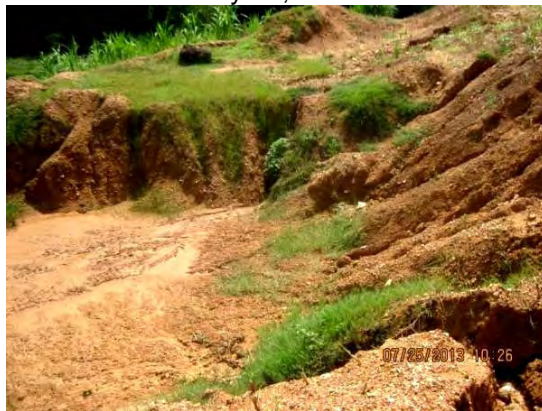
<p>July 25, 2013</p>   <p>July 25, 2013</p>   <p>August 22, 2013</p>	Location: Ben Gao Bridge
	Site visit: 3, 10, 18, 25 July; 13, 15, 22, 28 August; 13, 17, 24 September
	Date first observed: 26-Feb-2013
	Problems description and cause: Water flow and riverside are being impacted due to the Contractor excavated the soil on riverside to construct the temporary river crossing together with installing unsuitable temporary pipe culverts
	Recommendation and Action taken by Engineer: Comply with approved restoration plan. Refer to letter GET1/POS/A2/1873, 1907, 2118; GET/MISC/361, 363
	Responsible Party: Contractor
	Deadline: 29-Jun-2013
	Current status: The obstructions have not been removed completely from river bed
	  <p>September 13, 2013</p>

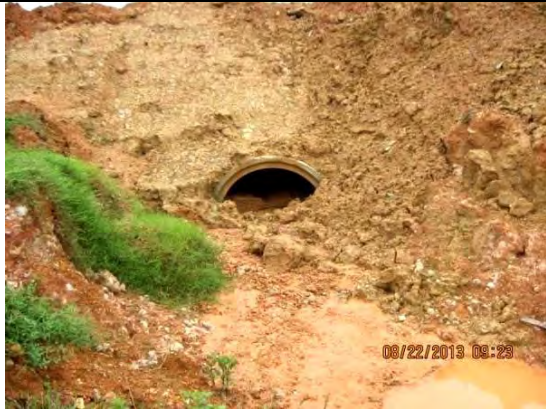
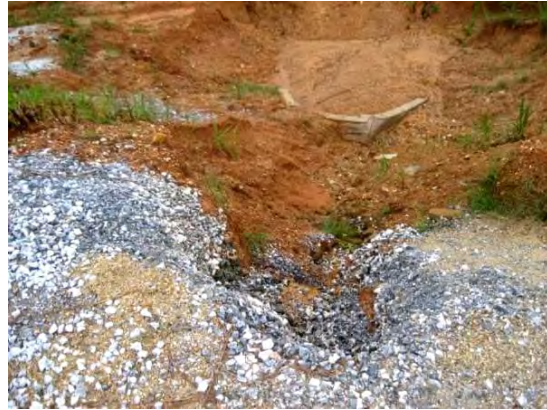
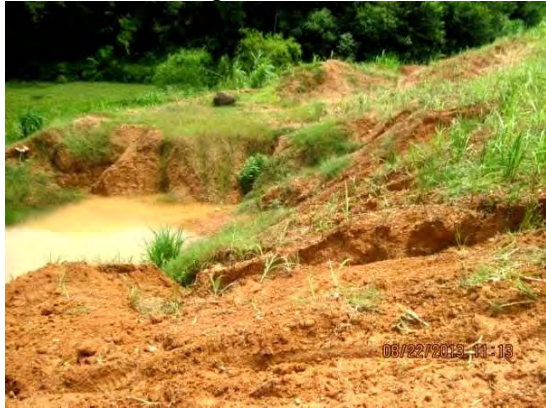
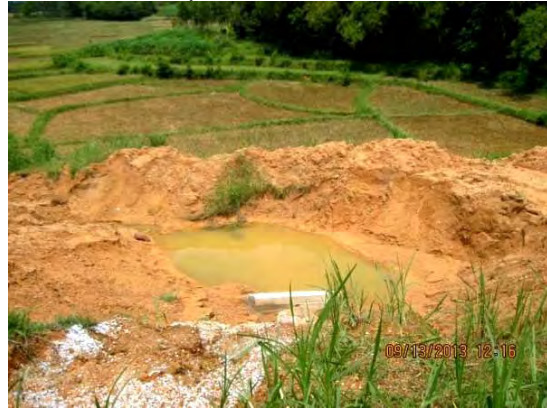
Location: Km 30+500 ~ Km 30+900 and Km 42+400 ~ Km 42+720

Problems description and cause: Drainage system is being blocked due to erosion and sedimentation

Current status: Mitigation measures have not been applied

Recommendation and Action taken by Engineer: Apply the erosion and sedimentation control measures; restore and maintain drainage system onsite. Refer to letter GET1/POS/A2/2002; GET/MISC/361, 363

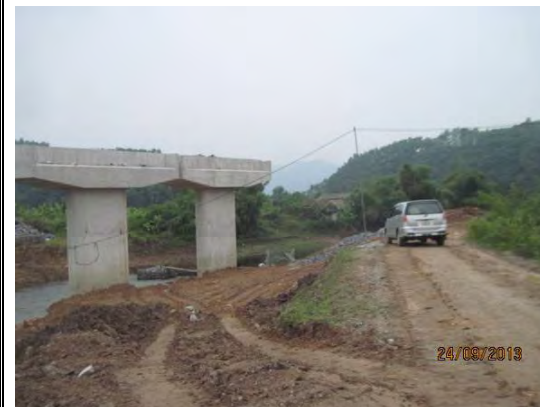
24/9/2013

Location: Ngoi Van Bridge
 	Site visit: 10,13,17,24,29,31/7/2013; 02, 07, 08, 15, 16, 22, 29/8/2013; 05, 11, 12, 19, 24, 26/9/2013
17/7/2013	Date first observed: 11/10/2012
	Problems description and cause: Disposal area is not followed the regulation which can cause landslide when it rains
	Recommendation and Action taken by Engineer: Restore the riverbank by removing accumulated soil from construction works and stabilize disturbed slope of riverbank.
	Responsible Party:
	Deadline: 15/7/2013
	Current status: Not improved
