Environmental Monitoring Report

Quarterly Report
July - September 2013

VIE: Greater Mekong Subregion Kunming–Hai Phong Transport Corridor Noi Bai– Lao Cai Highway Project

Prepared by Getinsa for the Vietnam Expressway Corporation, the Ministry of Transport,
the Government of Viet Nam, and the Asian Development Bank

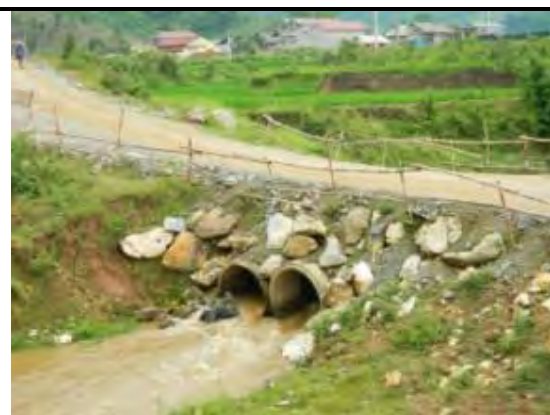
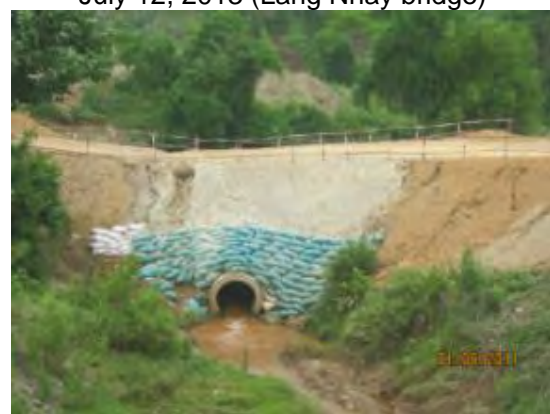
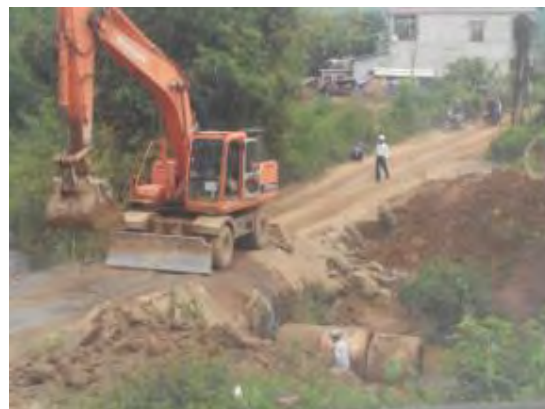
Location: Lang Nhay, Suoi Quan, Ngoi cong bridge's construction site.

Problems description and cause: The Contractor installed pipe culvert in order to ensure the water flow of the stream during construction.

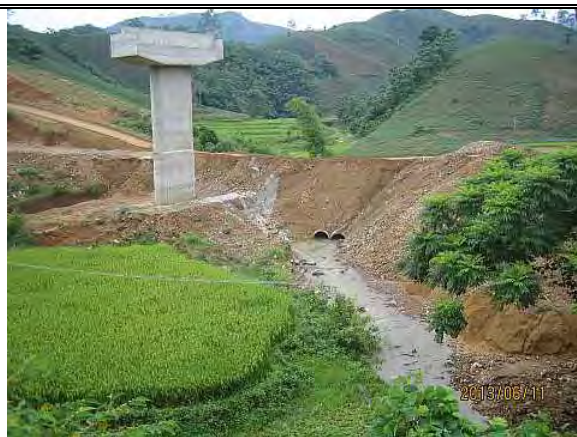
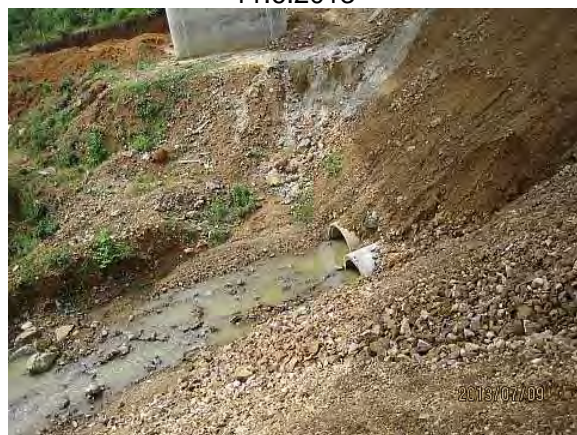
Location: Km193+379

Problems description and cause: The contractor dumped soil near water source. This obstructs water flow and affects stream and riverside maintenance

Recommendation and Action taken by Engineer: The contractors are required to clean to ensure flow rates and plant grass to stream and riverside maintenance

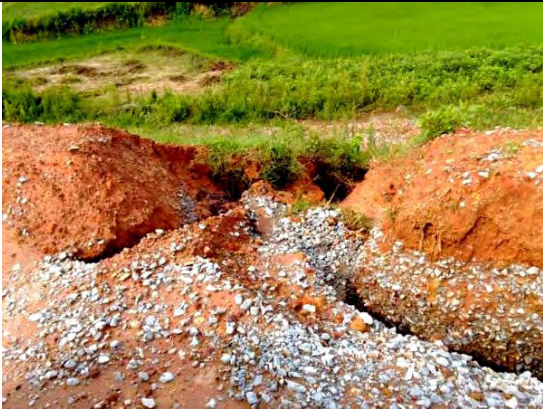
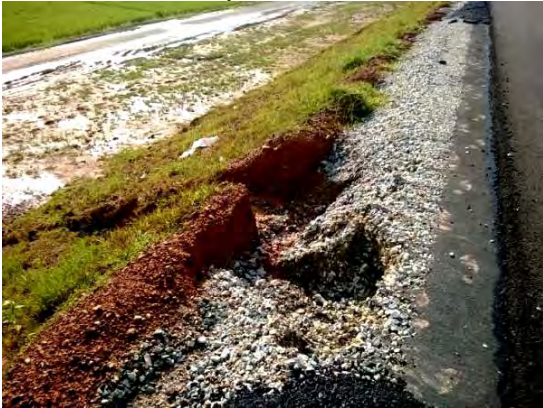
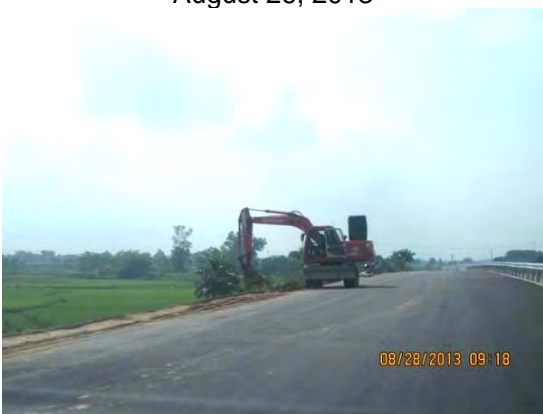
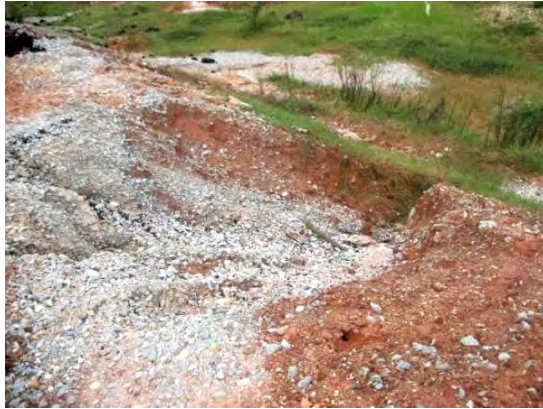
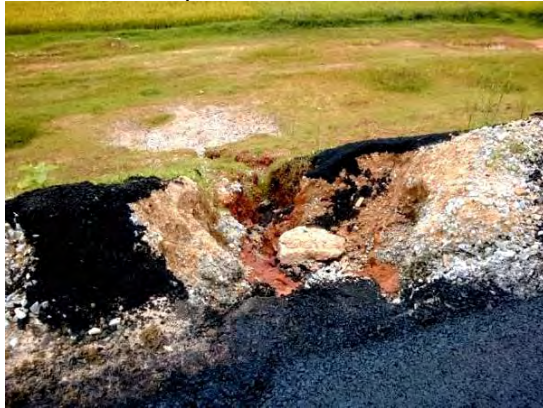
<p>July 19, 2013</p>	<p>Location: Embankment sections</p> <p>Site visit: 2, 9, 19, 25 July; 13, 16, 20, 28 August; 10, 11, 13, 17, 24 September</p> <p>Date of first observed: 19-Jul-2013</p> <p>Problems description and cause: Heavy rains caused erosion on unprotected slopes</p> <p>Recommendation and Action taken by Engineer: Apply erosion control measures at unprotected slope areas; restore affected slopes. Refer to letter GET1/POS/A1/2101</p> <p>Responsible Party: Contractor</p> <p>Deadline: Immediate</p>
--	---

In July: Mitigation measures have not been implemented

In August and September: Mitigation measures are being implemented slowly

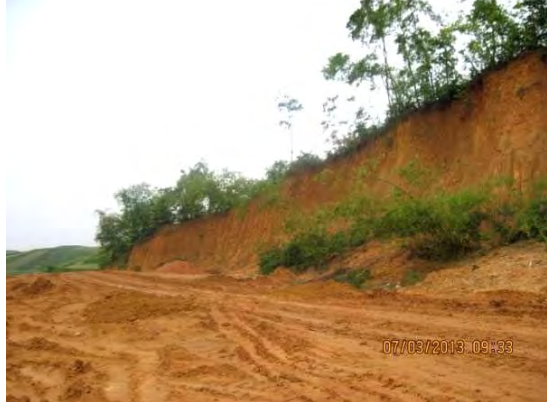
Location: Km 45+900 ~ Km 46+000

Site visit: 3, 10, 18, 25 July;
	Date first observed: 15-Oct-2012
	Problems description and cause: The Contractor did not comply with method statement to carried out the work with upright slope that causes high risk of landslide in this area
	Recommendation and Action taken by Engineer: The Contractor has to submit the plan to restore the affected area. Refer to letter GET1/POS/A2/1849
	Responsible Party: Contractor
	Deadline: 12-Apr-2013 (immediate)
	Current status: The Contractor is exploring soil in this area for embankment work

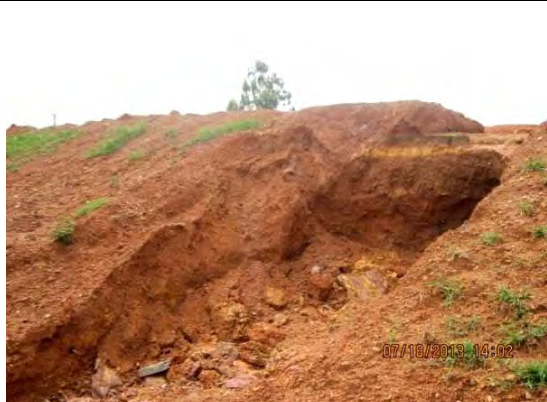
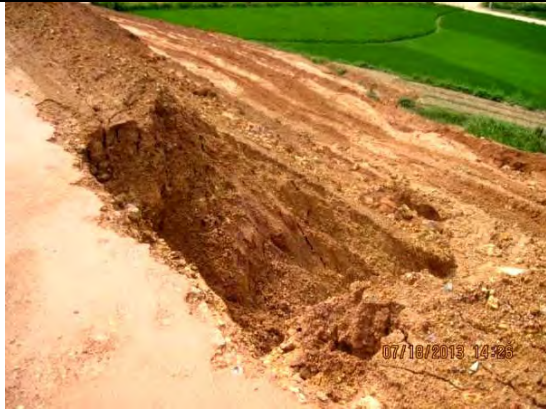
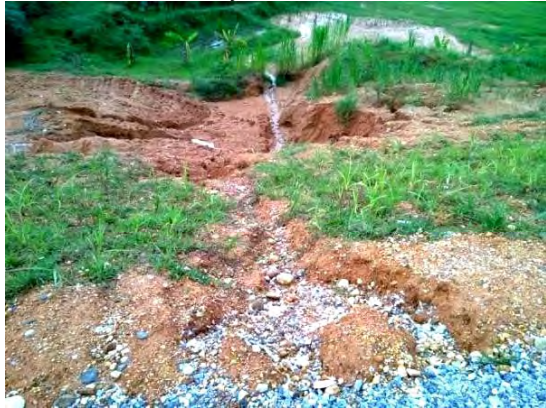
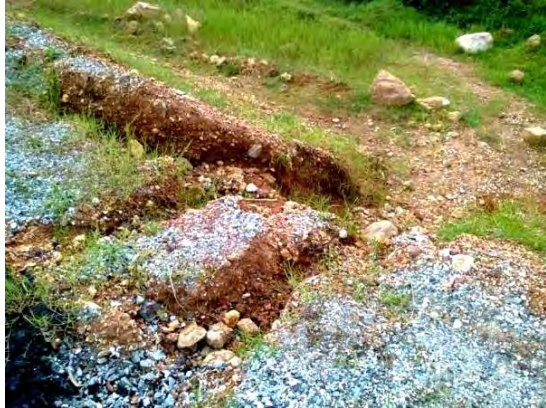
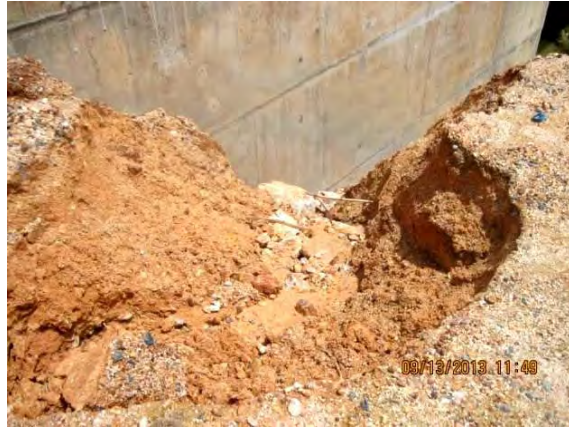
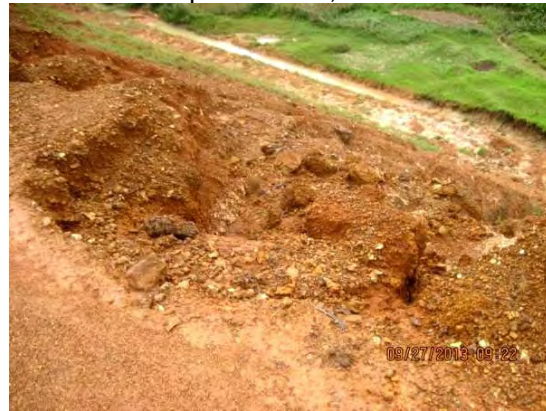
Location: Embankment sections
<p>July 18, 2013</p>	Site visit: 3, 4, 8, 10, 16, 18, 25, 29, 30 July; 8, 13, 15, 22, 28 August; 13, 17, 24 September
	Date first observed: 18-July-2013
	Problems description and cause: Heavy rain caused erosion on unprotected slopes
	Recommendation and Action taken by Engineer: Apply erosion control measures at unprotected slope areas; restore affected slopes. Refer to letter GET1/POS/A2/2098
	Responsible Party: Contractor
	Deadline: 20-July-2013
	Current status: Mitigation measures have not

been implemented

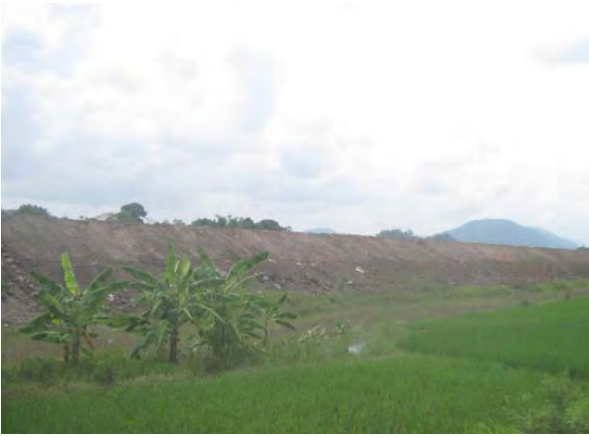
Location: Km 109+750

Date first observed: 28/3/2013
<p>28/3/2013</p>	Problems description and cause: The Slope had cracked.

Recommendation and Action taken by Engineer: Request Contractor to plant grass on the slope to avoid erosion and reinforced slope.
<p>24/7/2013</p>	Responsible Party:
<p>07/8/2013</p>	Deadline: 28/7/2013
<p>24/9/2013</p>	Current status: The Contractor has not planted grass yet to prevent landsides and erosion in rainy season.

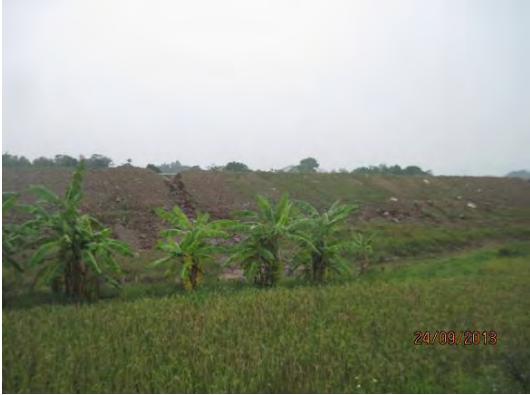
Location: Km81+700
10/7/2013	Site visit: 10, 13, 17, 24, 29, 31/7/2013; 02, 07, 08, 15, 16, 22, 29/8/2013; 05, 11, 12, 19, 24, 26/9/2013
 	Date first observed: 03/4/2013
22/8/2013	Problems description and cause: Soil has been slid into drainage canal
 	Recommendation and Action taken by Engineer: Require Contractor to remove all spoil to approved disposal area and improve slope.
24/9/2013	Responsible Party: Posco Contractor
24/09/2013	Deadline: 15/7/2013
	Current status: improved

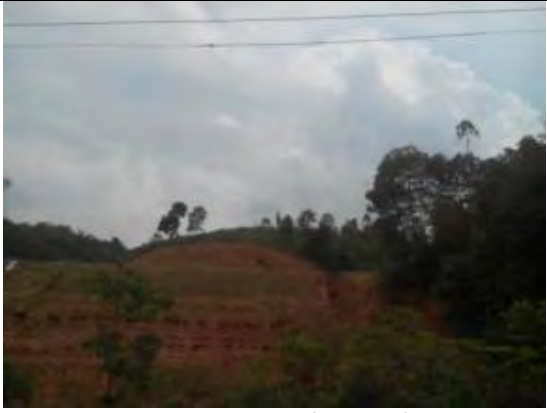
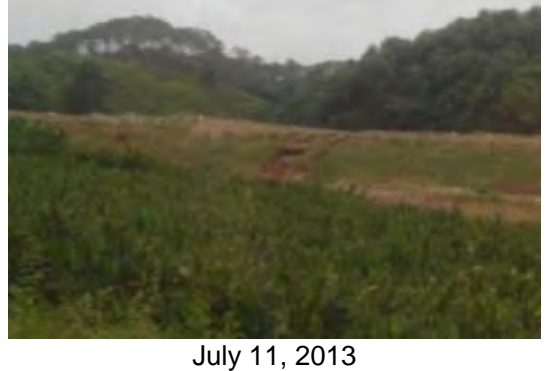
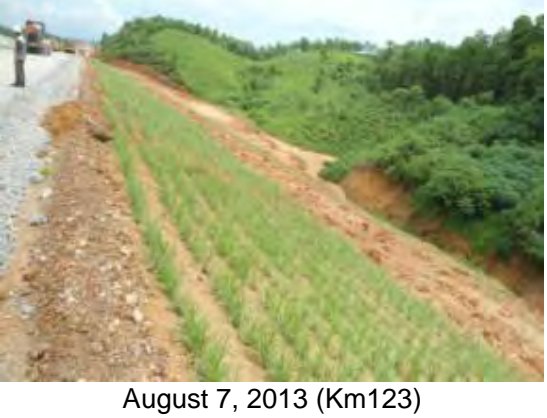
Location: Km139, Km138, Km129
<p>July 9, 2013 (Km139)</p>	Site visit: 9 and 11 Jul, 2013
	Date first observed: 9-Jul-2013
	Problems description and cause: During rainy days, erosion happened at some embankment slopes.

<p>Deadline: Immediate</p> <p>Current status: The contractor applying some measures in order to protect embankment slope: e.g. grass are planting at embankment and cutting slope, the contractor repairing damaged slope,</p>
<p>July 11, 2013</p>

<p>Recommendation and Action taken by Engineer:</p> <p>The Engineer pointed out this problem and requested the Contractor to implement it through the letters:</p> <ul style="list-style-type: none"> - Ref. GET3-KEANGNAM-13-A5-504; - Ref. GET3-KEANGNAM-13-A5-584;
<p>July 11, 2013 (Km129)</p>	<p>Responsible Party: Keangnam Contractor</p>

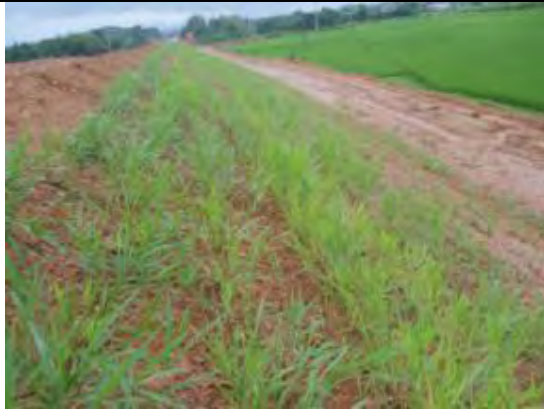
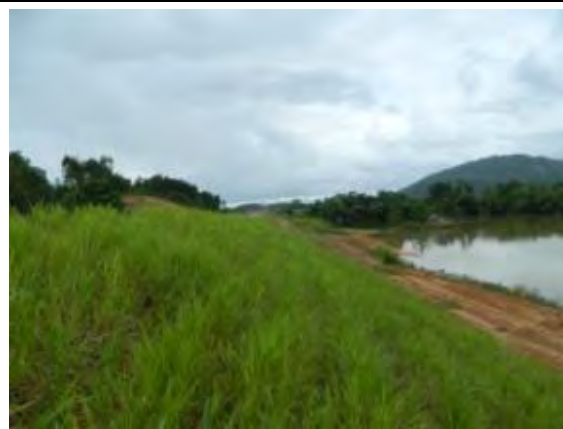
<p>Location: Km123, Km127, Km113,</p> <p>Site visit: 7, 9, 26 August , 2013</p> <p>Description: The Contractor is planting grass at cutting slopes and embankment slopes in order to minimize erosion risks and protect slope.</p>
<p>August 7, 2013 (Km123)</p>

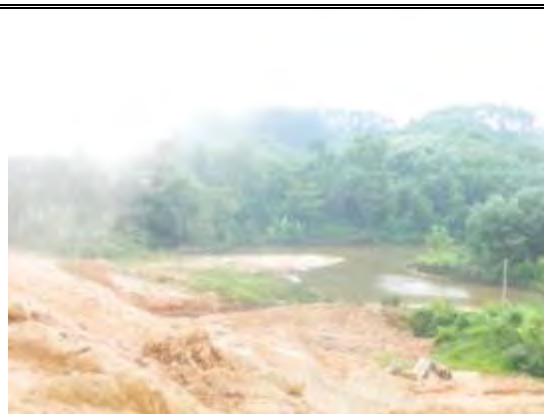
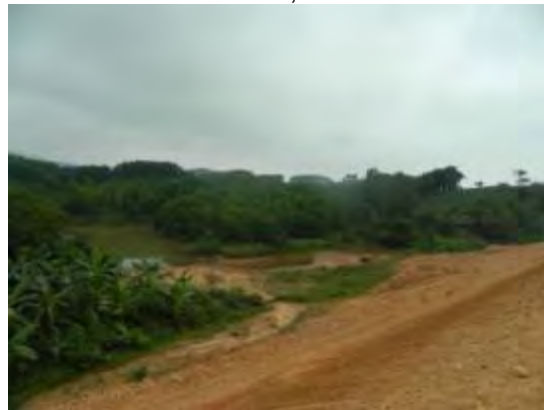
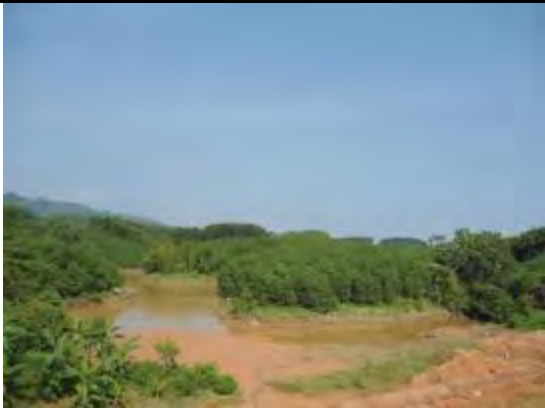
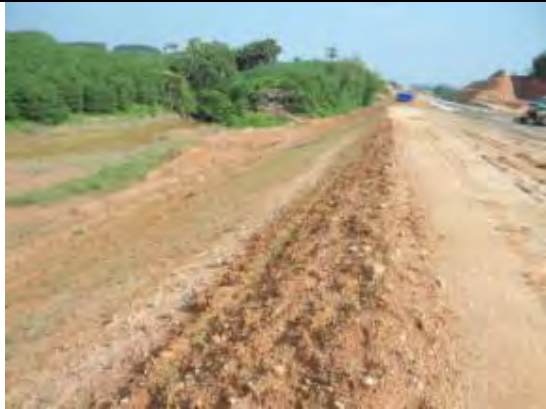
Location: Km124+080

Problems description and cause: At station Km124+080, soil from construction site was slid into lake, to date, the spoils have not been removed.

Current status: The Contractor combining with local authorities and local people to survey, determine filled up volume for affected households during construction site, At the same time, the Contractor is planting grass on the embankment slope at this location in order to protect slope and prevent erosion.

But, currently, dumped spoils still have not

<p>August 2, 2013</p>	<p>been removed by the Contractor.</p>

Recommendation and Action taken by Engineer: The Contractor must implement the tasks as follows:

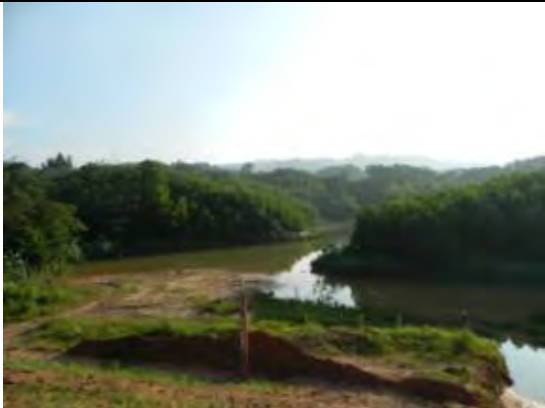
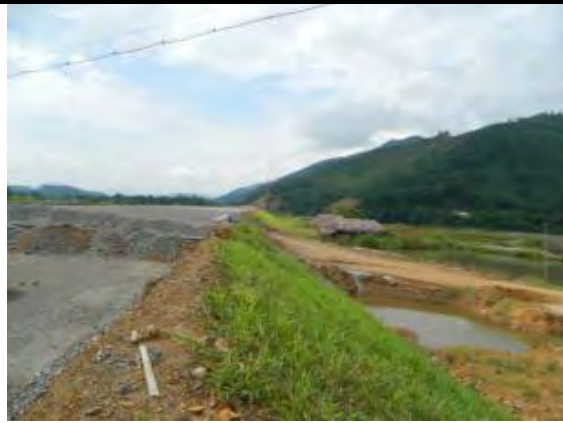
<p>August 27, 2013</p>	  <p>August 27, 2013</p>
  <p>September 3, 2013 (Km115)</p>	<p>Location: Km115, Km112, Km114, Km113,</p> <p>Site visit: 3, 13, 24 September , 2013</p> <p>Description: The Contractor is planting grass at cutting slopes and embankment slopes in order to minimize erosion risks and protect slope.</p>

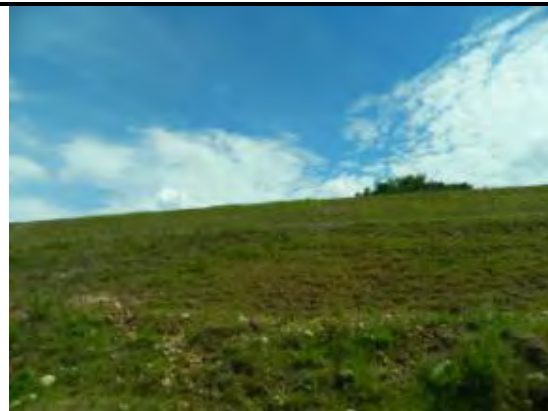
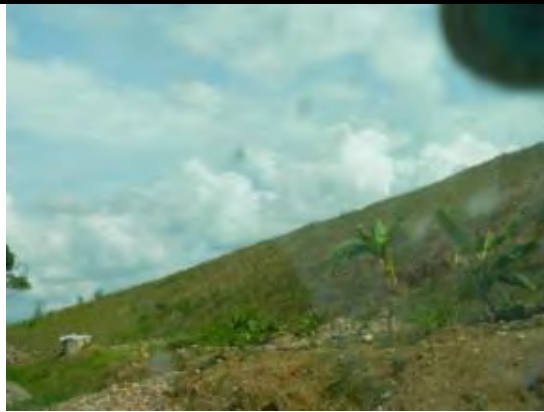
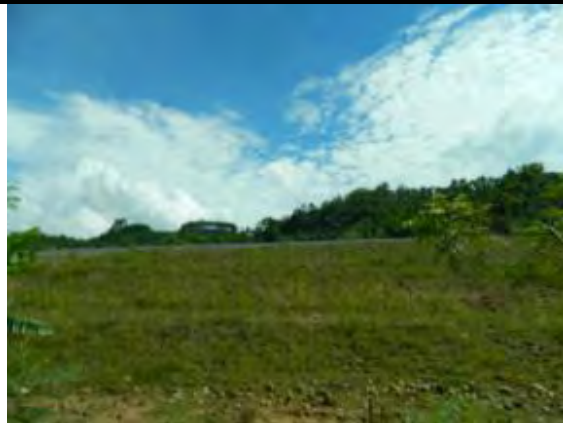
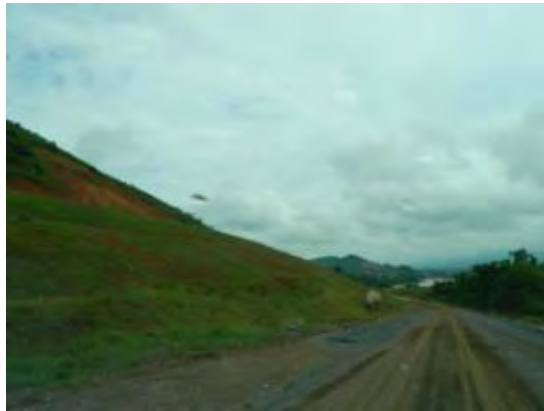
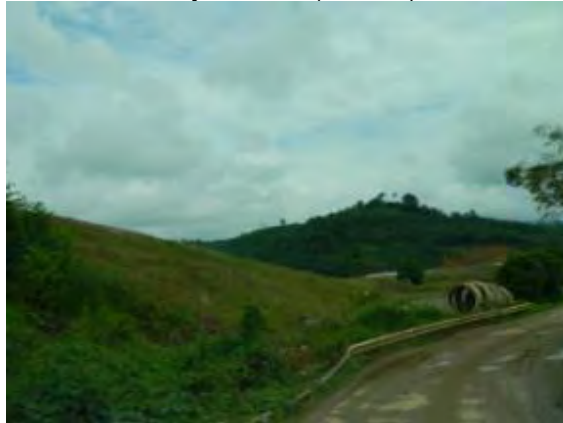
Location: Km151, Km152, Km159, Km160

Description: The Contractor is planting grass at cutting slopes and embankment slopes in order to minimize erosion risks and protect slope.

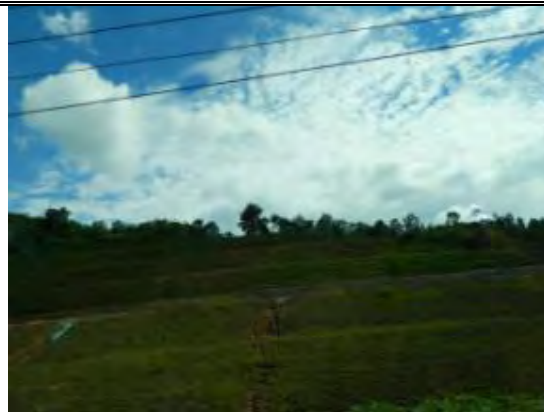
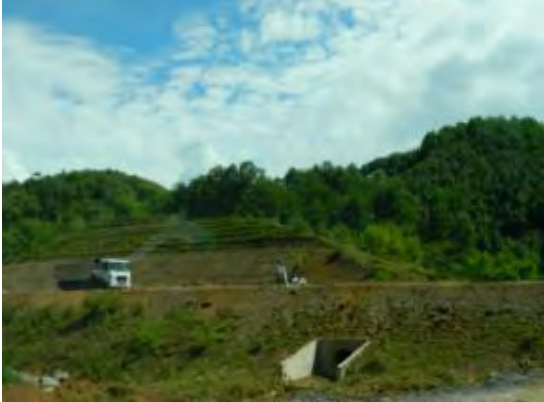
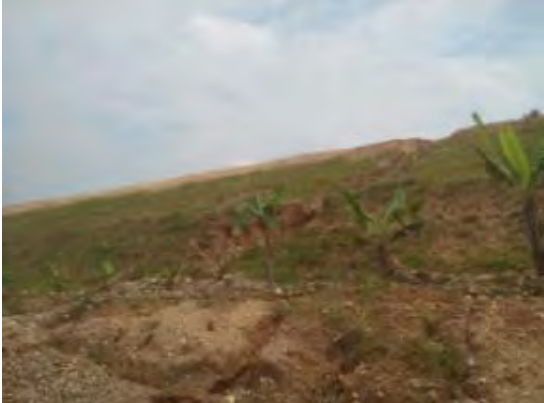
July 4, 2013 (Km154)

Location: Km154, Km155, Km176

Problems description and cause: During rainy days, erosion happened at some embankment slopes.

Recommendation and Action taken by Engineer:

- Ref. GET3-DOOSAN-13-A6-416;
- Ref. GET3-DOOSAN-13-A6-456;

<p>Current status: The contractor is applying some measures in order to protect embankment slope: e.g. grass is being planted at embankment and cutting slopes, to protect and repair these damaged slopes or in risk of erosion</p>
<p>July 4, 2013 (Km155)</p>

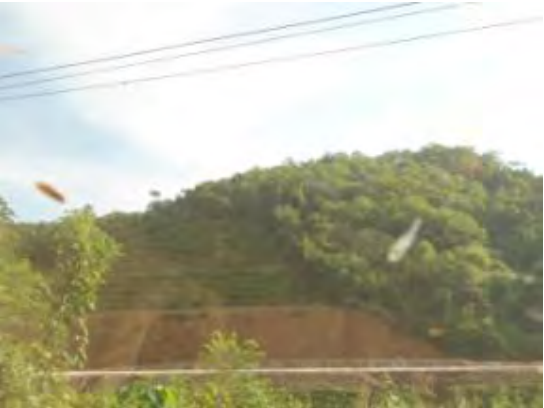
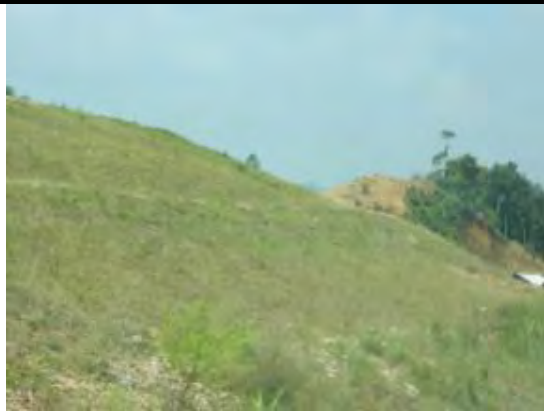
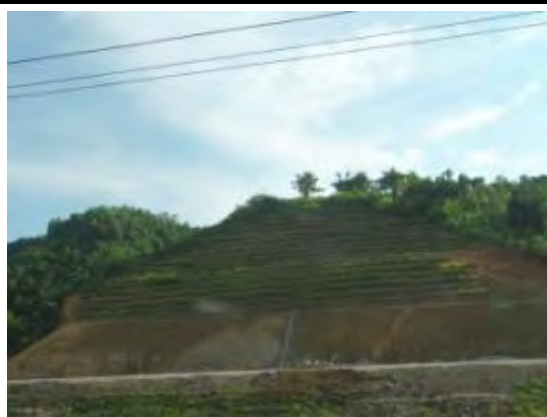
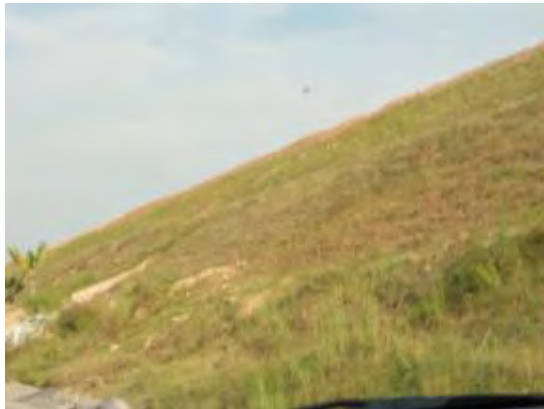
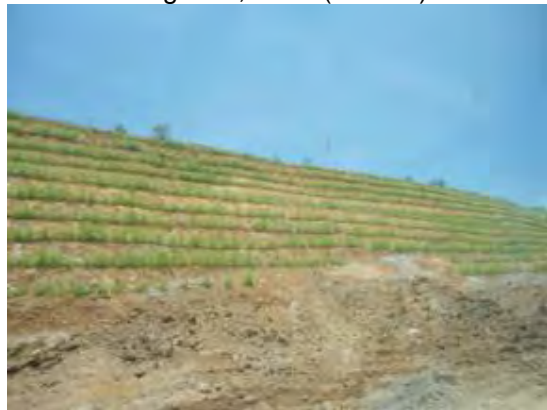
<p>Location: Km151, Km154, Km155, Km165</p>
<p>August 1, 2013(Km154)</p>	<p>Site visit: 1, 6, 20 and 29 August, 2013</p>
	<p>Description: The Contractor is planting grass at cutting slopes and embankment slopes in order to minimize erosion risks and protect slope.</p>

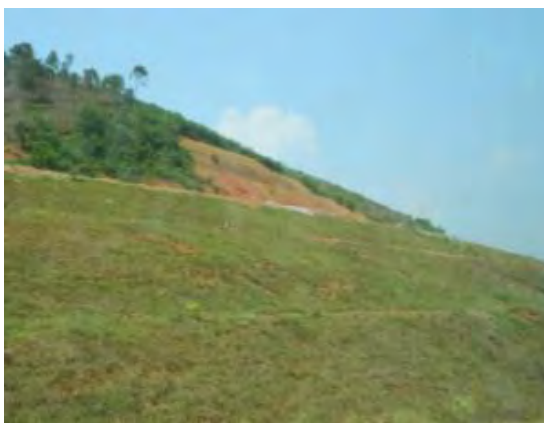
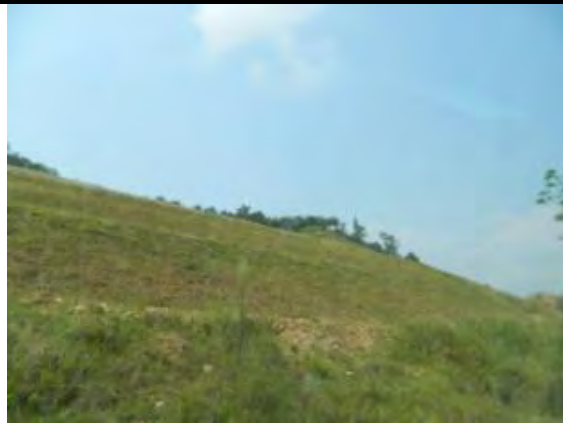
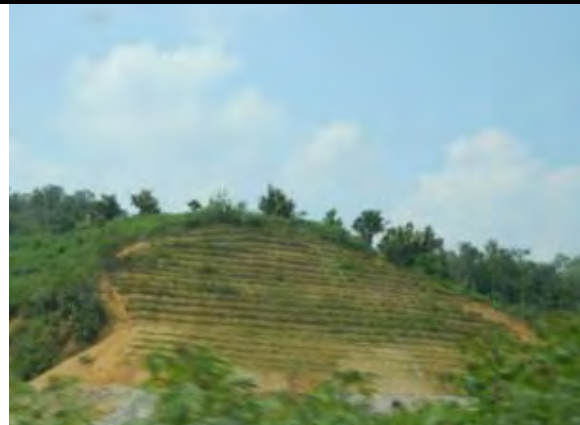
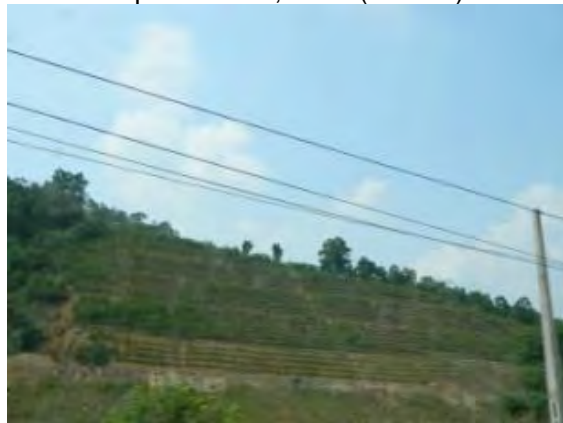
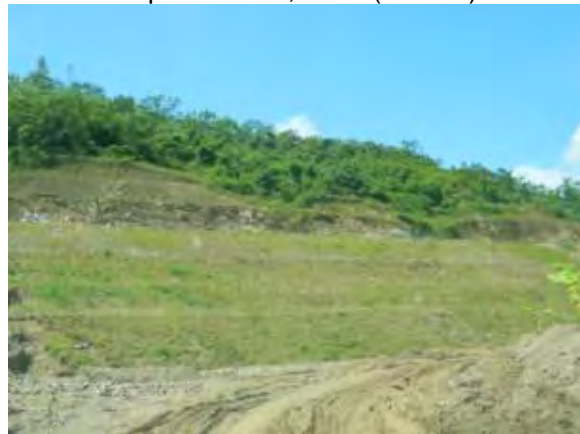
Location: Km161, Km154, Km153, Km151, Km174

Description: The Contractor is planting grass at cutting slopes and embankment slopes in order to minimize erosion risks and protect slope.

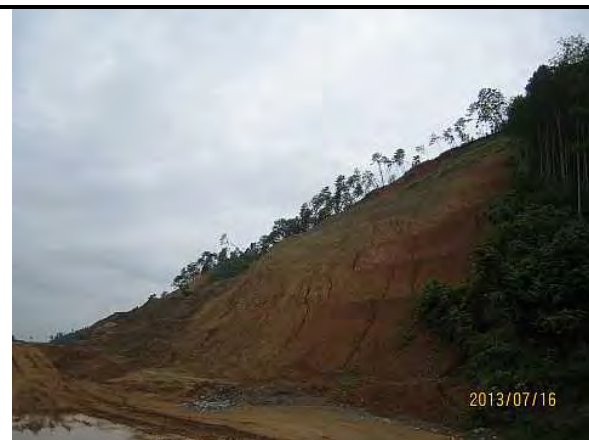
16.7.2013

Location: Excavation slope Km215+200

Problems description and cause:
Landside and erosion of slope happened because of heavy rains

Recommendation and Action taken by Engineer: Required the contractor to set up the safety fence and signpost around the landside and erosion areas and apply the slope protection method to overcome

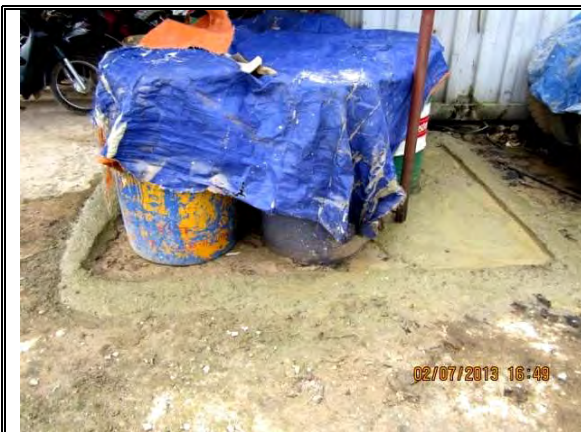
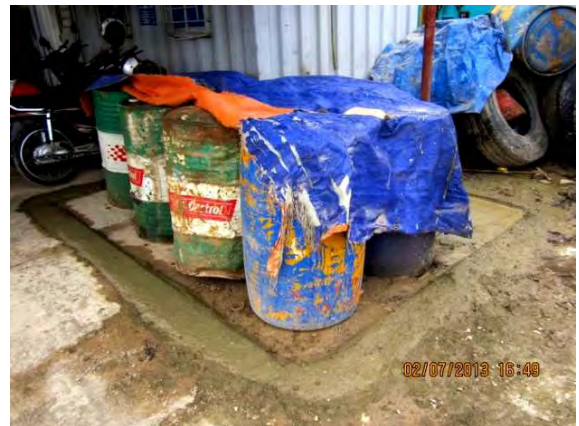
July 02, 2013

Location: All sections

Current status: During the site inspection we didn't detect any serious problem regarding to hazardous substance management

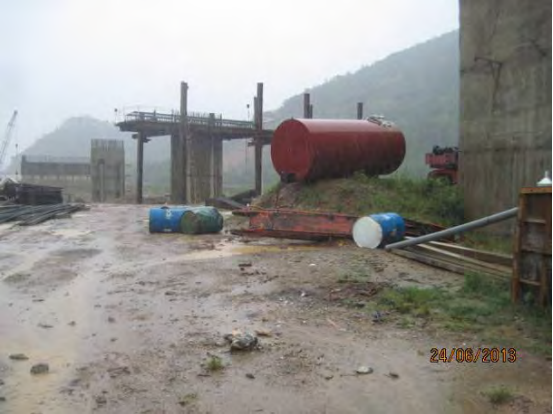
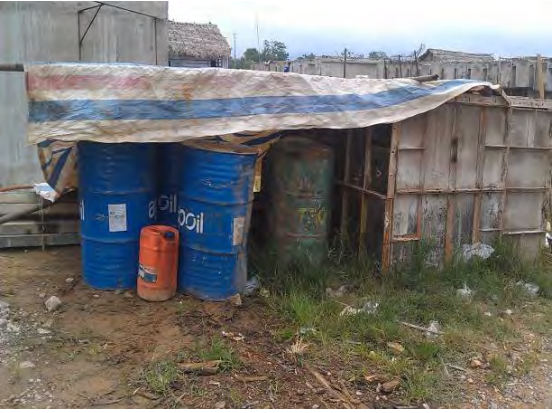
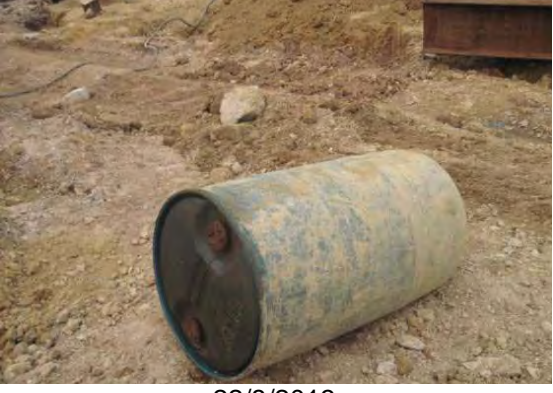
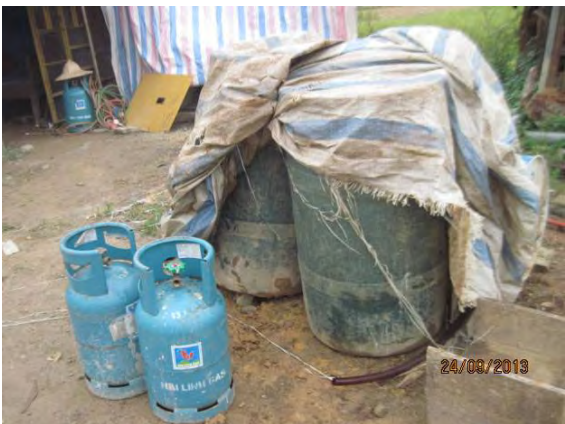
Location: Ngoi Lao bridge
<p>24/6/2013</p>	Site visit: 10, 13, 17, 24, 29, 31/7/2013; 07, 14, 21, 28/8/2013; 05, 11, 12, 19, 24, 26/9/2013

Date first observed: 24/6/2013
<p>10/7/2013</p>	Problems description and cause: Oil and waste oil barrels were not located in prescribed places

Recommendation and Action taken by Engineer: Place fuel/oil drums (including empty ones) in upright position in an area with impermeable floor, bund and roof.
<p>22/8/2013</p>	Responsible Party:
	Deadline: 15/7/2013
	Current status: In July: improved In August and September: Not improved

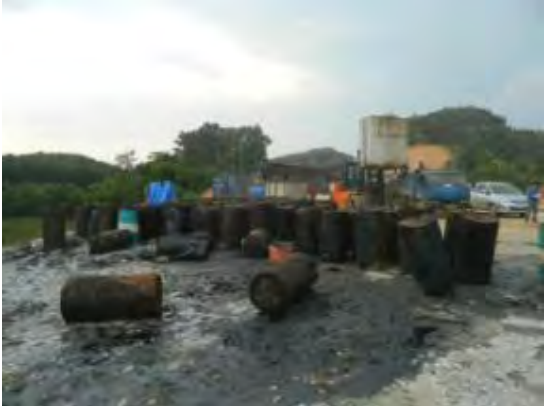
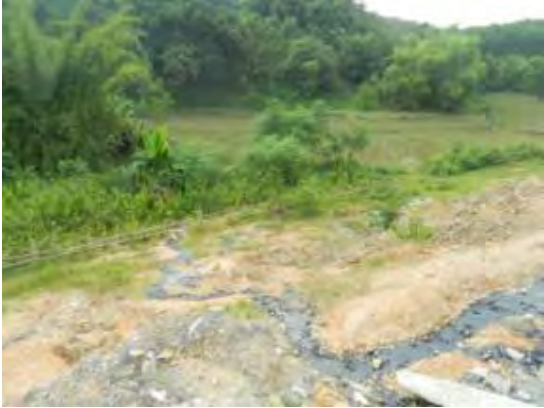
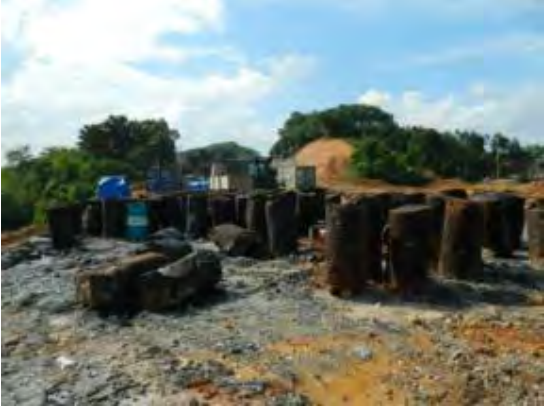
Location: Construction site Km131+130

Date first observed: 22 nd June, 2013
	Problems description and cause: From the embankment where more than 100 drums of bitumen drums are placed, leaks/spills of bitumen have spread onto the embankment slope and adjacent land. The bitumen was used for waterproofing the underpass structure at km 131+130
	Recommendation and Action taken by Engineer: The Engineer required the Contractor to implement the tasks as follows: 1. Remove spilled bitumen and properly dispose contaminated soil. Place bitumen drums in adequately protected areas such that these are not exposed to the elements and leaks/spills are avoided; 2. Stop repeating similar case;
	Responsible Party: Keangnam Contractor
	Deadline: 20-Apr-2013
	Current status: In July: No important changes done In August: The Contractor removed the spilled bitumen and disposed the contaminated soil. Beside, the Contractor is applying measure in order to avoid bitumen leaks (bitumen tanks were put in iron tanks). But these measures are not enough, the Engineer has still seen the spilled bitumen at this location though site visit on 29 th August, 2013. In September: The Contractor removed spilled bitumen and dispose contaminated soil. Besides, the Contractor also removed all

bitument tanks to Km117.
 	<div data-bbox="816 436 1390 867">   </div> <div data-bbox="914 867 1289 898"> August 27, 2013 (Km131+130) </div>
<div data-bbox="289 1073 711 1100"> September 16, 2013 (Km131+130) </div>

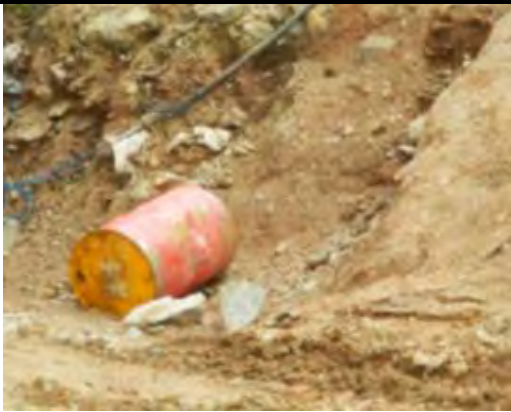
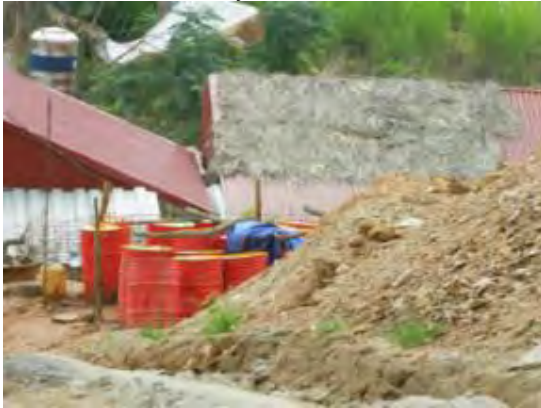
<div data-bbox="784 1287 1370 1318"> Location: Tunnel Construction site Km186+200 </div> <div data-bbox="784 1346 1154 1377"> Site visit: 4 and 18 July, 2013 </div> <div data-bbox="784 1404 1203 1436"> Date first observed: 4th July,2013 </div> <div data-bbox="784 1463 1377 1581"> Problems description and cause: Fuel control is not performed well. this situation is caused the leak of oil and soil pollution. </div>
<div data-bbox="410 1640 558 1671"> July 4, 2013 </div>

Engineer: The Engineer required the Contractor to improve fuel control at this location, at the same time, the Engineer also provided the instruction for this issues through the letter Ref. GET3-DOOSAN-12-A6-300.

Current status: Mitigation measure has been implemented by the Contractor.

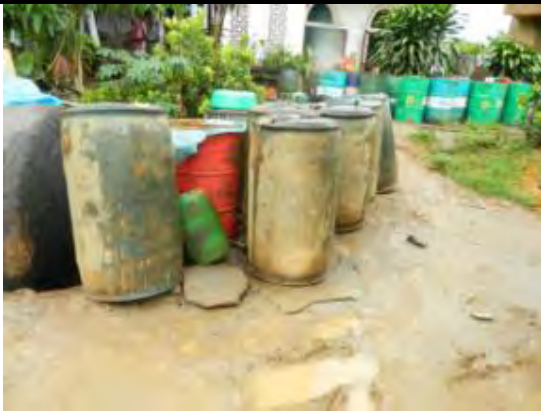
**Location:** Km166+900

Problems description and cause: Fuel control is not well performed. this situation is caused the leak of oil and soil pollution.

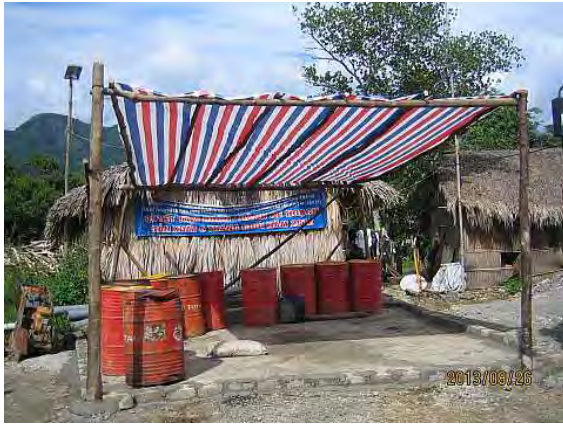
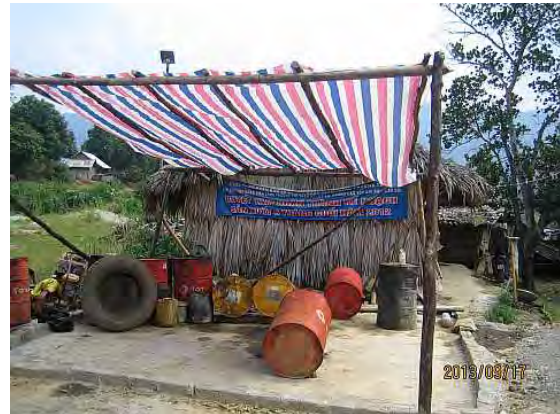
<p>2013/07/16</p> <p>16.7.2013</p>	Location: Store place Km197+080
	Site visit: 16.7 and 6.8.2013; 26.8.2013; 17.9.2013
	Date first observed: 8.1.2013
	Problems description and cause: Oil and waste oil tanks are put directly on the ground, this can affect soil quality
	<p>Recommendation and Action taken by Engineer: Required the contractor to keep oil and waste oil tanks in store with floor concreted.</p> <p>Responsible Party: GRBCC</p>

In August: Improved

In September: The contractor has improved this issue but not as required by Consultant

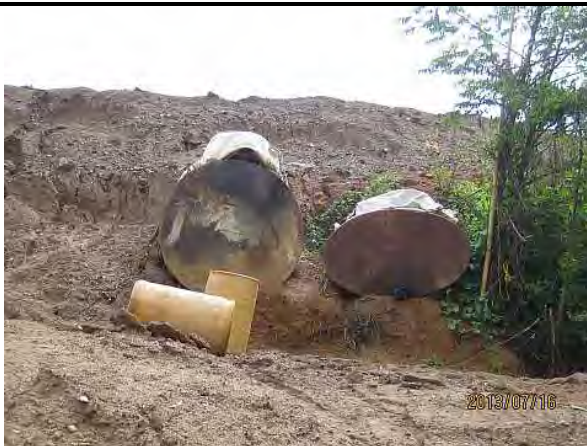
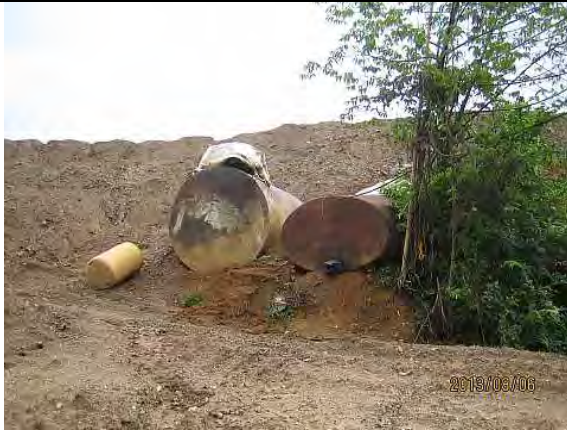
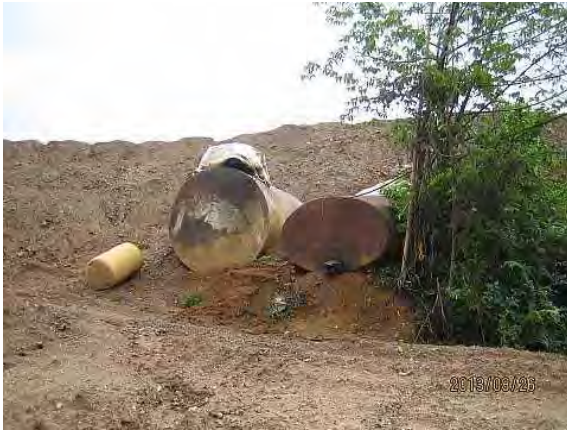
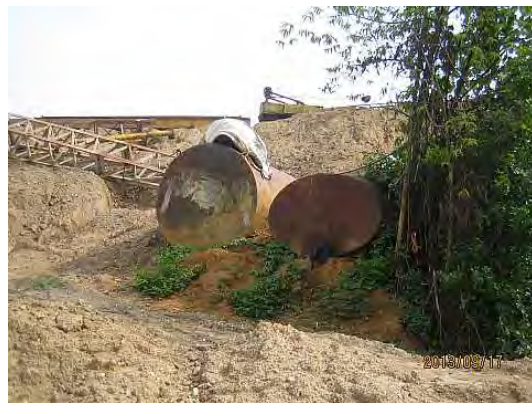
Location: Store place Km209+329

Problems description and cause: Oil and waste oil tanks are put directly on the ground, this can affect soil quality

not yet improved

In September: On September 18th, 2013, the contractor sent to ST4 letter No: Ref. GRBCC- GETINSA- A7- 1731 issued "Inform about removing concrete batching plant at Km209+300", Actually in this place, there is not any construction team and these oil tanks are empty. Thus the contractor proposed not to continue using these tanks.

Recommendation and Action taken by Engineer: Required the contractor to keep oil and waste oil tanks in store with floor concreted.

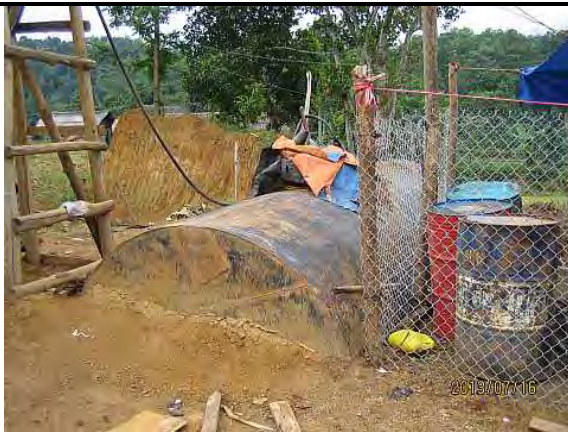
16.7.2013

Location: Store place Km213+100

Problems description and cause: Oil and waste oil tanks are put directly on the ground, this can affect soil quality

Recommendation and Action taken by Engineer: Required the contractor to keep oil and waste oil tanks in store with floor concreted.

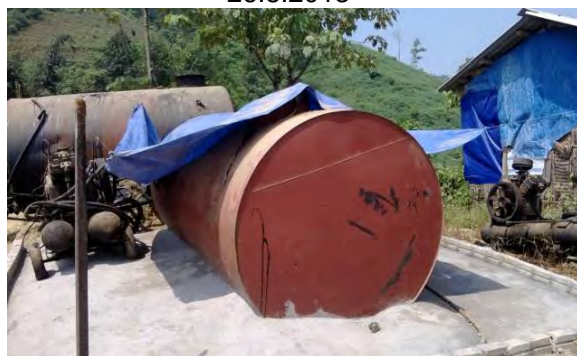
17.9.2013

<p>Location: Store place Km203+000</p>
	<p>Site visit: 16.7.2013; 26.8.2013; 17.9.2013</p>
	<p>Date first observed: 21.6.2013</p>
	<p>Problems description and cause: Oil and waste oil tanks are put directly on the ground, this can affect soil quality</p>
	<p>Recommendation and Action taken by Engineer: Required the contractor to keep oil and waste oil tanks in store with floor concreted.</p>
	<p>Responsible Party: GRBCC</p>
<p>16.7.2013</p>	<p>Deadline: 15.7.2013</p>
	<p>Current status: In July and August: The contractor has not</p>

yet improved this issue

In September: The Contractor has improved this issue but not as required by Consultant

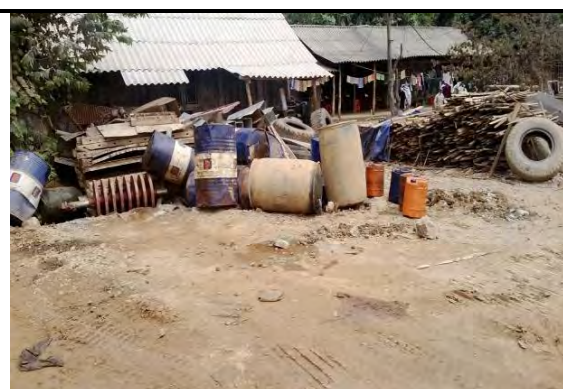
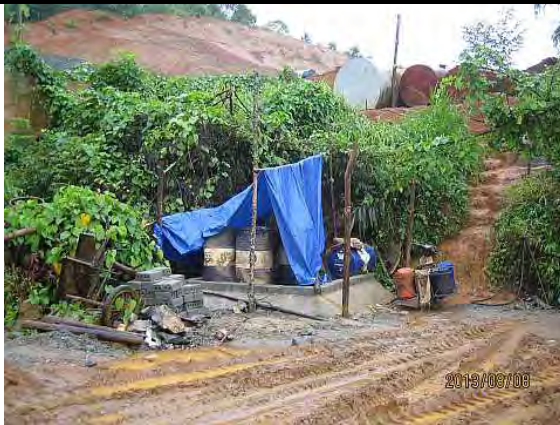
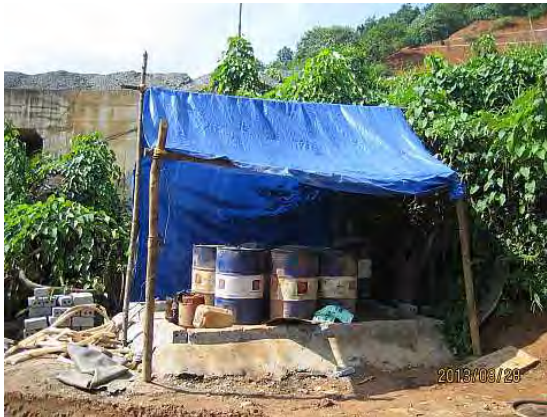
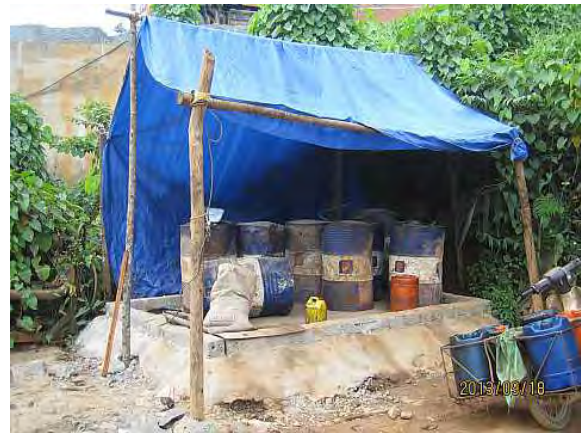
Location: Store place oil and waste oil
Km228+000

Problems description and cause: Oil and waste oil tanks are put directly on the ground. This can affect soil quality

Current status:

In July: Not improved

In August and September: The contractor had improved

Recommendation and Action taken by Engineer: Required the contractor to put oil and waste oil tanks inside store with floor concreted.

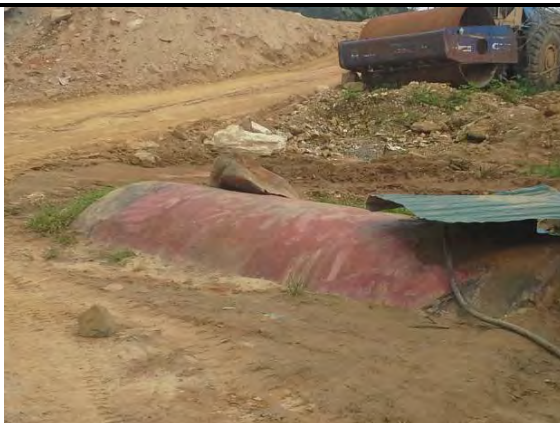
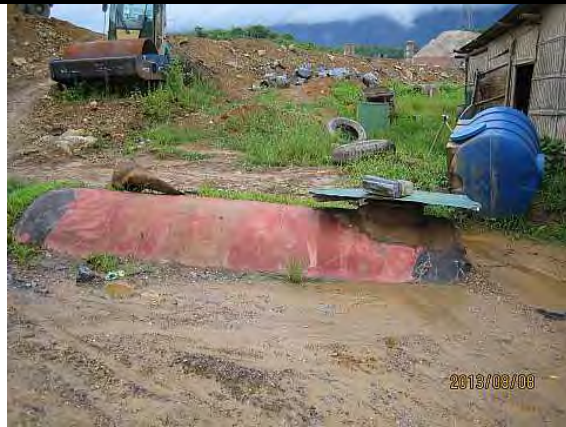
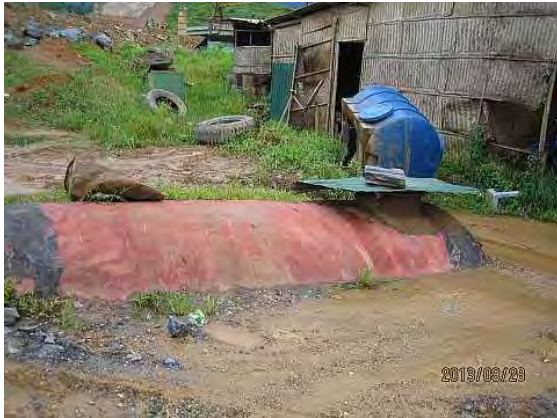
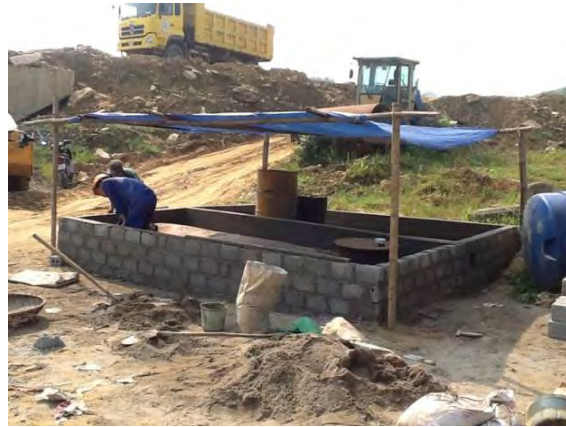
Location: Store place oil and waste oil
Km244+155

Problems description and cause: Oil and
waste oil tanks are put directly on the ground.
This can affect soil quality

Current status:

In July and August: The contractor has not yet improved

In September: The Contractor has improved this issue but not as required by Consultant

**Recommendation and Action taken by
Engineer:** Required the contractor to put oil
and waste oil tanks inside store with floor
concreted.

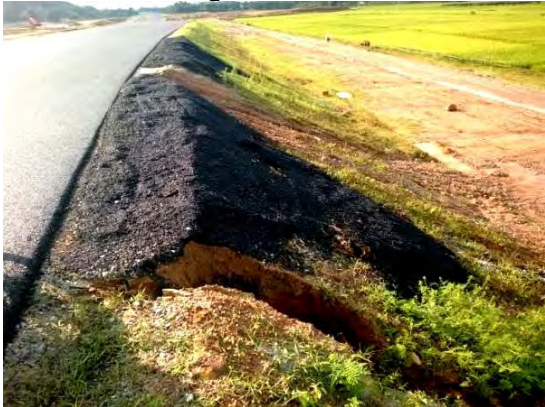
Location: Km 21+200
<p>August 13, 2013</p>	Site visit: 13, 16, 20, 22, 28 August; 10, 11, 13, 17, 24 September

Date first observed: 13-Aug-2013
<p>August 26, 2013</p>	Problems description and cause: Failure asphalt concrete is disposed on slopes
	Recommendation and Action taken by Engineer: The Engineer already requested the Contractor to remove all the failure asphalt concrete to approved disposal place. Refer to letter GET1/POS/A1/2147
	Responsible Party: Contractor
	Deadline: 16-Aug-2013
	Current status: Mitigation measure has not been implemented

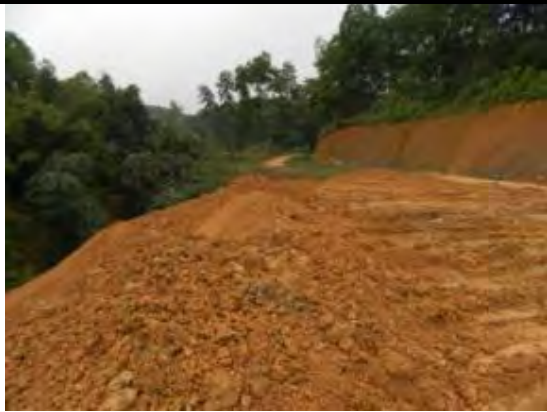
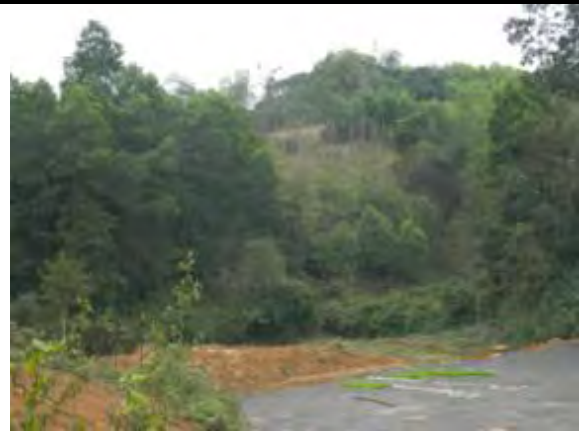
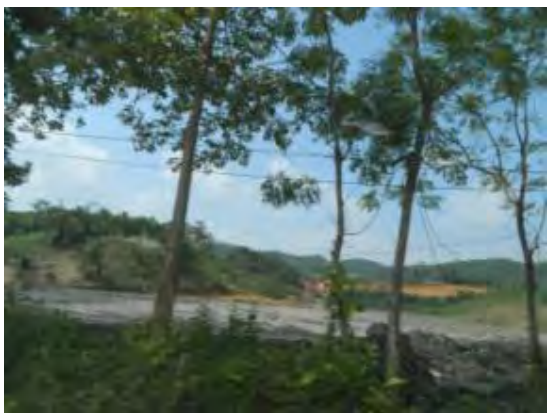
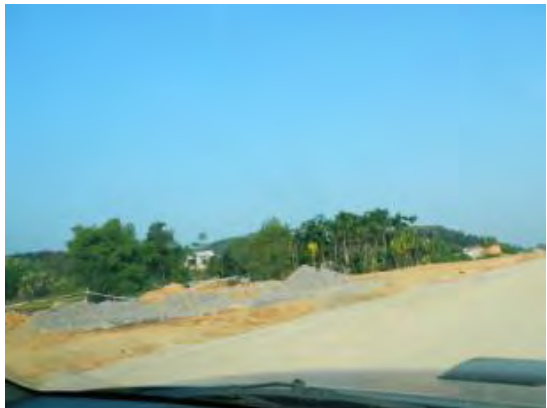
<p>Location: Disposal areas Km128; Km126, Km127</p>
	<p>Site visit: 9 and 11 July, 2013</p>
 	<p>Description: There was no serious problem of environment and safety from the disposal areas approved by the Consultant.</p>
<p>July 9, 2013 (Km128)</p>	  <p>July 11, 2013 (Km127)</p>
<p>July 9, 2013 (Km126)</p>	
 	<p>Location: Disposal areas Km148, Km127, Km126</p>
<p>August 27, 2013 (Km148)</p>	<p>Site visit: 2 and 27 August, 2013</p>
	<p>Description: There was no serious problem of environment and safety from the disposal areas approved by the Consultant.</p>
