Environmental Monitoring Report

Quarterly Report
July - September 2013

VIE: Greater Mekong Subregion Kunming–Hai Phong Transport Corridor Noi Bai– Lao Cai Highway Project

Prepared by Getinsa for the Vietnam Expressway Corporation, the Ministry of Transport,
the Government of Viet Nam, and the Asian Development Bank

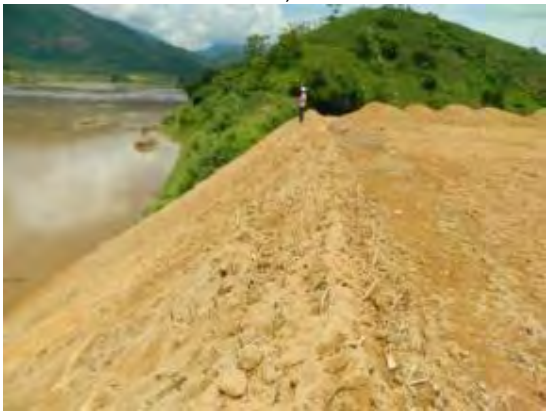
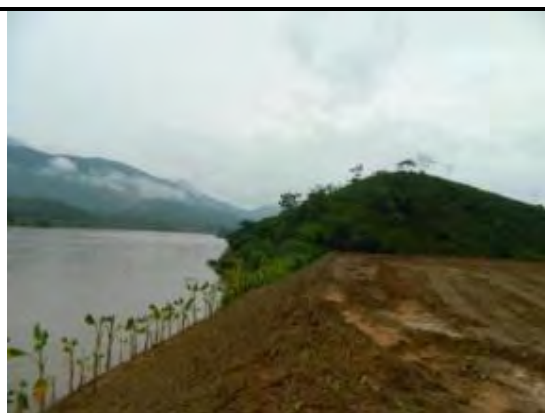
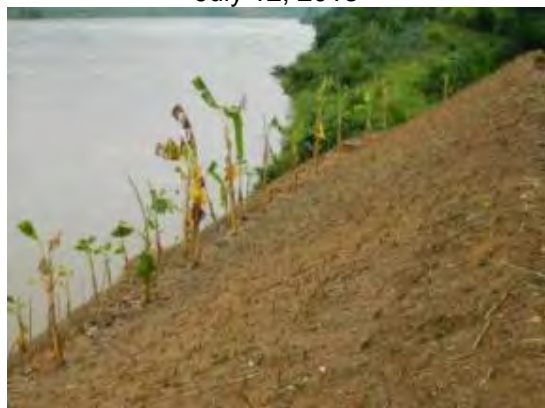
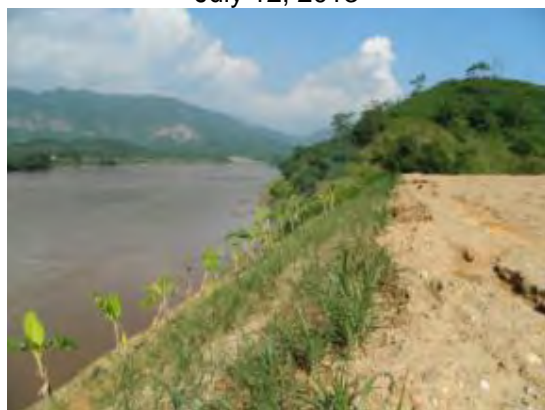
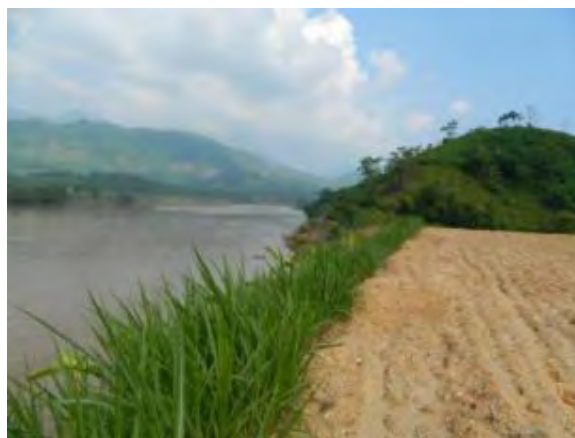
Location: Km166+860

Problems description and cause: At station Km166+860, unsuitable material was dumped onto the riverbed, this disposal area was not approved by the Engineer. This situation may cause impact to water flow and water quality of the river.

Current status: The Contractor is applying some measures as follows:
1. Stop discharging the unsuitable soil at this location;
2. Undertake restoration works: Make the slope

to be lower; Planting grass and trees at this location in order to protect slope;

Recommendation and Action taken by Engineer: The Engineer requested the Contractor to implement the tasks as follows: 1. Stop disposal of unsuitable soil at km 166+860; 2. Remove dumped unsuitable soil and transfer to approved disposal site; 3. Prepare a plan to restore the section of the riverbed and embankment that have been damaged due to unauthorized disposal and submit plan to PSC for approval; 4. Undertake restoration works; 5. Stop repeat dumping unsuitable soil to unapproved sites.

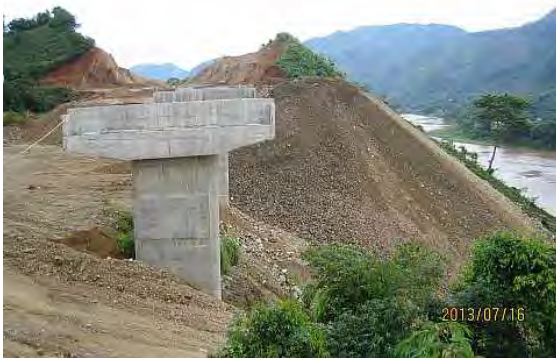
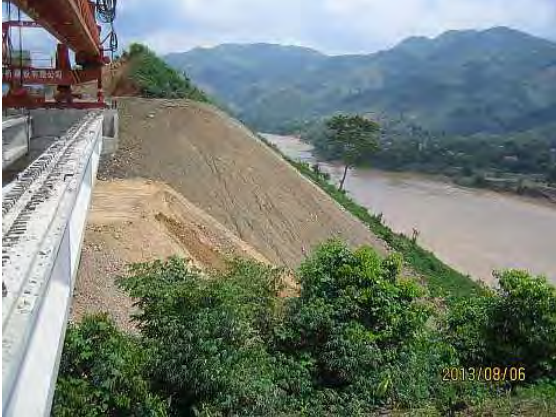
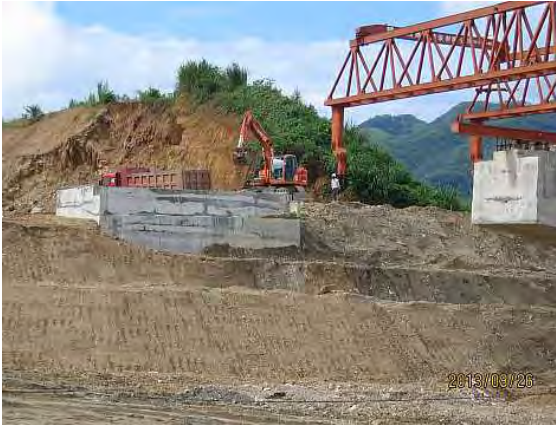
Location: Km190+420
16.7.2013	Site visit: 21.6; 16.7; 6, 26.8; 4,10,17,24.9.2013
	Date first observed: 15.5.2013
	Problems description and cause: The contractor dumped unsuitable soil on Red riverbank in an unauthorized disposal. This action can affect the flow rate and lead to erosion and landslide

6.8.2013	Also, this situation affects to engineering issues related with the stability of the pier, so, the way to solve this matter has to be coordinated with structural engineers.

Recommendation and Action taken by Engineer: The contractor was required to submit the documents related to waste disposal and to plant grass in order to avoid erosion and landslide into the riverbed, until the total removal of the soil from the river bank and surroundings.

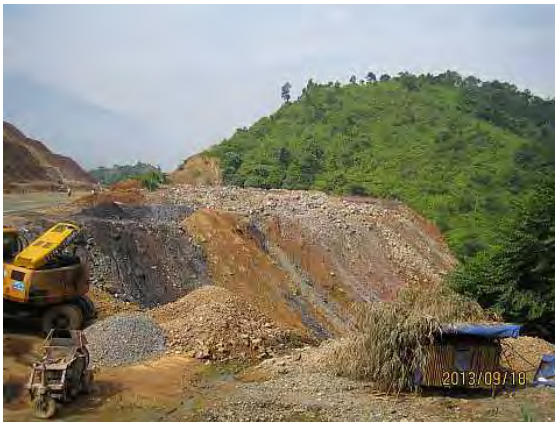
<p>18.9.2013</p>
---	---

<p>28.8.2013</p>	Site visit: 22.8 and 28.8.2013, 18.9.2013
	Date first observed: 22.8.2013
	Problems description and cause: The contractor dumping earth in place, which has not been approved by Engineers
	Recommendation and Action taken by Engineer: The contractor was required to submit the documents related to this waste disposal and to plant grass to avoid erosion and landside
	Responsible Party: Contractor
	Deadline: 31.8.2013

<p>6.9.2013</p>	<p>Current status: The contractor has not yet deployed according to consultant's instructions.</p>

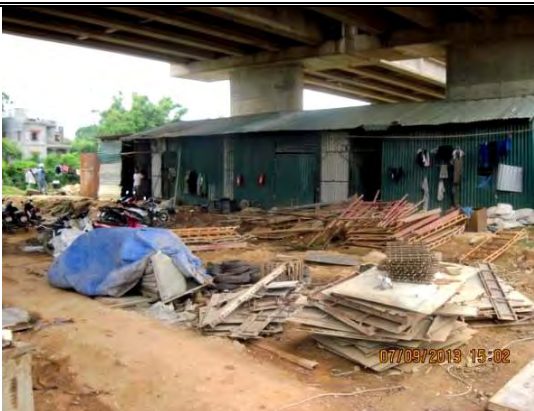
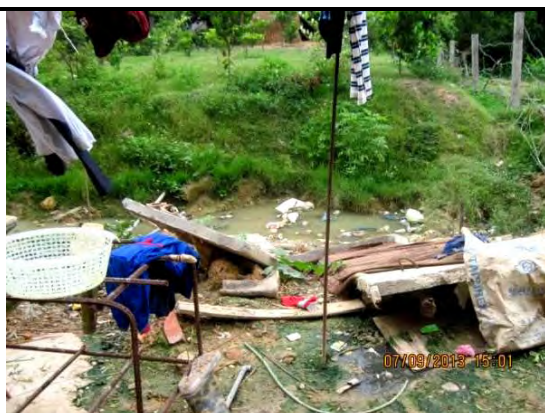
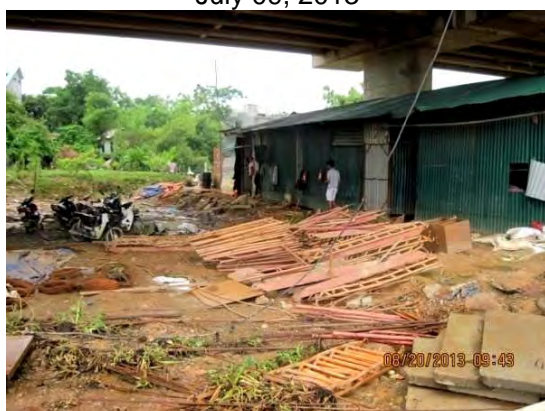
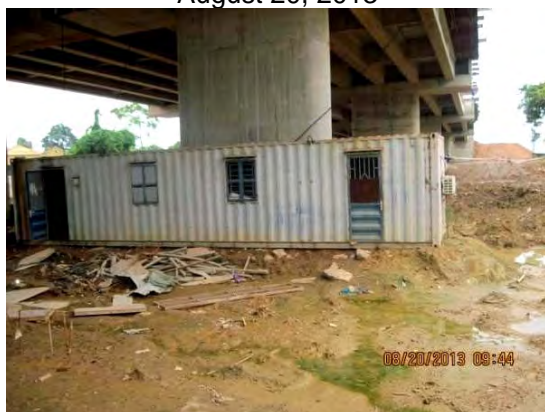
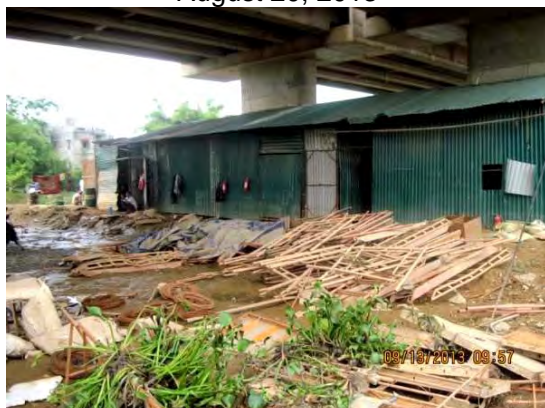
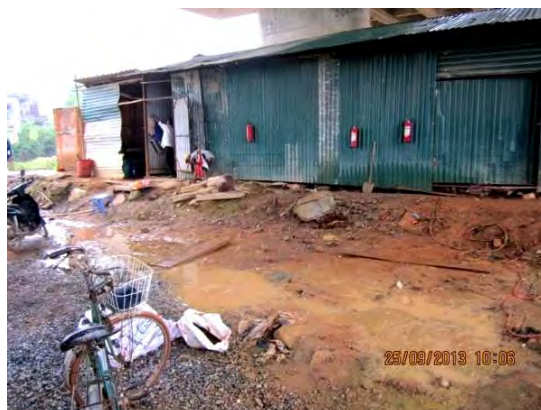
<p>July 09, 2013</p>	<p>Location: Trung Kien Bridge</p>
	<p>Site visit: 2, 9, 19, 25 July; 13, 20, 26, 28 August; 10, 13, 17, 24 September</p>
	<p>Date first observed:</p> <p>In July: 09-Apr-2013</p> <p>In August: 20-Aug-2013</p>
	<p>Problems description and cause:</p> <p>In July: Construction site is dirty and untidy with trash and material</p> <p>In August: Due to the flooding in this area, construction site becomes dirty and untidy with trash and material</p>
	<p>Recommendation and Action taken by Engineer:</p> <p>In July: The Engineer has orally requested the Contractor to rearrange the construction</p>

In July: The Contractor is cleaning and rearrange material to keep the site in cleanliness and sanitary condition; however, the improvement is inadequate

In August: Mitigation measure is being implemented

In September: Mitigation measure has been implemented

site to keep it in tidy and cleanliness condition. Refer to letter GET1/POS/A1/1900, 1920, 1993, 2016, 2091

In August: The Engineer has orally requested the Contractor to rearrange the construction site to keep it in tidy and cleanliness condition.

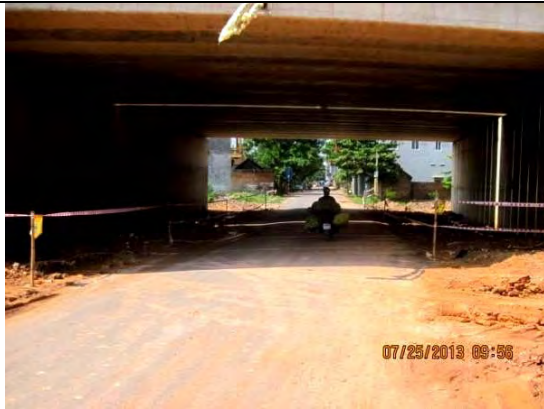
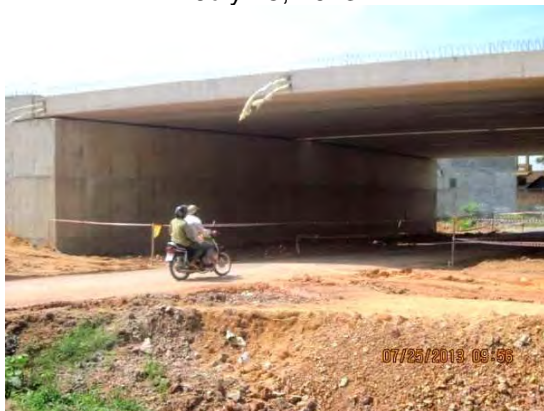
Location: TL309 Bridge

Engineer: The Engineer has requested the Contractor to rearrange this area and clean public road to keep the site in cleanliness and tidiness condition. Refer to letter GET1/POS/A2/2021, 2090, 2116

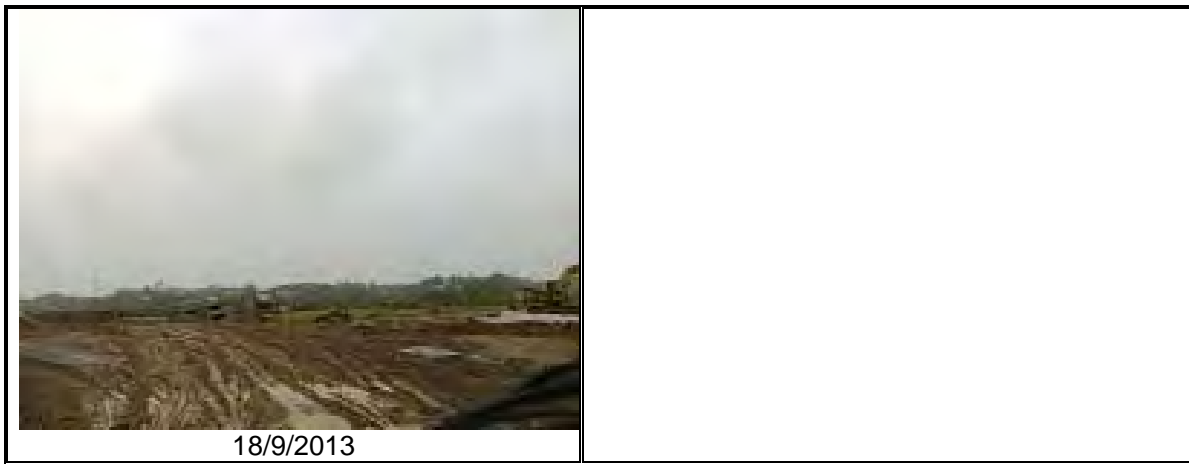
<p>04/9/2013</p>	Location: Red river bridge
	Site visit: 04,10,11,18,24,25/9/2013
	Date first observed: 04/9/2013
	Problems description and cause: A lot of mud was discharged near site
	Recommendation and Action taken by Engineer: Request Contractor to clean mud on site
	Responsible Party:
	Deadline: Immediately
	Current status: Not improved

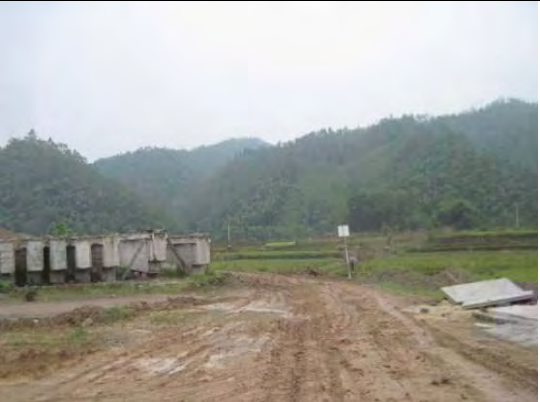
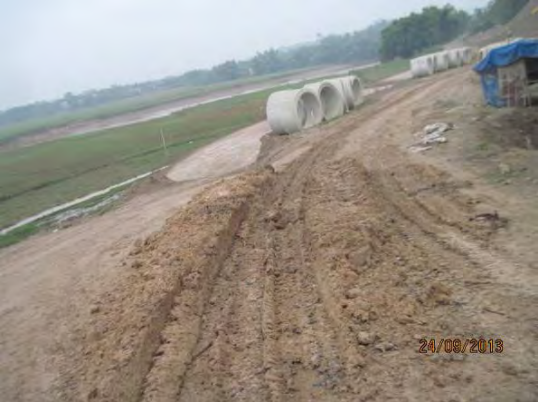
<p>29/7/2013</p>	Location: TL321C Bridge
	Site visit: 10, 13, 17, 24, 29, 31/7/2013; 02, 07, 08, 15, 16, 22, 29/8/2013; 05, 11, 12, 19, 24, 26/9/2013
	Date first observed: 08/5/2013
	Problems description and cause: Access road was full of mud when it rained
	Recommendation and Action taken by Engineer: Request Contractor to clean all mud to ensure safe travel when it rains
	Responsible Party:
  <p>07/8/2013</p>	Deadline: 10/7/2013
	Current status: Not improved

<p>05/9/2013</p>	Location: Ngoi Lao Bridge
	Site visit: 05, 11, 12, 19, 24, 26/9/2013
	Date first observed: 08/5/2013
	Problems description and cause: Access road was full of mud when it rained
	Recommendation and Action taken by Engineer: Request Contractor to clean all mud to ensure safe travel when it rains
	Responsible Party: Keangnam

<p>24/9/2013</p>	Deadline: 25/9/2013
	Current status: Not improved

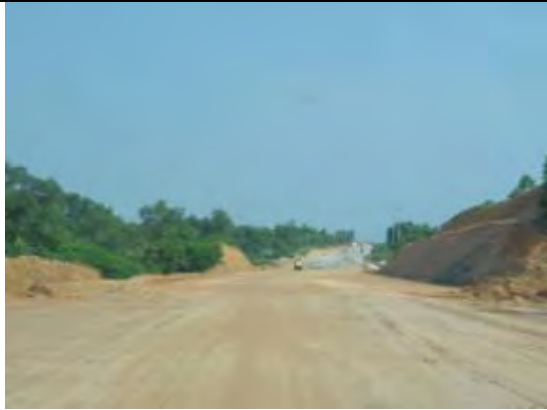
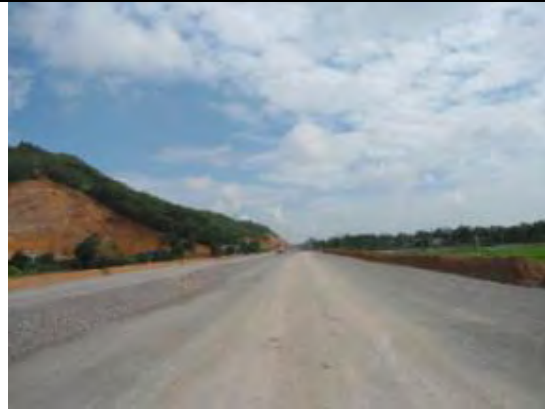
<p>July 11, 2013 (Km114)</p>   <p>July 26, 2013 (Km128)</p>	<p>Location: Km114, Km128, Km127</p>
	<p>Site visit: 9, 11 and 26 July, 2013</p>
	<p>Description: Construction site is tidy and clean</p>
	  <p>July 9, 2013 (Km127)</p>
  <p>August 2, 2013 (Km123)</p>	<p>Location: Km123, Km115, Km110</p>
	<p>Site visit: 2 and 7 August, 2013</p>
	<p>Description: Construction site is tidy and clean</p>

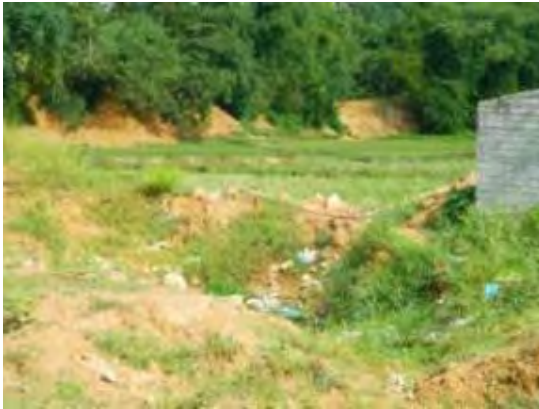
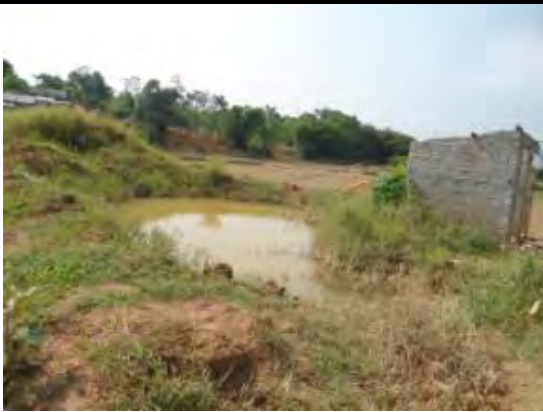
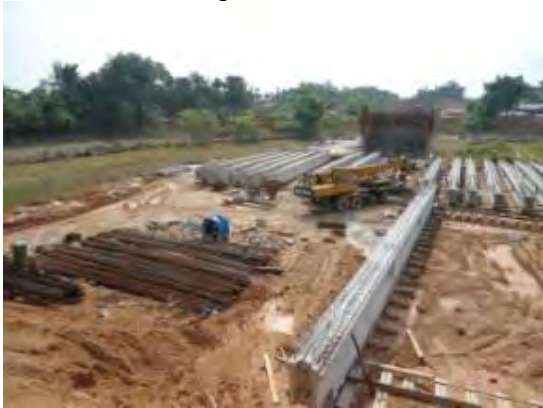
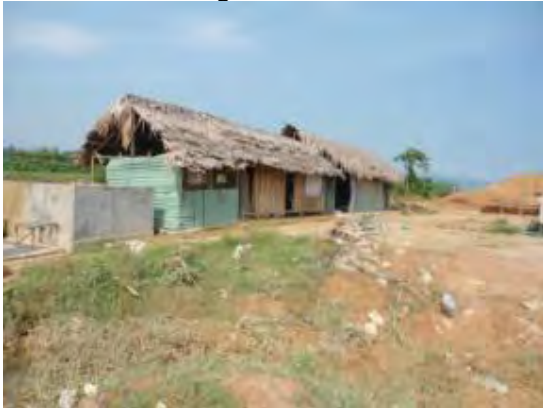
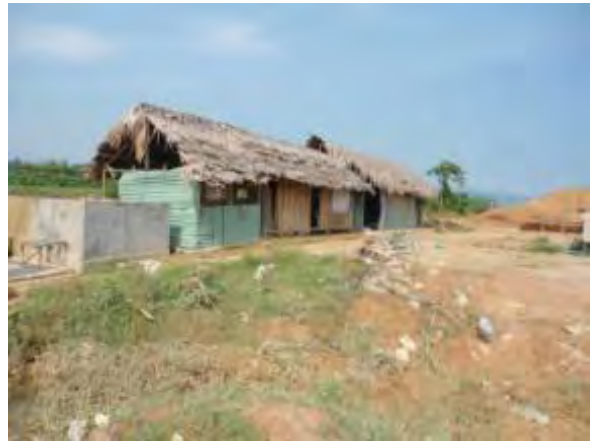
Location: Ngoi Gua bridge site

Problems description and cause: The workers camp at km 128 (Ngoi Gua bridge site) is garbage strewn (no bins). Construction materials are also unorganized posing safety risks.

In July and August: No important changes done

In September: The Contractor cleared at this location and arrange construction material. But, Sanitary toilets, fire-extinguishers, first aid kits, dustbins still have not been provided at this camp,

Recommendation and Action taken by Engineer: The Contractor must implement the tasks as follows: 1. Implement good housekeeping practices; 2. Build sanitary toilets at all the workers camps; 3. Provide fire-extinguishers, first aid kits, dustbins at all the workers camps;

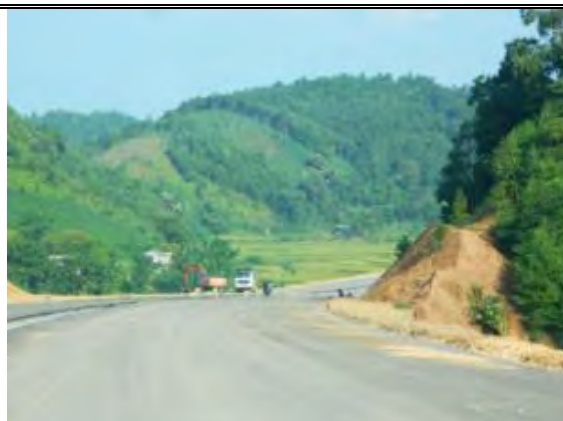
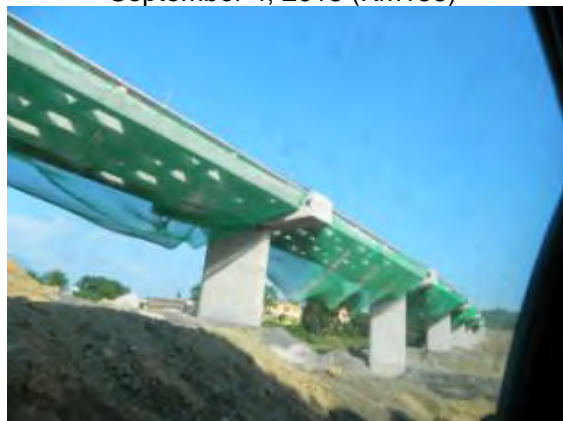
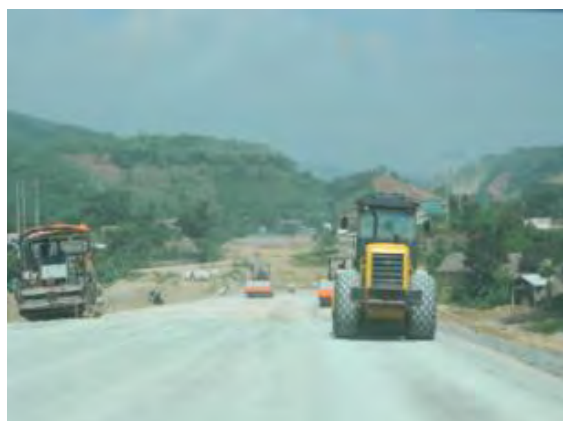
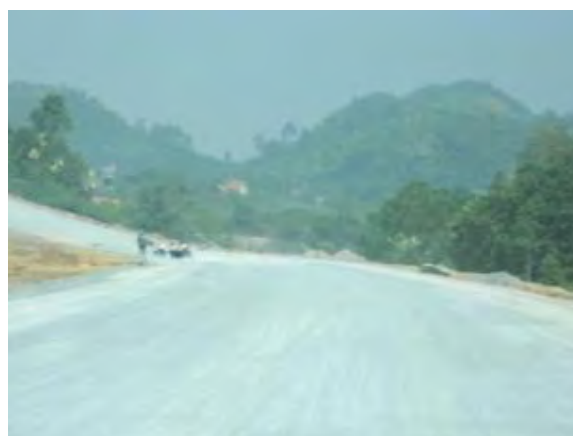
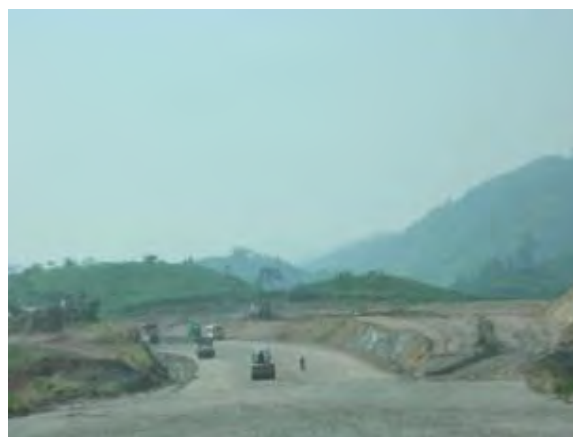
Location: Construction site Km158, Km157, Km155, Km171, Ngoi Tha bridge's construction site

Description: Construction site is tidy and clean

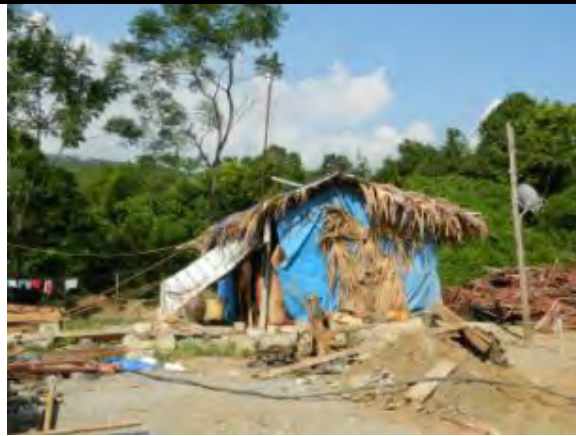
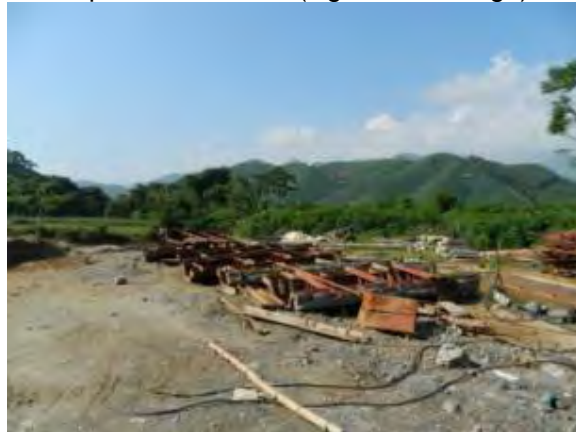
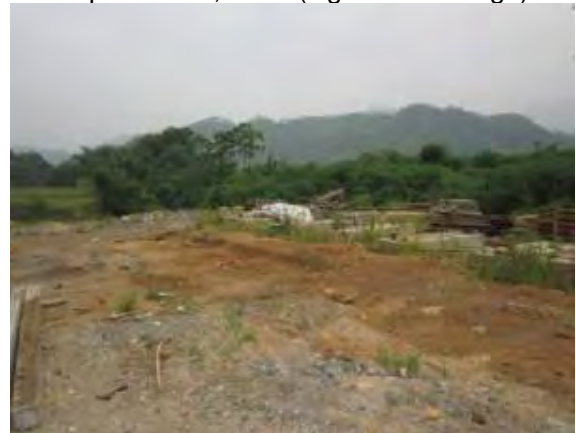
Location: The worker's camp at Ngoi Chac bridge

Problems description and cause: Working and living condition of this camp are not good. Construction materials are also unorganized posing safety risks.

Current status: The Contractor have got some actions in order to improve living and working condition at this camp.

- Worker's camp has been cleaned;
- Construction materials have been arranged;

Recommendation and Action taken by Engineer: The Engineer requested the Contractor to implement the tasks as follows:

- + Improve working and living condition at these workers camps;
- + Implement good housekeeping practices;
- + Build sanitary toilets at all the workers camps;
- + Provide fire-extinguishers, first aid kits, dustbins at all the workers camps;

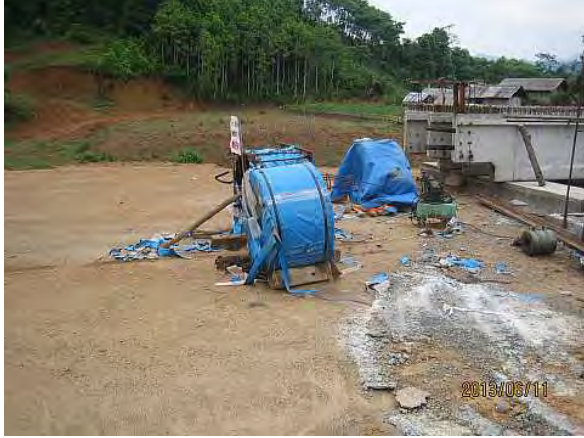
<p>11.6.2013</p>	Location: Cam Con Bridge Km214+678

<p>2.7.2013</p>	Site visit: 11.6; 2.7 and 23.7.2013; 6.8.2013
Date first observed: 9.5.2013 Problems description and cause: The construction works are not tidy and there is a lot of rubbish on site	Recommendation and Action taken by Engineer: Require the contractor to arrange the construction work, collect and classify rubbish according to regulation
Responsible Party: GRBCC	Deadline: 20.6.2013
Current status: So far the contractor didn't collect and transfer the rubbish to treatment area according to regulations

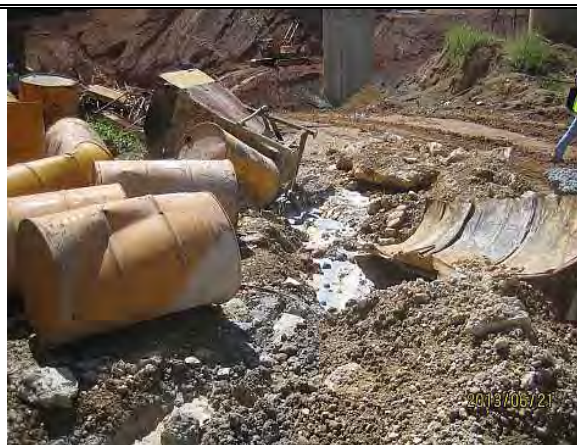
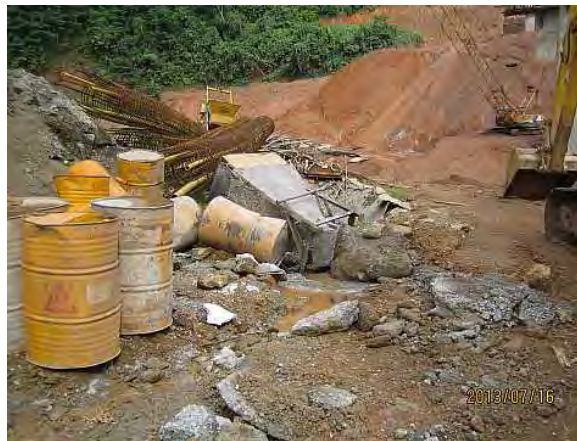
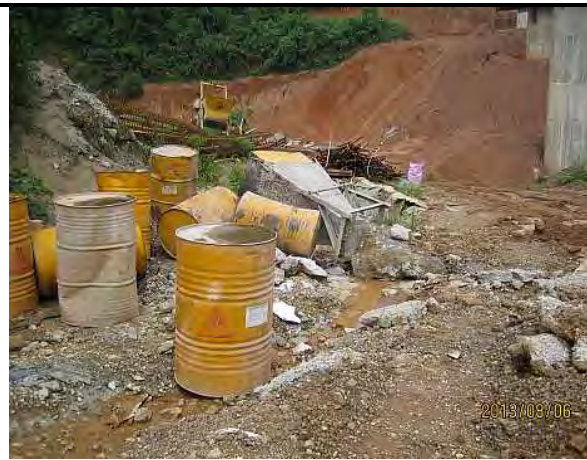
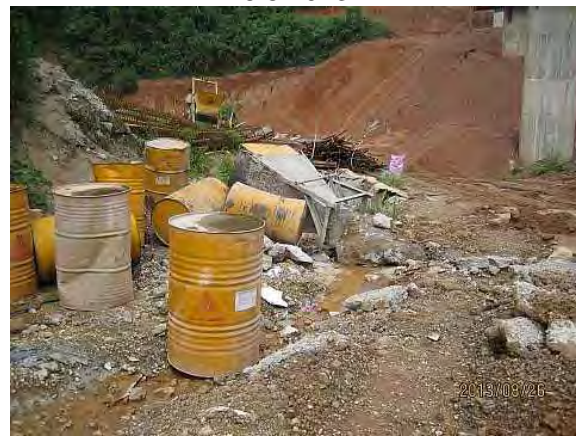
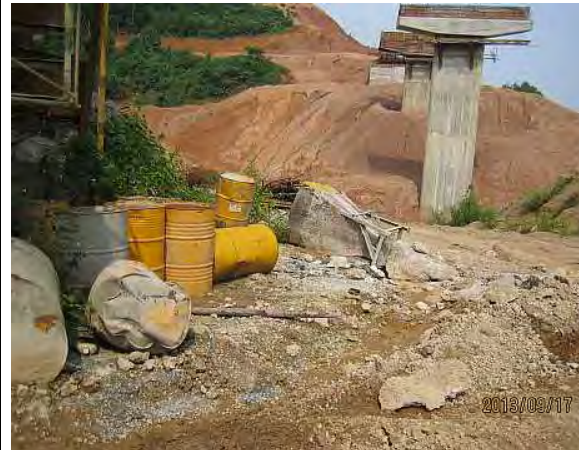
Location: CBP Tan Tien Bridge Km209+329

Problems description and cause: The drainage/canal leading to the settling pond at the CBP Tan Tien bridge was noted almost filled with cement slurry

In July and August: So far the contractor did not clear the canal to ensure efficiency and to avoid spill-over

In September: So far the contractor did not clear the canal to ensure efficiency and to avoid spill-over. On September 18th, 2013, the contractor sent to ST4 letter N^o: Ref. GRBCC- GETINSA- A7- 1731 issued "Inform about removing concrete batching plant at

Km209+300", Actually in this place, there is not any construction team and the contractor proposed not to continue using this concrete batching plant.

Recommendation and Action taken by Engineer: Require the contractor to Undertake dredging of settling pond and canal to ensure efficiency and to avoid spill-over

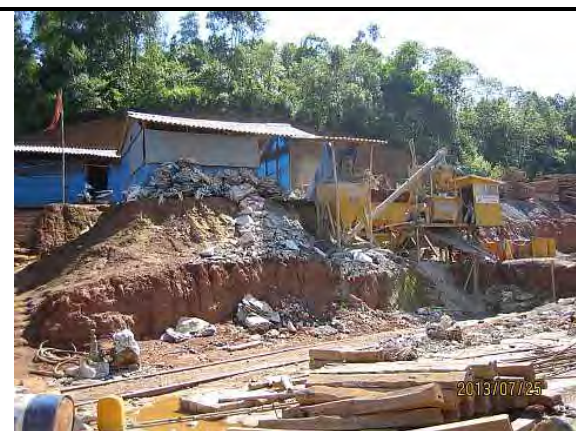
Location: Son Hai Bridge Km227+065

Problems description and cause: The construction works are not tidy and there is much rubbish on site

<p>15.8.2013</p>	Deadline: 15.6.2013
	Current status: Not yet improved   <p>18.9.2013</p>

Recommendation and Action taken by Engineer: Require the contractor to arrange the construction work, collect and classify rubbish according to regulation

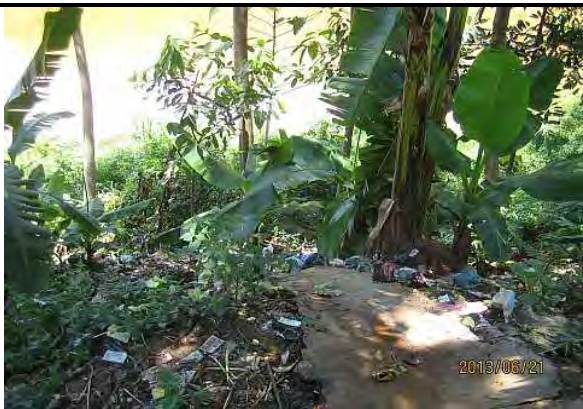
<p>21.6.2013</p>	Location: Suoi Nhu Bridge Km218+040
	Site visit: 21.6 and 17.7.2013

<p>17.7.2013</p>	Date first observed: 21.6.2013
	Problems description and cause: The construction works are not tidy and there is much rubbish on site
	Recommendation and Action taken by Engineer: Require the contractor to arrange the construction work, collect and classify rubbish according to regulation
	Responsible Party:
	Deadline: 15.7.2013
	Current status: Had improve

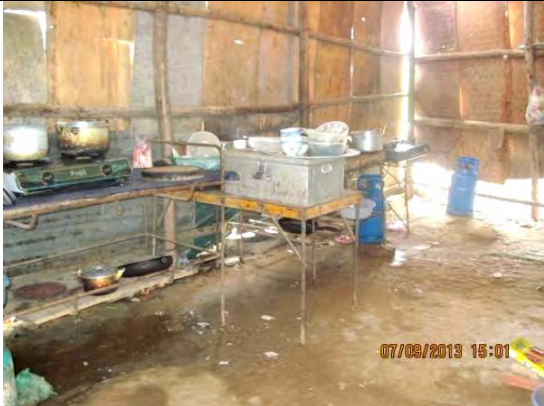
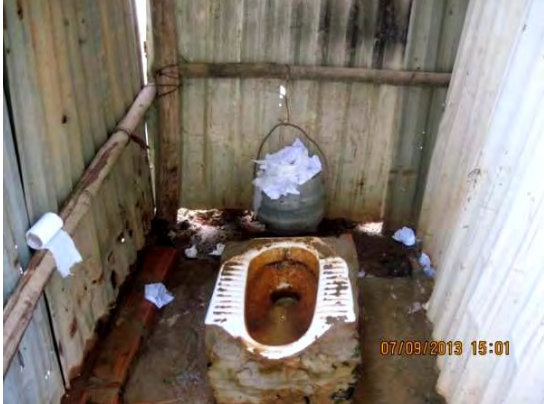
<p>07/09/2013 15:01</p> <p>June 04, 2013</p>	<p>Location: Trung Kien Bridge</p> <p>Site visit: 2, 9, 19, 25 July;</p> <p>Date first observed: 02-Apr-2012</p> <p>Problems description and cause: In July: The workers' camp is dirty with trash surrounding; lack of fire extinguishers</p> <p>Recommendation and Action taken by Engineer: Implement housekeeping at the camp in regular basis to keep the living condition of workers in cleanliness and sanitary condition. Provide first aid kit and fire extinguishers for worker's camp. Refer to letter GET1/POS/A1/1900, 1920, 1993, 2016, 2091</p> <p>Responsible Party: Contractor</p> <p>Deadline: Immediate</p> <p>Current status: In July: Mitigation measure has been implemented</p>

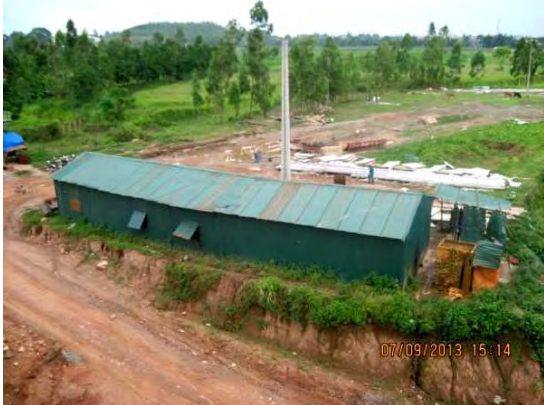
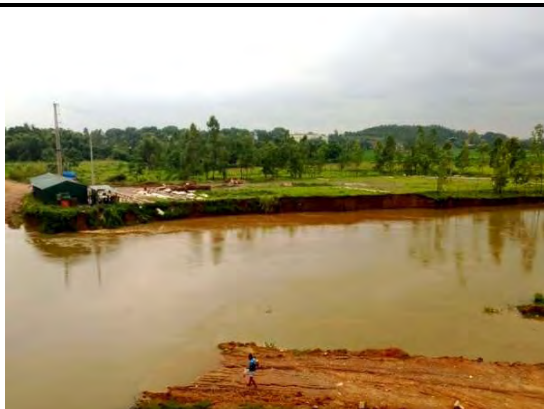
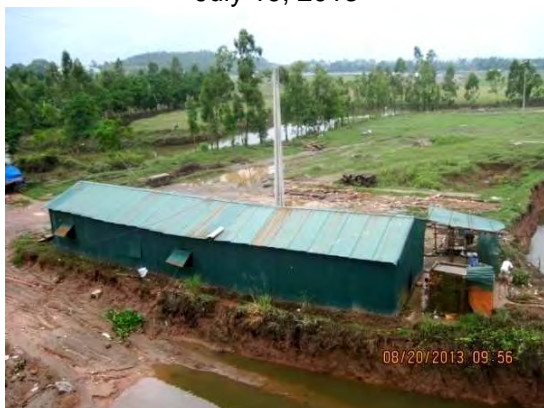
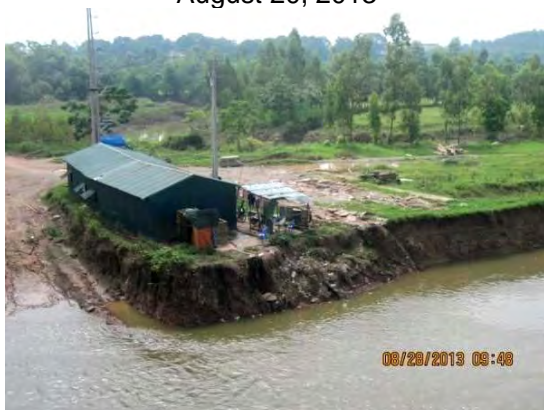
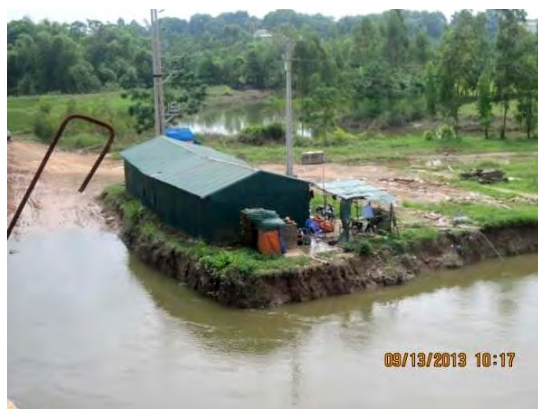
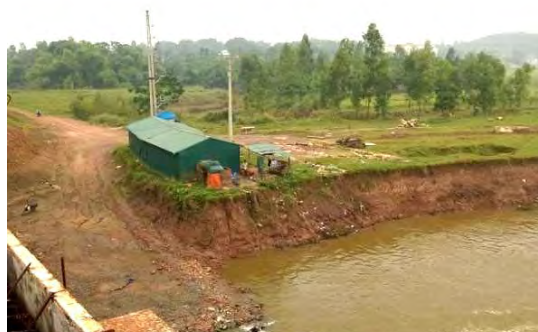
<p>07/09/2013 15:14</p> <p>July 09, 2013</p>	<p>Location: Dai Duong Bridge</p> <p>Site visit: 2, 9, 19, 25 July; 13, 16, 20, 26, 28 August; 10, 13, 17, 24 September</p> <p>Date first observed: 02-Apr-2013</p> <p>Problems description and cause: The worker's camp has not been provided septic tank</p> <p>Recommendation and Action taken by Engineer:</p>

Current status: Mitigation measure has not been implemented

In July: The Engineer has requested the Contractor to provide septic tank for workers and implement housekeeping work in regular basis to keep the worker's camp in cleanliness and sanitary condition

In August and September: The Engineer has requested the Contractor to provide septic tank for workers and implement housekeeping work in regular basis to keep the worker's camp in cleanliness and sanitary condition. Refer to letter GET1/POS/A1/2016, 2091

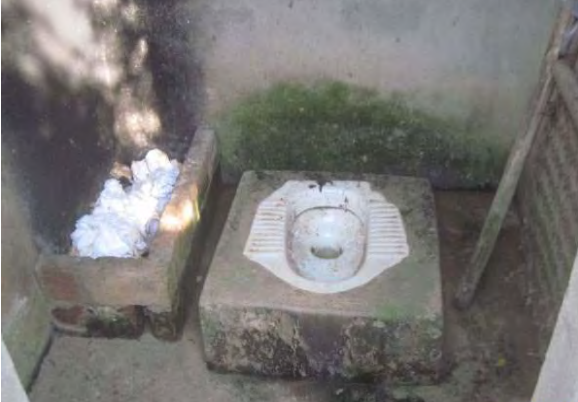
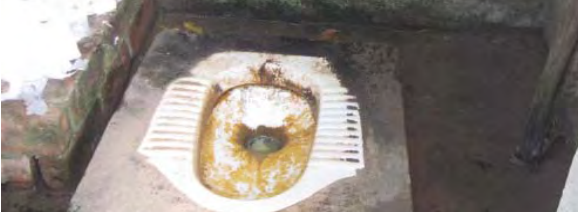
Location: Workers' camps at Ngoi Gianh Bridge
<p>24/7/2013</p>	Site visit: 10, 13, 17, 24, 29, 31/7/2013; 02, 07, 08, 15, 16, 22, 29/8/2013; 05, 11, 12, 19, 24, 26/9/2013

Date first observed: 07/3/2013
<p>22/8/2013</p>	Problems description and cause: A lot of rubbish at Worker' Camp.

Recommendation and Action taken by Engineer: Request Contractor to clean rubbish at Worker' Camp.
<p>26/9/2013</p>	Responsible Party:
<p>26/9/2013</p>	Deadline: Daily
<p>26/9/2013</p>	Current status: In July and August: Not improved In September: Improved

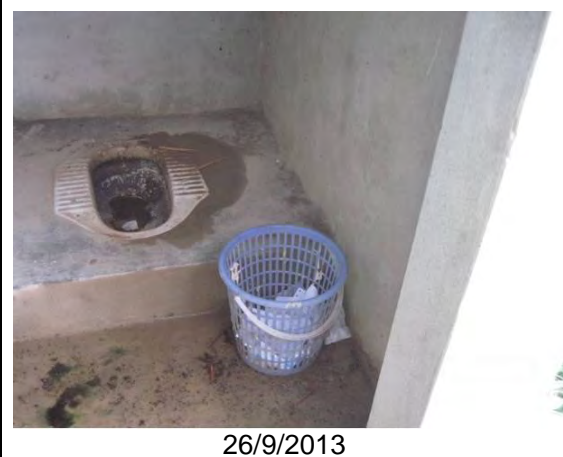
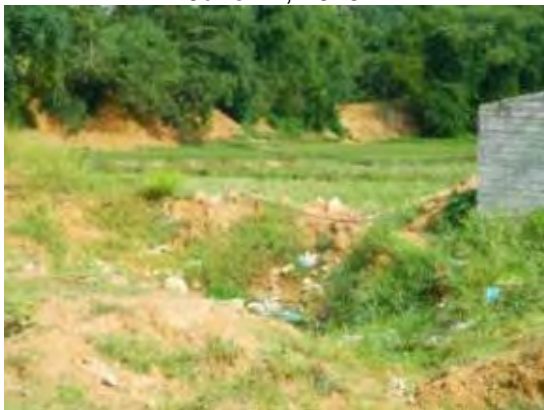
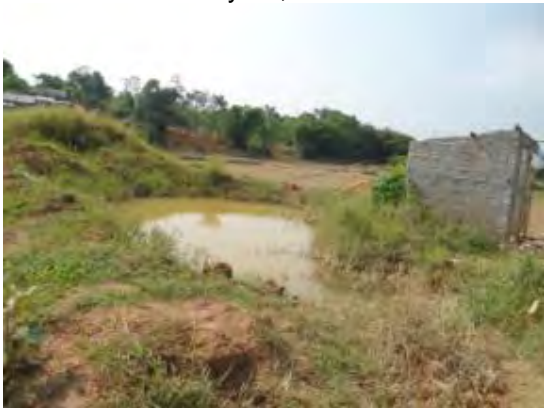
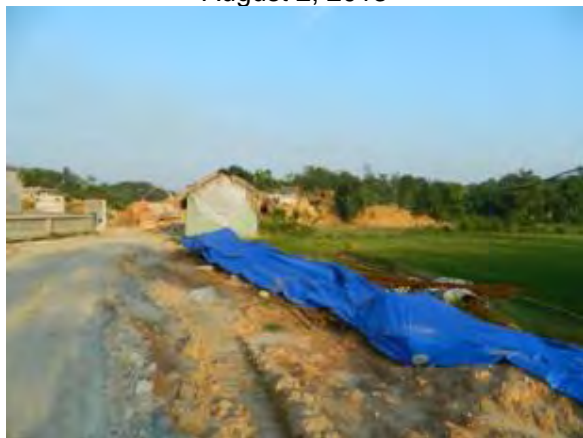
Location: Ngoi Gua bridge site
	Site visit: 22 Jun, 11 Jul, 2 and 9 Aug, 16 September, 2013
	Date first observed: 22 nd June, 2013
	Problems description and cause: The workers camp at km 128 (Ngoi Gua bridge site) is garbage strewn (no bins). Construction materials are also unorganized posing safety risks.
	Recommendation and Action taken by Engineer: The Contractor must implement the tasks as follows: 1. Implement good housekeeping practices; 2. Build sanitary toilets at all the workers camps; 3. Provide fire-extinguishers, first aid kits, dustbins at all the workers camps;
	Responsible Party: Keangnam Contractor
	Deadline: Immediate
	Current status: In July and August: No important changes, except cleaning the waste on the ground In September: The Contractor cleared at this location and arrange construction material. But, Sanitary toilets, fire-extinguishers, first aid kits, dustbins still have not been provided at this camp,

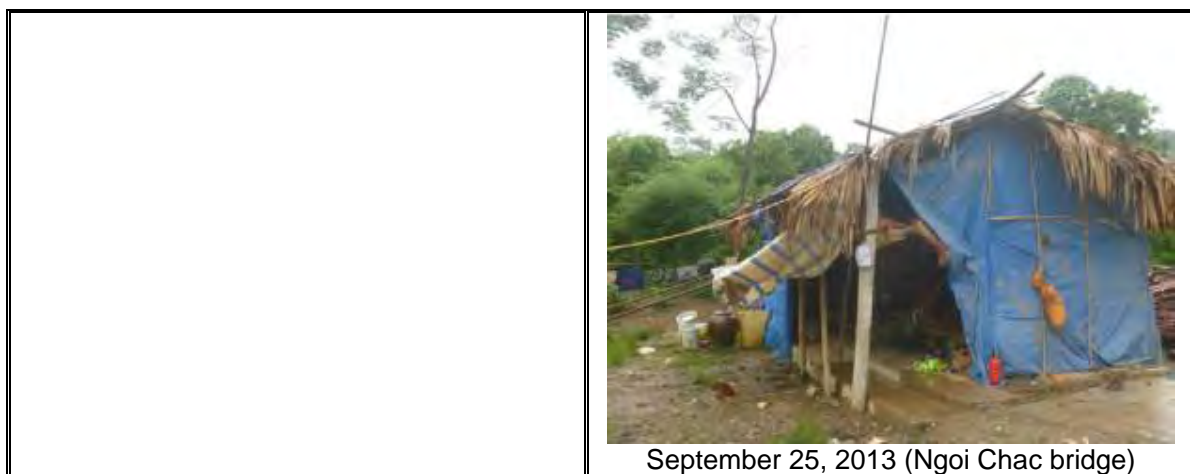
September 25, 2013 (Ngoi Chac bridge)	Responsible Party: Doosan Contractor
	Deadline: 25-September-2013
	Current status: The Contractor have got some actions in order to improve living and working condition at this camp. - Worker's camp has been cleaned; - Construction materials have been arranged;

Location: The worker's camp at Ngoi Chac bridge
	Site visit: 4 and 25 September, 2013
	Date first observed: 4 th September, 2013
 	Problems description and cause: Working and living condition of this camp are not good. Construction materials are also unorganized posing safety risks.
 	Recommendation and Action taken by Engineer: The Engineer requested the Contractor to implement the tasks as follows: + Improve working and living condition at these workers camps; + Implement good housekeeping practices; + Build sanitary toilets at all the workers camps; + Provide fire-extinguishers, first aid kits, dustbins at all the workers camps;

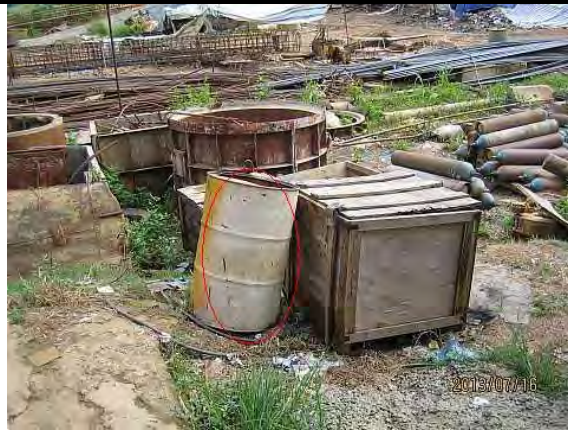
Location: Worker camps at Km209+329
<p>21.6.2013</p>	Site visit: 21.6 and 16.7.2013
	Date first observed: 21.6.2013
	Problems description and cause: There is not any rubbish bin at this workers' camp
	Recommendation and Action taken by Engineer: The contractor is required to provide the rubbish bin
	Responsible Party: GRBCC
	Deadline: 15.7.2013
 	Current status: The contractor had provided the rubbish bin
<p>16.7.2013</p>

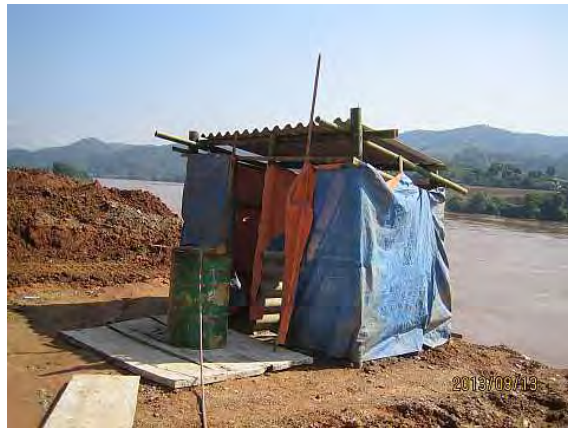
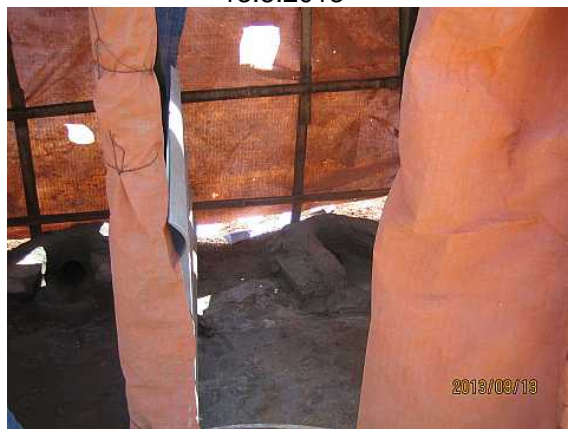
Problems description and cause: There is not any rubbish bin in the workers' camp and there is not any septic tank at the toilet

Current status: The contractor has not yet provided the rubbish bin and septic tank for toilet

Recommendation and Action taken by Engineer: The contractor is required to provide the rubbish bin and septic tanks for toilet

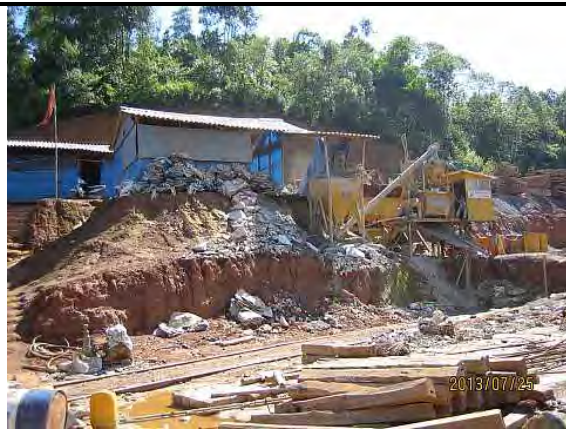
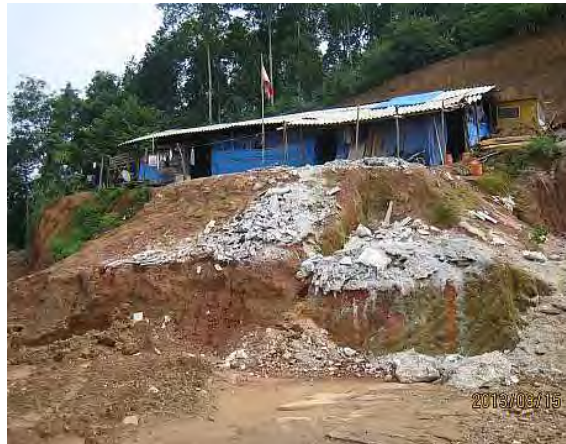
Problems description and cause: A lot of rubbish at Worker' Camp.

Recommendation and Action taken by Engineer: Request Contractor to clean rubbish at Worker' Camp.

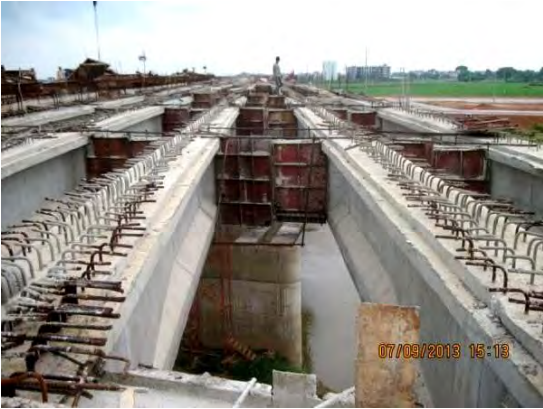
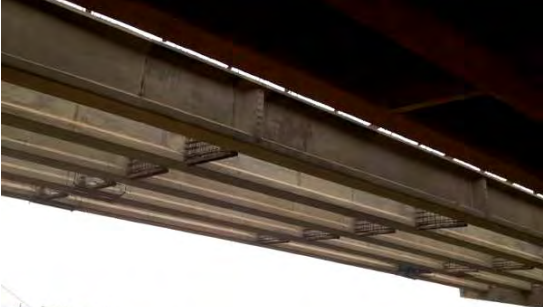
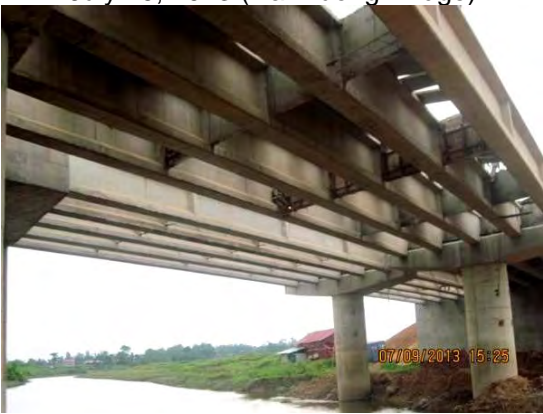
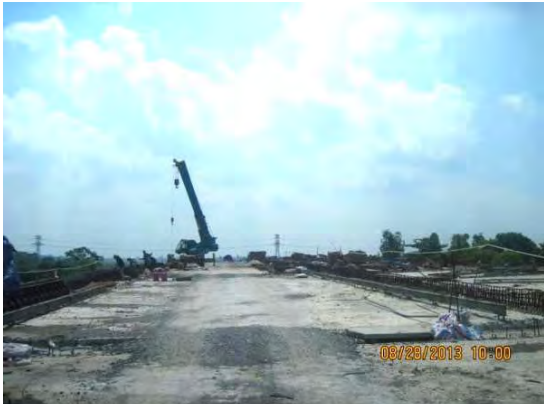
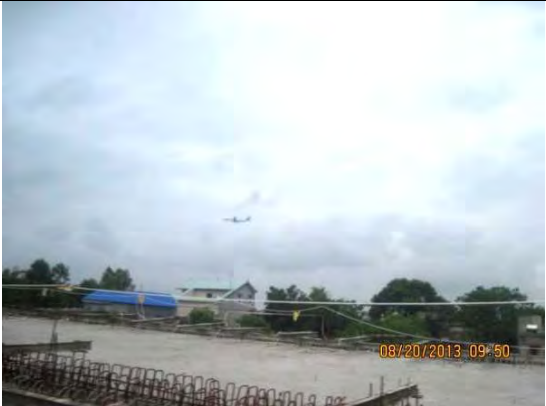
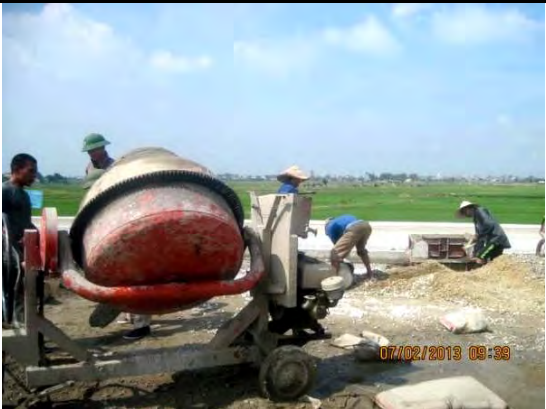
<p>Problems description and cause: Lack of safety net under launched girders</p>
<p>July 19, 2013 (Dai Duong Bridge)</p>	<p>Recommendation and Action taken by Engineer: The Contractor has to construct the safety work ways and install the safety net under launched girder to ensure the safety for workers. Refer to letter GET1/POS/A1/1900, 1920, 1949, 2016</p>

<p>Current status:</p> <p>In July: Mitigation measure has not been implemented</p> <p>In August: The Contractor has finished deck slabs of these structures</p>

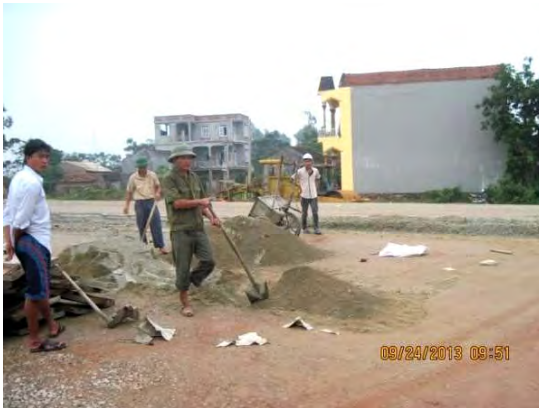
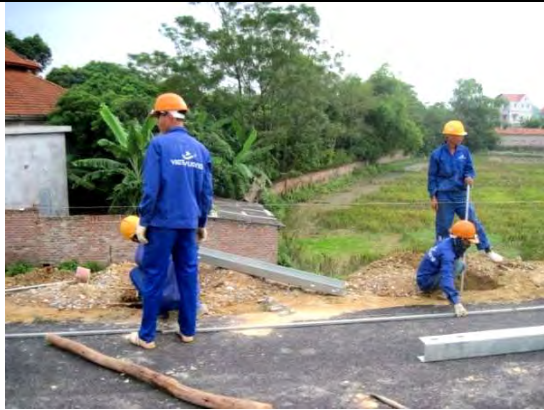
Date first observed: 04-June-2013
	Problems description and cause: Workers didn't use PPE at work
	Recommendation and Action taken by Engineer: The Engineer has requested the Contractor to ensure all the workers to use enough PPE at work. Refer to letter GET1/POS/A1/2016
	Responsible Party: Contractor
	Deadline: Immediate and daily control
	<p>Current status:</p> <p>In August: During the site inspections, at some sections we still detected this issue happening</p> <p>In September: The Contractor has provided PPE for workers</p>

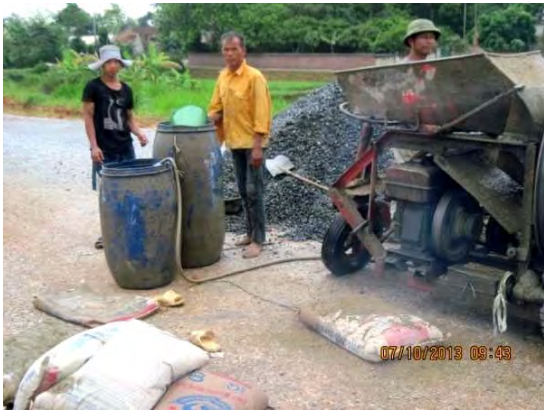
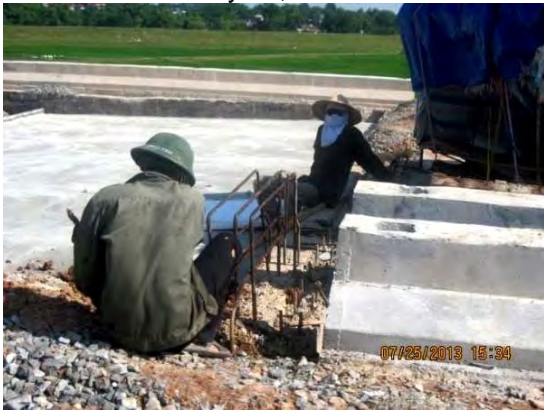
Problems description and cause: Workers didn't use PPE at work

In August: Mitigation measure has been implemented

Recommendation and Action taken by Engineer: Ensure all the workers to use enough PPE at work and daily control. Refer to letter GET1/POS/A2/2088, 2090, 2118

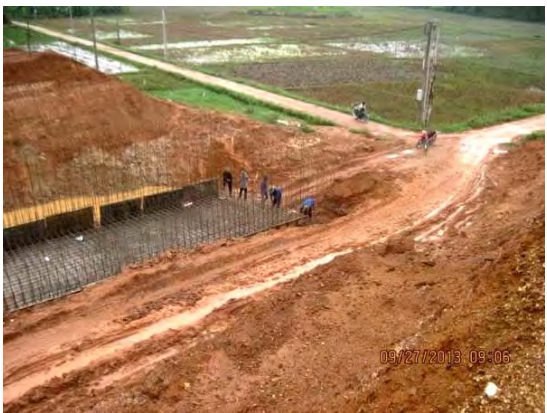
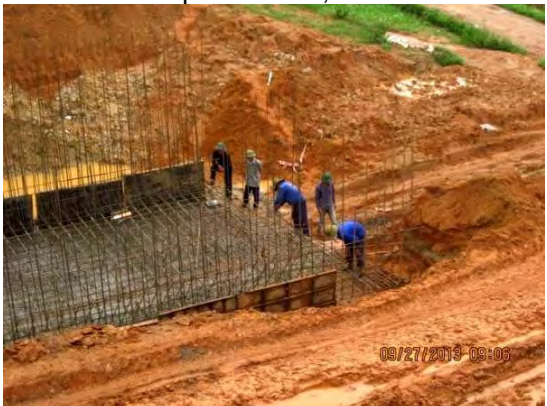
<table><tr><td>Location: Box culvert Km 30+875</td></tr><tr><td>Problems description and cause: Workers didn't use PPE at work</td></tr></table>

<table><tr><td>Location: Box culvert Km 30+875</td></tr><tr><td>Recommendation and Action taken by Engineer: The Engineer has orally requested the Contractor to provide PPE for workers and ensure all the workers to use enough PPE at work and daily control</td></tr></table>
