Environmental Monitoring Report

Quarterly Report
July - September 2013

VIE: Greater Mekong Subregion Kunming–Hai Phong Transport Corridor Noi Bai– Lao Cai Highway Project

Prepared by Getinsa for the Vietnam Expressway Corporation, the Ministry of Transport,
the Government of Viet Nam, and the Asian Development Bank

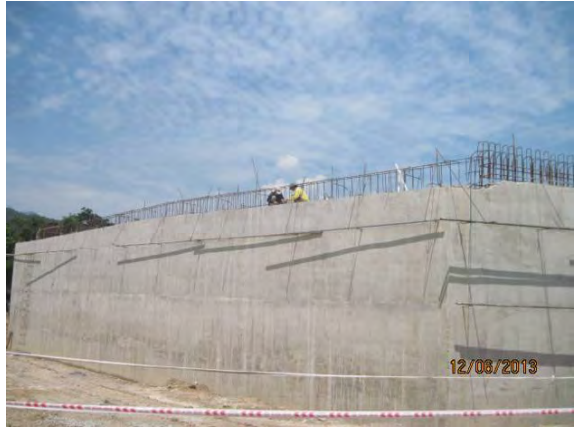
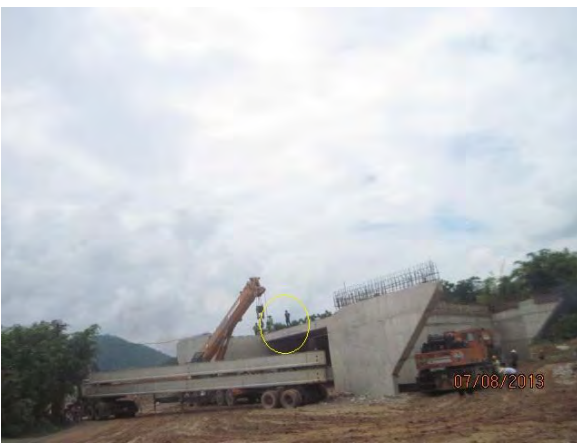
Location: QL32C bridge
12/6/2013	Site visit: 10, 13, 17, 24, 29, 31/7/2013; 02, 07, 08, 15, 16, 22, 29/8/2013

Date first observed: 12/6/2013
07/8/2013	Problems description and cause: Workers do not use enough PPEs while working on site
	Recommendation and Action taken by Engineer: Require the subcontractor to remind and propose labour safety for workers. If any worker continues to violate the regulation, he will be fired.
	Responsible Party:
	Deadline: Daily
	Current status: Not improved

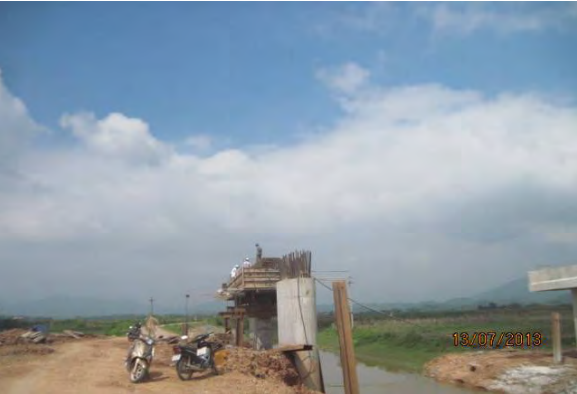
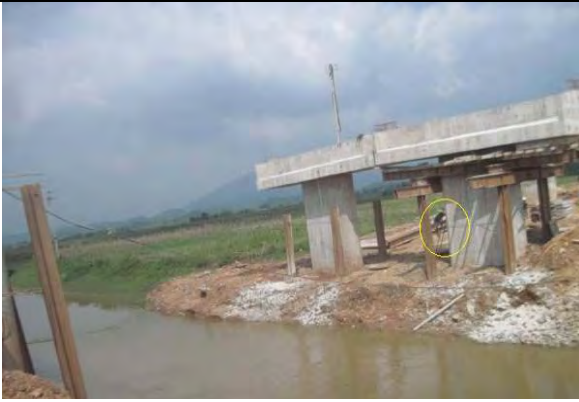
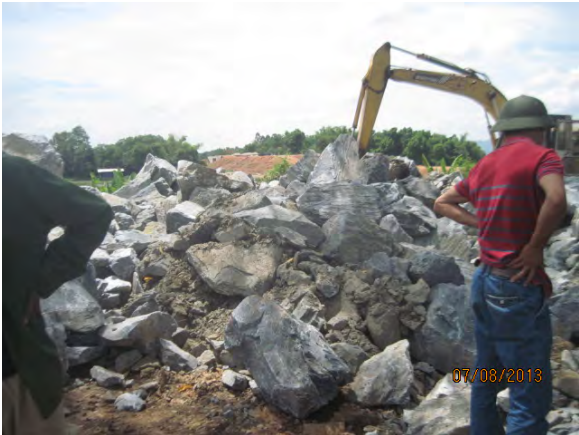
Location: Ngoi Gianh bridge
13/7/2013	Site visit: 10,13,17,24,29,31/7/2013; 02, 07, 08, 15, 16, 22, 29/8/2013; 05, 11, 12, 19, 24, 26/9/2013
	Date first observed: 13/7/2013
	Problems description and cause: Workers do not use enough PPEs while working on site
	Recommendation and Action taken by Engineer: Require the subcontractor to remind and propose labour safety for workers. If any worker continues to violate the regulation, he will be fired. Beside, local

<p>children were found on site</p>
	<p>Responsible Party:</p>
	<p>Deadline: Daily</p>

<p>07/08/2013</p>	<p>Current status: Not improved</p>

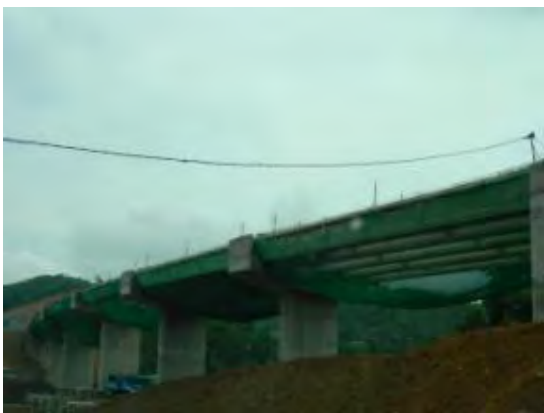
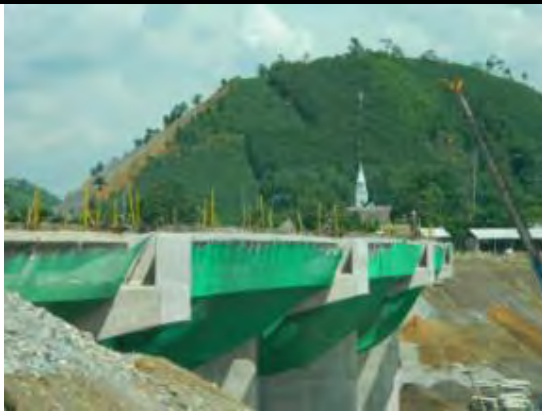
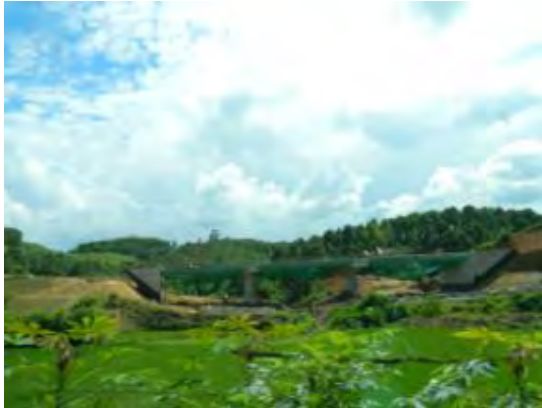
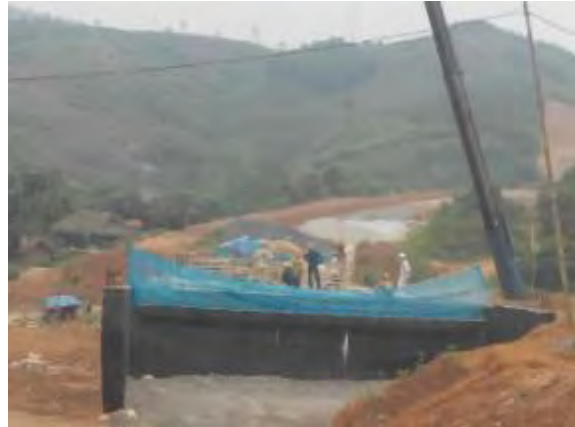
Description: Safety net were installed at bridge's construction site; The workers use fully PPE during work.

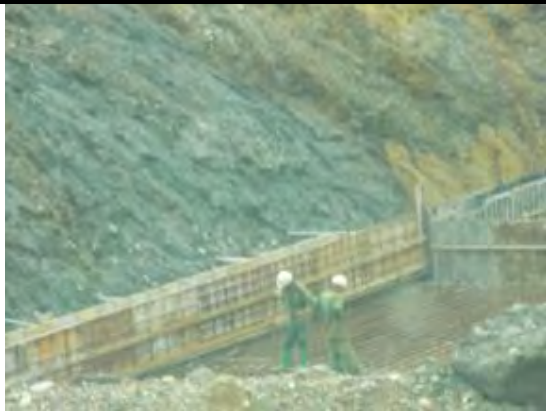
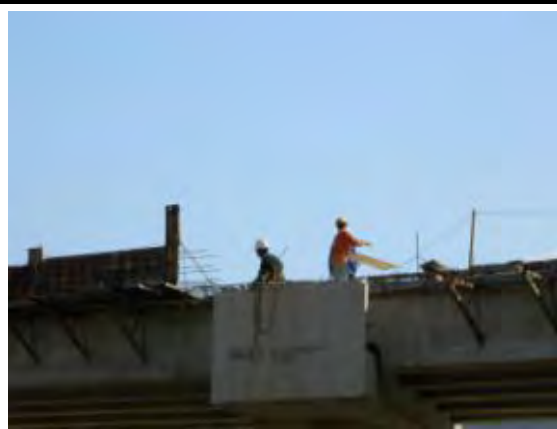
Description: Safety net were installed at bridge's construction site; The workers use fully PPE during work.

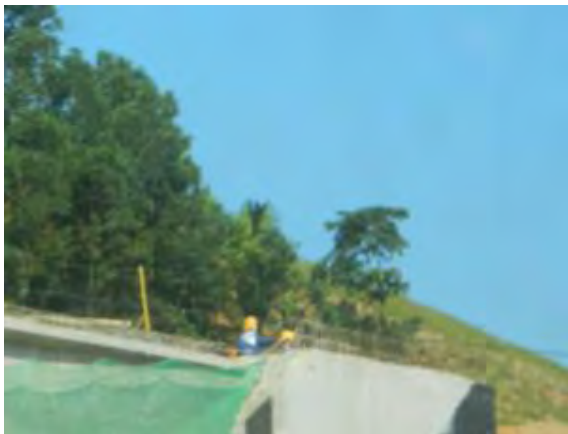
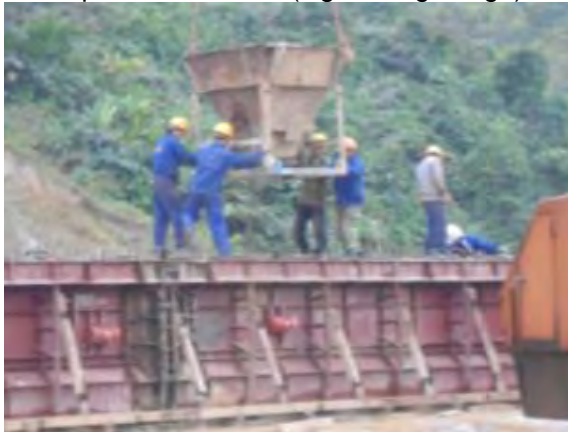
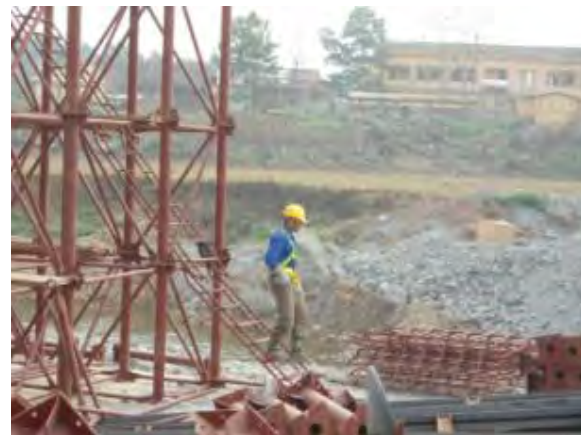
Location: Ngoi Cong bridge. Ngoi Don bridge, Ngoi That bridge

Description: Safety net were installed at bridge's construction site; The workers use fully PPE during work.

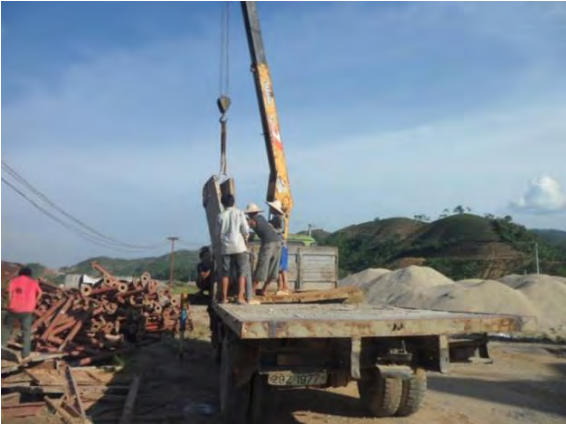
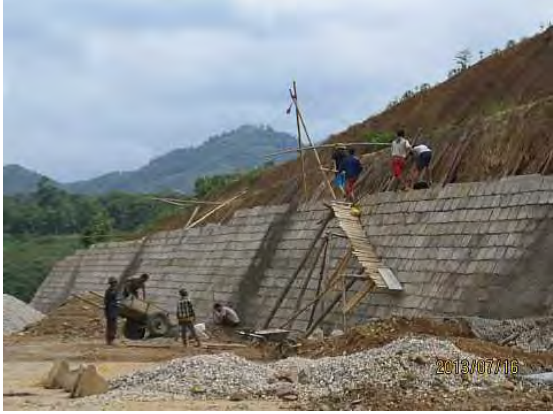
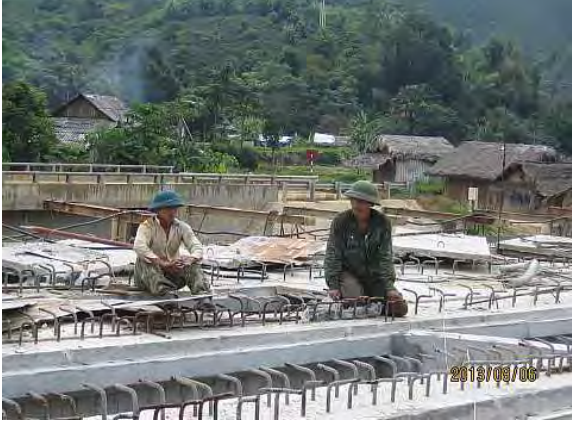
Location: Km195+800; Km202+700 and Km199+050
<p>21.6.2013 at Km195+800</p>	Site visit: 21.6; 16.7 and 6.8.2013

First observed: 21.6.2013
<p>16.7.2013 at Km202+700</p>	Problems description and cause: The workers are not supplied enough PPEs during the working time

Recommendation and Action taken by Engineer: The consultant had issued letter No: Ref. GET- EPMU-2617 with contents: "Proposed to reject the Safety manager and Environment Manager of Package A7"
<p>6.8.2013 at Km199+050</p>	Responsible Party: GRBCC
	Deadline: Immediately
	Current status: During on July the contractor had didn't improve

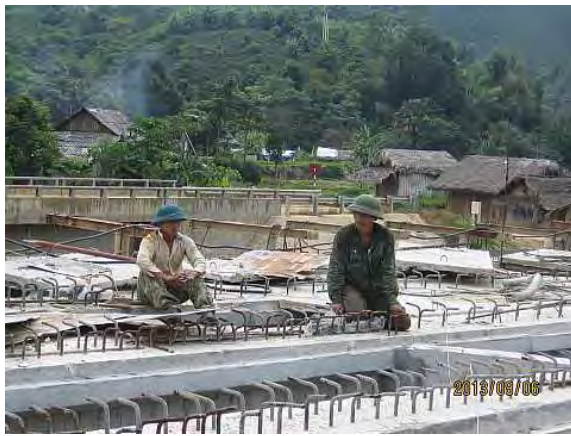
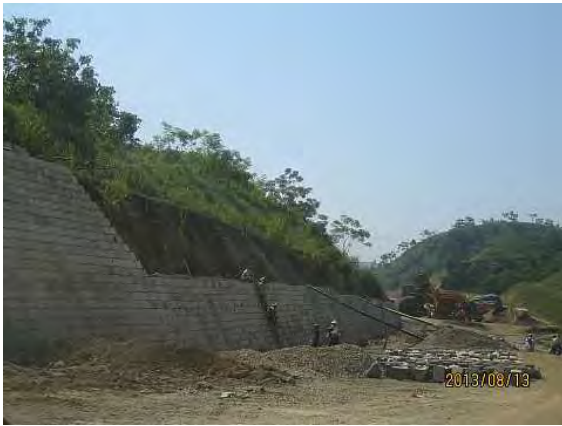
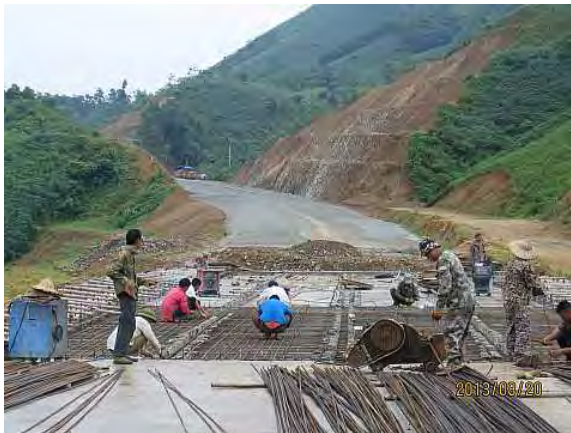
Location: Km199+050; Km202+700;
Km202+500 and Km193+379

Problems description and cause: The workers are not supported the full labour equipment during the working time

Current status: During August the contractor had not improved

Recommendation and Action taken by Engineer: The consultant had issued letter No: Ref. GET- EPMU-2617 with contents: "Proposed to reject the Safety manager and Environment Manager of Package A7"

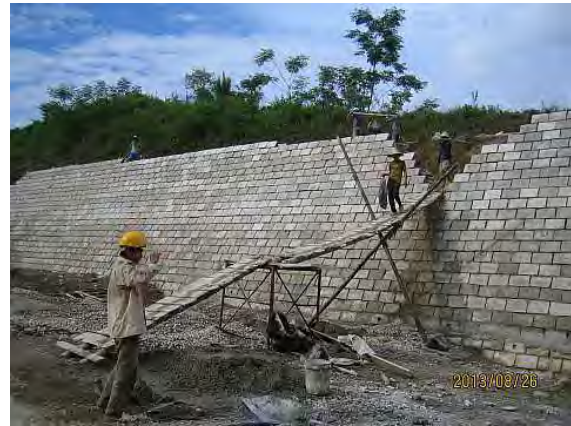
<p>26.8.2013 at Km202+700</p>	Location: Km202+700;
	Site visit: 26.8.2013; 17.9.2013
  <p>17.9.2013 at Km202+700</p>	First observed: 21.6.2013
	Problems description and cause: The workers have not been supplied fully PPEs during the working time
	Recommendation and Action taken by Engineer: The consultant had issued letter No: Ref. GET- EPMU-2617 with contents: "Proposed to reject the Safety manager and Environment Manager of Package A7" and Consultant had issued many letters to the contractor such as: Get4- GRBCC- 952. 979 and GET- GUA- 107, 119, 125
	Responsible Party: GRBCC
	Deadline: Immediately
	Current status: Not improved

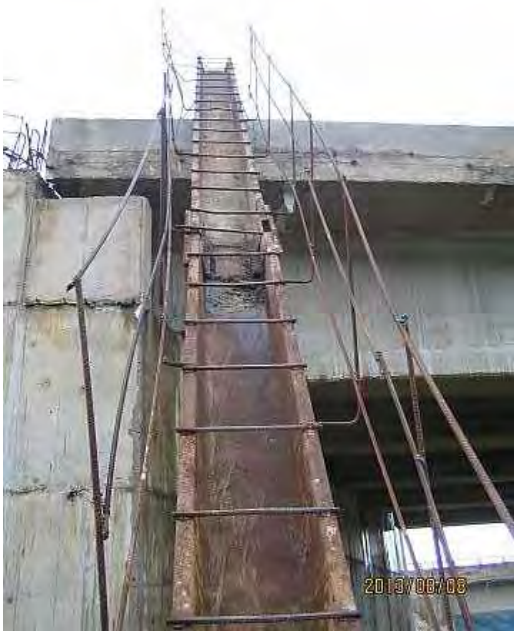
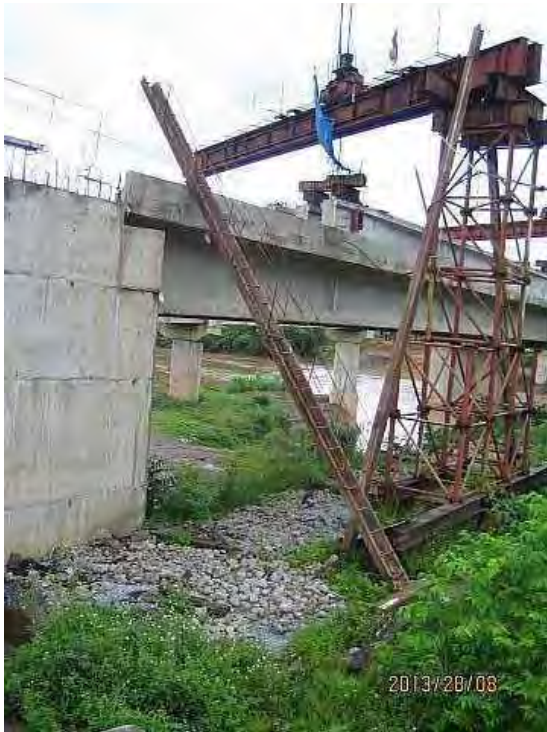
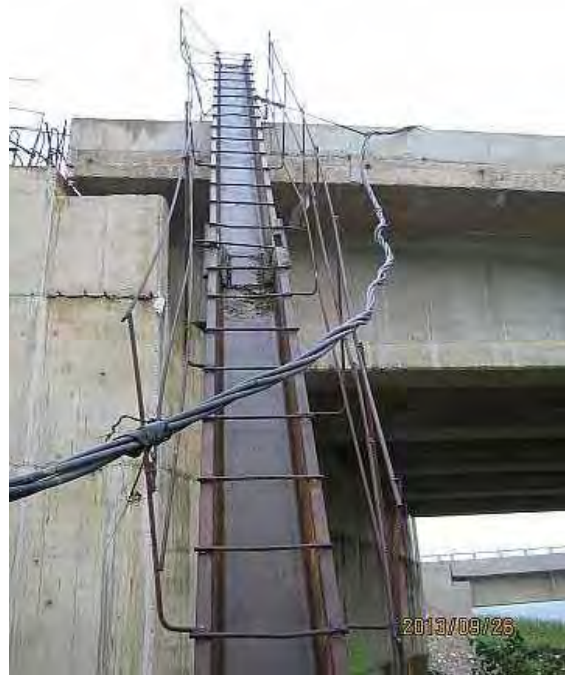
<p>25.7.2013</p>	Location: Construction works of Suoi Nhu Bridge Km218+040
	Site visit: 25.7.2013 and 8.8.2013; 28.8.2013; 26.9.2013
	Date first observed: 25.7.2013
	Problems description and cause: we observed that the access ladder leads to construction the deck slab of Suoi Nhu Bridge is not safe enough for workers, inspectors and engineers to go up and come down during time working and inspection
	Recommendation and Action taken by Engineer: The contractor is requested to

Current status: Had improved

repair and fix IMMEDIATELY the access ladder according to project safety plant and method statement approved by Engineer

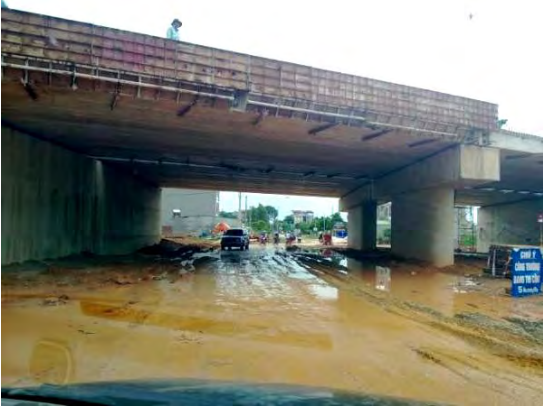
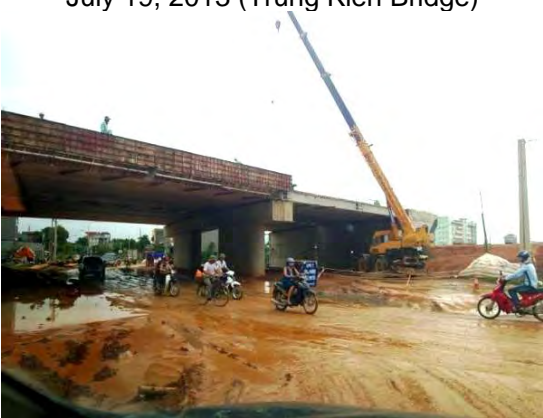
<p>July 19, 2013(Trung Kien Bridge)</p>	Location: Construction sites where intersect public roads
	Site visit: 2, 9, 19, 25 July;
	Date first observed: 19-July-2013
	Problems description and cause: Dirtiness and slippery status is noted on existing road at TL301 Bridge construction site
	Recommendation and Action taken by Engineer: The Engineer has orally requested the Contractor to clean and repair the existing road to ensure the traffic safety for road users. Refer to letter GET1/POS/A1/2032
	Responsible Party: Contractor
	Deadline: Immediate and daily control
	Current status: Mitigation measures have not been implemented

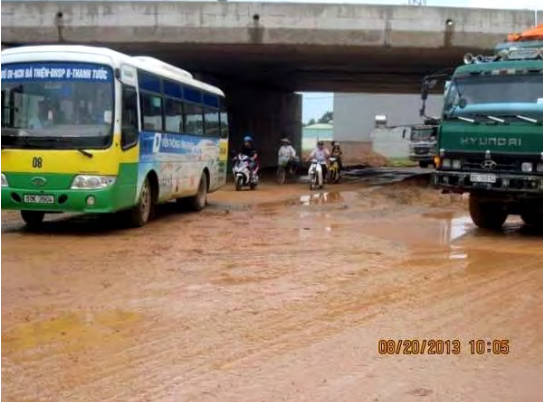
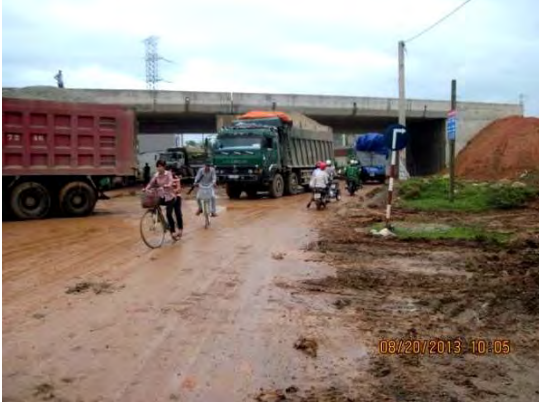
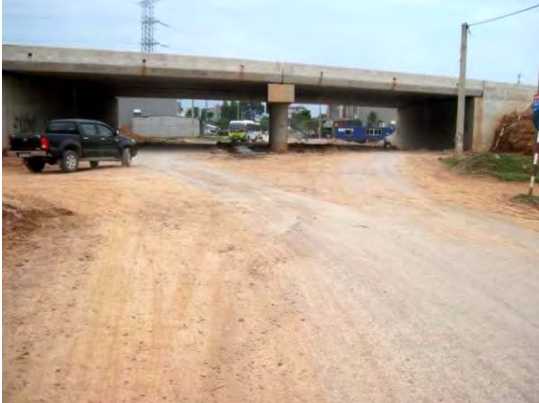
<p>August 20, 2013</p>	Location: TL301 Bridge
	Site visit: 13, 20, 26, 28 August; 10, 13, 17, 24 September
	Date first observed: 19-July-2013
	Problems description and cause: Dirtiness and slippery status is noted on existing road at TL301 Bridge construction site
	Recommendation and Action taken by Engineer: The Engineer has orally requested the Contractor to clean and repair the existing road to ensure the traffic safety for road users.

Deadline: 23-Aug-2013
September 17, 2013	<p>Current status:</p> <p>In Aug: Mitigation measures have not been implemented</p> <p>In Sep: The Contractor has repaired the surface of detour road but not supplemented fence/signboard/lighting system</p>

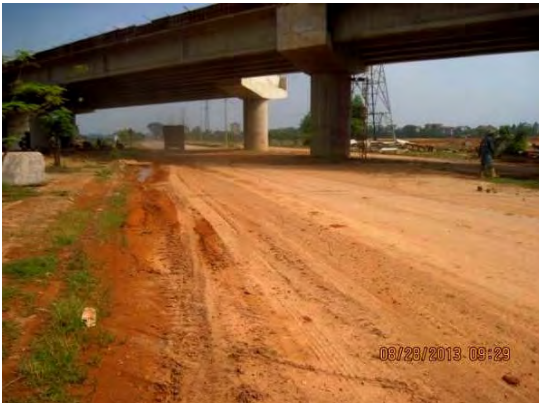
Location: Ba Thien Bridge
August 28, 2013	Site visit: 13, 20, 26, 28 Aug.; 10, 13, 17, 24 Sep.
	Date first observed: 28-Aug-2013
	Problems description and cause: Dirt is tracked onto public road causing difficulty status and endanger road users
	<p>Recommendation and Action taken by Engineer: The Engineer has orally requested the Contractor to clean and repair the existing road to ensure the traffic safety for road users.</p>
	Responsible Party: Contractor
	Deadline: Immediate

<p>August 28, 2013</p>	
 	<p>Current status: Mitigation measures have not been implemented</p>
<p>September 24, 2013</p>

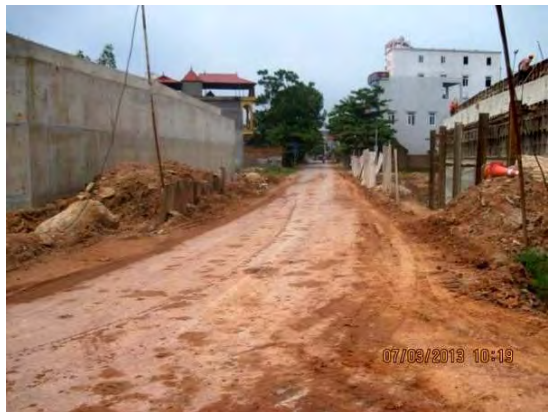
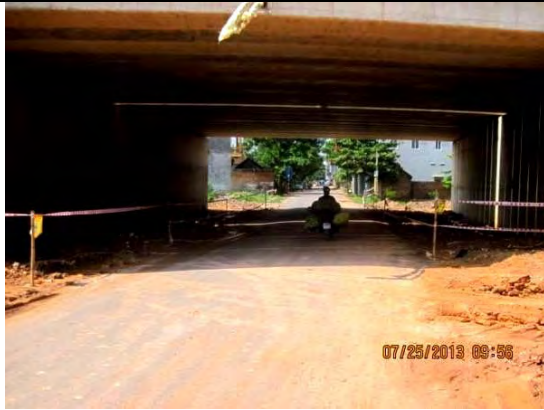
<p>Location: TL309 Bridge</p>
	<p>Site visit: 3, 10, 18, 25 July;</p>
	<p>Date first observed: 15-Mar-2013</p>
	<p>Problems description and cause: There is no safety fence, no traffic guide, no signboard and dirt is tracked onto public road during carrying out the construction work that affect public traffic</p>
	<p>Recommendation and Action taken by Engineer: Reinstall the fence at both construction sites and supplement the signboard and lighting system. All the items must be met specification. Refer to letter</p>

Current status: Mitigation measures have been implemented

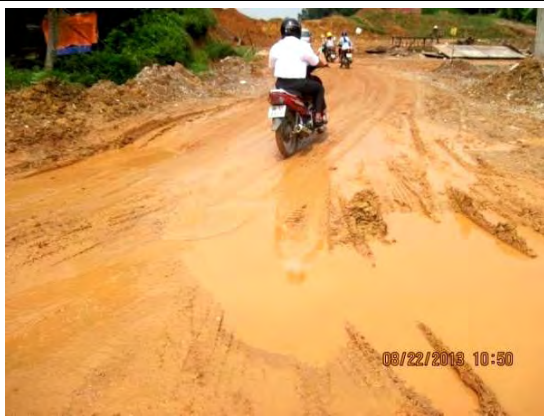
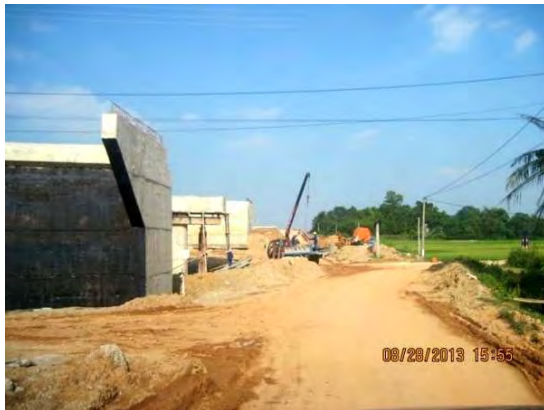
Location: TL305C Bridge

Problems description and cause: The detour road deteriorated and lack of warning fence

Current status: Mitigation measures have not been implemented

Recommendation and Action taken by Engineer: Leveling the detour road and supplement base/sub-base on the surface of detour road to avoid slippery status; supplement warning fence as well

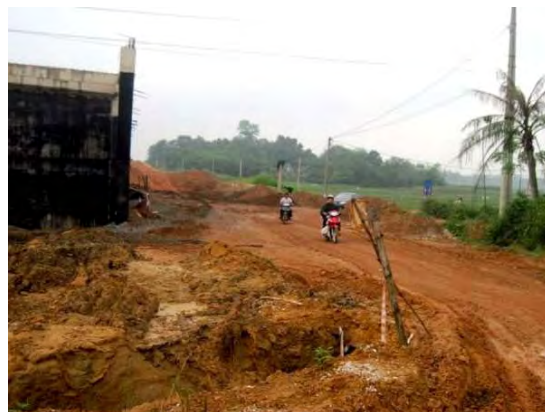
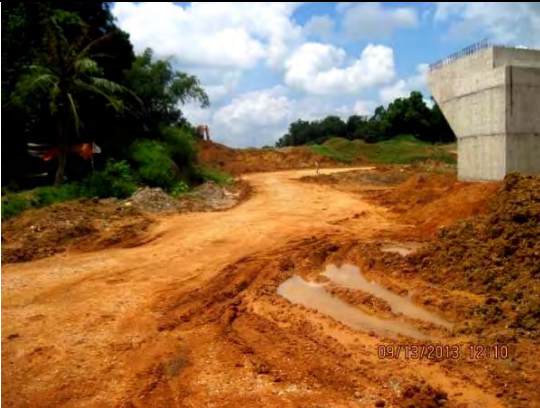
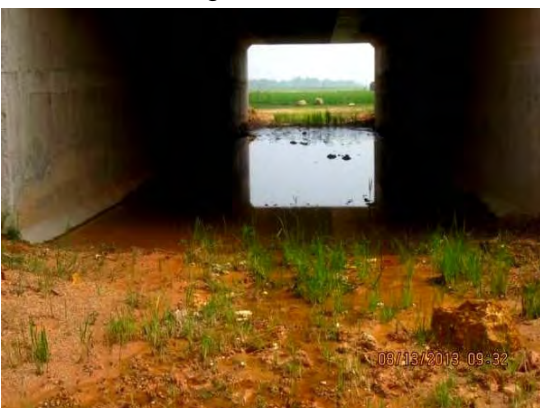
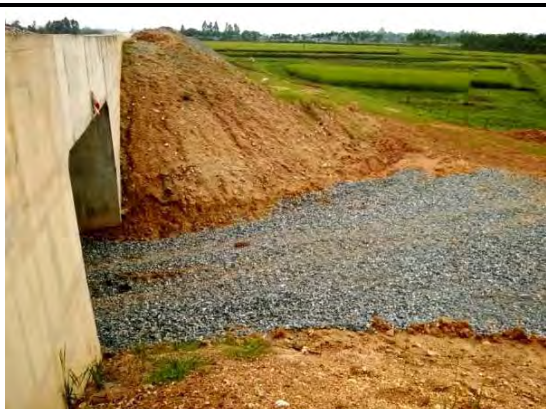
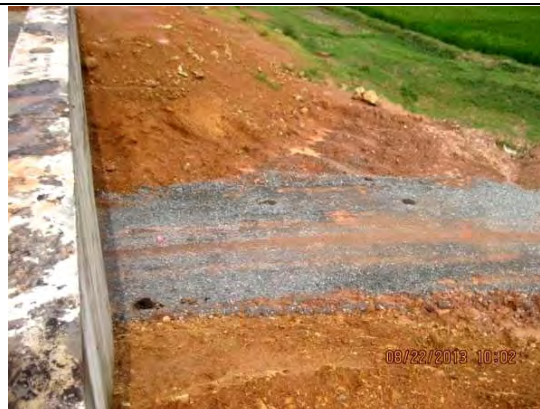
<p>September 17, 2013</p>
<p>September 13, 2013</p>	
 	<p>Location: Underpass box culverts Km 36+460 and Km 36+915</p>
<p>August 13, 2013</p>	<p>Site visit: 13, 15, 22, 28 August;</p>

<p>Date first observed: 13-Aug-2013</p>
<p>August 13, 2013</p>	<p>Problems description and cause: Dirt is tracked into underpass and caused slippery status and difficulty for road users</p> <p>Recommendation and Action taken by Engineer: Remove dirt from underpass; supplement base/sub-base on the surface of access road to avoid slippery status; apply erosion control measures. Refer to letter GET1/POS/A2/2154</p>
	<p>Responsible Party: Contractor</p>
	<p>Deadline: 14-Aug-2013</p>
	<p>Current status: Mitigation measures have been implemented</p>

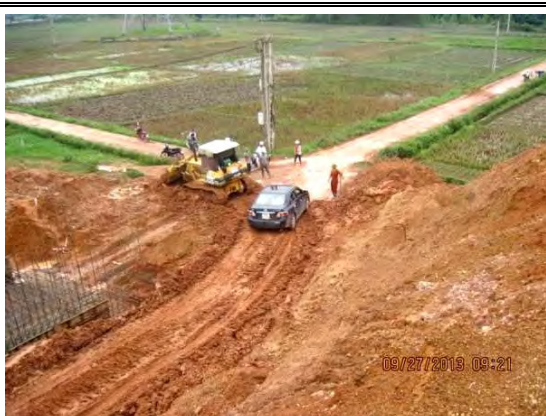
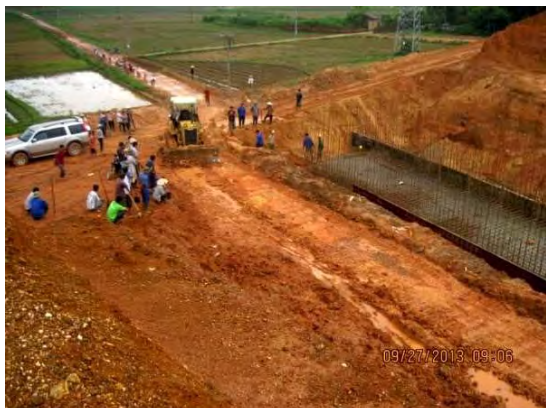
Location: Underpass box culverts Km 30+875

Problems description and cause: Dirt is tracked onto temporary road and caused slippery status and difficulty for road users

Recommendation and Action taken by Engineer: Remove dirt from underpass; supplement base/sub-base on the surface of access road to avoid slippery status; apply erosion control measures

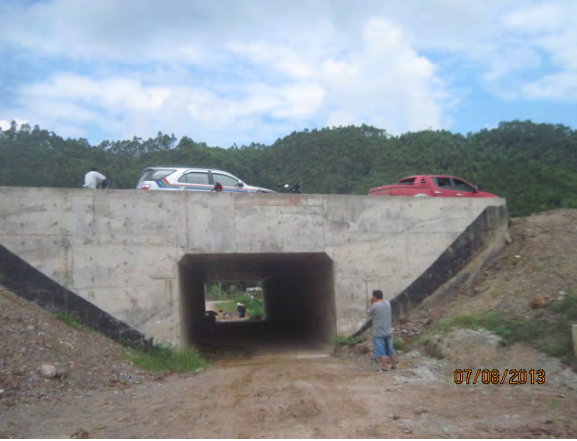
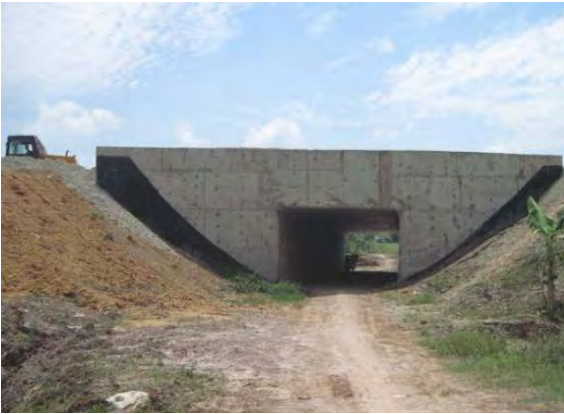
Location: Box culvert Km109+500
	Site visit: 10,13,17,24,29,31/7/2013; 02, 07, 08, 15, 16, 22, 29/8/2013; 05, 11, 12, 19, 24, 26/9/2013
	Date first observed: 08/5/2013
	Problems description and cause: Traffic sign board has not been installed yet
	Recommendation and Action taken by Engineer: GET2-KEA-A4-1003
	Responsible Party: KEANGNAM
	Deadline: 10/7/2013
	Current status: Not improved

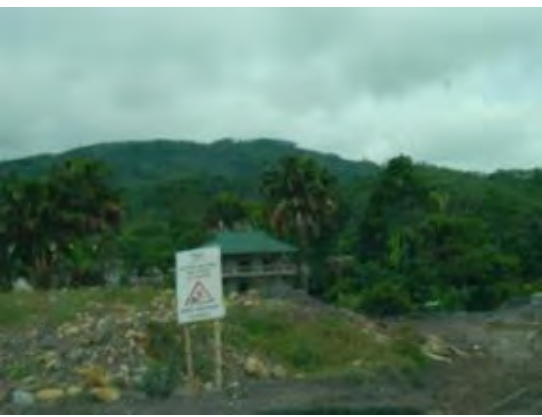
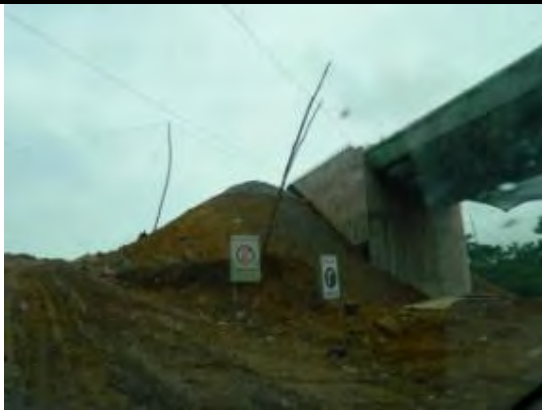
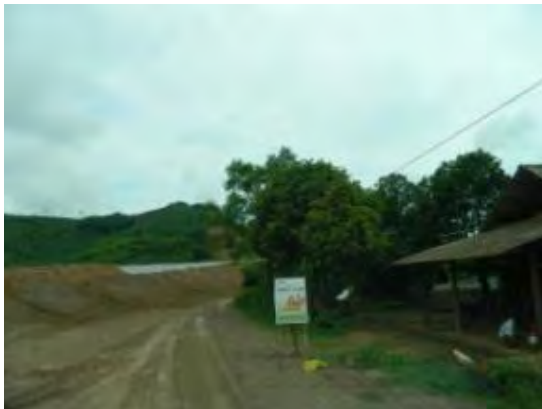
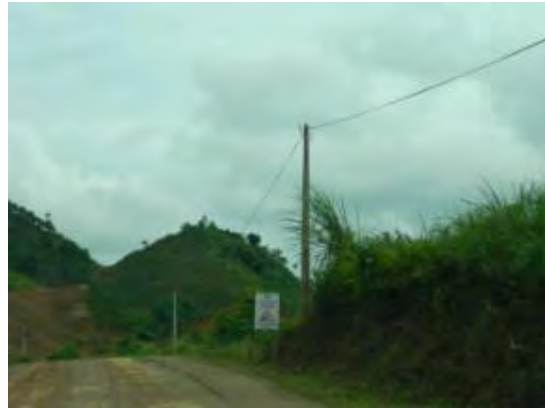
<p>Location: Location Km156; Ngoi Cong bridge's construction site; Km160; Km161</p>
<p>July 4, 2013 (Km156)</p>	<p>Site visit: 4 and 12 July, 2013</p> <p>Description: The Contractor installed safety signboard in roads.</p>

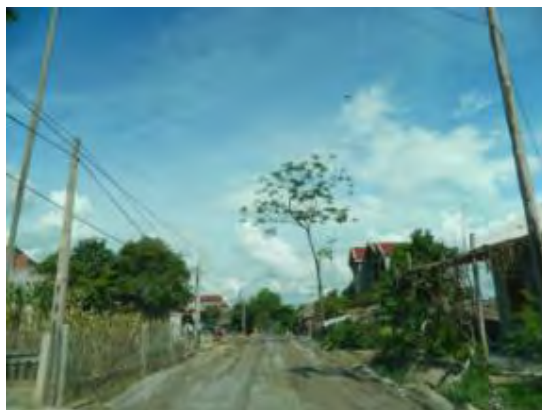
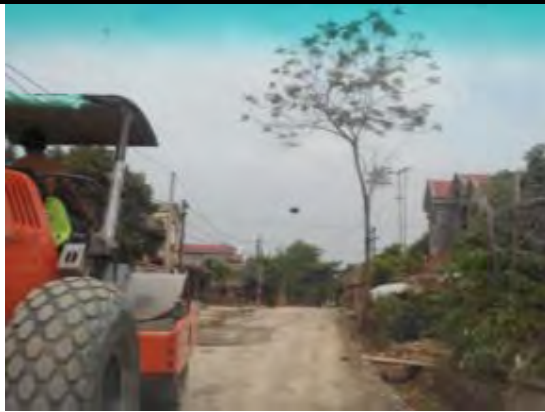
Location: Public road Km152

Problems description and cause: The quality of public road was impacted by the Contractor's construction activities and material transportation.

Current status: The Contractor has already repaired public road in order to ensure the region's traffic.

Engineer: The Engineer has orally requested the Contractor to repair damaged roads which were impacted by the Contractor's construction activities and material transportation.

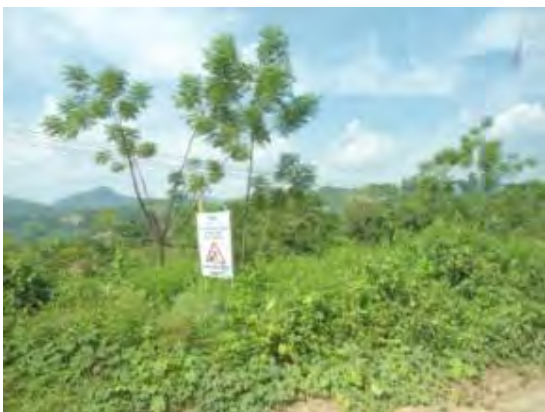
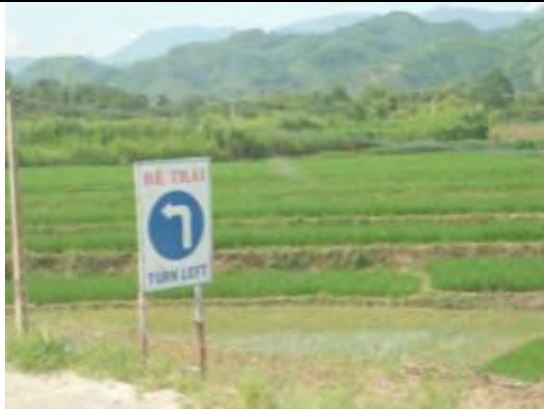
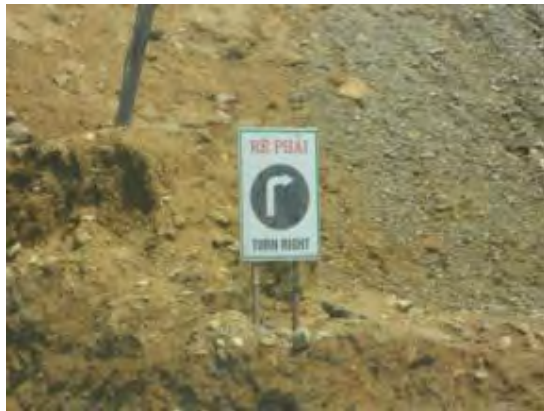
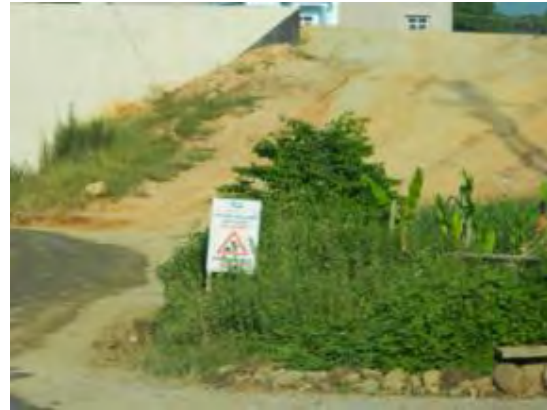
Description: The Contractor installed safety signboard in roads.

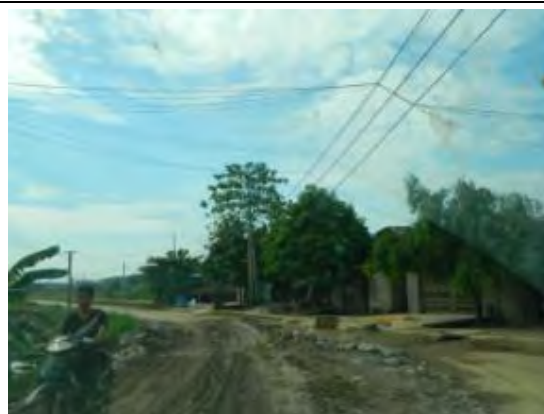
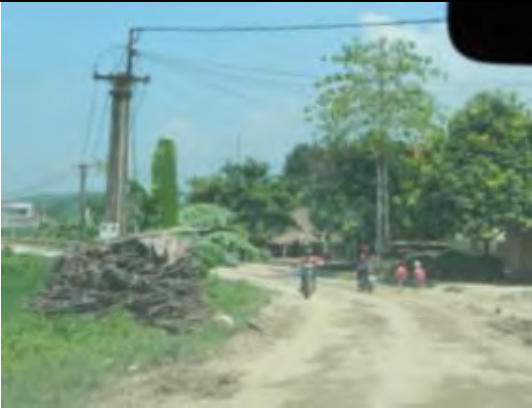
August 1, 2013

Location: Access road Km162

Problems description and cause: The quality of public road was impacted by the Contractor's construction activities and material transportation.

Recommendation and Action taken by Engineer: The Engineer has orally requested the Contractor to repair the damaged roads which were impacted by the Contractor's construction activities and material transportation.

Deadline: 16-August-2013
	Current status: The Contractor has already repaired public road in order to ensure the region's traffic.

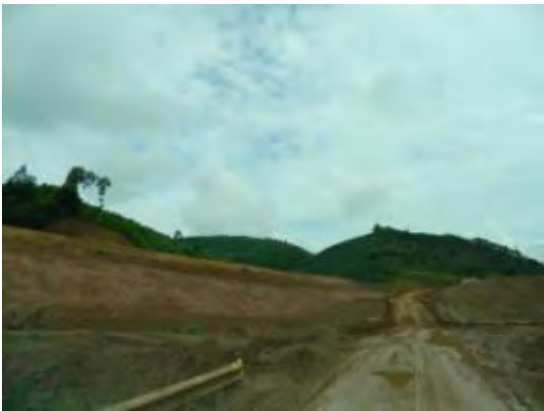
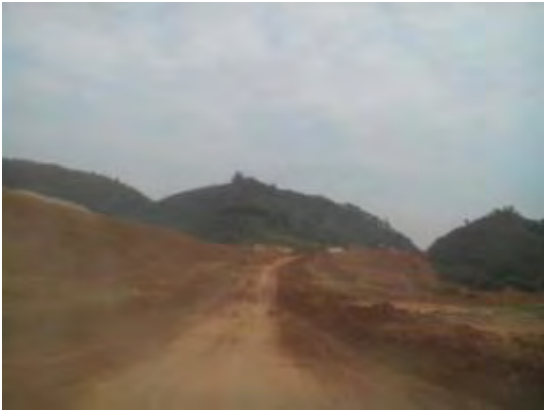
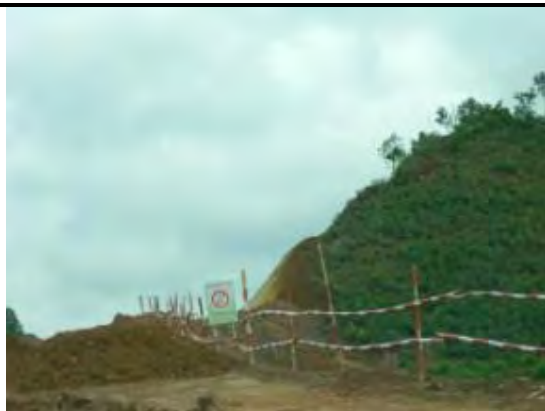
August 29, 2013

Location: Access road Km160
	Site visit: 1 and 29 August, 2013

Date first observed: 1 st August, 2013
	Problems description and cause: The quality of public road was impacted by the Contractor's construction activities and material transportation.
<p>August 29, 2013</p>	Recommendation and Action taken by Engineer: The Engineer has orally requested the Contractor to repair damaged roads which were impacted by the Contractor's construction activities and material transportation.
	Responsible Party: Doosan Contractor
<p>August 29, 2013</p>	Deadline: 10-August-2013
	Current status: The Contractor has already repaired public road in order to ensure the region's traffic.

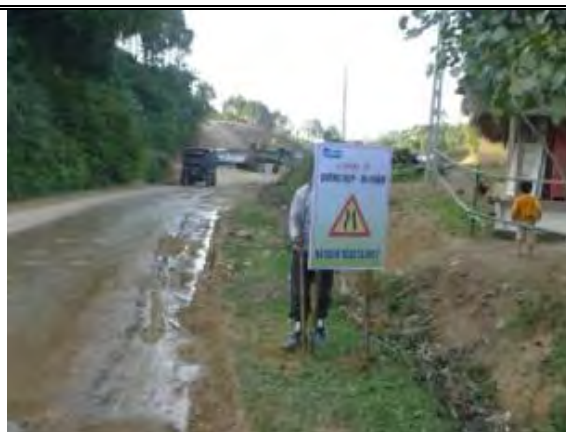
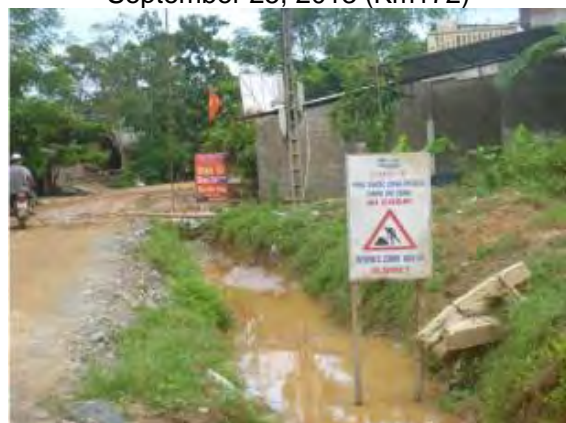
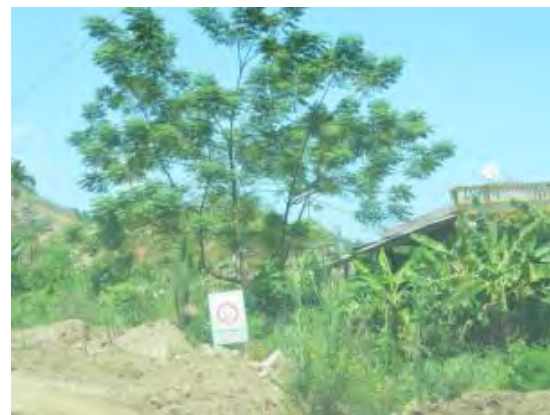
Location: Km172, Km169, Km165, Km174

Description: The Contractor installed safety signboard in roads.

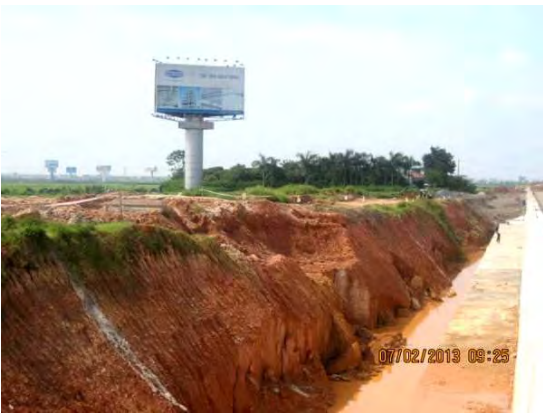
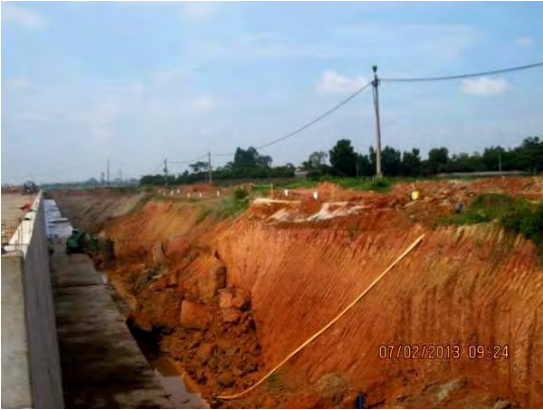
<p>July 02, 2013</p>	Location: Underpass NH2
	Site visit: 2, 9, 19, 25 July;
	Date first observed: 28-May-2013
	Problems description and cause: The fence was broken and has not been reinstalled, this issue facilitates the access of unauthorized persons into construction area without control
	Recommendation and Action taken by Engineer: The Engineer has requested the Contractor to reinstall the fence and signboard system to prevent access of unauthorized persons into construction area. Refer to letter GET1/POS/A1/2016
	Responsible Party: Contractor
	Deadline: 31-May-2013
	Current status: Mitigation measure has been implemented

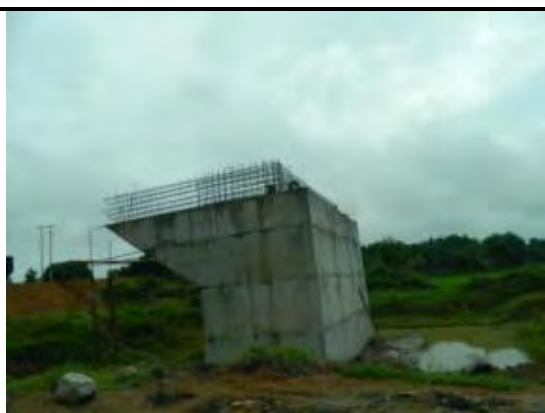
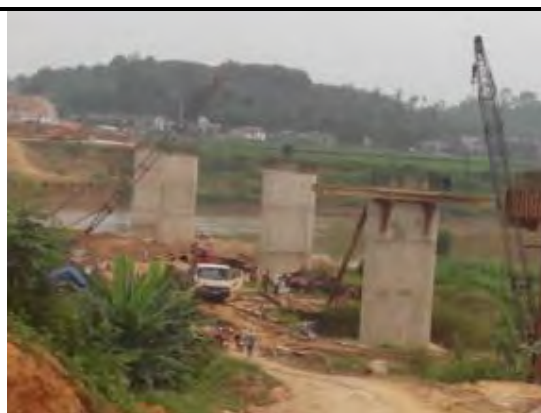
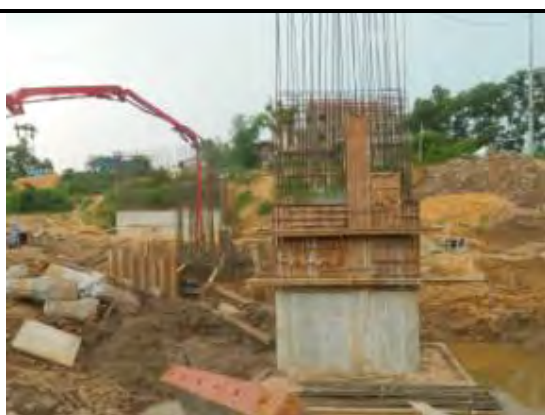
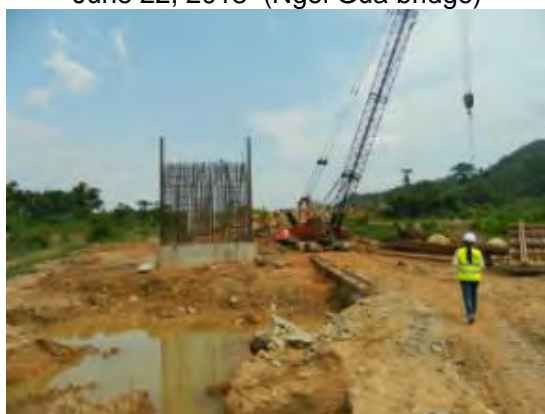
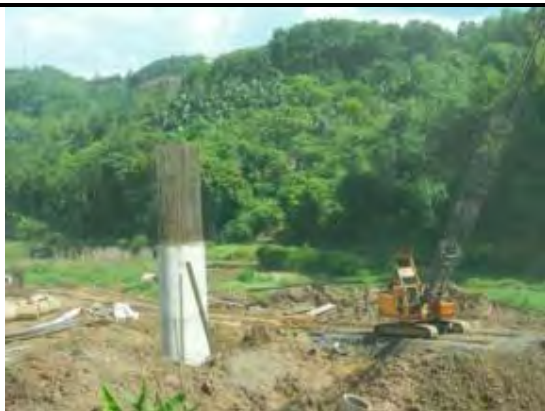
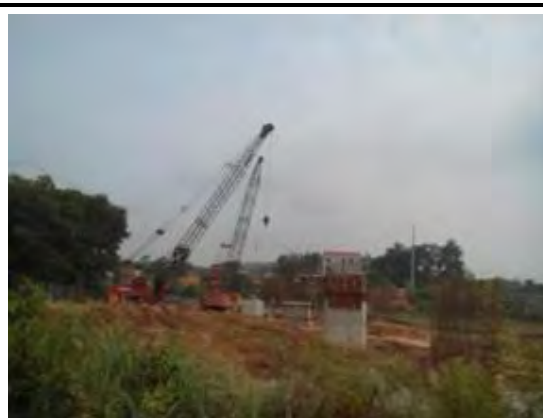
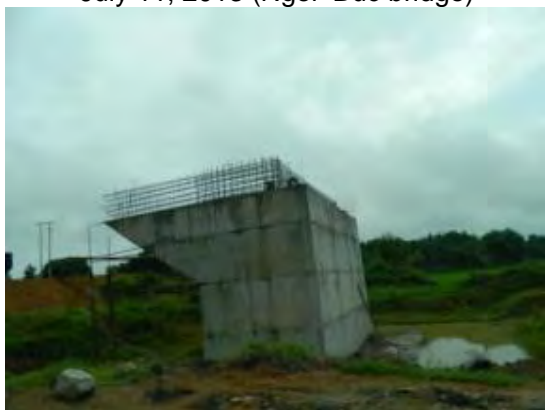
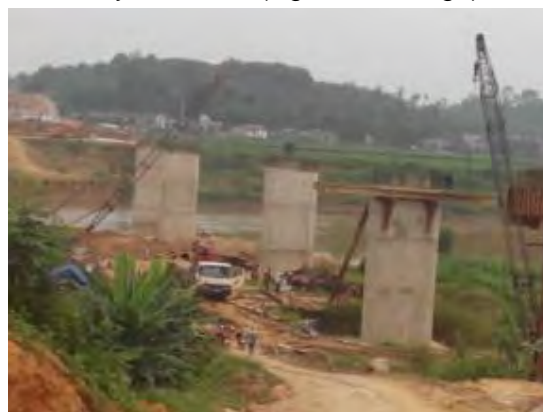
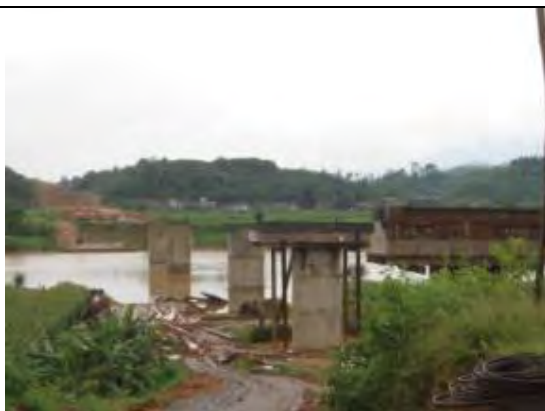
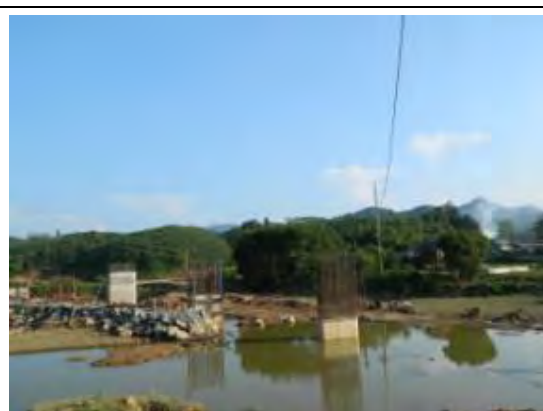
Location: Ngoi Rao, Ngoi Giua, Ngoi thia, Ngoi Buc bridge's construction site

Problems description and cause: Lack of safety fence and signboards at many dangerously areas

Recommendation and Action taken by Engineer: The Engineer required the Contractor to install safety fence and signboard at dangerous areas in order to keep the Project's safety (referring to the letters: No GET3-KEANGNAM-13-A5-494; GET3-KEANGNAM-13-A5-642)

Current status: No improvement seen

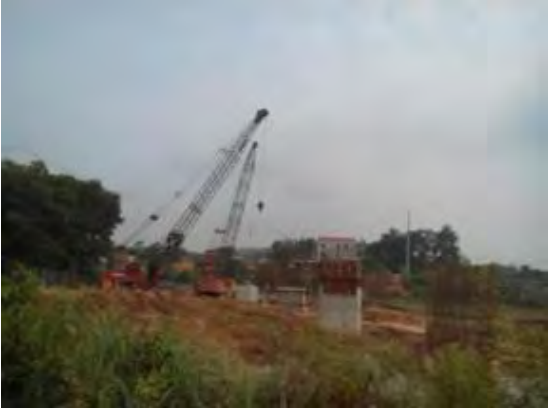
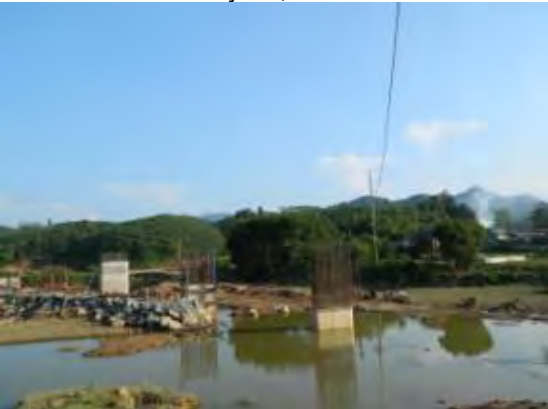
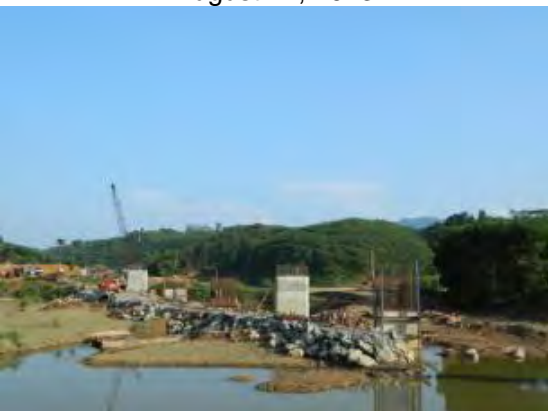
<p>September 13, 2013 (Ngoi Rao bridge)</p>	Location: Ngoi Rao bridge's construction site
	Site visit: 22 July and 27 August, 13 September, 2013
	Date first observed: 22 nd July, 2013
	Problems description and cause: Lack of safety fence and signboards at dangerously areas
	Recommendation and Action taken by Engineer: The Engineer required the Contractor to install safety fence and signboard at dangerous areas in order to keep the Project's safety (referring to the letters: No GET3-KEANGNAM-13-A5-494; GET3-KEANGNAM-13-A5-642)
	Responsible Party: Keangnam Contractor
	Deadline: Immediate
	Current status: No improvement seen

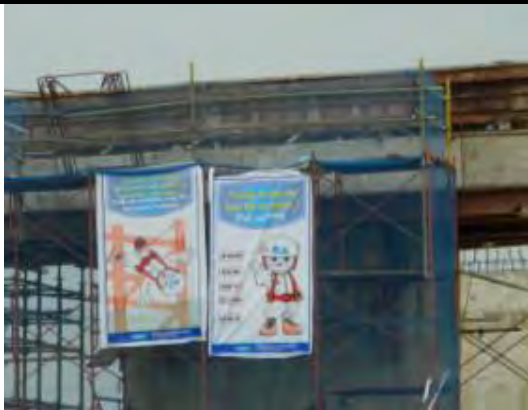
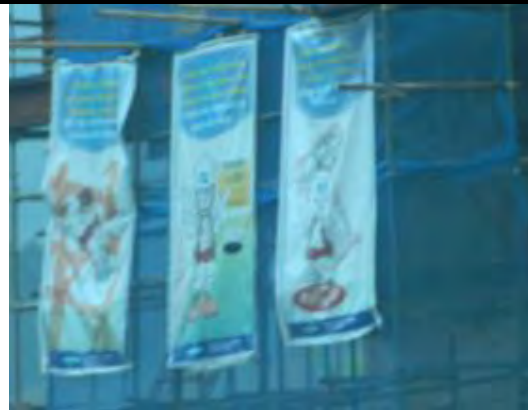
<p>July 4, 2013 (Ngoi Cong bridge)</p>	Location: Ngoi That bridge's construction site, Km159, Km155, Lang Nhay, Ngoi Nhuoc bridge's construction site.
	Site visit: 12 and 22 July, 2013
	Description: The Contractor installed signposting in dangerous surfaces in order to keep the Project's safety.
  <p>July 12, 2013 (Km159)</p>	  <p>July 12, 2013 (Km160)</p>

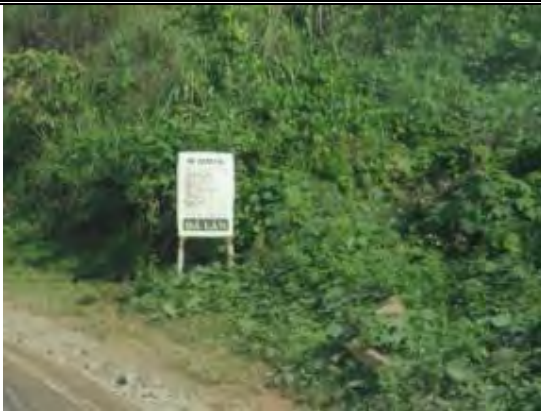
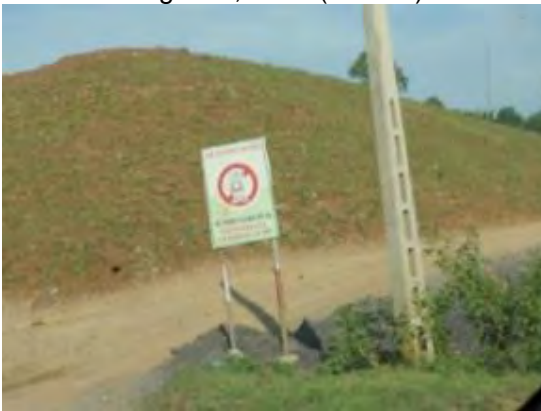
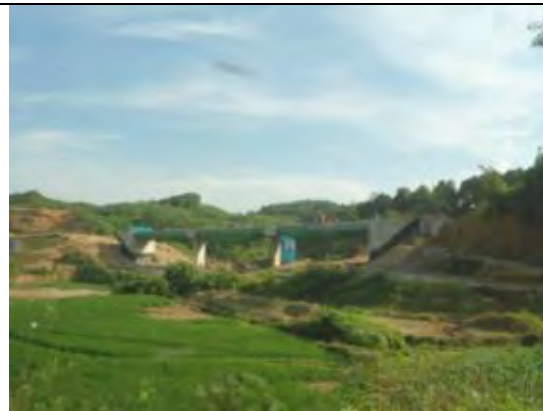
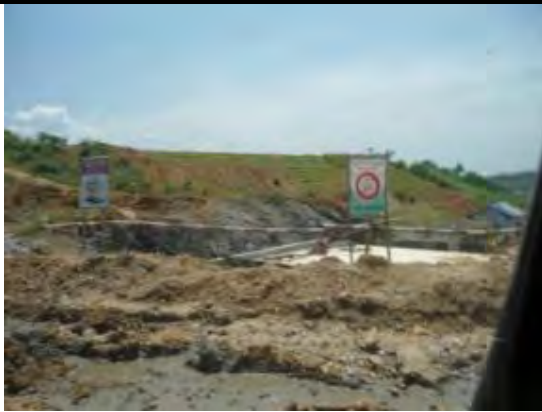
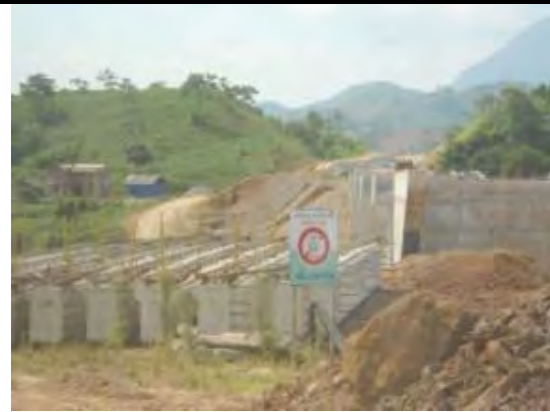
Location: Km159, Km156, Khe Chuong bridge, Km166, Ngoi Chac bridge

Description: The Contractor installed signposting in dangerous surfaces in order to keep the Project's safety.
