Environmental Monitoring Report

Quarterly Report
July - September 2013

VIE: Greater Mekong Subregion Kunming–Hai Phong Transport Corridor Noi Bai– Lao Cai Highway Project

Prepared by Getinsa for the Vietnam Expressway Corporation, the Ministry of Transport,
the Government of Viet Nam, and the Asian Development Bank

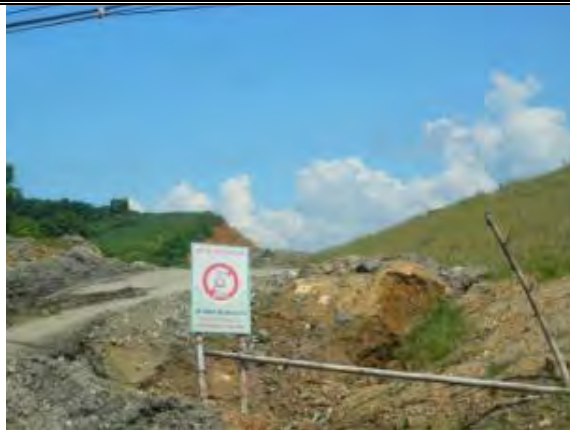
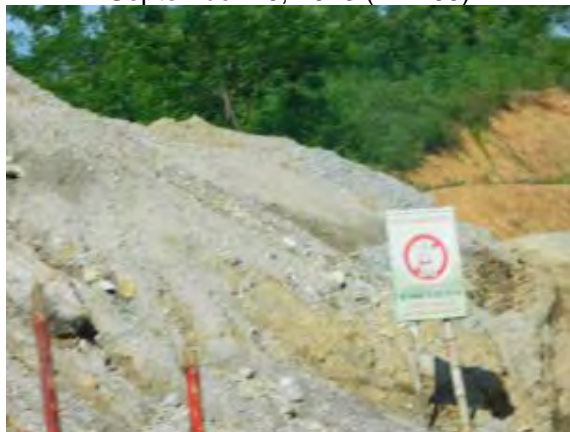
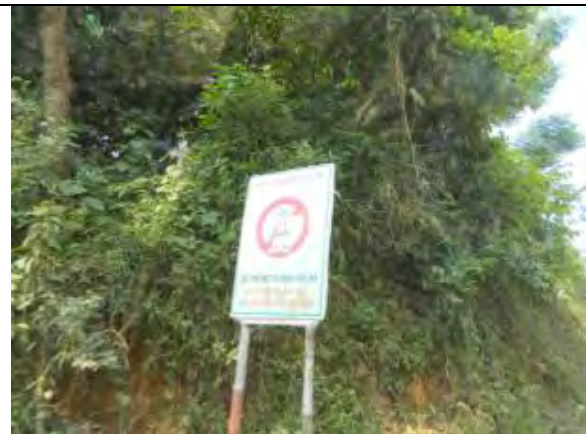
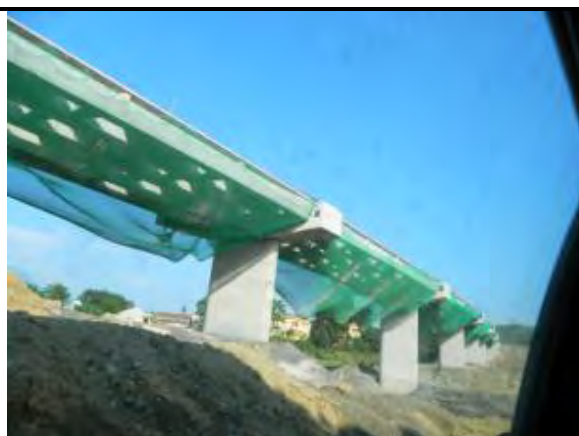
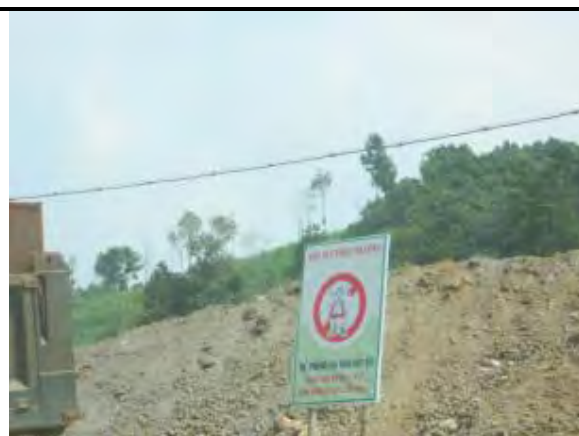
Location: Km159, Km165, Ngoi That bridge, Km178, Km165

Description: The Contractor installed signposting in dangerous surfaces in order to keep the Project's safety.

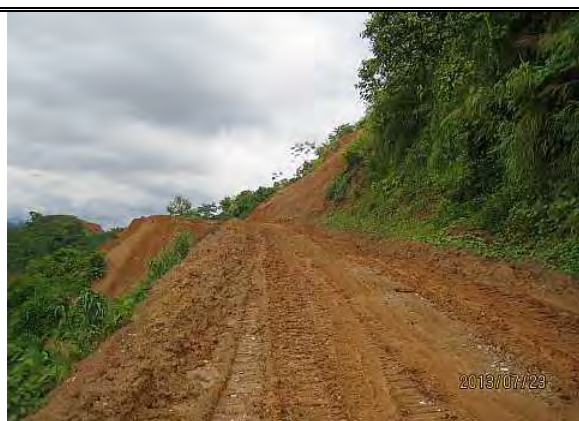
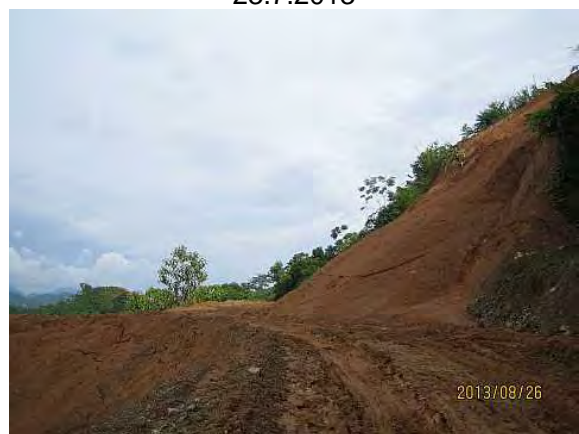
Location: Tan Tien Bridge Km209+329

Problems description and cause: There is not any safety fence and any signposting at dangerous areas

Recommendation and Action taken by Engineer: Required the contractor to install the safety fence and signpost at dangerous area

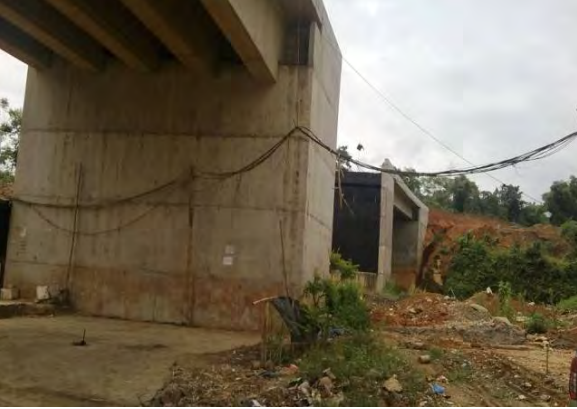
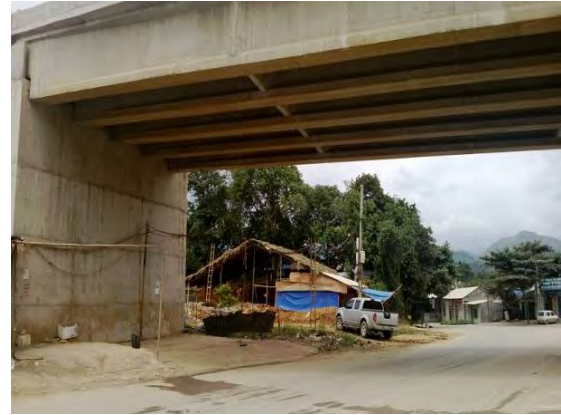
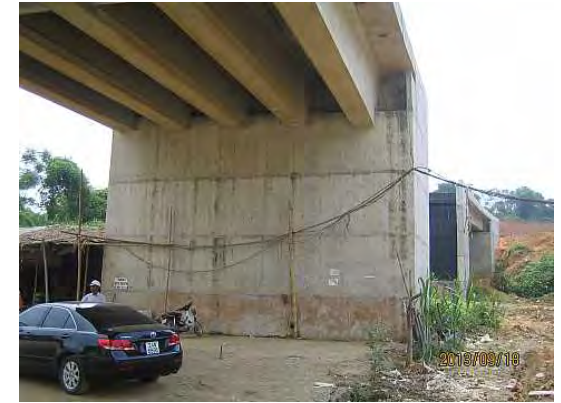
Location: IC18 Bridge Km244+540

Date first observed: 21.6.2013
	Problems description and cause: There is not any signpost and fence in construction work areas
	Recommendation and Action taken by Engineer: Require the contractor to install fully fence and signpost at this area and forbid local people entering site area
	Responsible Party: Contractor
	Deadline: 15.7.2013
	Current status: The issue was solved. Currently, no local people remains with their businesses under the structure of the bridge

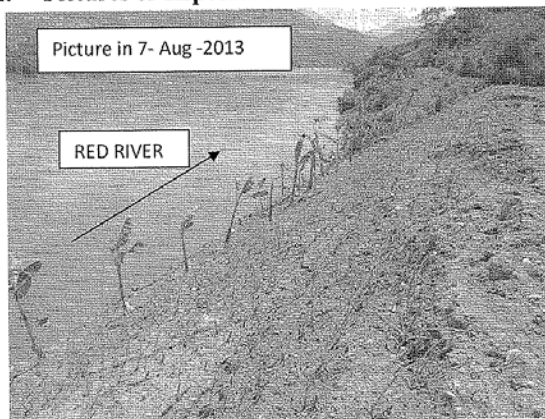
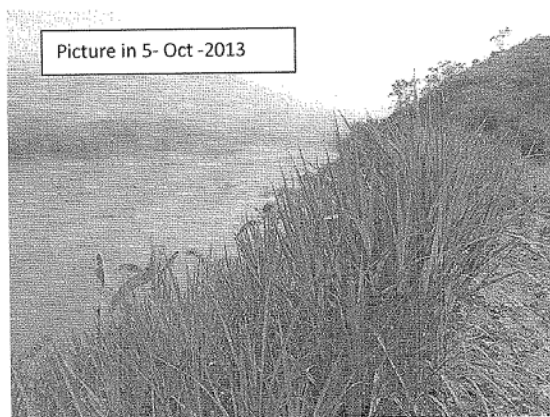
2.2. Pictures of disposal area:

2.1. Key plan of unauthorized disposal area at Km166+860:
