VIE: Song Bung 4 Hydropower Project

SONG BUNG 4 HYDROPOWER PROJECT
Monitoring and Assessment of Environmental Quality

**THE 12th ENVIRONMENTAL MONITORING
REPORT**

Construction phase

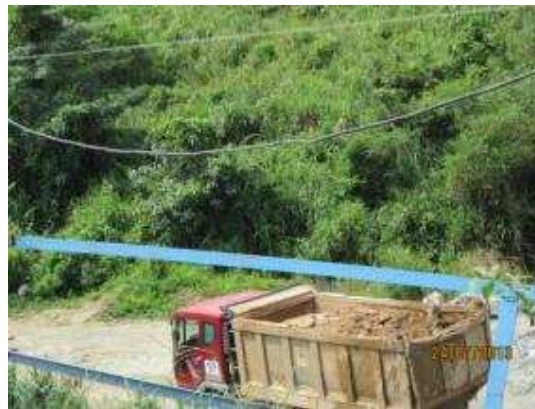
- The vehicles transporting refuse soil and rock from the rock quarry to waste disposal site No. 1 have no canvas covered. According to contractor Song Da 5, the vehicles have not been provided with canvas sheets because of the near distance from the rock quarry to waste disposal site No. 1.

Figure8: Transporting truck without canvas covered

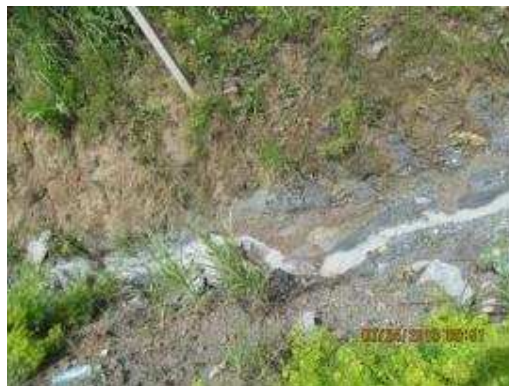
- Wastewater from the rock crushing plant at the rock quarry: The contractors have not yet collected the whole wastewater from the crushing plant so that wastewater from the plant has still been discharged into the environment.

Figure 10: Wastewater from the rock crushing – rock quarry is not collected into the sedimentation tank

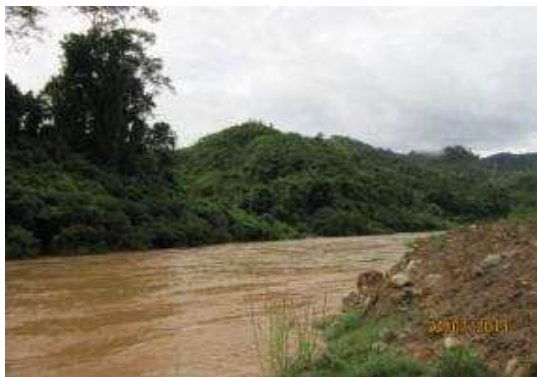
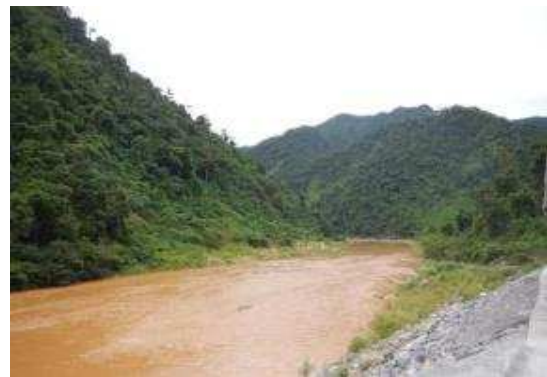
At time of the 12th monitoring, the project area has been being in the rainy season so the water level in Bung River is still high with high content of turbidity. turbidity measured in the upstream and downstream of construction areas is 1412 NTU and 996 NTU respectively. Similar to the previous monitoring, the content of turbidity in the upstream of construction areas is higher than that in the downstream of construction areas. The reason for this may be as follows: the water level in the downstream area is lower than that in the upstream area; the flow in the downstream area runs slowly and it is affected by the erosion of land along the river banks.

(a) Bung river in the upstream of construction area

(b) Bung river in the downstream of construction area

Figure 13: Quality of water in Bung River

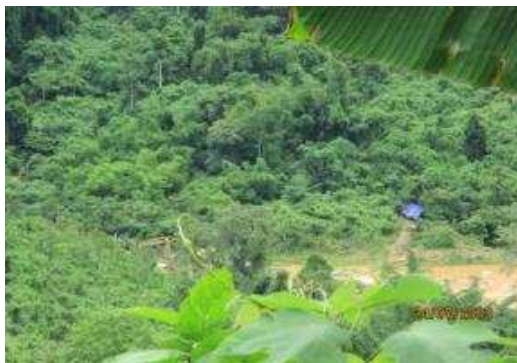
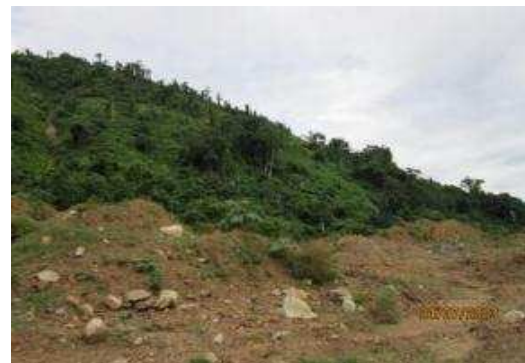
At time of the 12th monitoring, the project area has been being in the rainy season. Main construction activities that have been being carried out are concrete placement in the dam area and a part of excavation and backfill. The main reasons that make the content of turbidity in surface water are illegal gold exploitation in Khe Vinh area, the construction in the upstream area (construction of Song Bung 2 Hydropower Project) and erosion and landslide along the river banks. Illegal gold exploitation has still been occurred in Khe Vinh area and some other areas in the upstream area. The illegal gold exploitation in waste disposal site No. 3 that was detected in the previous monitoring visits has stopped, leaving an area of turned and excavated soil along the river banks.

Figure 14: Illegal gold exploitation in Khe Vinh area (a) and the river bank has been excavated by the exploitation in the waste disposal site No. 3 (b)

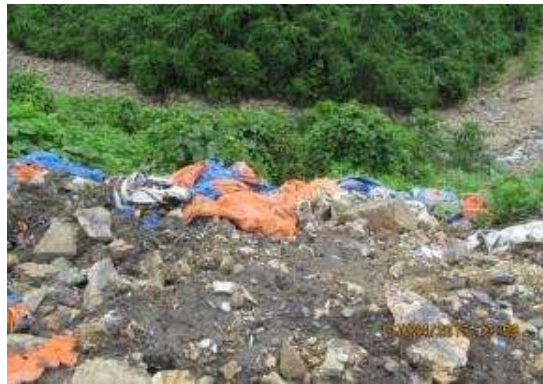
transportation of refuse soil and rock have been decreased. Transportation of surface soils from the rock quarry to the waste disposal site No.1 is the main activity. The solid waste is collected in the waste disposal sites along the construction roads. However, in some places in the construction site, construction solid waste has not yet been cleaned up after the construction completion such as the powerhouse area, access road to the intake gate, etc. The EMC suggested the contractors to clean the areas promptly.

Figure15: Construction waste near the intake gate construction area

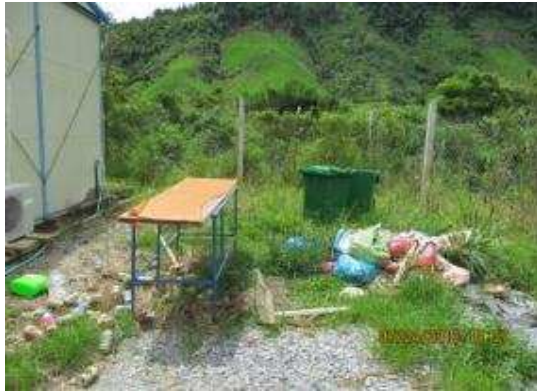
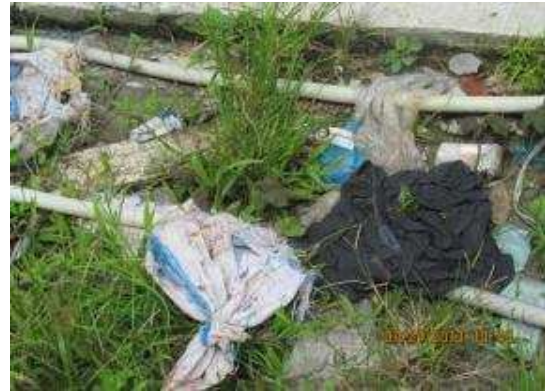
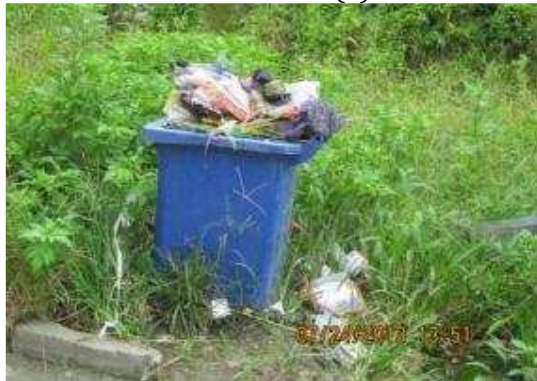
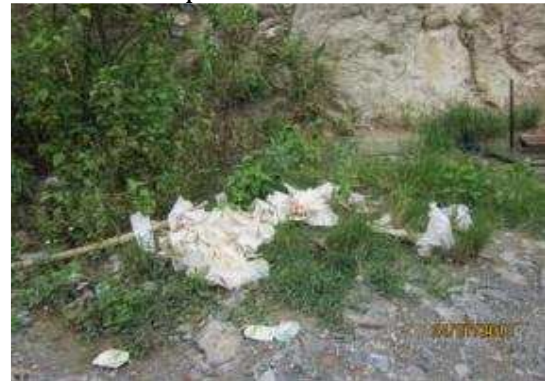
All camps are provided with wastebaskets, yet some camps do not keep the environment clean. Throwing waste away scattered or collecting brimful of waste in the wastebaskets still occurred at the camps: main camp of contractor SinoHydro, camp No. 13 (near Big Bear Bridge) and camp in the surge tank construction area.

(a) Domestic waste in main camp area

(b) Brimful wastebasket in camp No. 13

(c) Domestic waste in the camp area in the surge tank construction area

Figure16: Camp areas in which the collection of waste has not been well-implemented

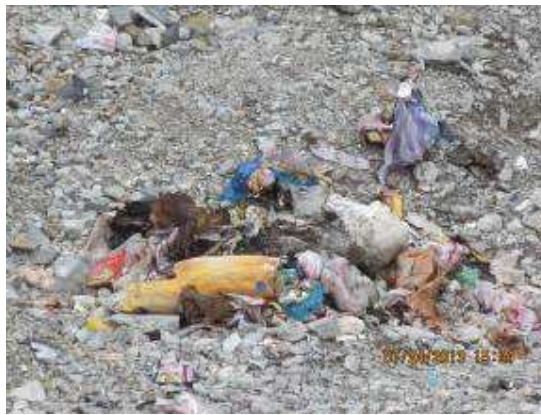
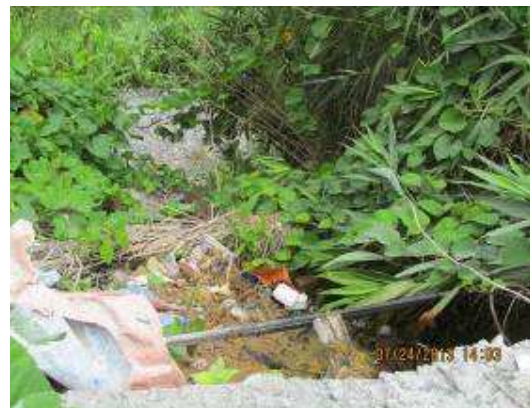
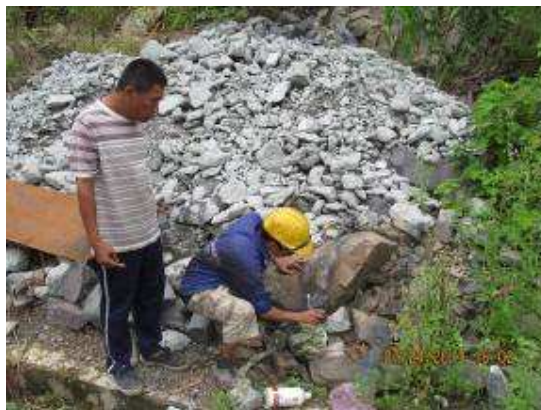
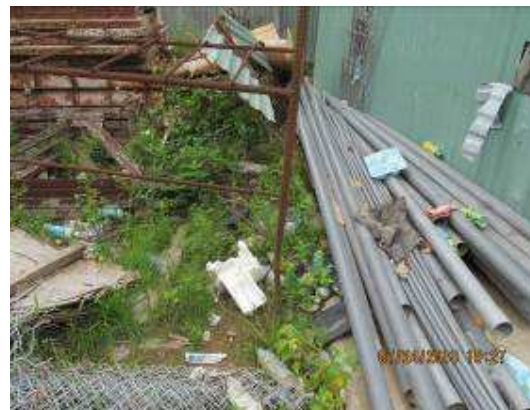
The contractors have arranged wastebaskets to collect domestic waste that could be generated in the break time by the workers. However, due to the poor awareness of the workers, domestic waste has still been thrown in many places in the construction site such as the powerhouse area, the intake gate construction area, etc. The EMC proposes that the contractors should remind the workers of this issue and fine the offenders to keep the environmental sanitation in the construction site.

(a) Powerhouse area

(b) Intake gate area

(c) Vehicle repairing area in the left abutment

(d) Timber gathering area

Figure21: Domestic waste thrown by the workers in the construction site

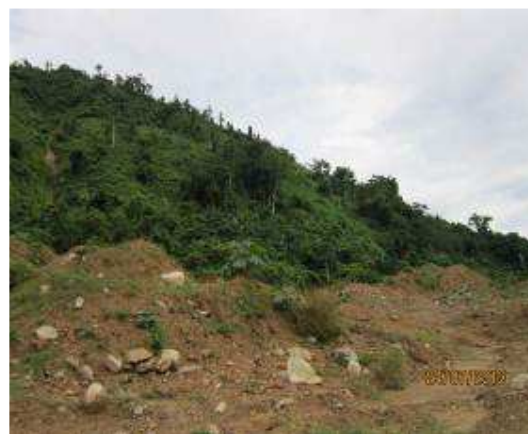
Landslide in the river bed near waste disposal site No. 3

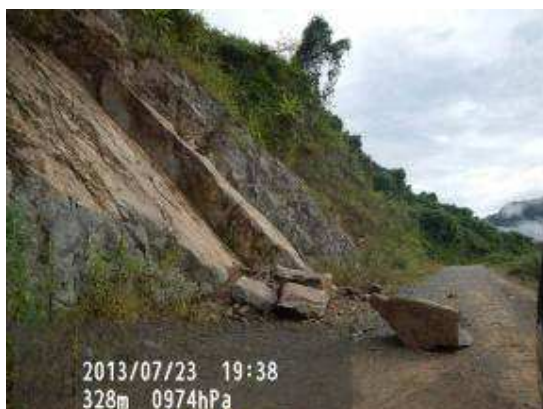
Landslide on Pa Pang road
Coordinate: Longitude: 15°41'47"

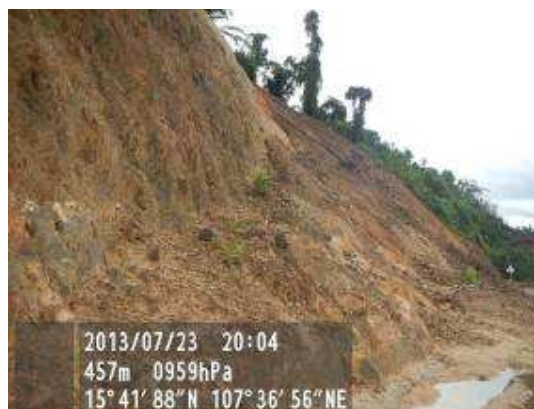
Landslide on Pa Pang road
Coordinate: Longitude: 15°42'09"

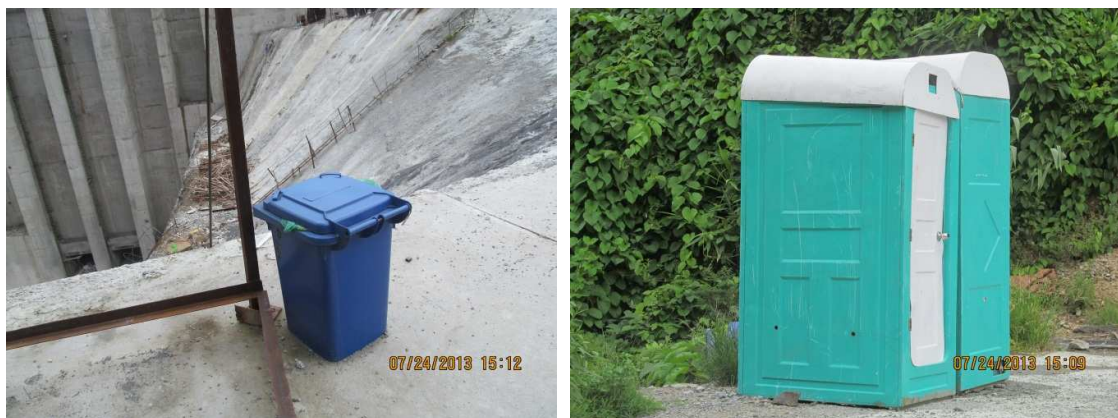
According to the representative of the Division of Work Safety and Environment of contractor SinoHydro, the construction workers concentrates mainly in the powerhouse and the dam area. The EMC observed that waste containers and mobile toilets have been arranged in the areas; however, the number of mobile toilets is small that does not meet the demand of a large number of construction workers. Additionally, the workers' awareness on keeping environmental sanitation are still poor. The EMC suggests that the contractors provide more mobile toilets and arrange them reasonably as well as improve the workers' awareness of keeping the camp areas and the construction site clean.

Figure 32: Waste container and mobile toilet in the powerhouse area

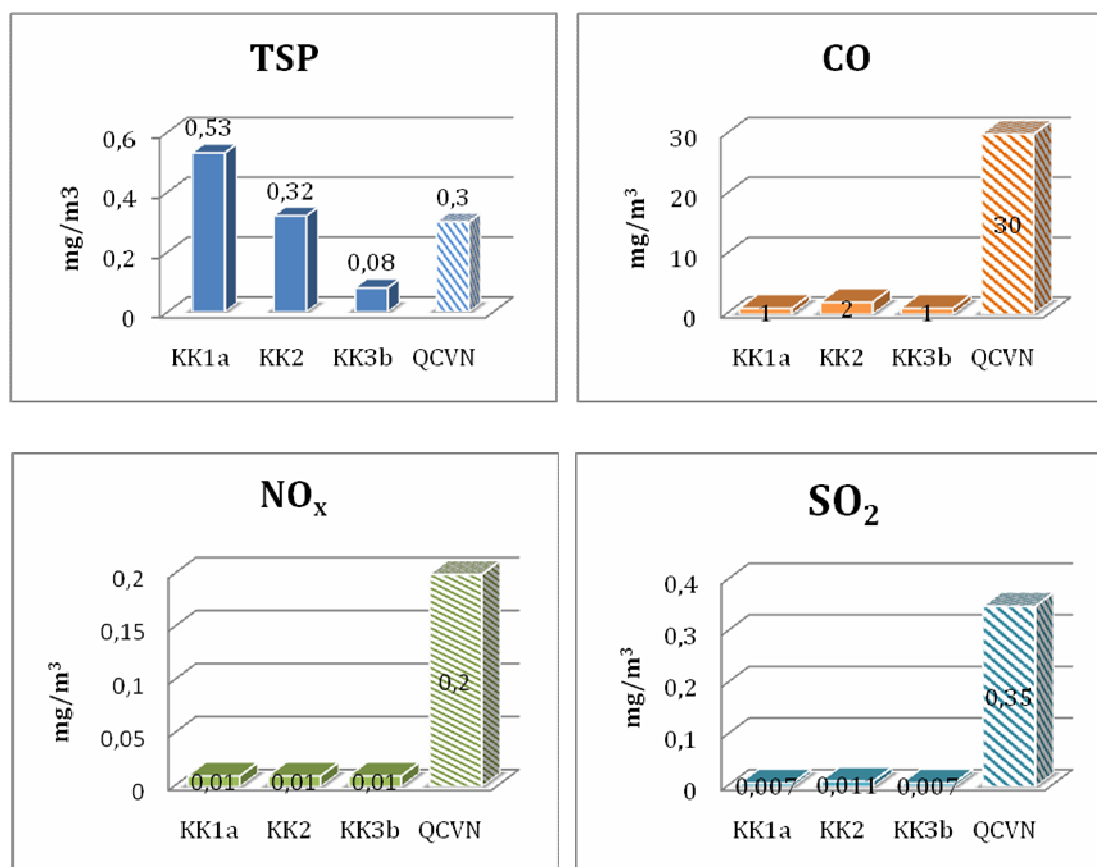
Figure37: Content of TSP, CO, NO_x and SO₂ in the air

Content of CO, NO_x, SO₂ is within the regulated limit as per the National Technical Regulations on quality of the ambient air - the QCVN 05:2009/BTNMT. Content of dust in sample KK3a is within the regulated limit while content of dust in sample KK1a and sample KK2 is higher than the regulated limit but it is not significant. (TSP in sample KK1a is 1.76 times higher; TSP in KK2 is 1.06 times higher than the regulated limit of QCVN 05:2009/BTNMT).

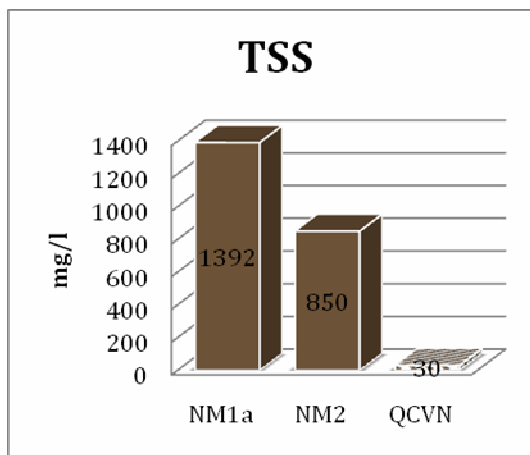
Figure39: Content of TSS in the surface water

Content of TSS of surface water samples in the upstream construction site and NM2a is respectively 46.4 times higher and 28.3 times higher than the regulated limit of the National Technical Regulations on quality of surface water – the QCVN 08:2008/BTNMT. Content of TSS in the upstream area is higher than that in downstream area because the water in the downstream area has smaller disorder. In addition, the illegal gold exploitation leads to this problem.

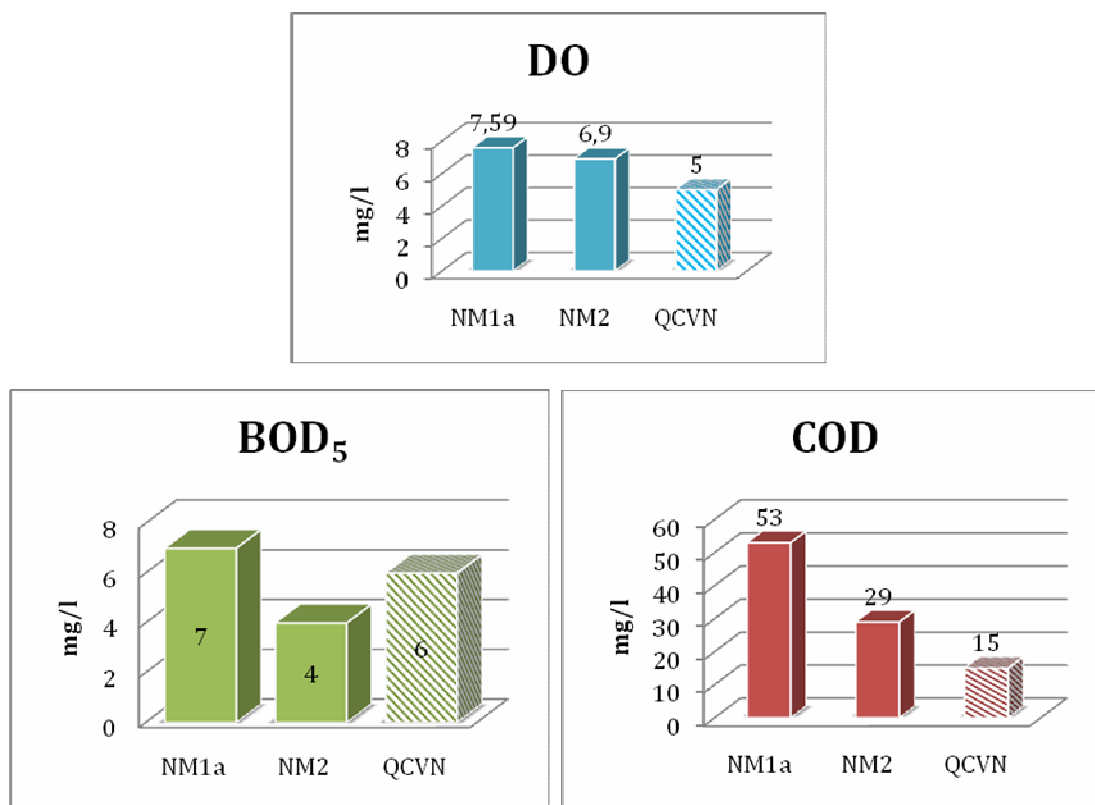
Figure40: Content of DO, BOD₅ and COD in the surface water

Content of COD and BOD₅ in the upstream area (COD = 53 and BOD₅ =7mg/l) and in the downstream area (COD = 29) is higher than the regulated limit (COD ≤ 15 and BOD₅ ≤ 6mg/l).

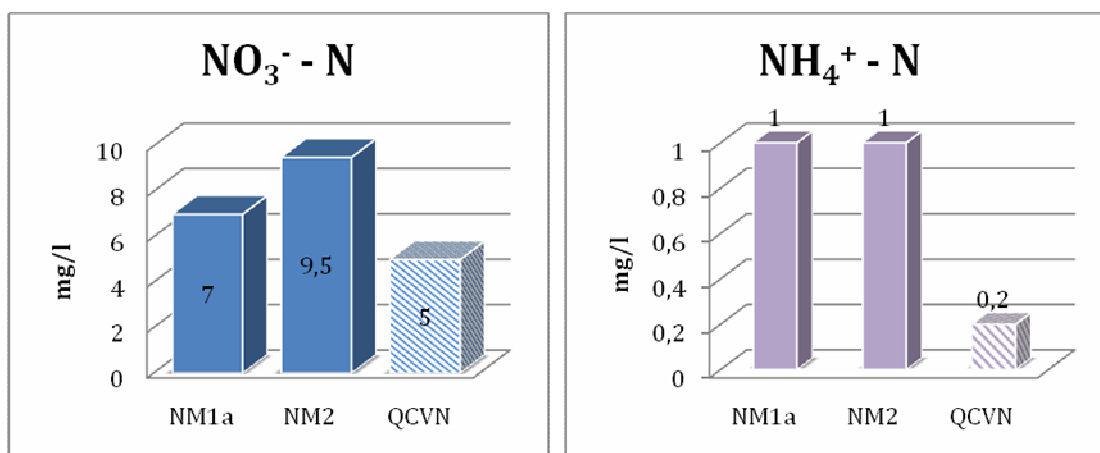
Figure 41: Content of $\text{NO}_3^- - \text{N}$ and $\text{NH}_4^+ - \text{N}$ in the surface water

Content of $\text{NO}_3^- - \text{N}$ in the two samples in the upstream area and downstream area was all higher than the regulated limit as per the QCVN 08:2008/BTNMT, of which content of $\text{NO}_3^- - \text{N}$ in the upstream area was 1.4 times higher and in the downstream area was 1.9 times higher than the regulated limit.

Content of $\text{NH}_4^+ - \text{N}$ in sample NM1a and NM2 is 5 times higher than the regulated limit as per the QCVN 08:2008/BTNMT. Content of $\text{NH}_4^+ - \text{N}$ in the surface water may be caused by the domestic wastewater from the worker camps that is not collected and treated strictly.

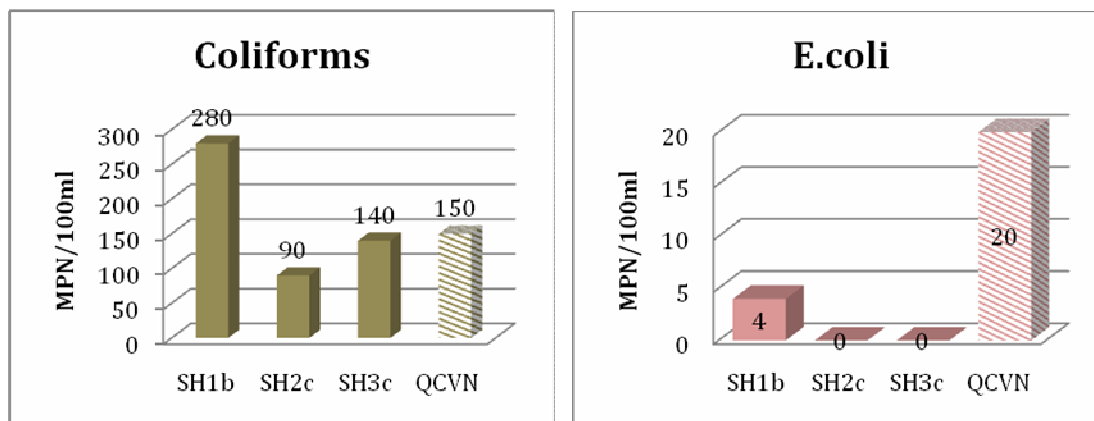
Figure 46: Content of Coliforms and Ecoli in domestic water

Conclusions: Among 3 samples of domestic water, colour of 02 samples SH1b and SH3c is 1.06-1.7 times higher than the regulated limit while content of colour in other samples is within the regulated limit of the QCVN 02:2009/BYT – National Technical Regulations on Domestic Water quality, exclusive of the content of Coliforms in the sample SH1b. In general, worker-serving domestic water in the camp area of Song Da 5 (SH2c) and the camp area No.45 (SH3c) relatively meets requirement on quality. Domestic water in the surge tank camp area (SH1b) need to be treated through filter and carefully boiled before being used for cooking.

- (iii) The content of Coliforms in domestic water in the camp area in the surge tank has not met the requirement on domestic water quality. Domestic water used in the camp area has been taken from the streams. The source of water has been used for cooking after being treated carefully before by the filter system. Using of the water source contaminated by coliform bacteria during a long-term can cause diseases of the digestive system and other diseases. Therefore, the contractors should examine the operation of the domestic water filter system in the surge tank area to ensure that quality of the domestic water meets the regulated criteria of the QCVN 02:2009/BYT.

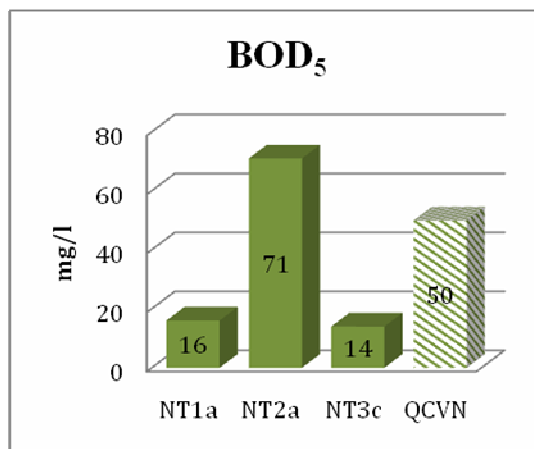
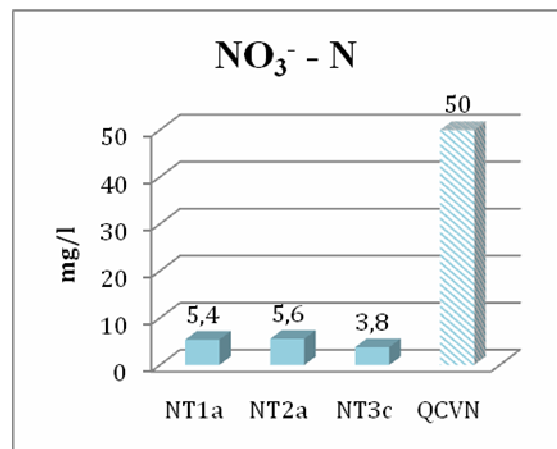
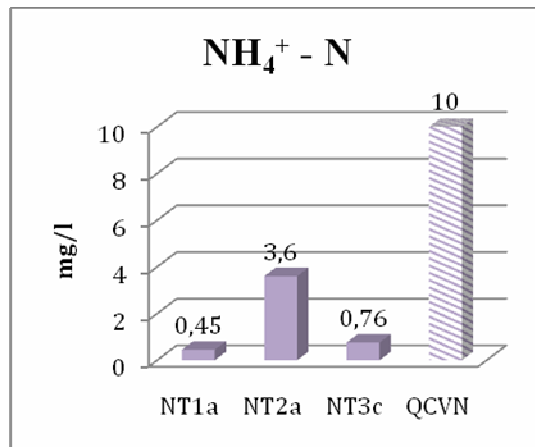
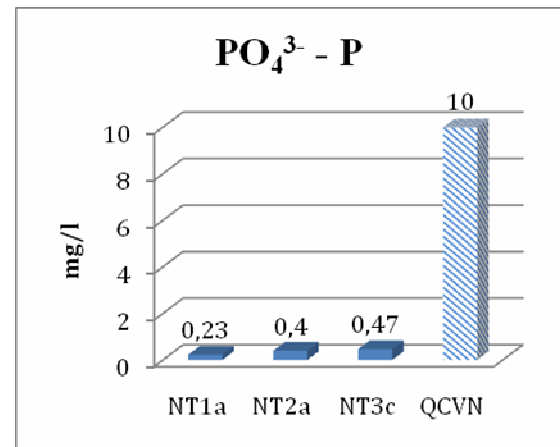
The content of all samples NT1a and NT3c is within the regulated limit as per QCVN 14:2008/BTNMT, except NT2a.

Content of $\text{NO}_3^- - \text{N}$ and $\text{PO}_4^{3-} - \text{P}$ at the last-end section of domestic wastewater discharge- pipe was lower than the regulated limit. The reason is that the rich organic substances from kitchen are not led to the treatment tank. Only wastewater from toilets of the construction workers and officers is treated by the sedimentation tank.

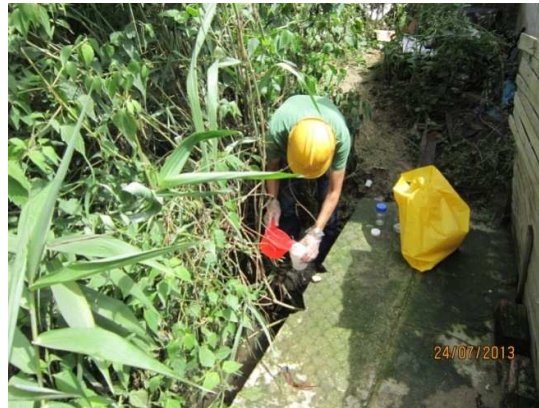
Figure75: Domestic wastewater sampling in the camp of Song Da 5 – Rock quarry
