## **PNG: HIGHLANDS REGION ROAD IMPROVEMENT INVESTMENT PROGRAM (HRRIP) – TRANCHE 3**

### **GEWA-GEMBOGL ROAD SUB-PROJECT**

# **SEMI-ANNUAL ENVIRONMENTAL SAFEGUARDS MONITORING REPORT**

**(JULY TO DECEMBER 2019)**

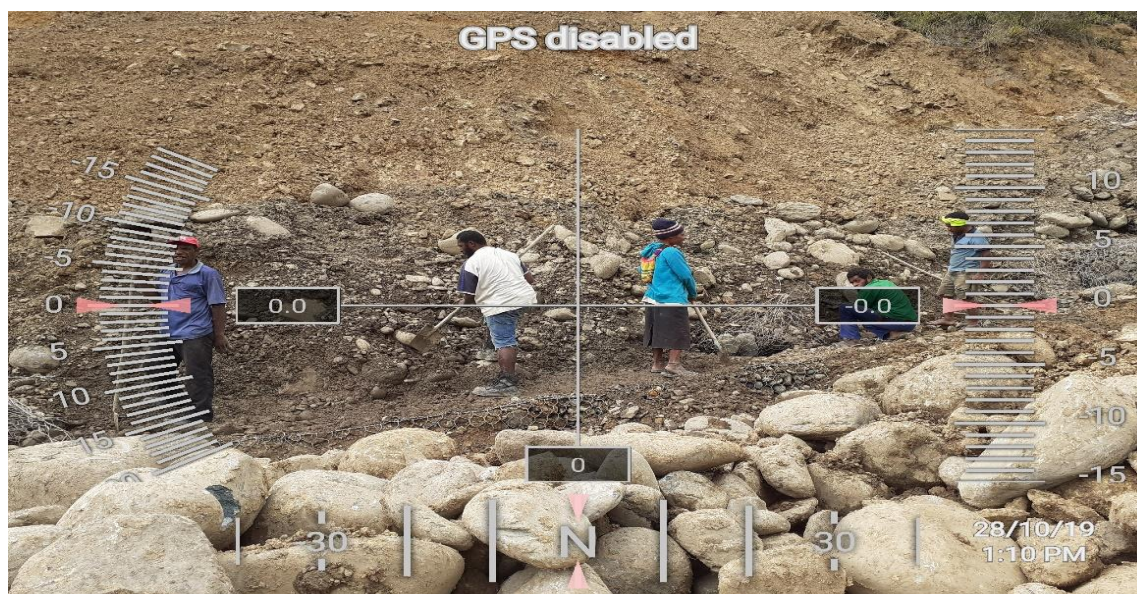
**Picture 15:** Women involves in line drain works and stone wall protection.

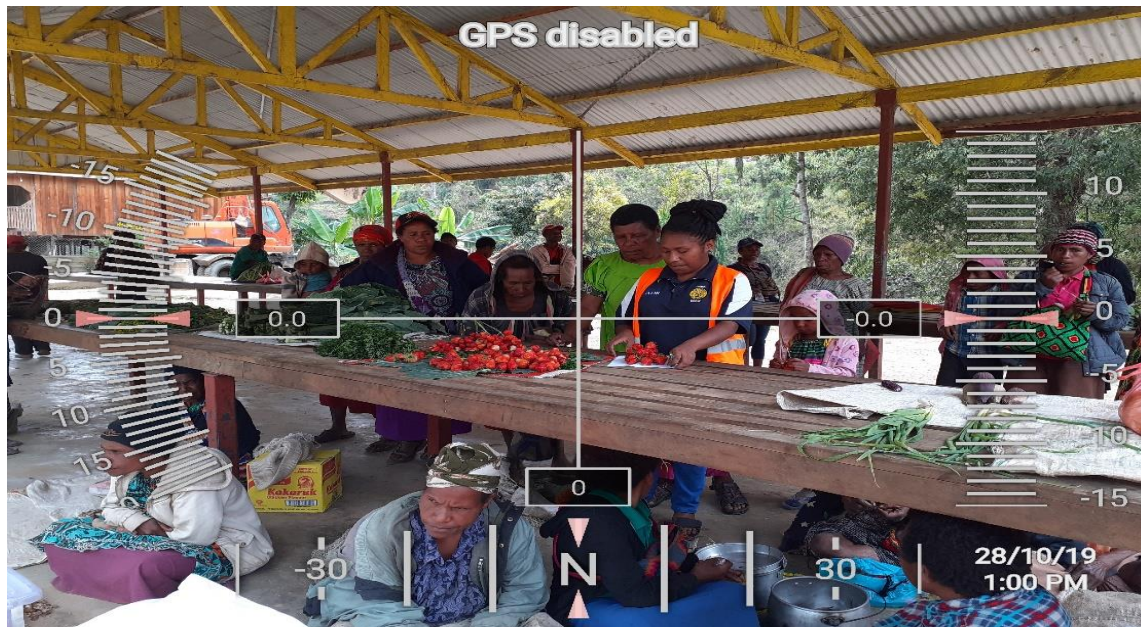
There is rise in the economic activity along the project road corridor. Informal markets are seen increasing along the project road corridor.

**Picture 16:** Local market built by the project at Gembogl station for women.

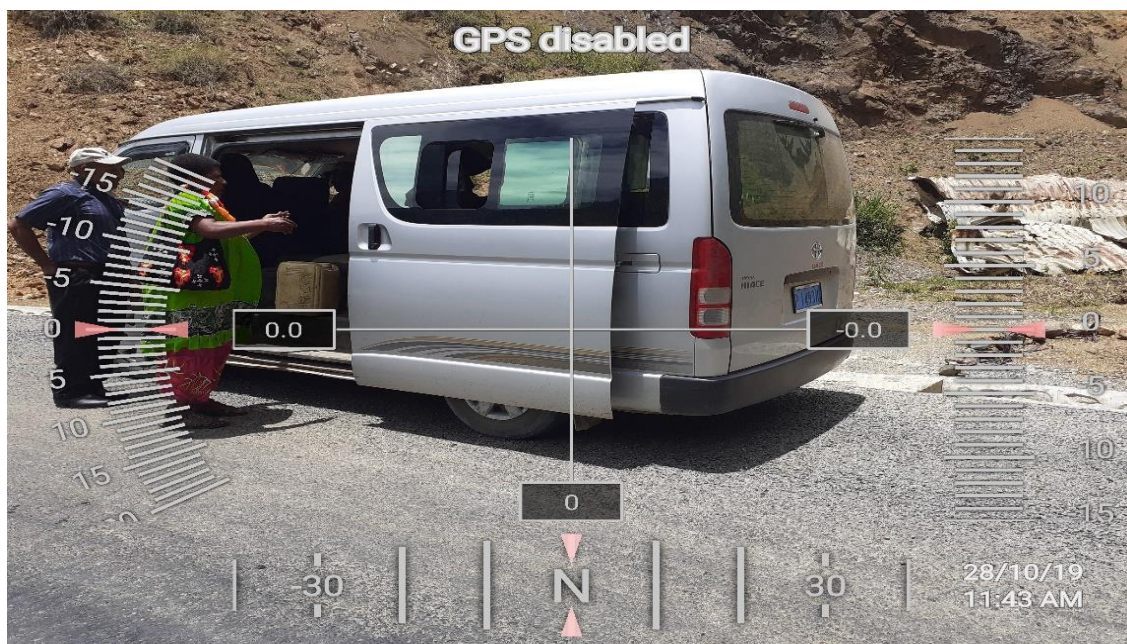
Because of the upgraded road conditions PMV vehicles are seen increasing and are making more added trips than the previous road condition resulting in PMV owners making money.

**Picture 17:** PMV Transport buses operating on the newly sealed roads

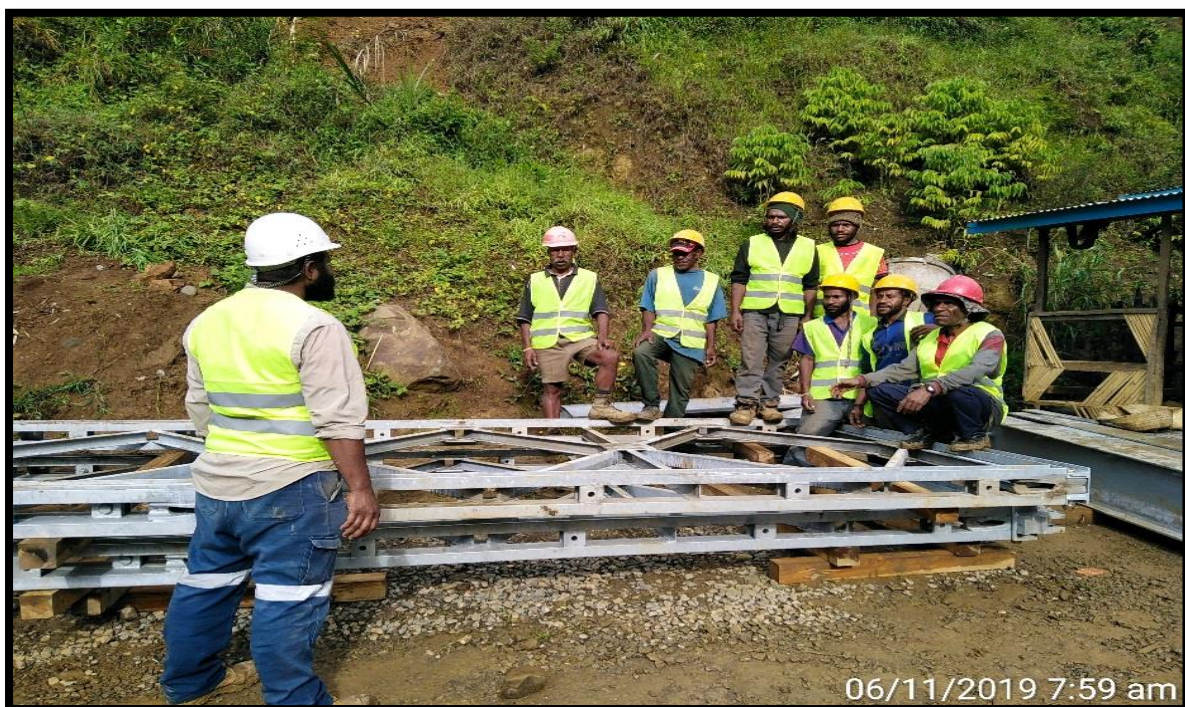
**Picture 20:** Safety meetings and instructions given to workers during bridge construction

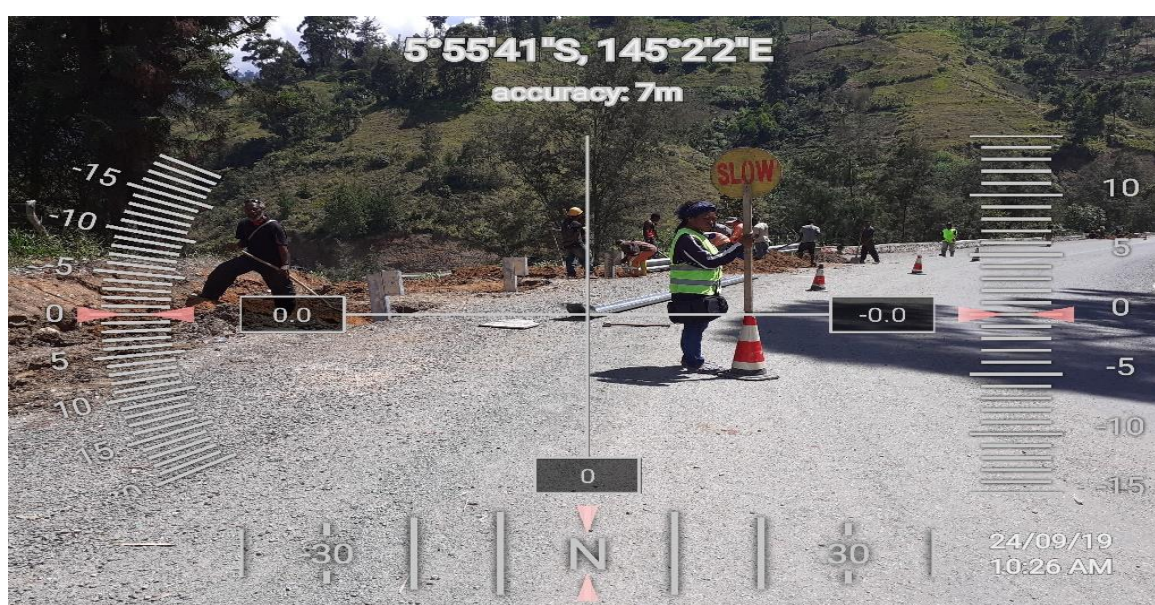
The Contractor has provided traffic signage for public traffic (Photograph 21). However, this sign could have been more visible if mounted on a traffic post. Women were employed by the contractor as traffic aides and are utilized to control the traffic during the construction (Photograph 22).

**Picture 22:** Local female employee controlling traffic

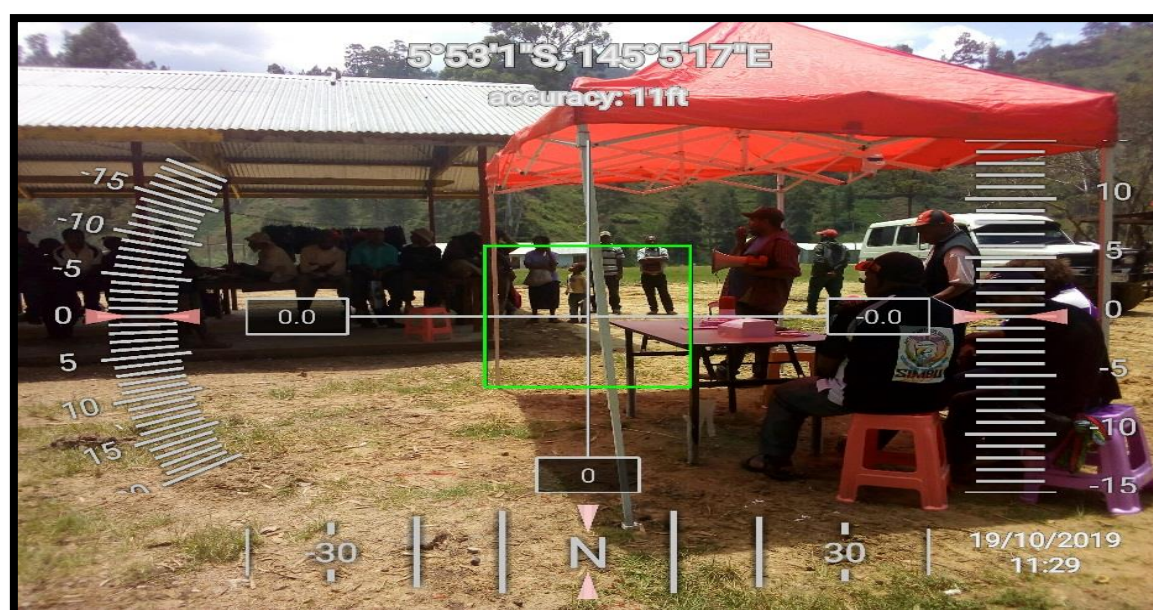
More effort has been put to increase awareness activities, HIV-AIDS tests, pamphlets, condom distribution and the number of participants from the average of 62. Attendance to awareness was high in the three months awareness conducted. No HIV/AIDs awareness were conducted in the other three months.

**Picture 23:** HIV and Aids Awareness at Gembogl station in October 2019.

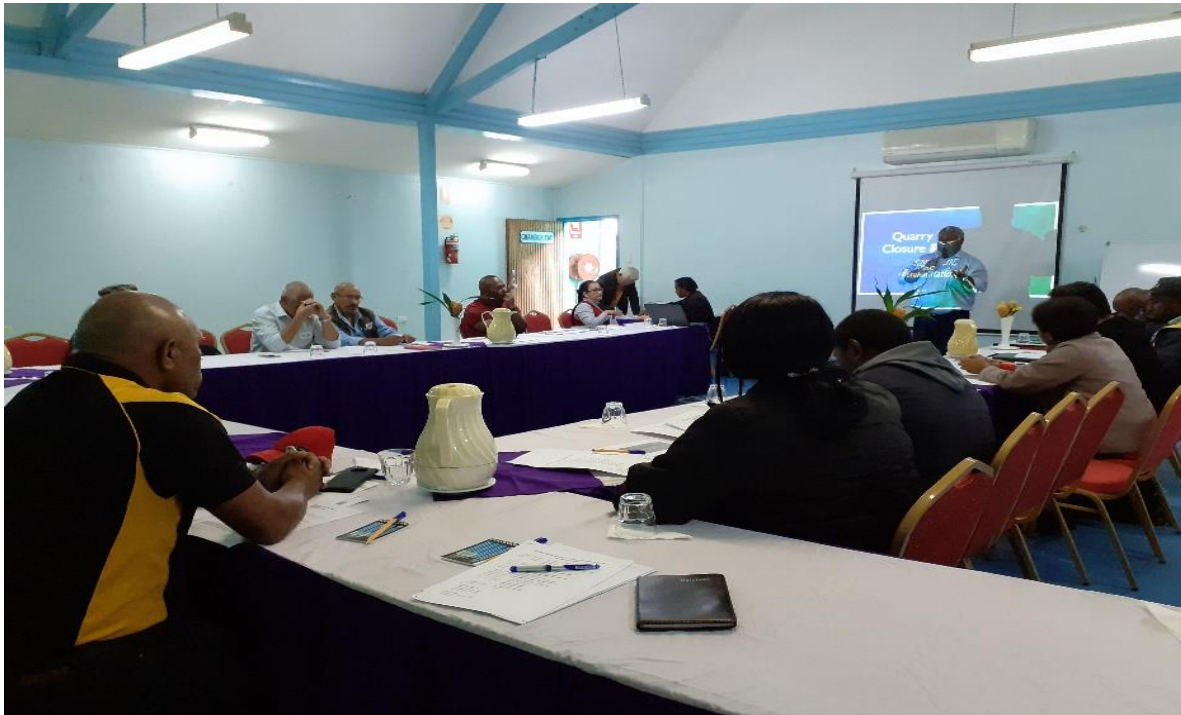
There was a short training on Quarry Management, Closure & Rehabilitation held at Kimininga Hotel on the 9<sup>th</sup> of September 2019. The training was facilitated by Grace Nuevas-International Environment and Social Safeguards Specialist. Main discussions were based on the difference between the two Quarry Types, Riverine Quarry and Hard rock Quarry. Basing on the ongoing projects at the moment, views were expressed by officers from each project of how existing quarries are managed and their plans to rehabilitate and close quarries when projects wind down.

**Picture 24:** Quarry Closure and Rehabilitation Workshop at Kimininga Hotel in Mt. Hagen
