Semi-annual Report

August 2020

PNG: HIGHLANDS ROADS IMPROVEMENT INVESTMENT PROGRAM (HRRIP) – TRANCHE 3

HENGANOFI-NUPURU ROAD SUB-PROJECT

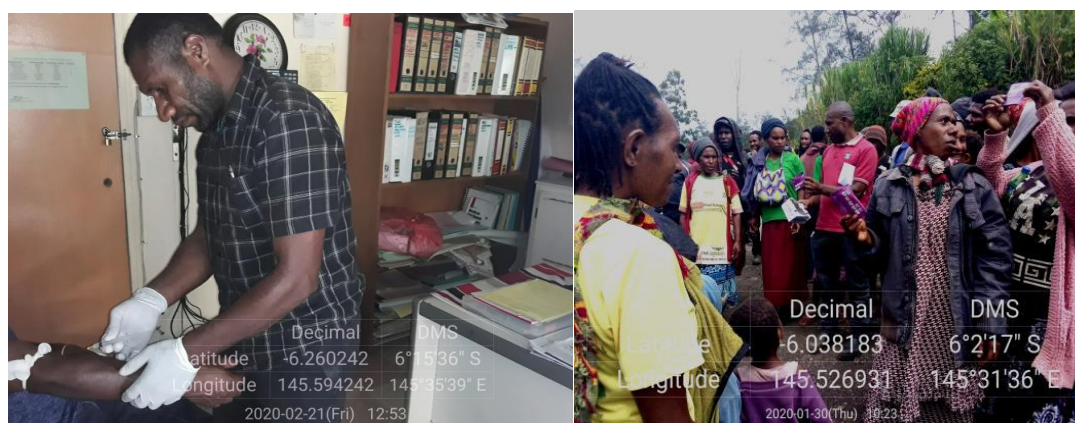
Photographs 39-40: Showing the HIV/AIDS testing at Fore Health Centre by the Nursing Officials during the awareness activity.

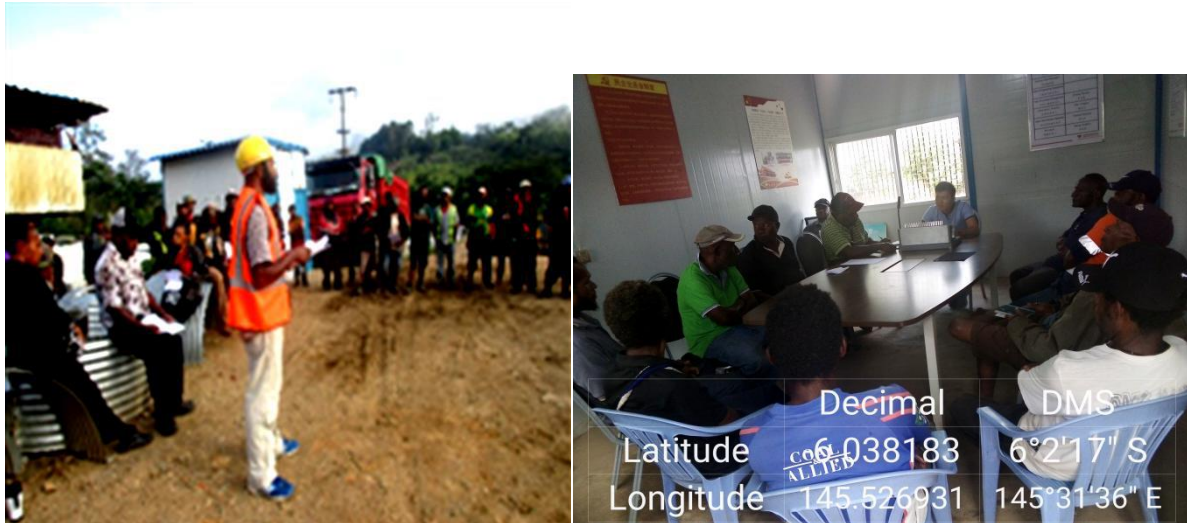
Photographs 41-42: Showing Toolbox meeting with the targeted employees for the safety and welfare of the company.

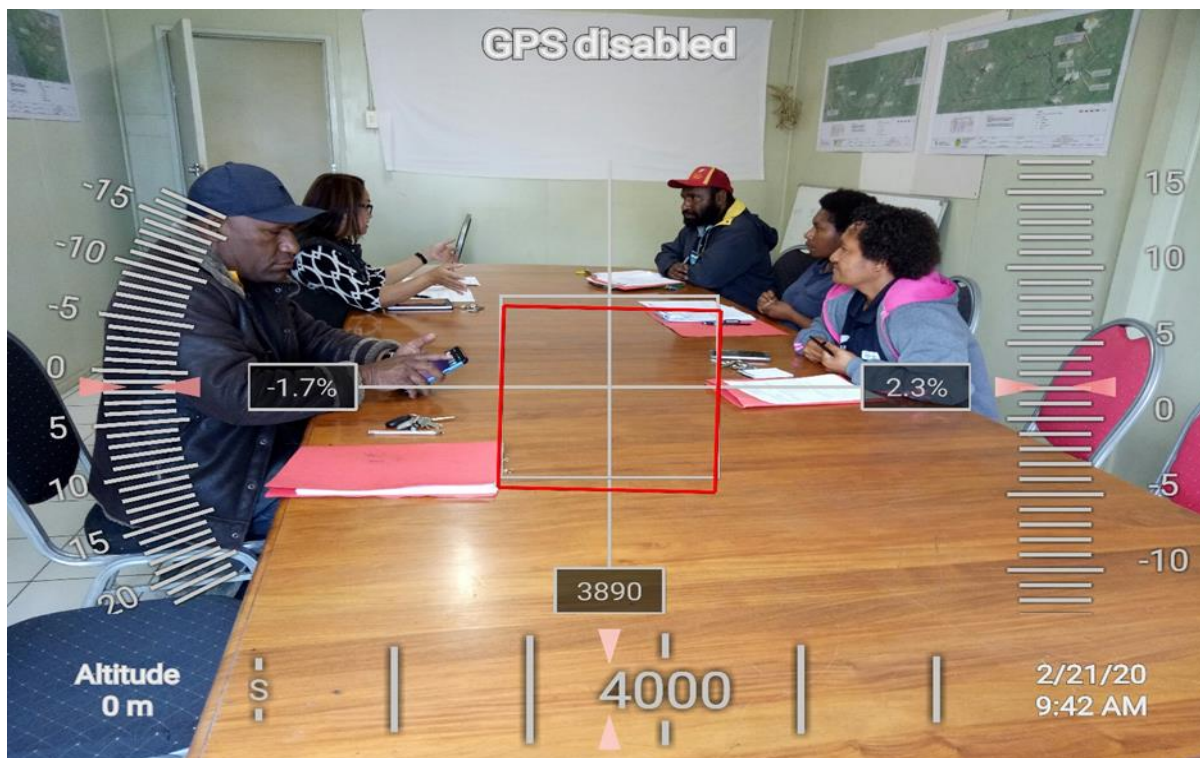
Photograph 43: Socio Economic Survey Coordination meeting facilitated by International Social Safeguards & Environmental Specialist of Renardet S.A Engineering.
