Semi-Annual Report

January 2019

PNG: HIGHLANDS REGION ROAD IMPROVEMENT INVESTMENT PROGRAM (TRANCHE 3)

Gewa-Gembogl Road Sub-Project

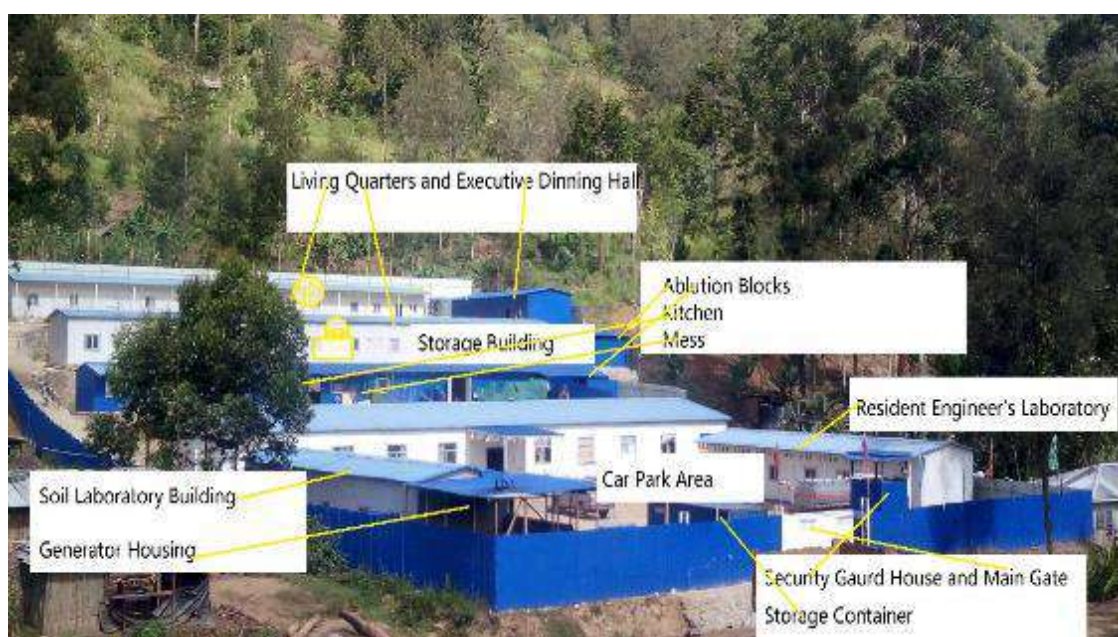
39. The Contractor's camp at Goglime has been completed in the third quarter 2018. (Photograph 1). However, a Camp Site Development Plan has not been provided to review its sewage facilities among others.

Photograph 1. Contractor's camp at Goglime with building designations.

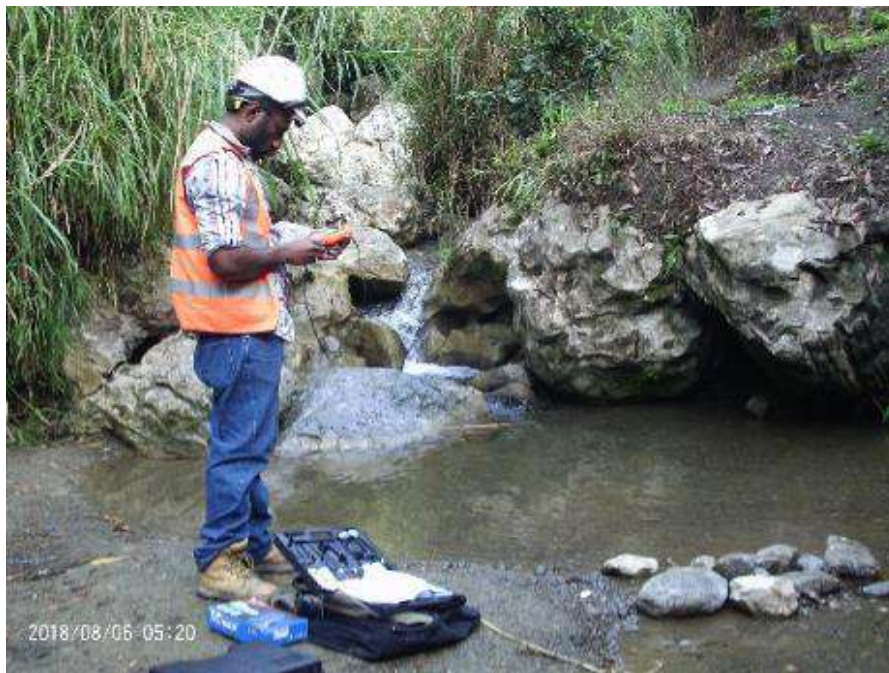
48. The monthly monitoring of water qualities is ongoing and the contract has established sampling stations (Photograph 8). It is recommended that the identified monitoring stations should be followed during the next reporting period.

Photograph 8. Contractor's Environmental Officer collecting water samples.

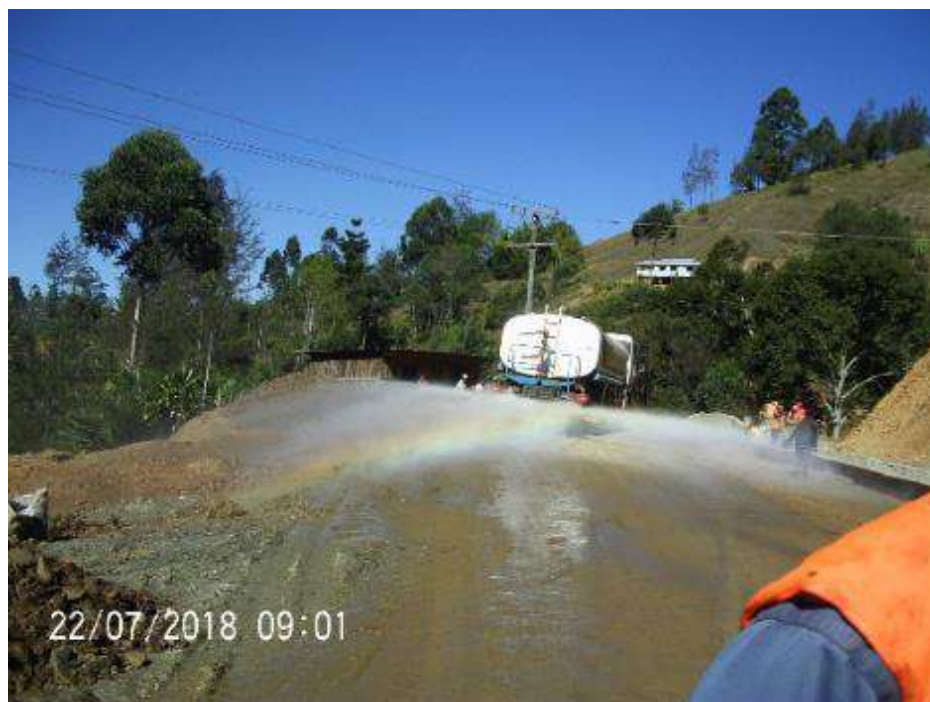
51. Road wetting from water trucks reduce dusts generated by vehicular traffic (Photograph 10).

Photograph 10. Road wetting using water truck sprinklers.

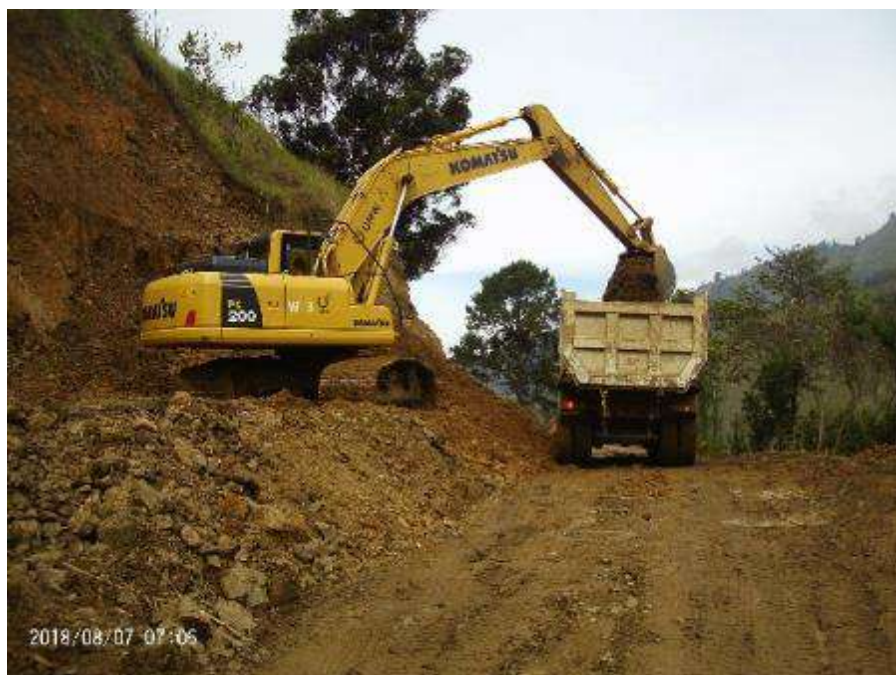
53. The previous report has observed the improper disposal of wastes from clearing and grubbing. In the second quarter of the year however, the contractor has improved to haul spoils to selected disposal sites (Photograph 11).

Photograph 11. Contractor hauls spoils to disposal site.

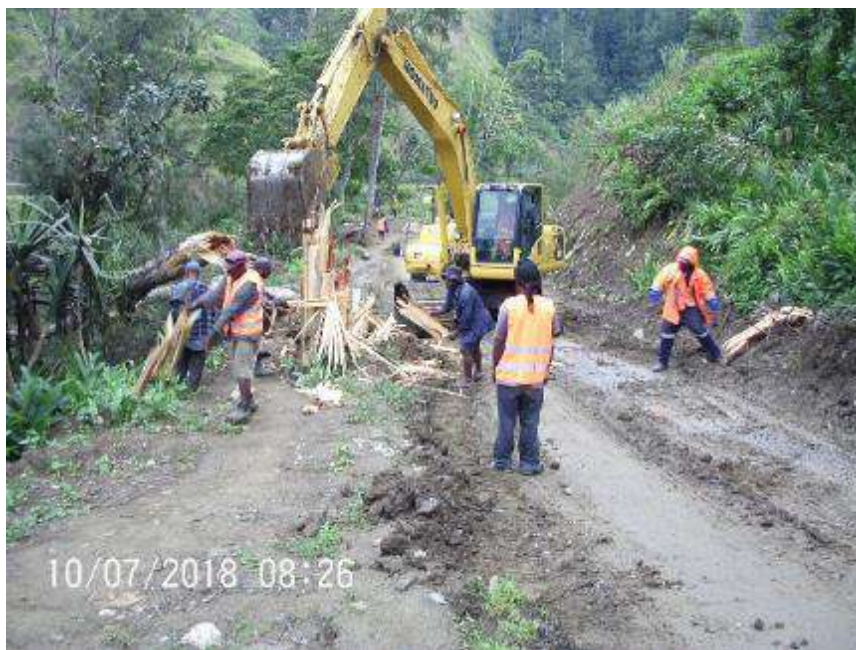
65. The trees destroyed or cut were given to the land owners (Photograph 19) for firewood or converted into timber for local use (Photograph 20). The commercial production of timber in the future could have negative impacts on the surrounding forest area.

Photograph 19. Destroyed trees are given to the landowners.

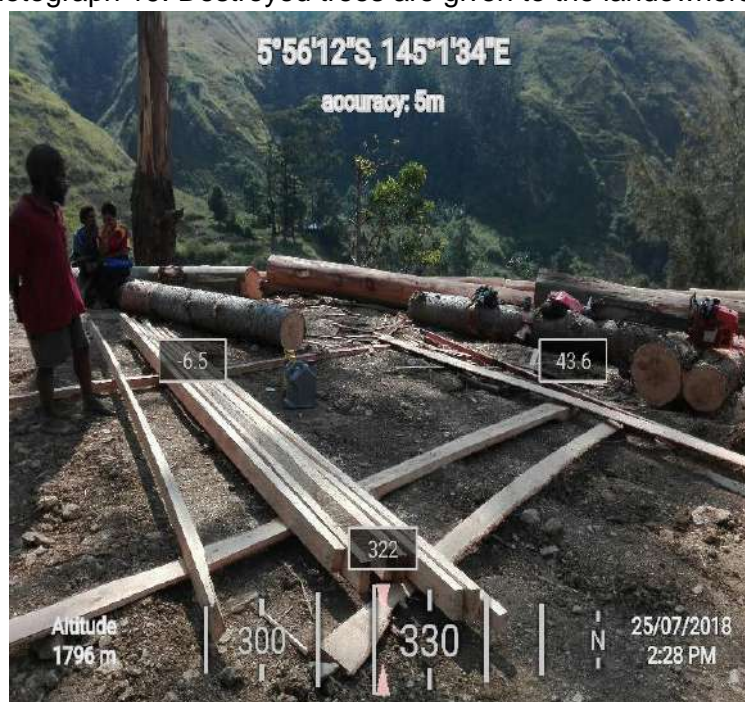
Photograph 20. A portable sawmill cutting the trees into timber at Ch:17+800.

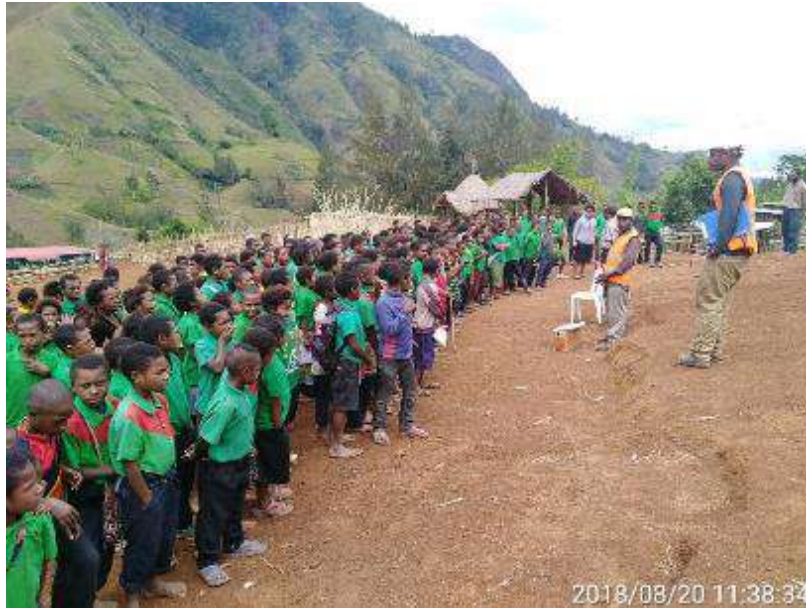
74. Public school education campaigns on road safety is also an important activity (Photograph 24).

Photograph 24. Safety Education at Barengil Primary School

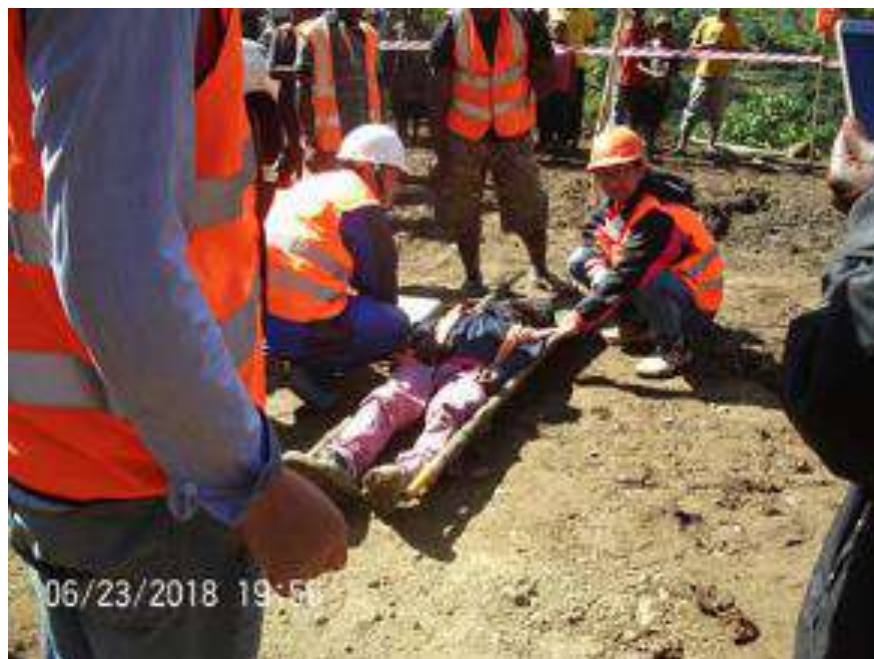
75. An accident during the previous reporting period has highlighted the need for worker's safety and appropriate emergency responses. The contractor has initiated First Aid seminar for its personnel (Photograph 25).

Photograph 25. First Aid and Emergency Response training.

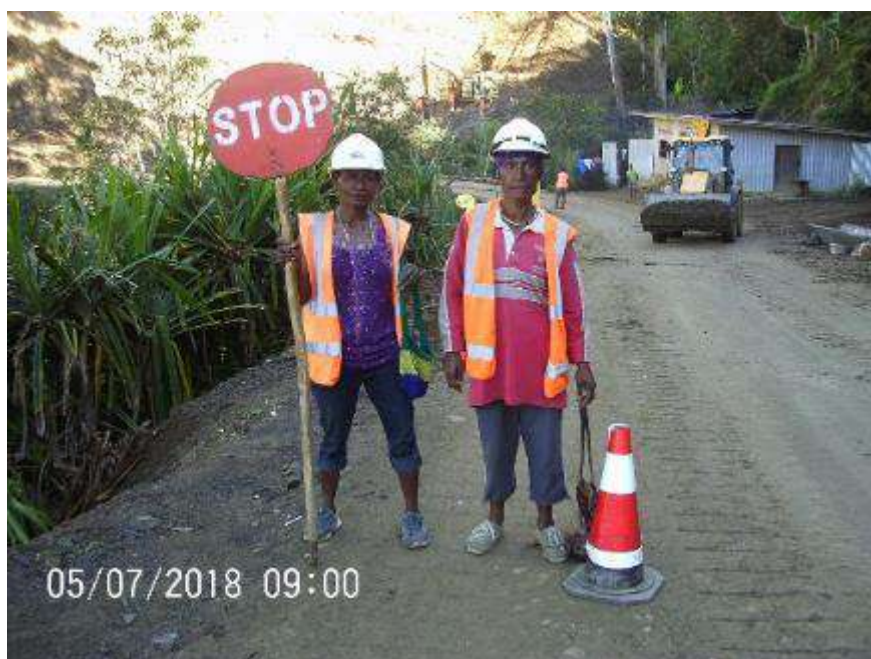
77. Women traffic aides are utilized for traffic management (Photograph 28).

Photograph 28. Women as traffic aides for traffic management.

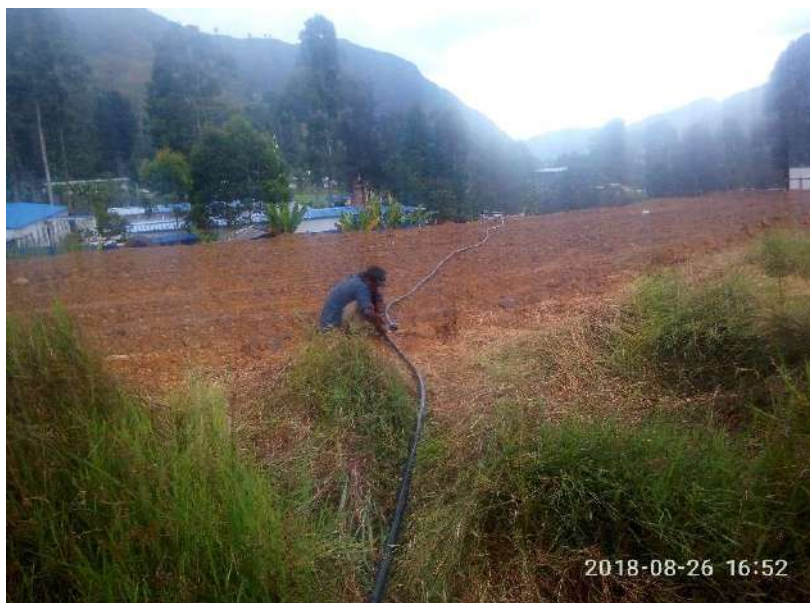
82. For the monitoring period from July to December 2018, the only issue was the provision by the contractor of a water pipe for water distribution in the community (Photograph 31).

Photograph 31. Water pipe provided for the use of the community.
