Semi-Annual
Report

PNG: HIGHLANDS REGION ROAD IMPROVEMENT INVESTMENT PROGRAM (TRANCHE 3)

Henganofi-Nupuru Road Sub-Project (January to June 2019)

Prepared by Highlands Road Management Group (HRMG) of the Department of Works for the Asian Development Bank

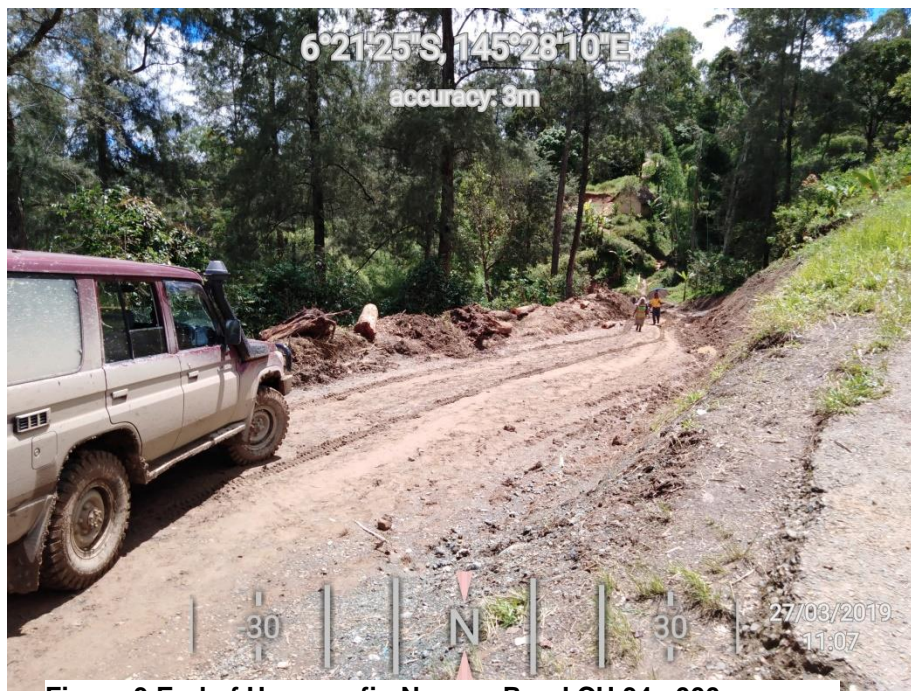
Figure 3 End of Henganofi - Nurpuru Road CH 34+ 000

48. All earth work for Henganofi-Nurpuru Road Project is completed as of March 2019. The contractor is now focused on Capping and road base works as well as sealing on front sections of the 34km Road.
