Environmental Monitoring Report

Semi-Annual Report
January-June 2014

INO: West Kalimantan Power Grid Strengthening Project

SEMI-ANNUAL REPORT **on** **ENVIRONMENTAL ISSUES**

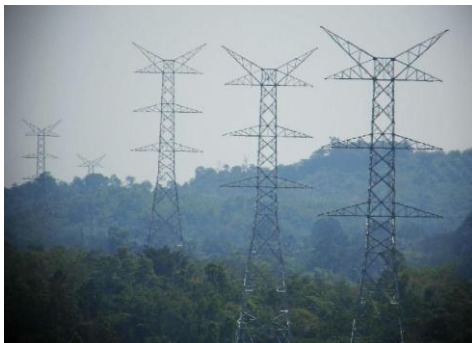
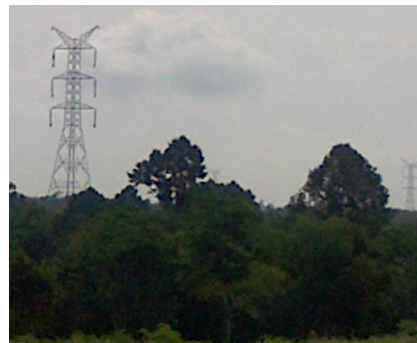
No of Picture: 8 & 9
Route: 275 kV Bengkayang-Jagoibabang
Location: Ledo sub district
Status: Tower erected
Picture taken: June 24, 2014

- Left: Serial of towers T-68, T-69, T-70, T-71 and T-72
- Right: T.129. Insulators installed

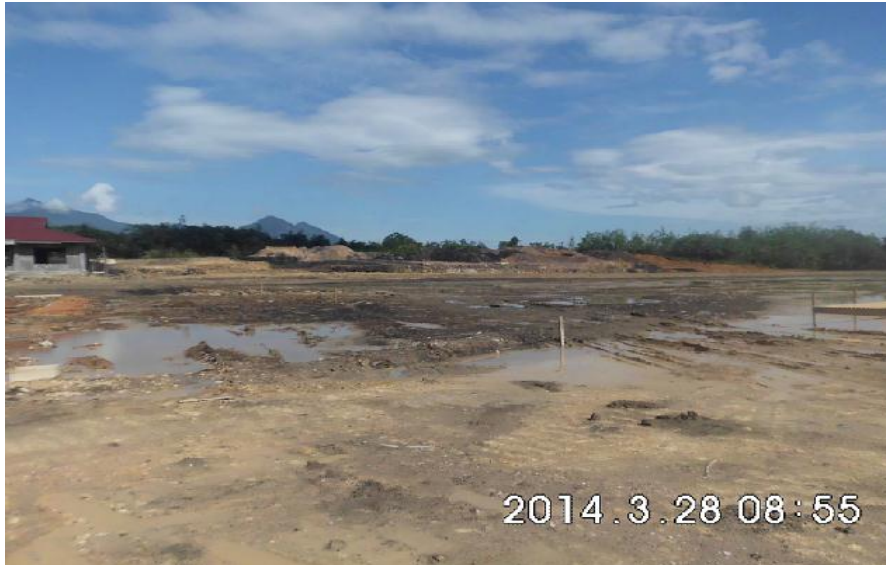
No of Picture: 10
Route: 275/150/20 kV Bengkayang Substation
Location: 275 kV Substation site
Status: -
Picture taken: March 28, 2014
Note: Land preparation has been completed, the civil structure works have not been initiated yet

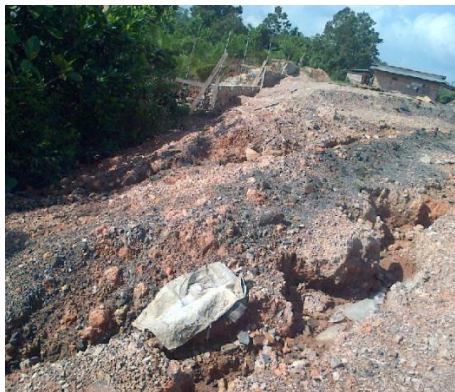
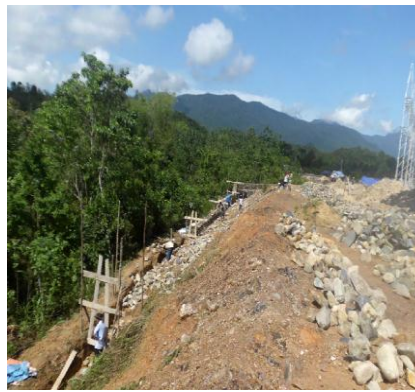
No of Picture: 11
Route: 275/150/20 kV Bengkayang Substation
Location: 150/20 KV Substation site
Status: Foundation works
Picture taken: June 6, 2014

Note:
Retaining wall construction of 150/20 KV Bengkayang Substation site

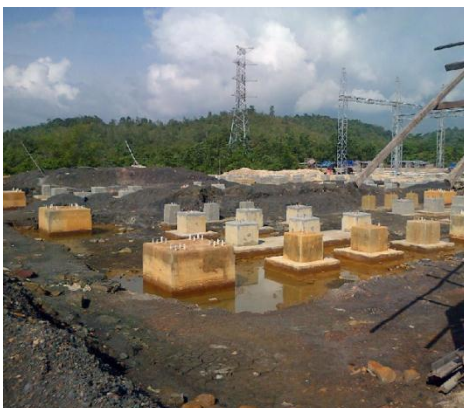
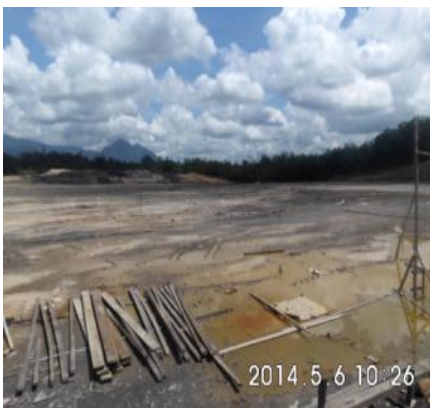
No of Picture: 12
Route: 275/150/20 kV Bengkayang Substation
Location: 275 and 150 KV Substation sites
Status: Foundation works
Picture taken: Right: June 6, 2014 Left: June 24, 2014

Note:
Left: 150 kV area:Construction of foundation

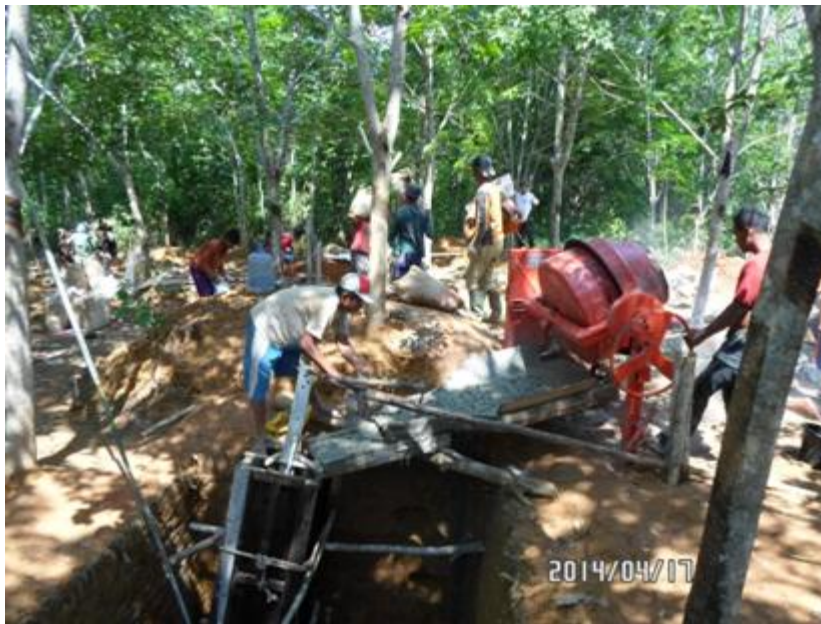
No of Picture: 14
Route: 150 kV Bengkayang- Ngabang
No of Tower: 177
Location: Young rubber plantation at Antan Raya village
Status: -
Picture taken: April 17, 2014
Note: The workers pouring the concrete for the column of the tower's leg

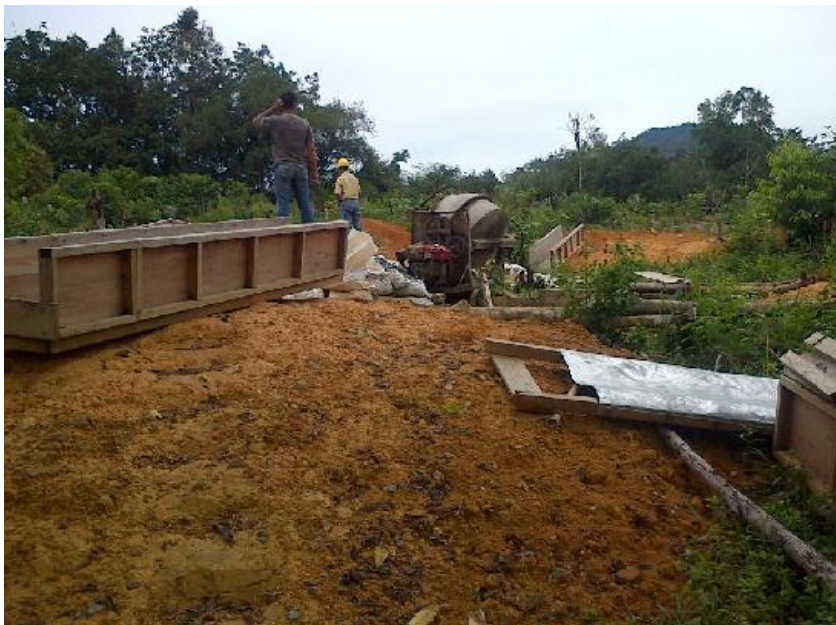
No of Picture: 15
Route: 150 kV Bengkayang- Ngabang
No of Tower: 81
Location: Banyukehulu village, Landak Subdistrict
Status: Foundation Construction
Picture taken: June 3, 2014
Note: Foundation excavation has been finished, rebar of tower pad was being installed

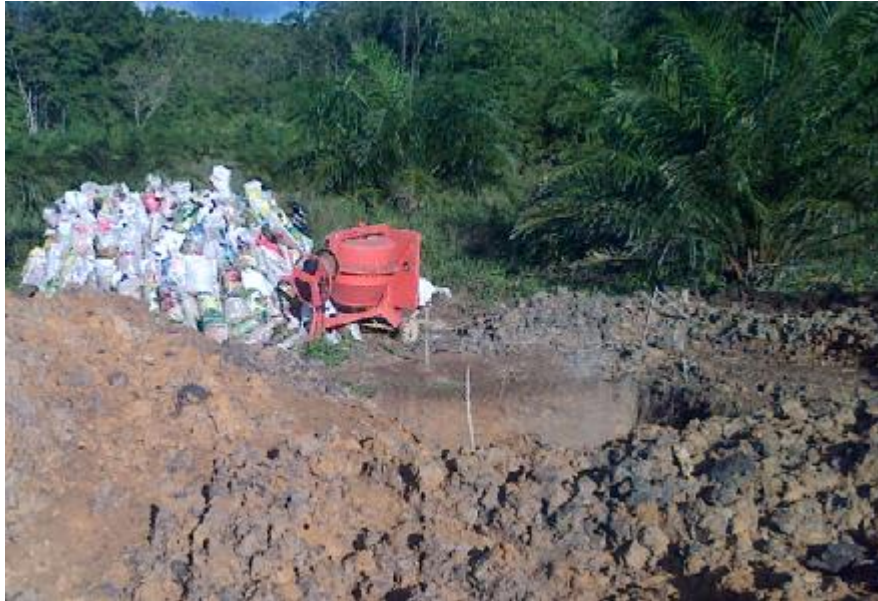
No of Picture: 16

Note: Land Excavation has
been finished.
Sand and gravel in hemp
sacks ready for construction

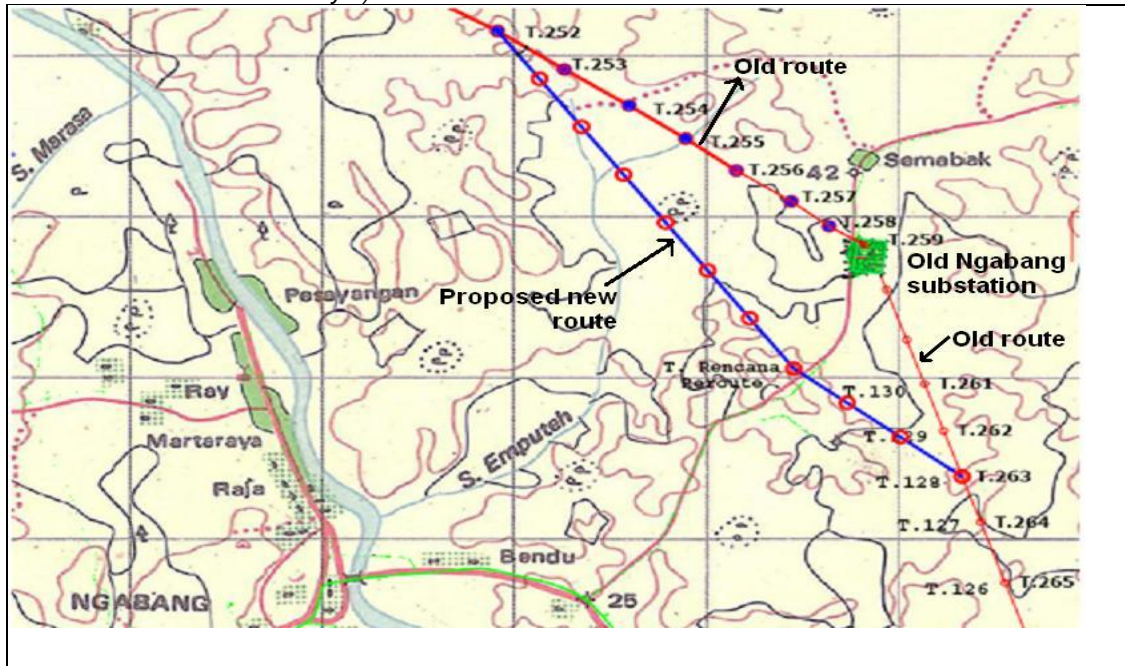
Map A-3.1 Tower re-routes of 150 kV Bengkayang-Ngabang Transmission Line at originally proposed Ngabang substation

Note: The green mark (T.259) was planned for Ngabang substation, but now it is used as dwelling area, so it has been decided to relocate the substation to the South-East of Ngabang (see Map No. A-3.2)
