Environmental and Social Monitoring Report

July - December, 2016

Kiribati: South Tarawa Sanitation Improvement Sector Project

Prepared by Ministry of Public Works and Utilities, Government of Kiribati for the Asian Development Bank

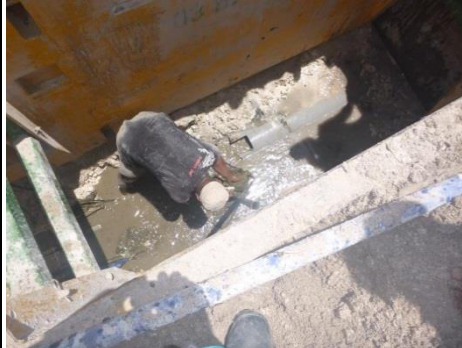
Environmental Issue	Monitoring Detail	Issues	Actions taken
1.3 Occupational health and safety measures	1.3 Ensure all staff are wearing appropriate PPE. JSEAs for work tasks have been completed and signed.	Working with raw sewerage (27 – 28 September) without wearing proper protective clothing and equipment
