# Environmental Monitoring Report

## GEO: Urban Services Improvement Investment Program – Project 1

## BI-ANNUAL ENVIRONMENTAL MONITORING REPORT

### **GEORGIA: URBAN SERVICES IMPROVEMENT INVESTMENT PROGRAM (TRANCHE 1) (FINANCED BY THE ASIAN DEVELOPMENT BANK)**

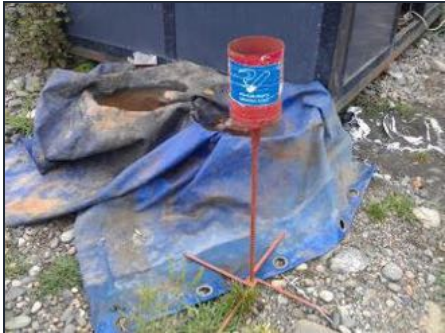
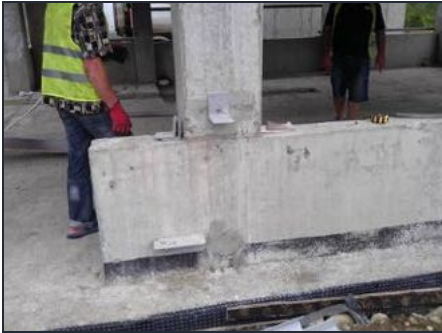
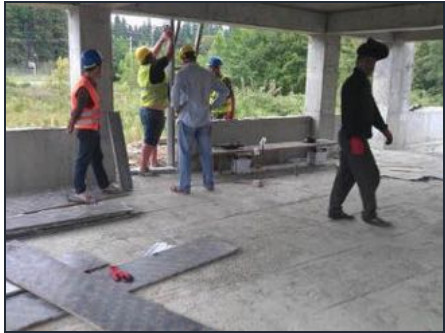
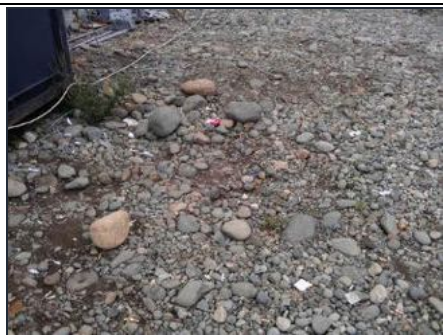
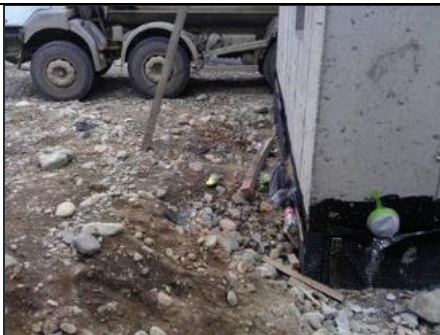
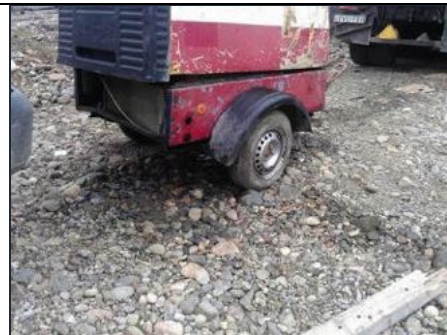
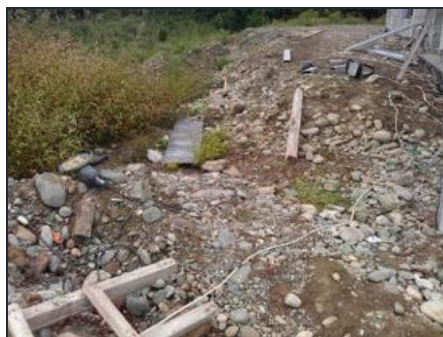
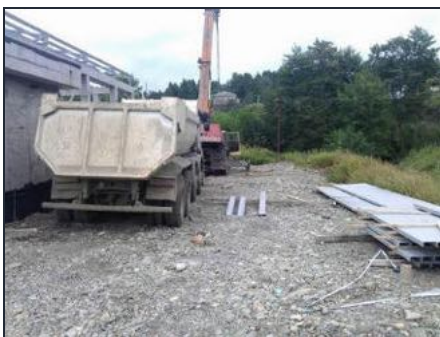
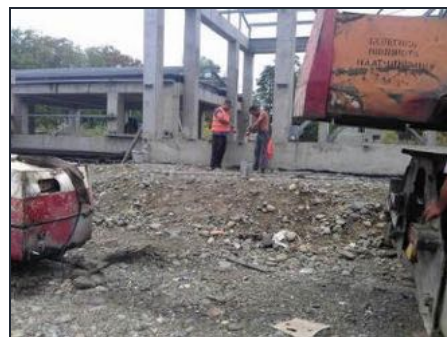
<b>Project: USIIP</b>	<b>Non-compliance Notice</b> <b>UREKI</b>
<b>Contract No: URE-01</b>	
<b>Contractor: PERI</b>	
<b>Reference:</b> <b>UREKI - UREKI PAMPING STATION</b>	
This notice is to advice you, the prime Contractor, on the referenced Contract, of the following notice on environmental measures to be implemented <b>urgently</b> .	
<p><b><u>NON-COMPLIANCE IN UREKI</u></b></p> <p><b>PAMPING STATION</b></p> <ul style="list-style-type: none"><li>- Proper place for Parking with relevant sign should be arranged</li><li>- All construction materials should be properly segregated and stored adequately</li><li>- Fuel/oil spill response items (sand, sawdust, special containers) should be equipped with relevant signs</li><li>- Machinery and equipment should be in standard technical condition (no leakage of fuel and lubricants)</li><li>- Use tarpaulins to cover during materials transportation</li><li>- All workers (even personnel of subcontractor) should be equipped with complete PPE</li><li>- Site internally should be arranged properly and cleaned regularly</li></ul> <div>

All these conditions have to be remedied within five days (by the 25 September 2016) by the prime Contractor (Peri).

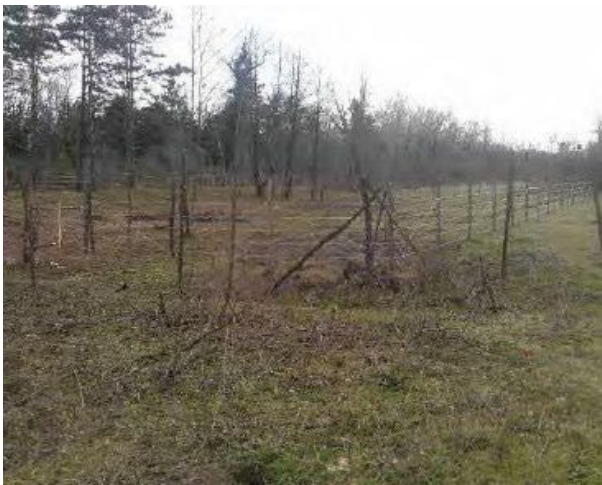
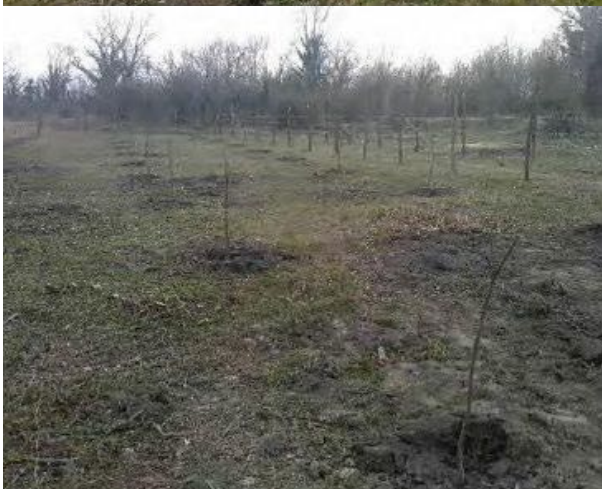
41. CAP was agreed with the MoENRP of Georgia in November 2015. Based on this CAP Contractor “Cobra” planted 50 individuals of Imeretian Oak trees (10 instead of each cut tree) and takes responsibility for taking care of saplings of the same species in suiting environment offered by the National Forestry Agency of MoENRP during the five years (Figures 1 and 2).

### **Figures 1 and 2: 50 planted seedlings of Imeretian Oak trees**

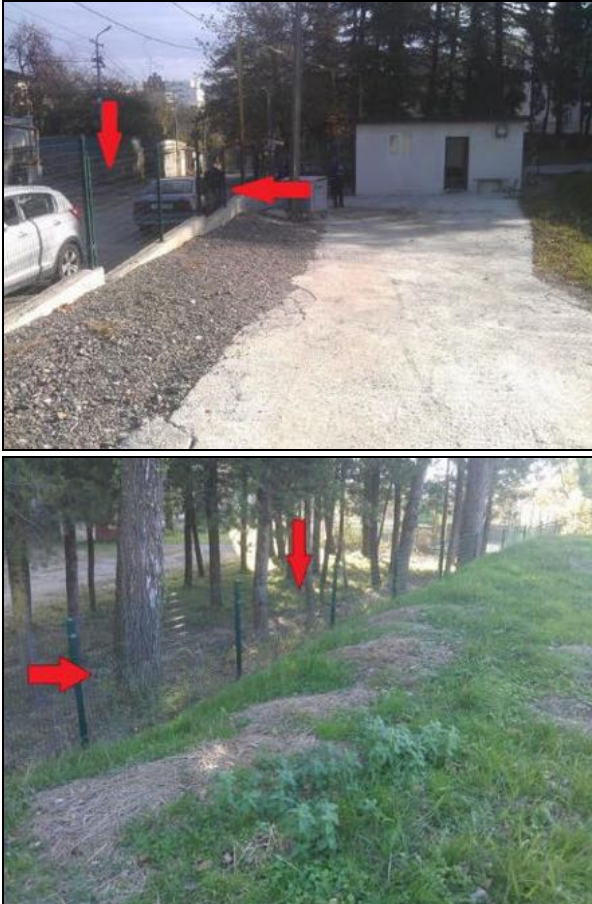
48. The construction site is fully fenced (Figures 3 and 4).

**Figures 3 and 4: Fencing of Vaja-Pshavela Reservoir construction Site**

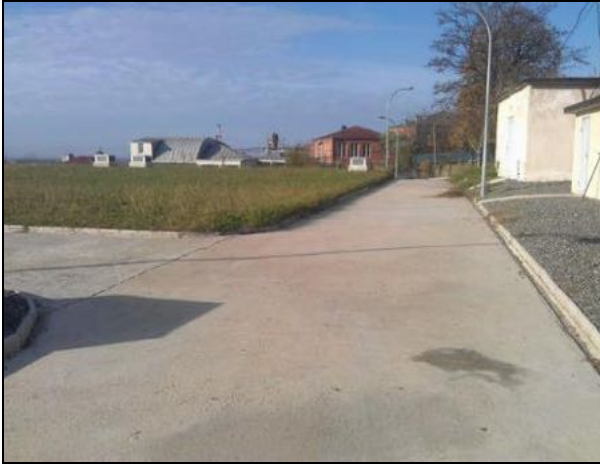
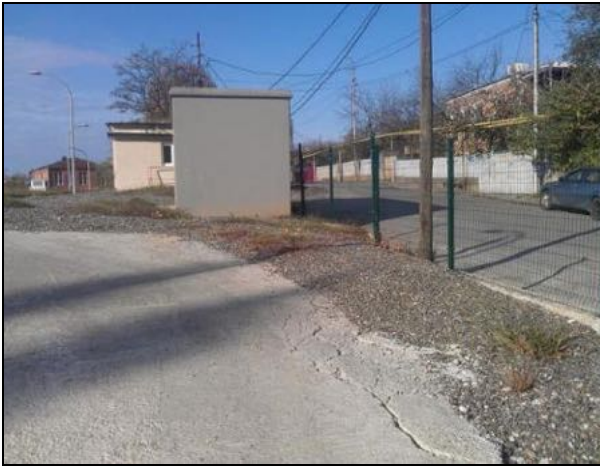
49. All kinds of waste are totally removed from the site and all temporary facilities are also removed. The local roads are laid and the area is improved (Figures 5 and 6).

**Figures 5 and 6: Reservoir site in Vazha-Pshavela Street**

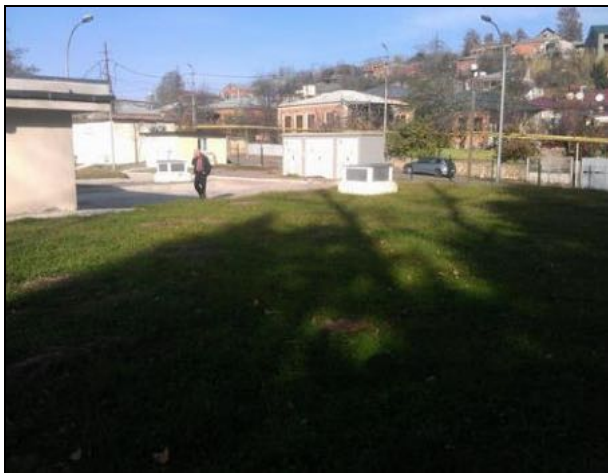
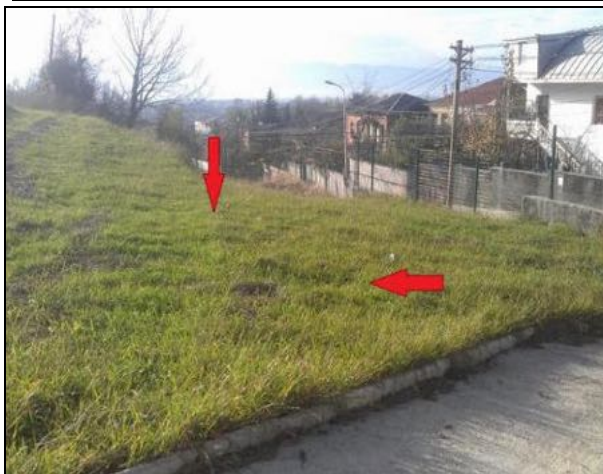
50. The reconstruction works are accomplished fully and satisfactorily in the area (Figures 7 and 8). The access road to the reservoir is also coated.

**Figures 7 and 8: Reinstated Construction Site**

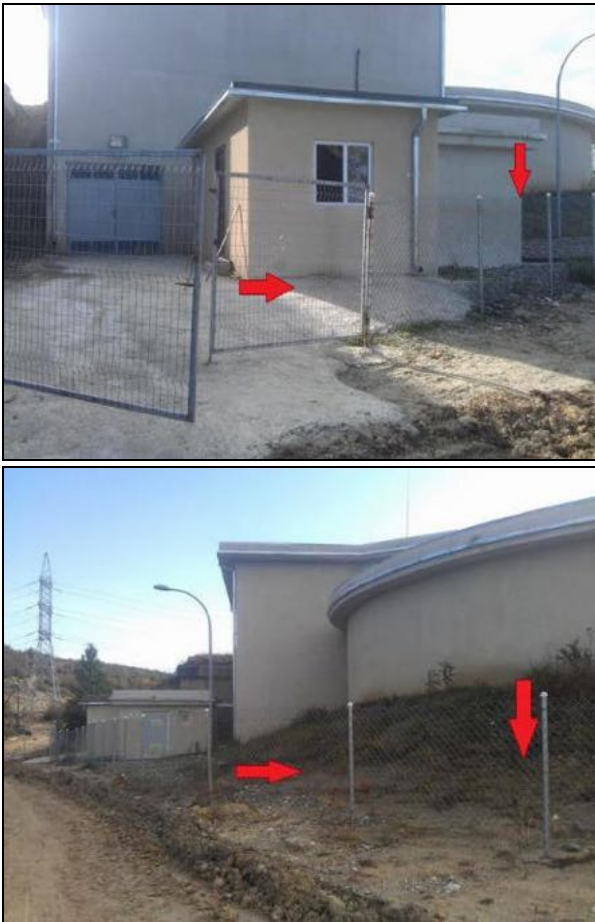
51. During the final audit process non-compliances at the construction site of TV Tower have not been revealed. The construction site is fully fenced (Figures 9 and 10). Filled in post-construction environmental checklist is attached in Annex 2.

**Figures 9 and 10: Installed fencing around the TV Tower Construction Site**

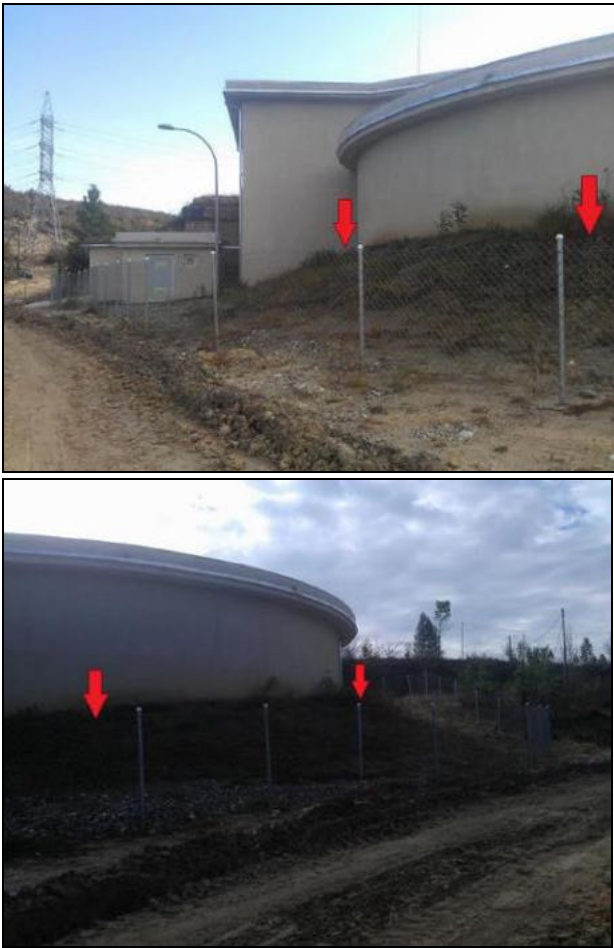
52. The reconstruction works are accomplished satisfactorily (Figures 11 and 12); all kinds of waste, including construction waste are removed from the site. The demolition of the auxiliary buildings and premises is complete.

**Figures 11 and 12: Returning of topsoil and reinstatement of vegetation cover**

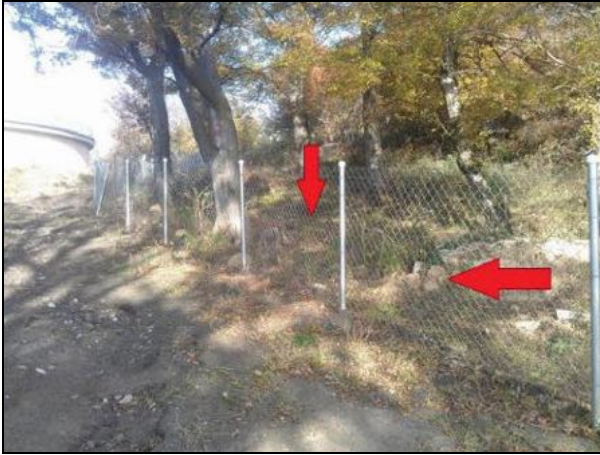
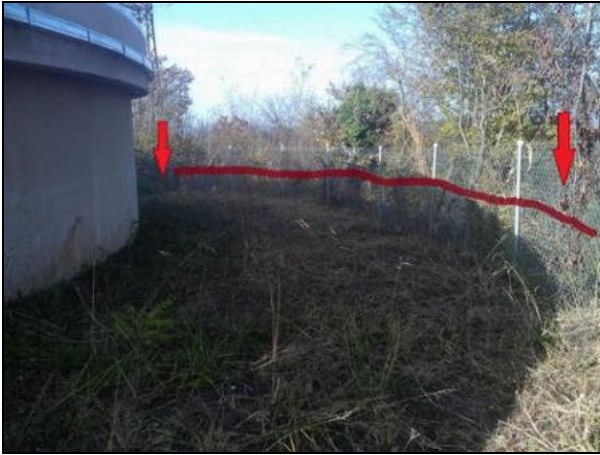
**Figures 13 and 14: Tetramitsa Reservoir Fencing**

54. During the final audit process non-compliances at the construction site of Tetramitsa Reservoir have not been revealed. The construction site is fully fenced (Figures 13 and 14). Filled in post-construction environmental checklist is attached in Annex 3.

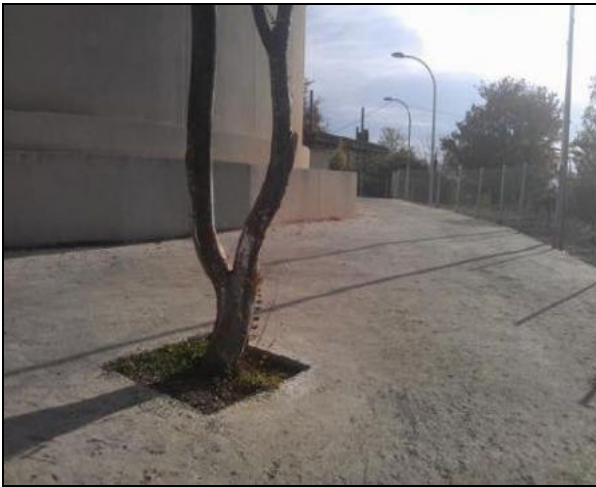
**Fig. 15. Local roads**

55. The local roads on the reservoir site are faced (Figure 15) and the the access road to the reservoir is also restored (Figures 16). All types of waste are totally removed from the project zone. The temporary buildings and premises are demolished and the waste is removed from the site.

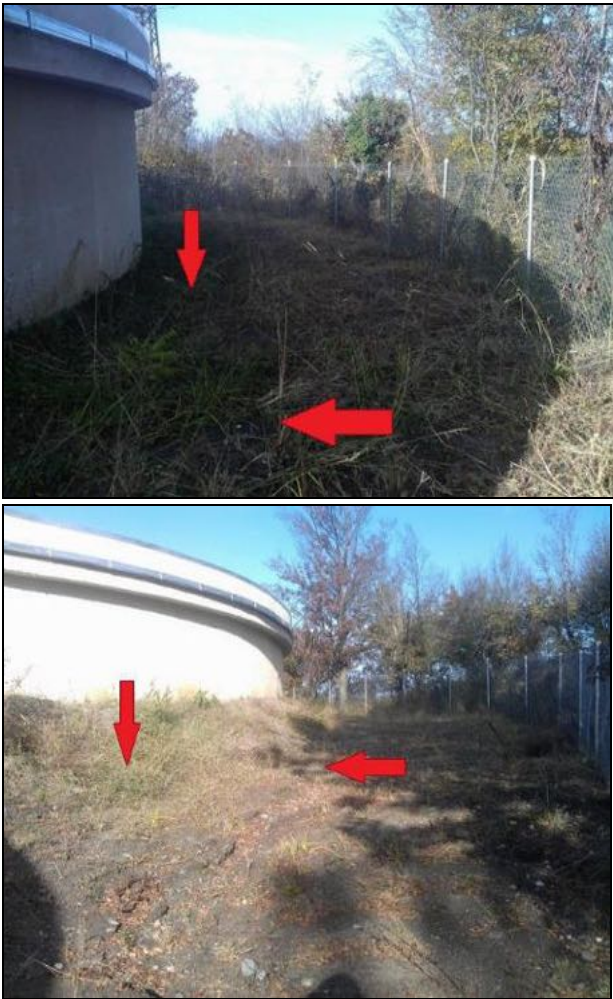
56. Reinstatement of post-construction territory is satisfactory (Figures 17 and 18).

**Figures 17 and 18: Returning of top soil and reinstatement of vegetation cover at Tetramitsa construction site**

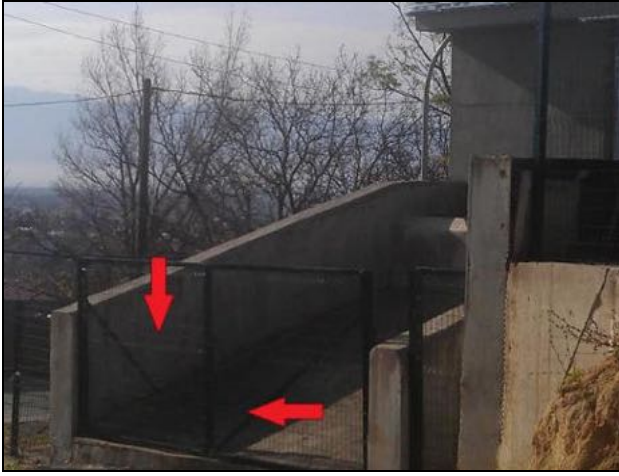
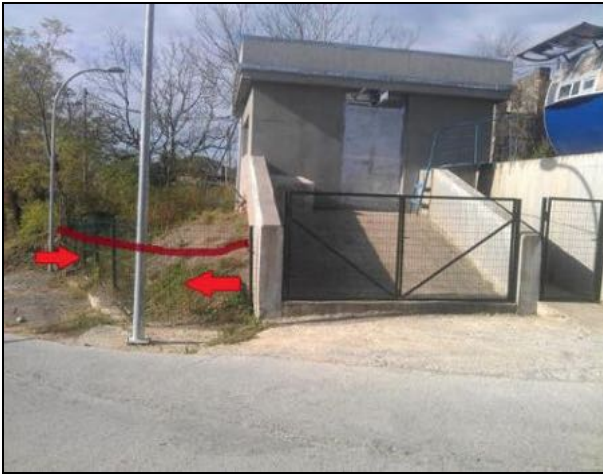
**Figures 17 and 18: Kldiashvili Pumping Station fencing**

57. During the final audit process non-compliances at the construction site of Kldiashvili Pumping Station have not been revealed. The construction site is fully fenced (Figures 17 and 18). Filled in post-construction environmental checklist is attached in Annex 4.

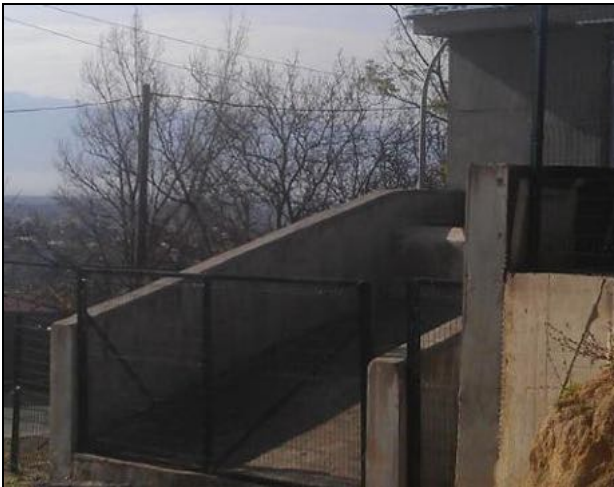
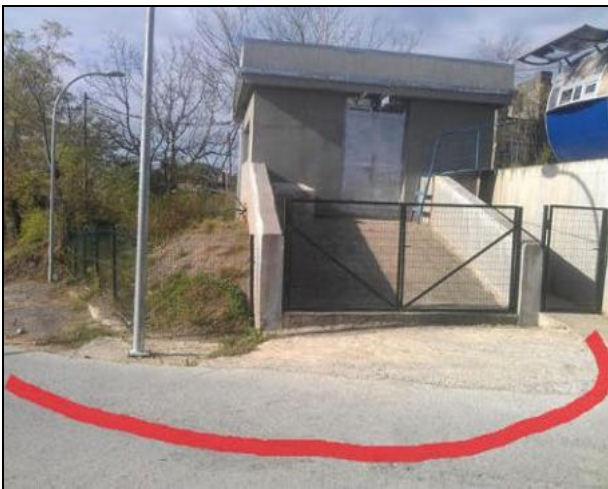
**Figure 19: Local roads      Figure 20: Access Road**

58. The waste is removed from the site and both, local access roads and the access road to the reservoir are faced (Figures 19 and 20).

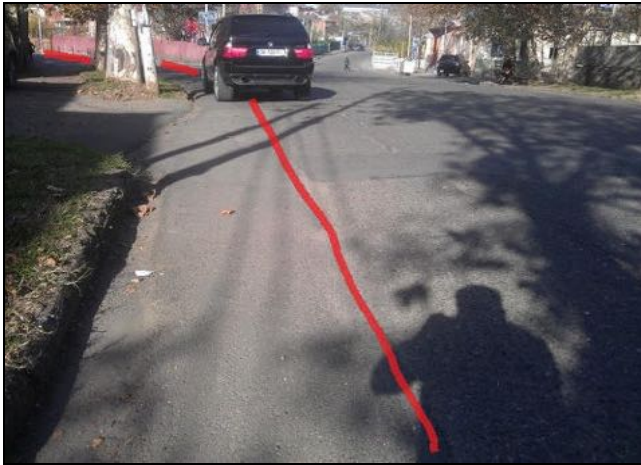
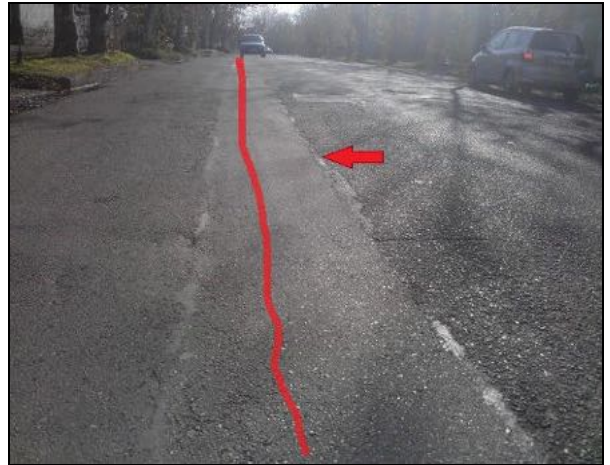
63. The rehabilitation works on the whole territory of the city, where the existing water supply pipes were changed or new pipes were laid, were accomplished satisfactorily. Figures 21 to 30 show the visual proof of the rehabilitation works accomplished in different streets of the city.

**Figures 21 and 22: Reinstatement of May 26 Street with installed network**

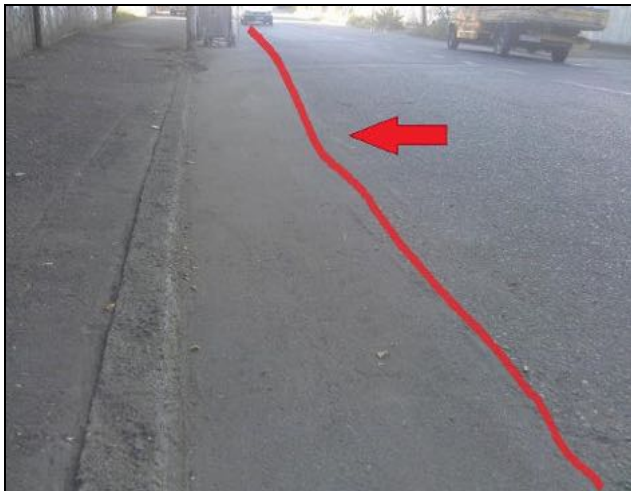
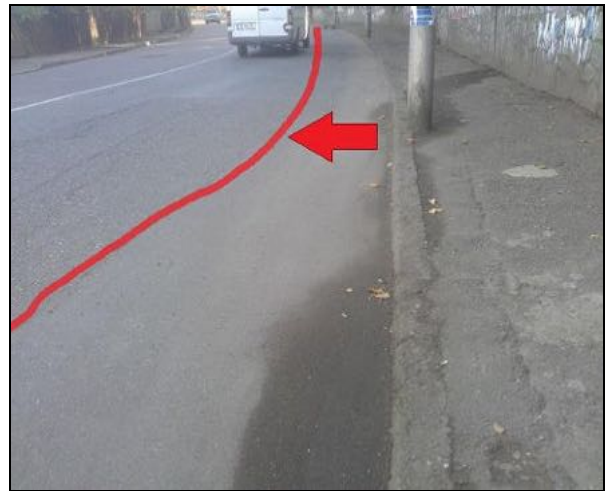
**Figures 23 and 24: Reinstatement of Tsereteli 1-st turn with installed network**

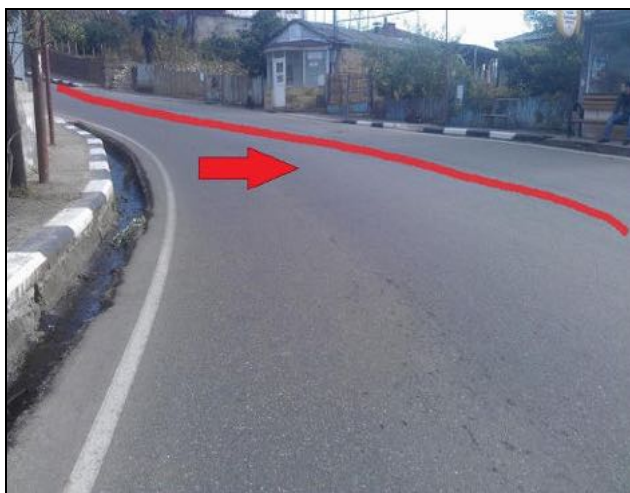
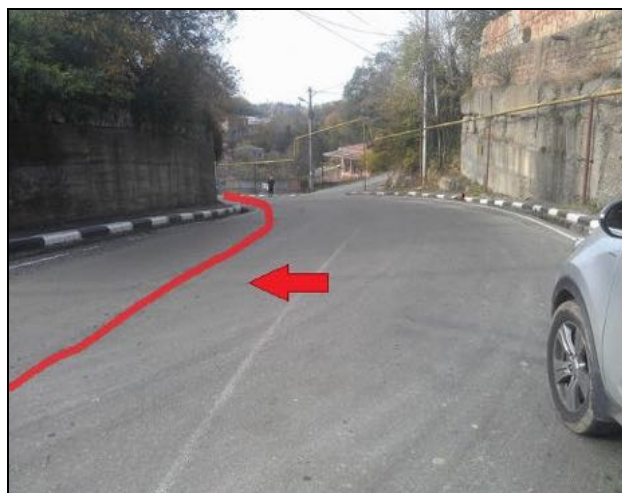
**Figures 25 and 26: Reinstatement of Gelati Street with installed network**

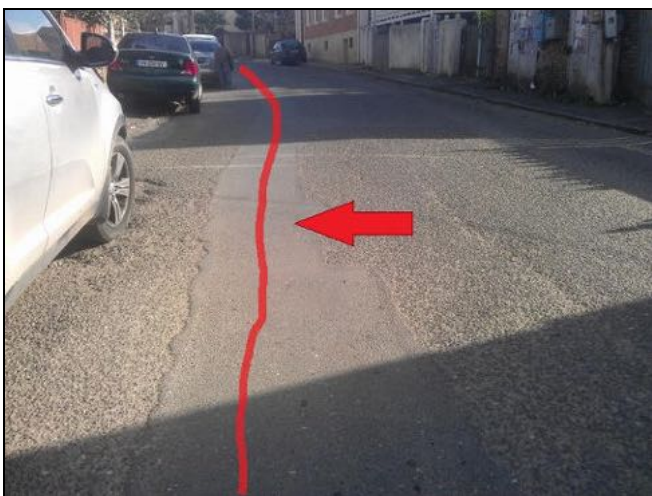
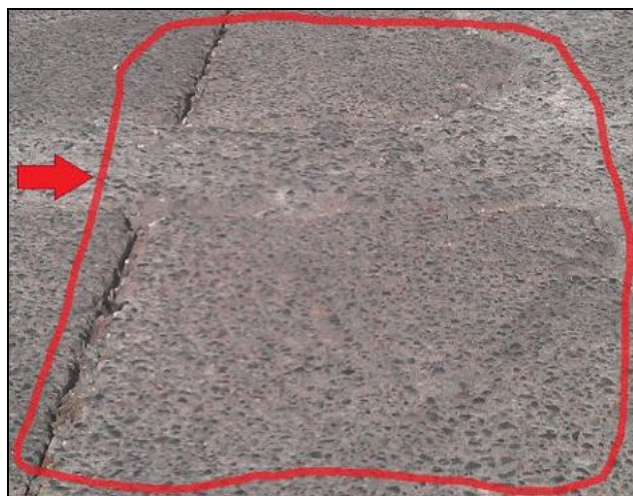
**Figures 27 and 28: Reinstatement of Kldiashvili Street with installed network**

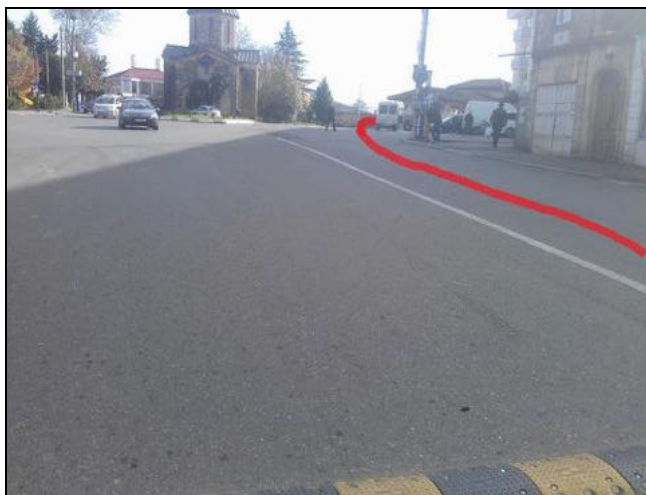
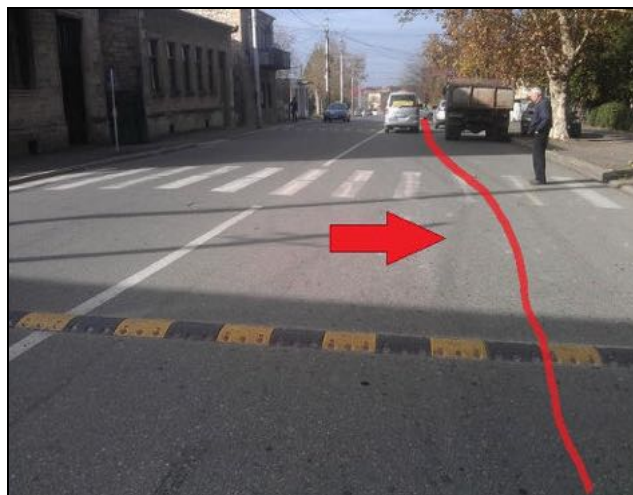
**Figures 29 and 30: Reinstatement of Solomon I Street with installed network**

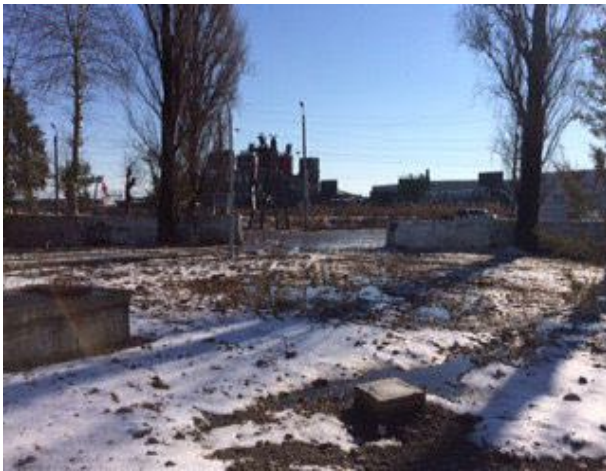
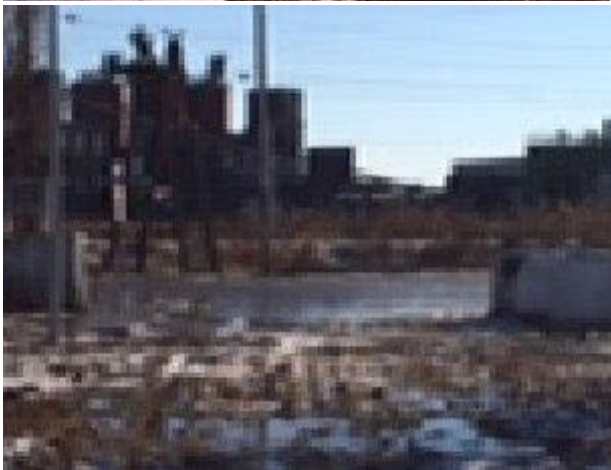
**96. Non-compliance 1:** The site of Nabada reservoir is fenced, but it has no gate (Figures 39 and 40) making it possible for the animals to move around the reservoir site (across the sanitary zone).

**Figures 39 and 40: The site of Nabada reservoir has not gates**

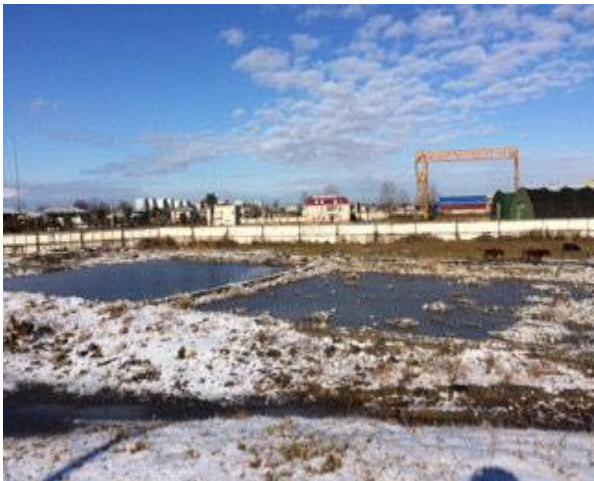
**99. Non-compliance 2:** The project envisaged the disassembly of the existing reservoir on the territory of Nabada and removal of the construction waste from the area. At present, only the upper ground layer of the existing reservoirs is removed, while the underground part of the reservoir is untouched. As it rains, the rainwater is accumulated on the site resulting in two basin-like units on the site of the reservoir (Figures 43 and 44).

**Figures 43 and 44: Water-flooded site of the existing reservoirs**

**100. Corrective action:** The old reservoirs on the territory must be totally disassembled and the construction materials must be removed and disposed as per the legislative requirements.

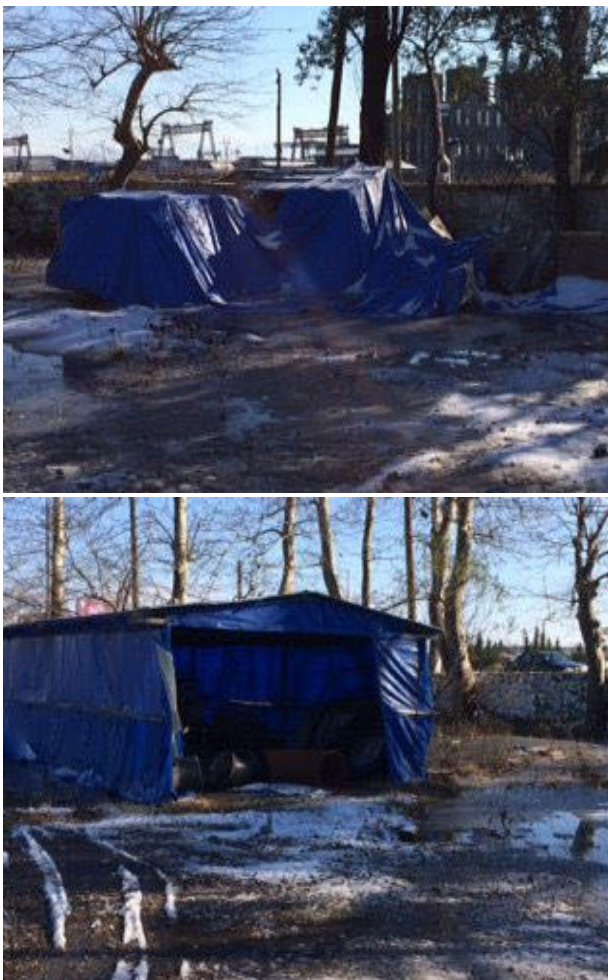
105. As the audit demonstrated, a number of actions on the site of Nabada reservoir envisaged by the project are not complete by the Construction Contractor. Consequently, a certain proportion of the construction equipment of the Construction Contractor is still found on the territory of the reservoirs (Figures 49 and 50). The said construction equipment must be removed from the area following the accomplishment of the corrective actions.

**Figures 49 and 50: Equipment, machinery and temporary facilities of Contractor**
