Environmental & Social Monitoring Report (July to September 2014)

Project Number: 44914

PAK: Patrind Hydropower Project

Prepared by Star Hydro Power Limited

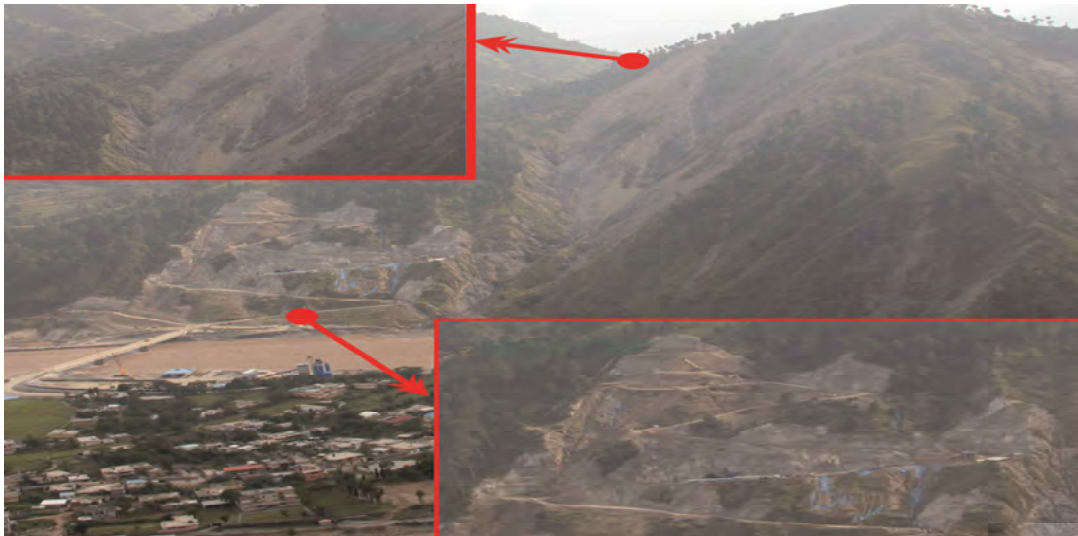
Majority of the debris avalanches are associated with bedding plane failures. Earthquake-induced acceleration produced additional downslope force, causing marginally stable slopes to fail. The low cohesion and high water content caused high increase in debris avalanches, which left behind many V-shaped scars. Down the slope, the debris avalanches spread and transformed into flow slides. Geologically these avalanches are located in the brown to dark gray rubbly slates, limestone and dolomite in the study area.

The increase in landslides area for the post few years, showing a very slight change in landslide activity except one massive landslide triggered right at the head of under-constructed power house site.

It signifies the fact that most of the rainfall-induced landslides were still related to the earthquake rooted disturb topography. The most abundant types of landslide are debris fall and slide (translational slides), which are increasing in the area and also causing occurrence of few new landslides which were observed just at the top of tunnel constructed at power house site.

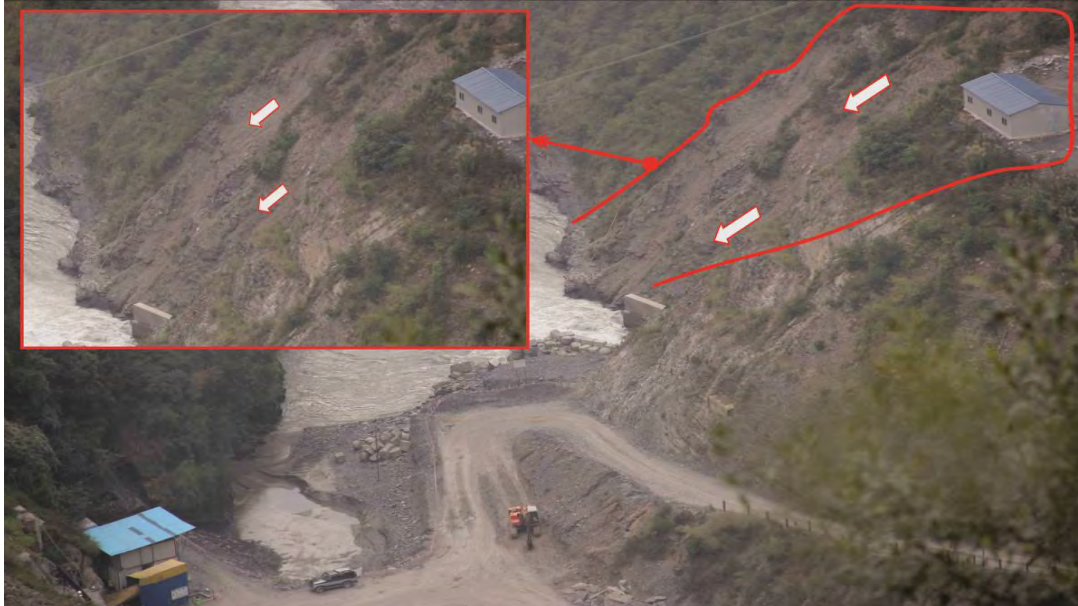
Most of those are old landslides occurred in highly fractured shale, slate, clastic sediments, limestone and dolomite on slopes along river and roads.

On Muzaffarabad–Abbottabad road linking Muzaffarabad District to KPK at Lohargali point, massive landslides present along the right bank of river Jehlum in semi-circle shape in close pockets which are major irritant which remained always a source of disruption and hazardous where half kilometer portion is turned into permanent slide and slippage. This is the main supply artery for the transportation of heavy supplies to different ongoing projects including Patrind Hydro Power Project, which often remains suspended over the days. At least 2 to 3 villages having considerable population also located at the back of slide area and are also threatened due to persistent and excessive land sliding being reached to the toes of the inhabitant areas. During March 2014 this landslide was suddenly triggered and claimed two precious lives, one highly qualified Ph.D agriculture professional and his medical student daughter travelling to Muzaffarabad city for joining their duties, who were hit by huge land slide while the jeep was completely submerged into mud. This massive land/mud slide is a potential hazard that can be further triggered anytime which is a serious threat to the precious lives and public property and may increase the sediment load in the Jhelum River. Area opposite to this slide on the back is also prone to land sliding. Very high susceptibility to ongoing land sliding is predicted due to the steepness of the terrain, and the road itself. This point needs special arrangements to keep safe and out of danger.

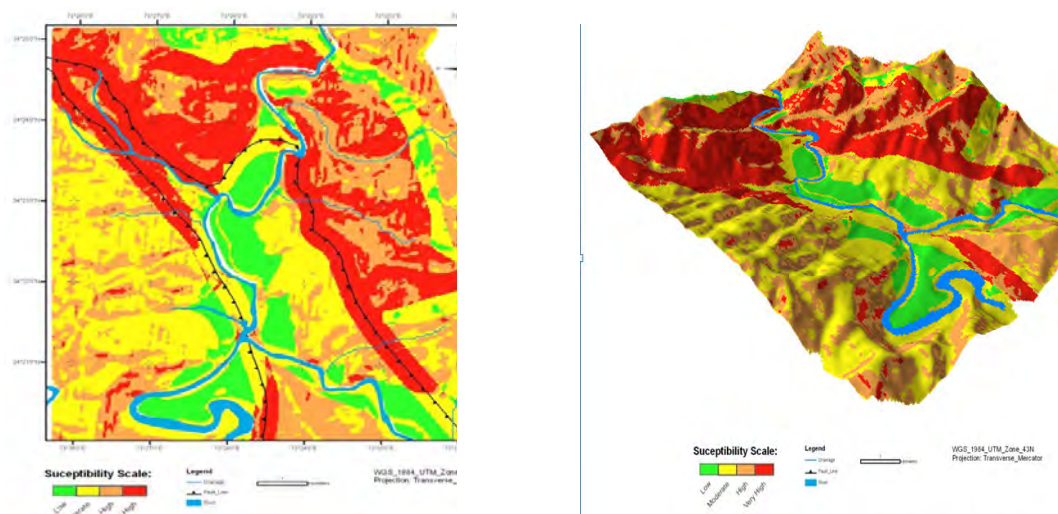
Landslide Susceptibility Map

A notable proportion of landslides in the area were caused by human- induced factors, especially deforestation, poor terracing and habitations located on exposed slopes, and road construction. The negative impact of road construction, other developmental engineering work on slope stability resulting in land sliding causing physical, socio-economic and environmental losses.

Following susceptibility map can provide a cheap and comprehensive assessment of the likelihood of future failures, which can be useful to planners for the rebuilding process and future zoning issues. Individual landslide areas can be remediated by employing engineering techniques, such as, the use of retaining wall, but these are expensive and need continuous monitoring.

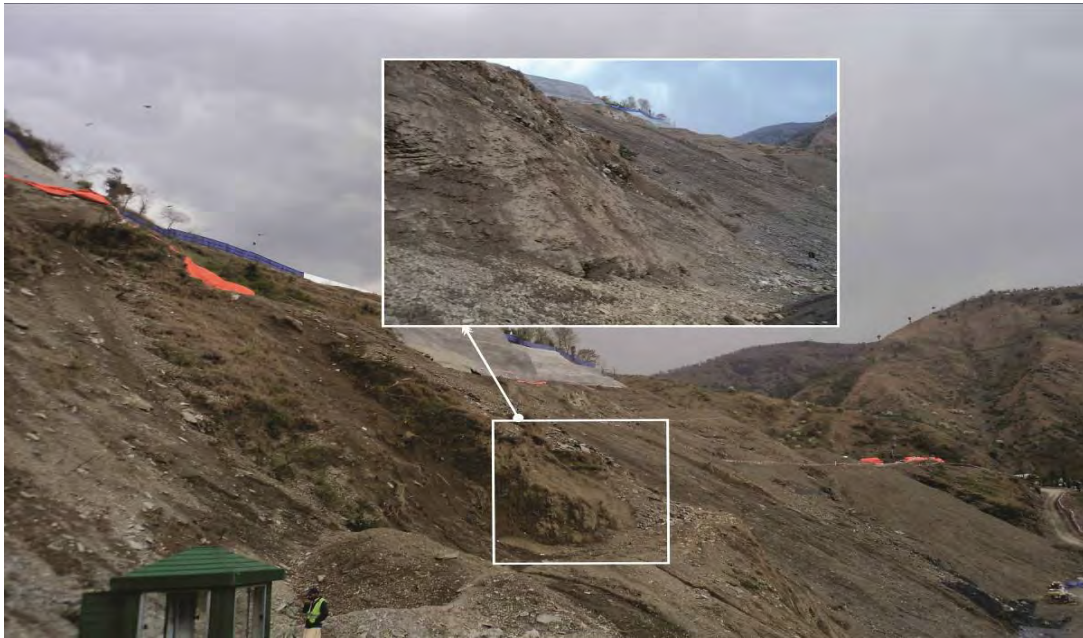
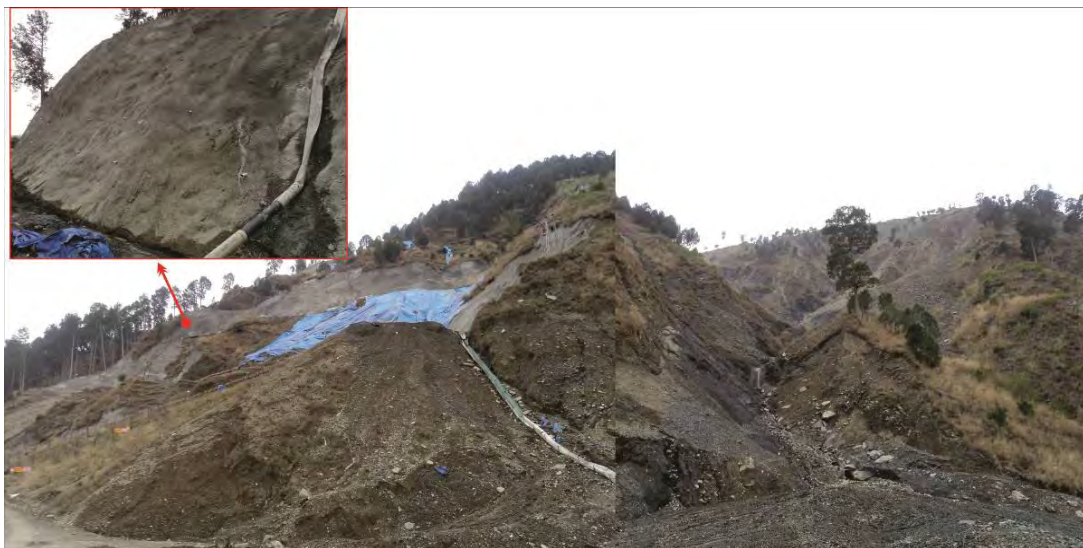
Changes of landslide types and spatial distribution of slope failures are required to determine after each monsoon. These selected sites should be re-visited and re-photographed in same season during forthcoming years. This will allow us to make an assessment of the short-term changes that occurred during the period. The collected data and set of photographs will be used to compare landslide changes in coming years. Visual estimates and on-screen digitization of field photographs will be used to calculate percent changes in landslide surface area.

To manage and mitigate the potential impacts of landslide hazard, massive close spacing plantation of fast growing trees and appropriate engineering measures are recommended to mitigate the landslide hazard in future. There is a need to establish proper drainage pattern to reduce the instability of the area. Monitoring of slope movement and ground-water levels are required to assess potential movement of landslides. Discontinuing the landslide slope through terracing. Provision of cut off drains to divert the flow towards the natural course.

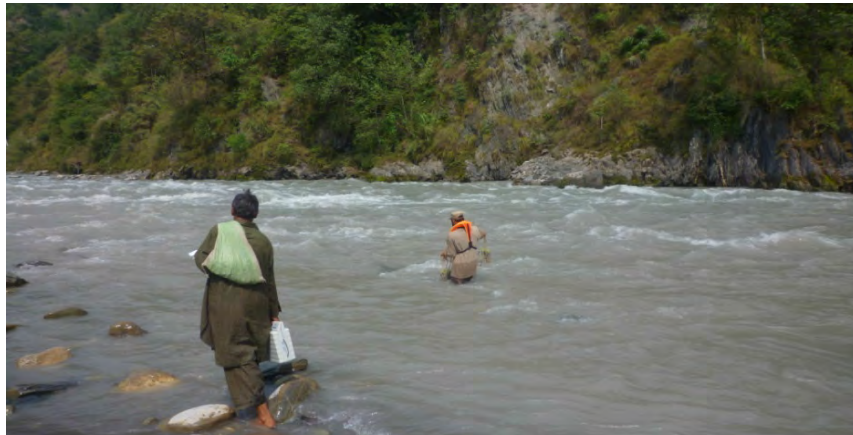
This is the point situated at $34^{\circ} 18' 19''$ N, $73^{\circ} 26' 44''$ E at 723 meters of elevation above sea level. The water level is moderate and it is clear as compared to last sampling during June 2014. The fish has most probably migrated due to seasonal changes in the hydrology of the river water. Last time the fish catch was high which shows that the fish catch during June-August remains high. No fish has been caught during this month of September 2014 at this point.

Fig 2. Fishing with cast net at point 1

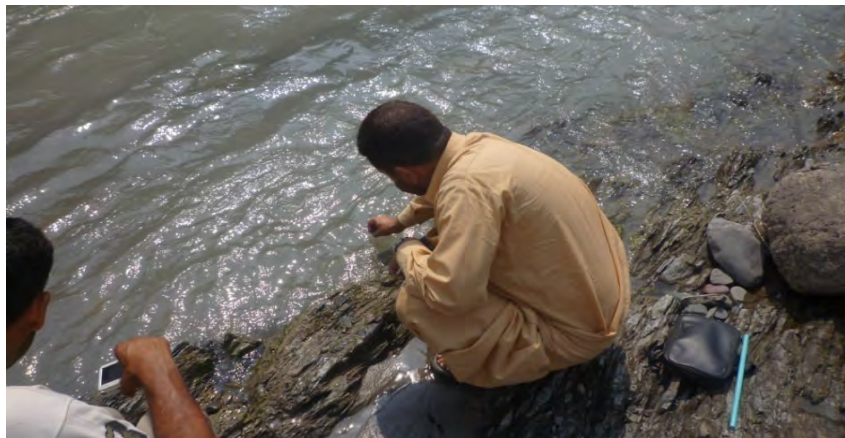
Fig 3. Testing of water parameters

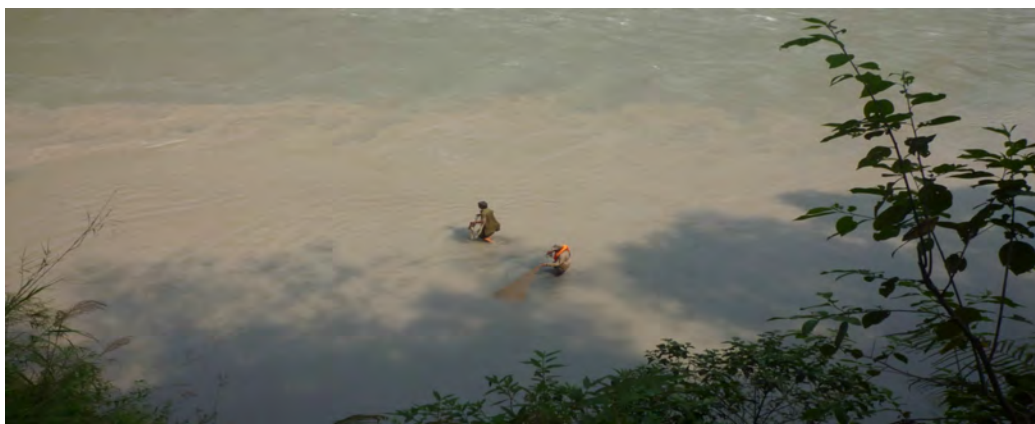
One sample fish caught at the point of confluence of NallahBoi with Kunhar was encircled with a tin ring thrown into the river. Such other items were also noted especially where small streams and creeks join the river Kunhar. Plastic bottles, bags and nylon clothes are detrimental for the aquatic life.

Fig 5. Netting at confluence of NallahBoi with Kunhar River

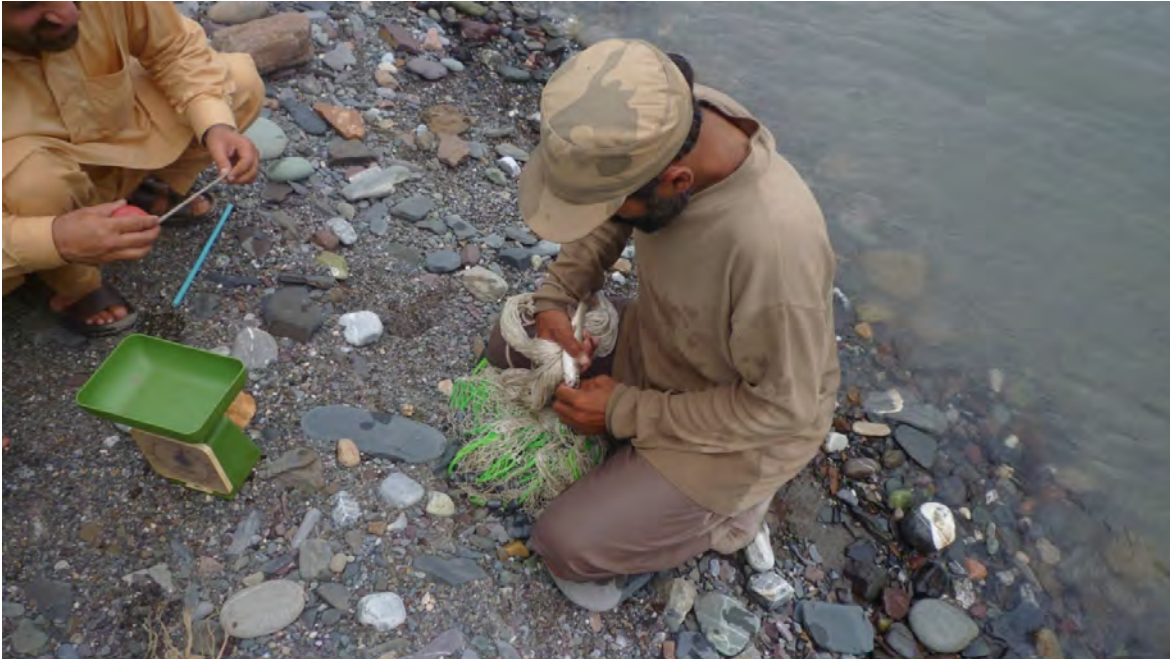
This is the point situated at $34^{\circ} 19' 47''$ N, $73^{\circ} 25' 35''$ E at 750 meters of elevation above sea level. A small creek joins this point with a warmer temperature providing the chances of better food items to flow into the river. River also makes few small pools providing better chances for the fish to feed and spawn. This is again a good fishing point situated at about 3 km downstream of Patrind weir point. The catch of fish was 1 of *Schizothorax plagiostomus*.

Fig 6. Fish caught at parri

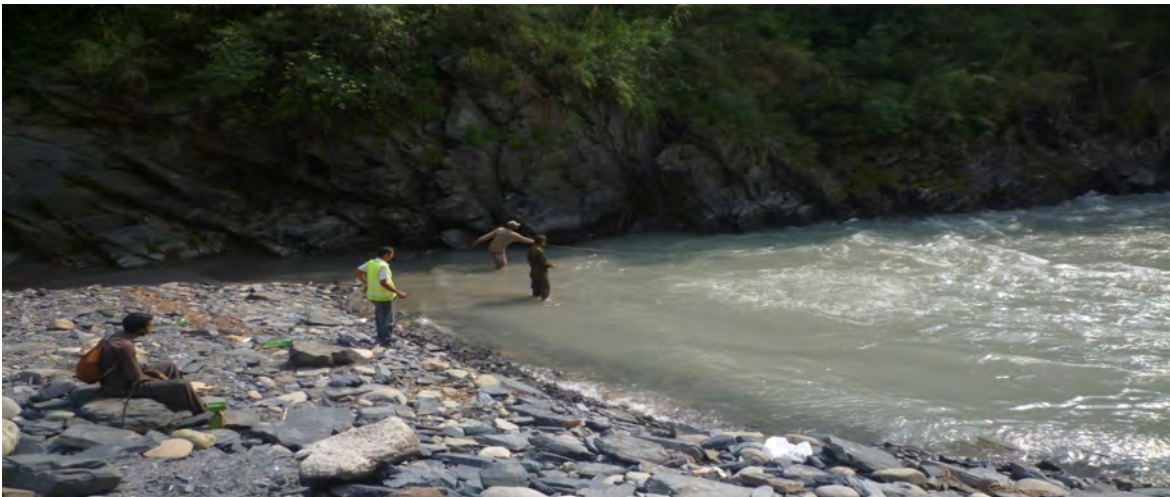
This is the point situated at $34^{\circ} 18' 19''$ N, $73^{\circ} 26' 44''$ E at 766 meters of elevation above sea level. A small pool has appeared at the left side of the very fast flowing outlet of the diversion where survived fish from the roaring outlet can have the survival environment. Food scarcity has been observed so the growth of the fish will be stunted here. This diversion tunnel has a definite impact on the fish production but to maximum of 800 meters downstream.

Fig 7. Netting at Outlet of Diversion Channel at Patrind

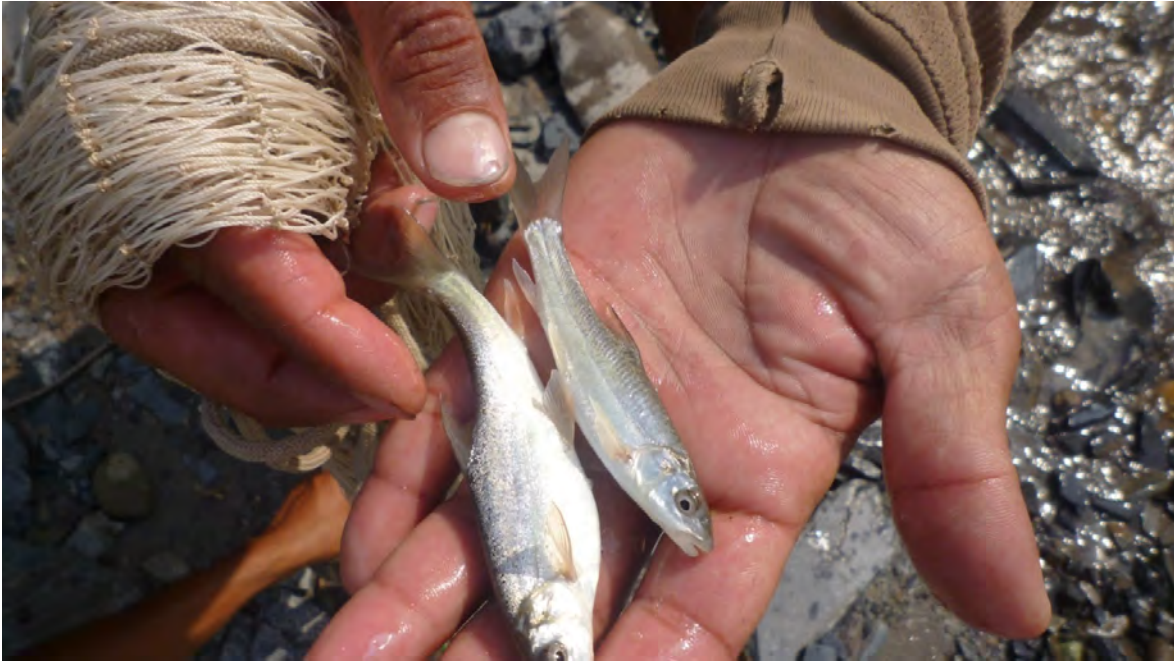
Two very small fish of *Schizothoraxplagiostomus* were found here.

Fig 8. Fish caught from the pool appeared at the side of the outlet

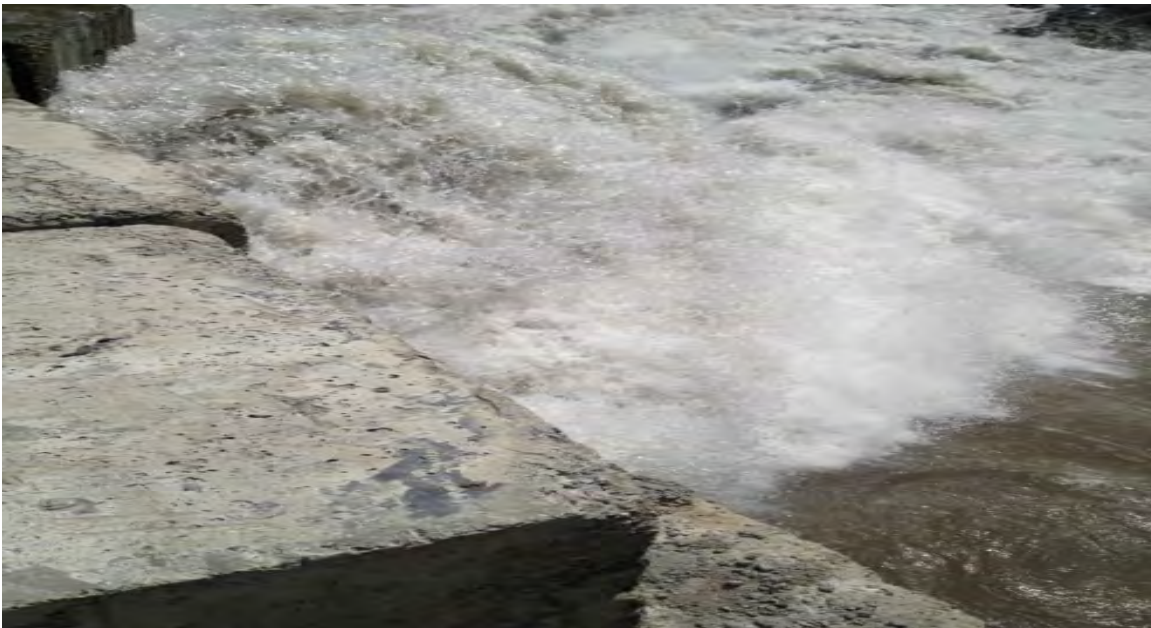
Fig 9. High speed flowing water at the outlet

Water hitting the side walls at outlet

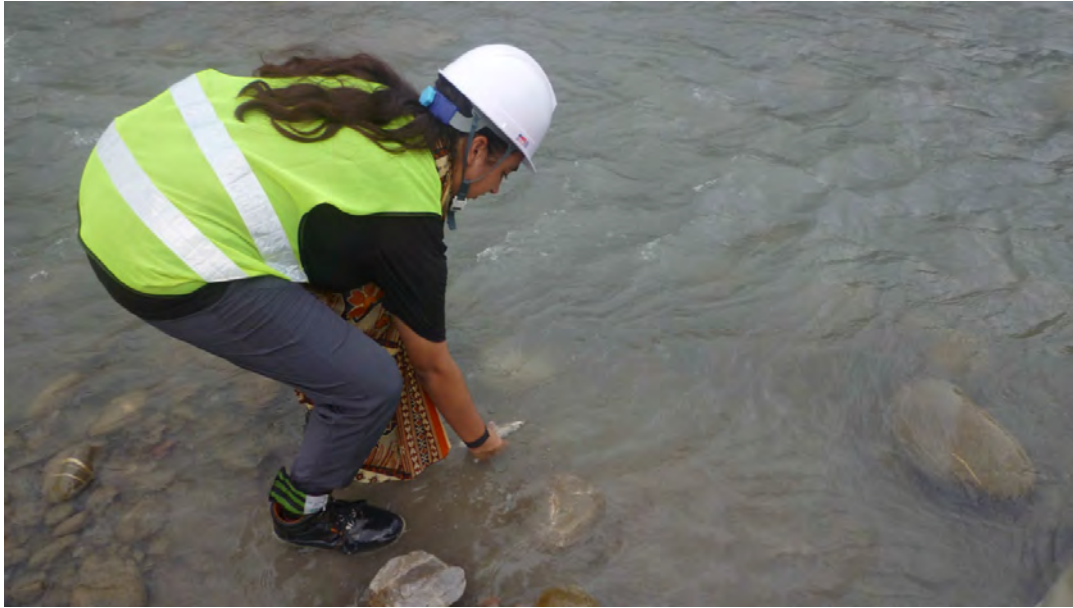
Fig 10. Release of caught fish back into the river by PES staff member

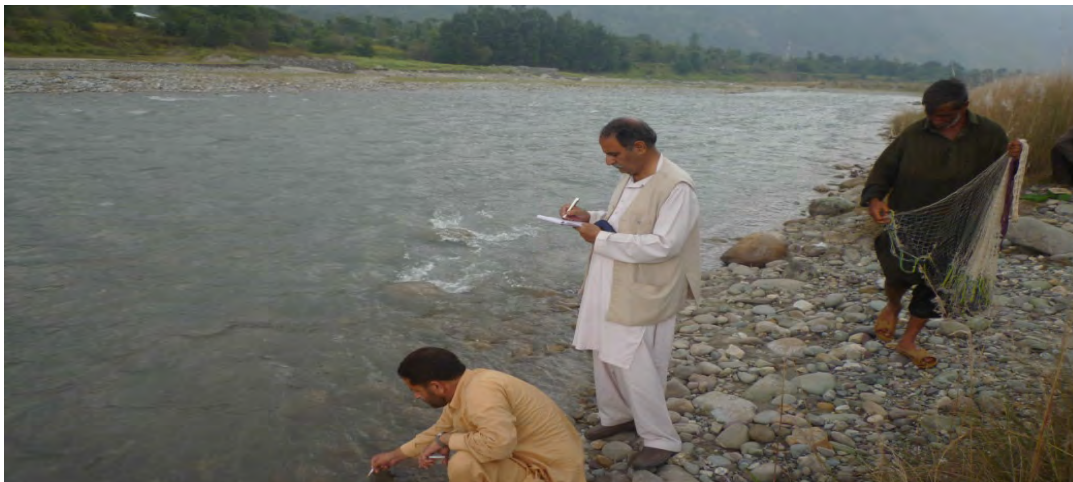
This is the point situated at $34^{\circ} 18' 19''$ N, $73^{\circ} 26' 44''$ E at 776 meters of elevation above sea level. This is a point of zero water level of the expected lake. The river has divided into two parts here this time. No fish sample could be collected from here this time as compared to two fish of species *Schizothorax plagiostomus* were caught during June 2014. This will have little impact by the construction of dam but better picture will appear after the construction of the weir.

Fig 11. Sampling at Shorran/Tarchilla
