# Environmental Monitoring Report

Semi-Annual Report no. 8  
For the period covered July-December 2020  
Project Number: 47381-002  
January 2021

## Sri Lanka: Mahaweli Water Security Investment Program – Tranche 1

## Semi Annual Environmental Monitoring Report (SAEMR) No. 08 (July to December 2020) for Upper Elaheera Canal Project (UECP)

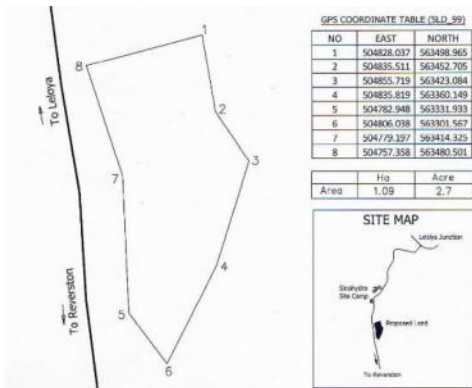
<p>Oil leak from generator</p>																											
PMDSC-KMTC-RE/ICB-2B/ShCL/L246 on 25 November 2020	<p>(i) PMU /PIU was informed through the referenced letter on 25 Nov 2020, submitting additional lands for disposal of 56,000 m<sup>3</sup> tunnel muck resulted from Tunnel 2 inlet at Lel oya. The additional land is located at Lel oya with an extent of 1.09 ha which is an abandoned paddy land</p> <p>(ii) PIU informed through Letter Ref. UECP/PD/KMTC/01-ii on 26/11/2020 that PIU will inform relevant authorities and see the possibilities to get the land, but the time taken for this process will be lengthy as it is required to carry out required environmental studies prior to approve</p> <p>(iii) PIU has informed FD seeking approval on 08 Dec 2020 though letter Ref. UEC/DPD/Env-16</p>
