# Environmental Monitoring Report

July – December 2019  
March 2020

## KGZ: CAREC Corridors 1 and 3 Connector Road Project (Section “Epkin [Km 89] to Bashkugandy [formerly Dyikan] [Km 159]”)

Prepared by Gentek Consulting Muhendislik for the Ministry of Transport and Roads of the Kyrgyz Republic and the Asian Development Bank.

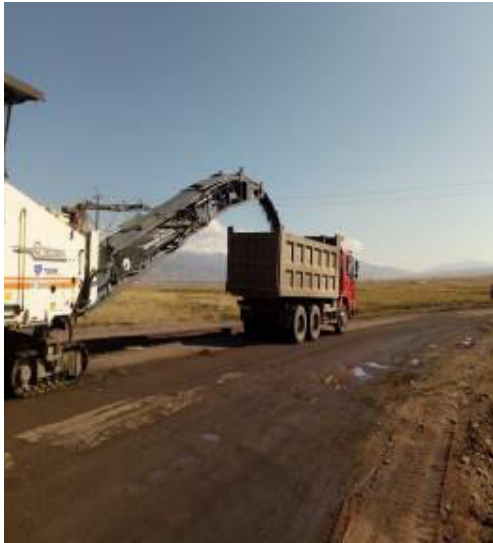
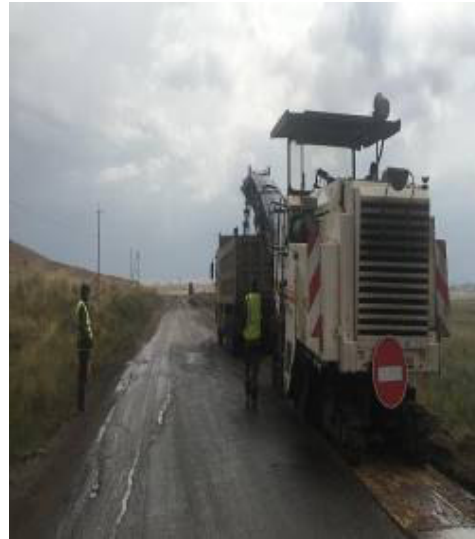
**Figure 3. Old asphalt removal.**

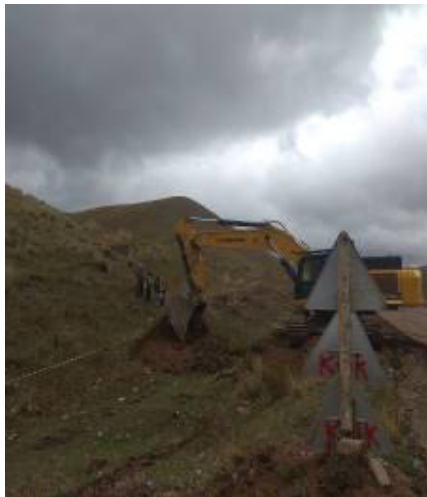
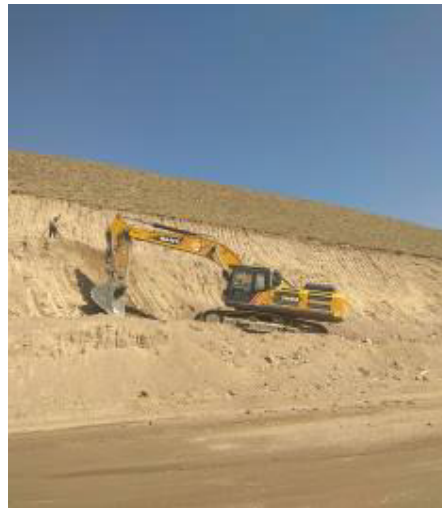
**Figure 4. Excess soil removal**

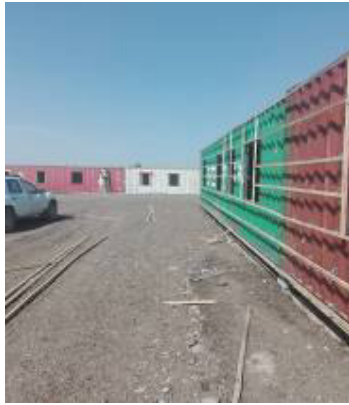
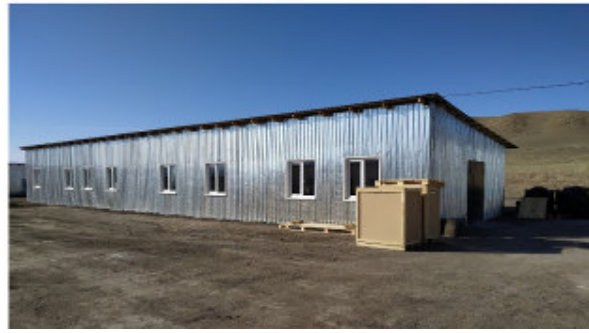
**Figure 5. Construction of office camp in progress.**

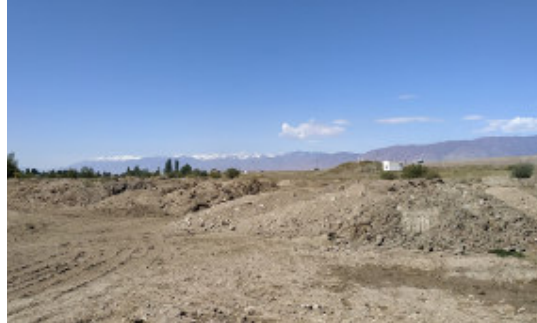
33. Topsoil is removed and stored in special areas allocated by the local administration of Bash-Kugandy Ayil-Okmotu. After completion of the construction work, it can be used for backfilling slopes.
34. Obtaining permission to remove topsoil in the construction corridor from the environmental authorities is not required. The contractor has obtained permission from local authorities to store topsoil in several sections. Embankments of topsoil are kept at a height not exceeding 1.5 m and maximally protected from the impact of elements, mainly, from a wind during the dry construction season. Currently, topsoil is removed on an area of 5 hectares.

**Figure 6. The stored topsoil.**

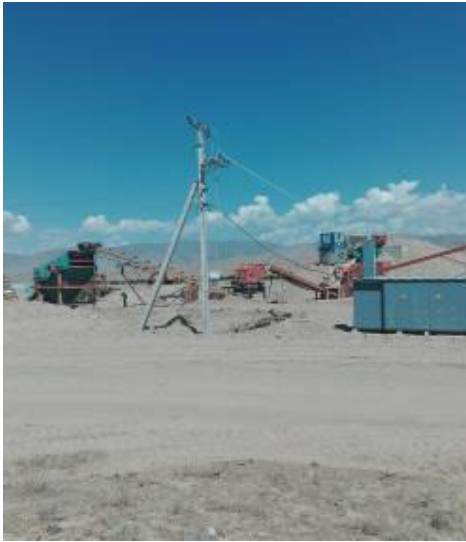
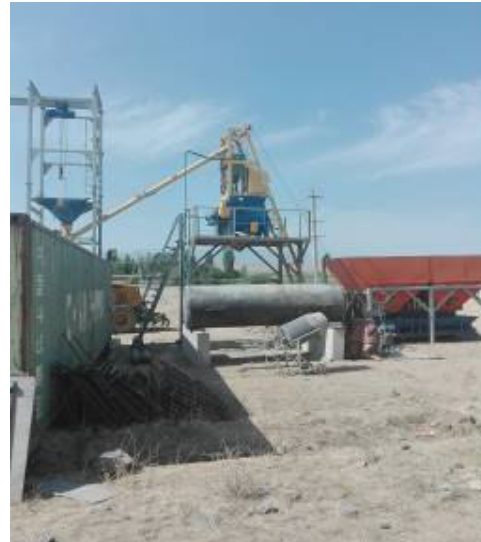
**Figure 7. Stone crushing plant.**

52. It has been found that the stone-crushing plant operates without following good housekeeping practice with separate handling of construction and household wastes, burning some construction waste and no fire extinguishers arranged on site. Non-compliance letter was sent to the Contractor and issues were resolved by the sub-contractor.
53. Fuel and oil spillage detected during the walk around the plant and fueling station of the sub-contractor. Oil and Lubricants were stored on the ground and causing potential oil leaks to the ground.

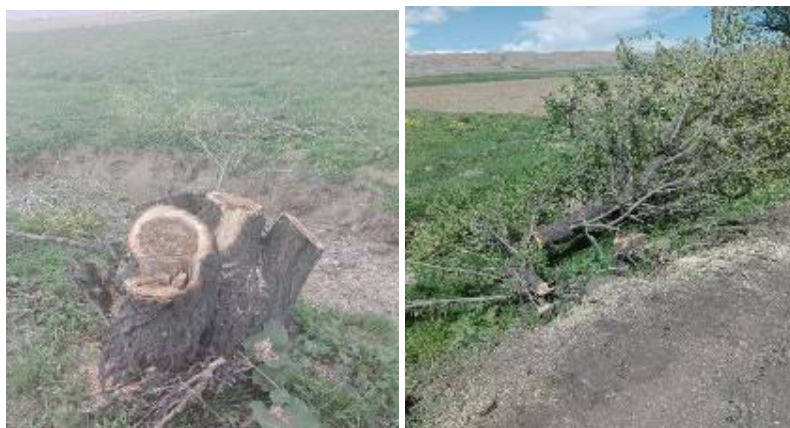
39. At sections km 91+846 and km149+500, 853 trees were marked, all documentation was prepared, permission for tree cutting was obtained from the local environmental authorities. Stems of the cut down trees were distributed among local authorities. The exact number of trees to cut was determined during the designing of the road by the contractor and it lead to discrepancy with IEE identified number of the trees, With further works movement, this number of trees may change.

**Figure 8. Cutting the trees.**
