Environmental Monitoring Report

January – June 2020
September 2020

KGZ: CAREC Corridors 1 and 3 Connector Road Project (Section “Epkin [Km 89] to Bashkugandy [formerly Dyikan] [Km 159]”)

Prepared by Gentek Consulting Muhendislik for the Ministry of Transport and Roads of the Kyrgyz Republic and the Asian Development Bank.

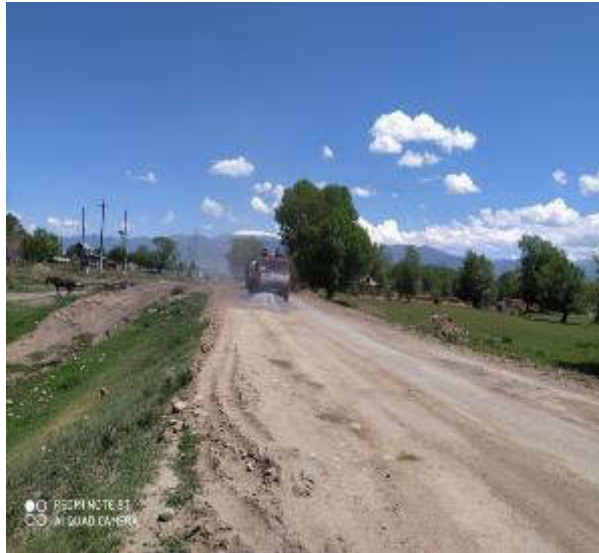
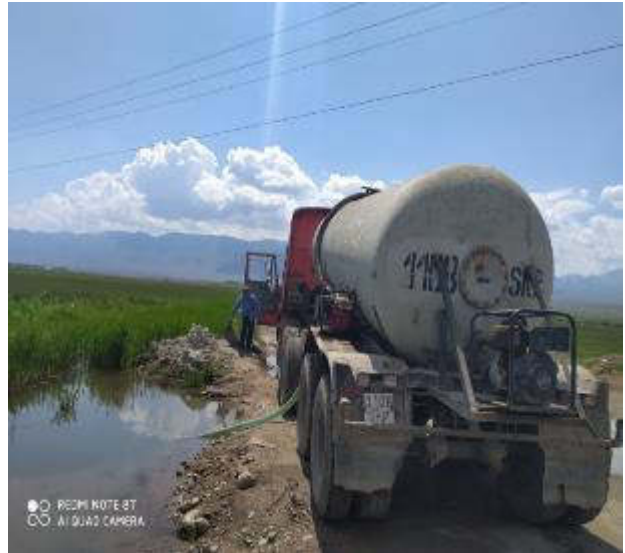
Figure 5. Irrigation on the Road

25. As hot weather had set in, regular irrigation of these areas was established, but taking into account the hot weather, dust formation is still observed on the road. 9 water sprinklers were working on the road. Water for irrigation is taken from the Jumgal, Tugol-Sai and Kyzartsuu rivers. Even though, during seasonal irrigation works there were problems with local villagers regarding access to water.

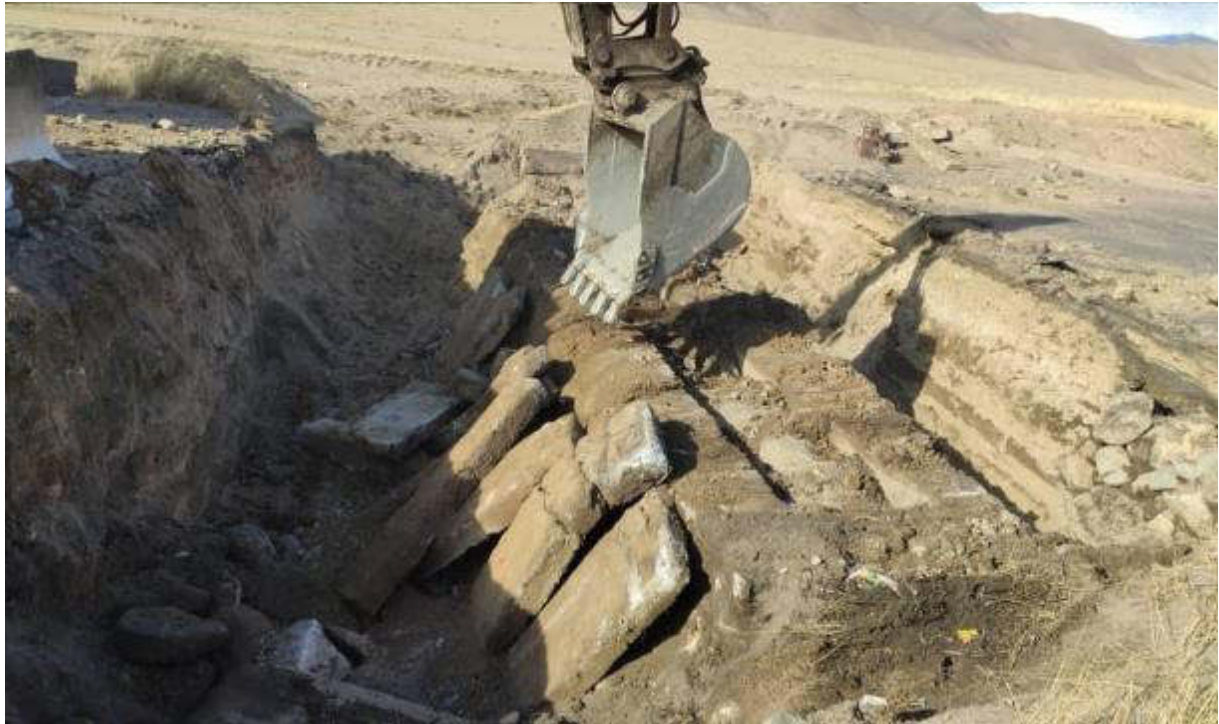
Figure 18. Existing Culverts Removal

58. At km 112 + 500, in the open trench of the culvert during the rainy season, water filled up and posed a danger to the population and domestic animals. The Contractor was requested to eliminate inconsistencies regarding pumping out water and organizing temporary fencing in the identified areas.
59. Removing of old culvert is underway on the project sites.
60. In connection with these construction works, old reinforced concrete elements are stockpiled on the shoulder, which, as soon as they are stocked in some amount, are handed over to the local Road Maintenance Company, and the broken ones are disposed of. During the reporting period, cases were identified when old culverts interfered with road safety. Disposal locations are determined by local authorities.

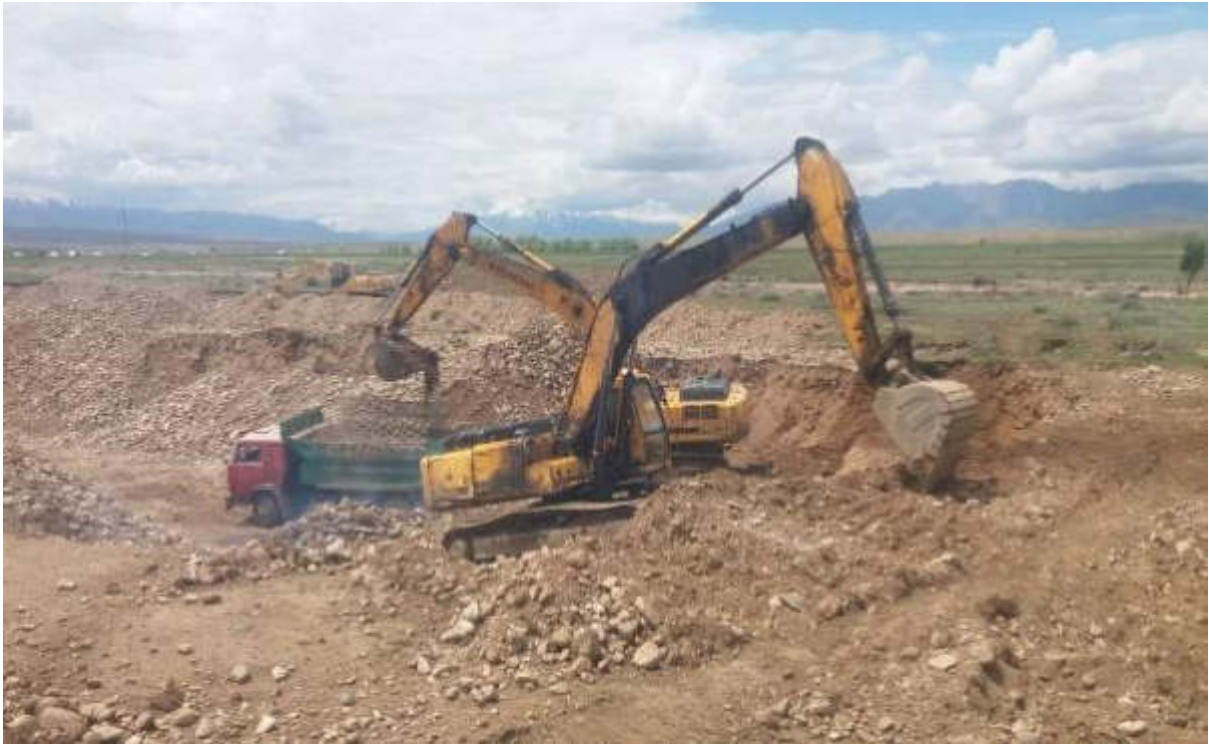
Figure 20. Quarry at km 148+630

61. The quarry at km 148 + 630 belongs to the category of self-renewing due to the quarry location in the river floodplain, exposed to mudflows.

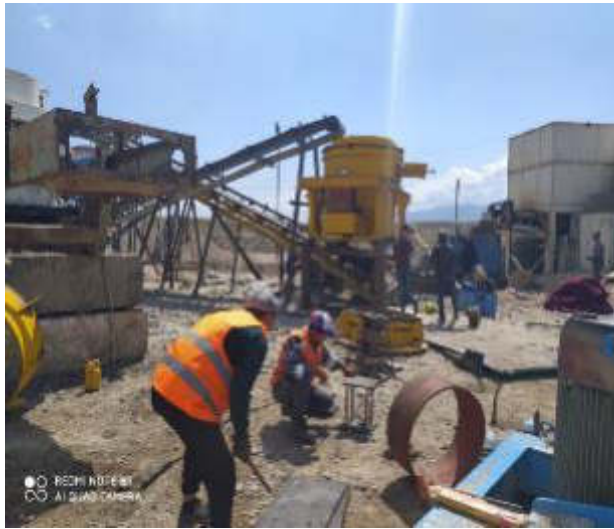
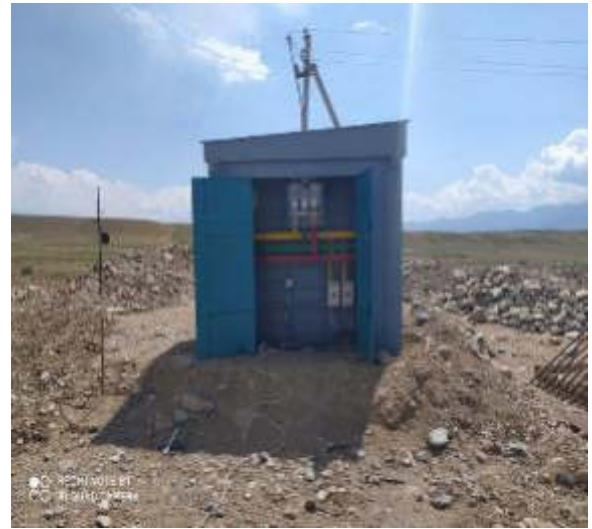
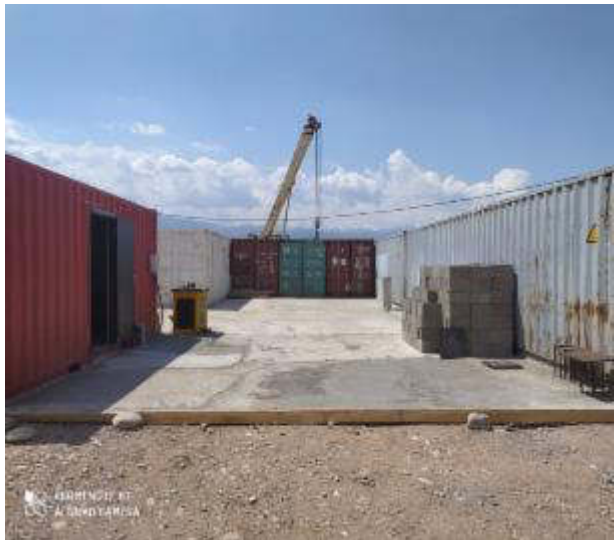
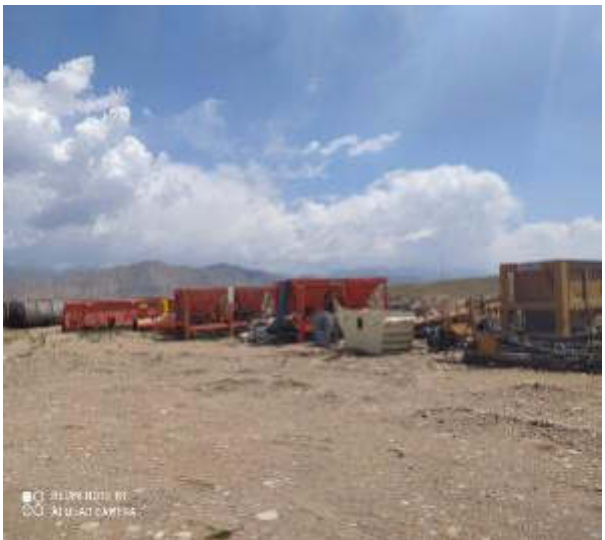
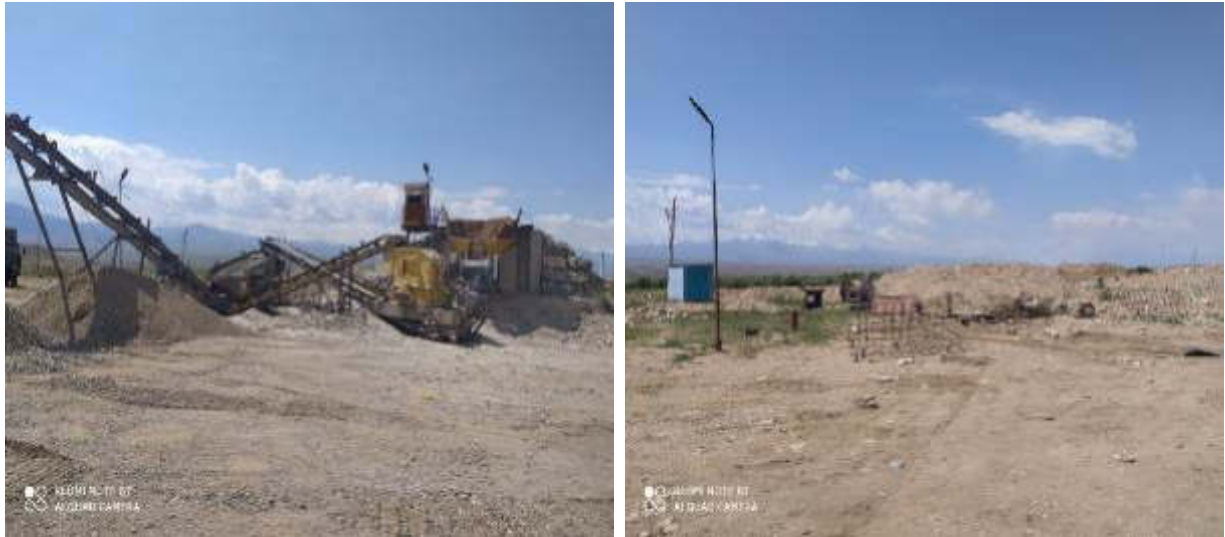
Figure 23. Production site territory

66. It was found that the Crusher was working without proper maintenance of cleanliness and order of the workplace with separate processing of construction and household waste and the absence of a fire shield in place.
67. On the production site territory, tanks for fuels and lubricants were not installed on a concrete base. Fuel and oil spill on the ground was detected during the walk-around. The fire shield was not completed. A non-compliance letter was sent to the Contractor and the problematic issues were resolved.

97. Based on the notification, the territory of the production site was cleared of construction waste. All noted violations were eliminated. Separate waste containers were installed. Fire safety measures were taken, fire shields were completed.

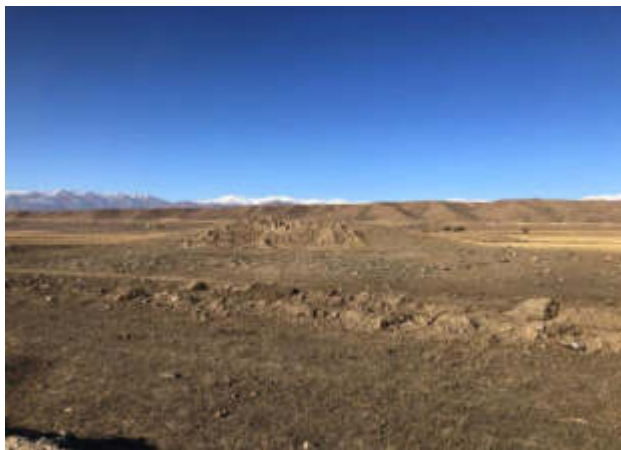
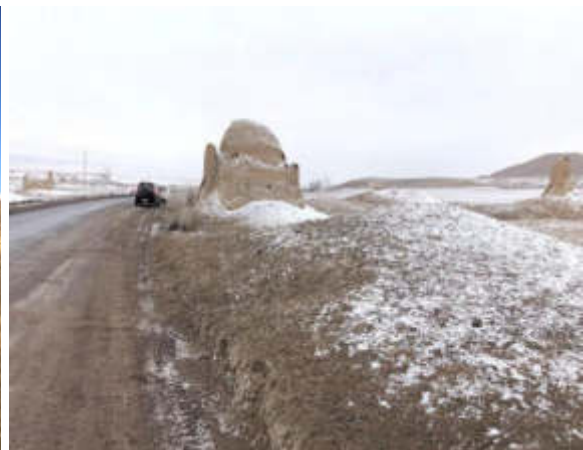
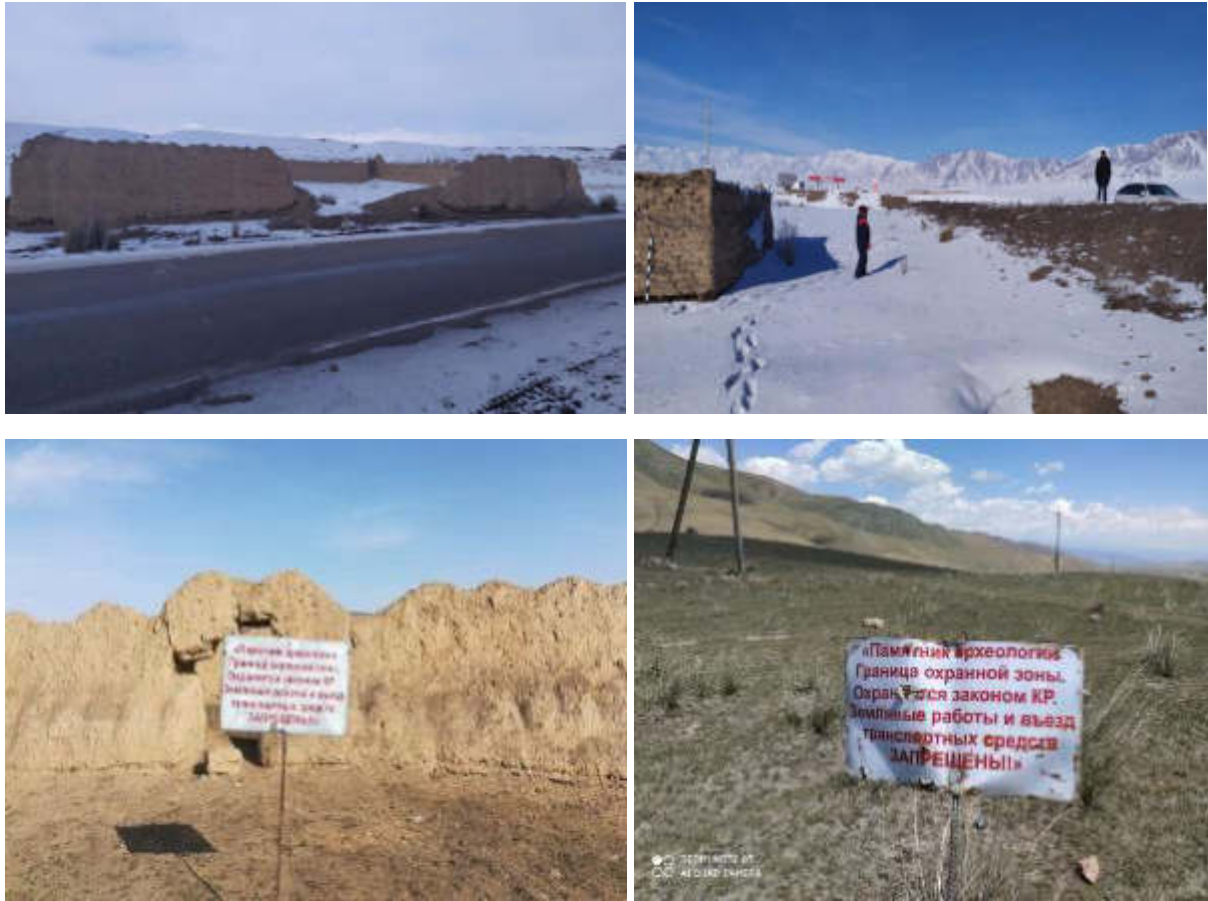
Figure 26. HCHS and protective measures

79. The contractor is taking measures to protect HCHS at the construction road section (installation of information shields and protective tapes).
80. The Contractor has not yet provided a specific report on the study of the presence of additional objects that may be encountered in the excavation work, prior to the start of construction work at the archaeological sites.

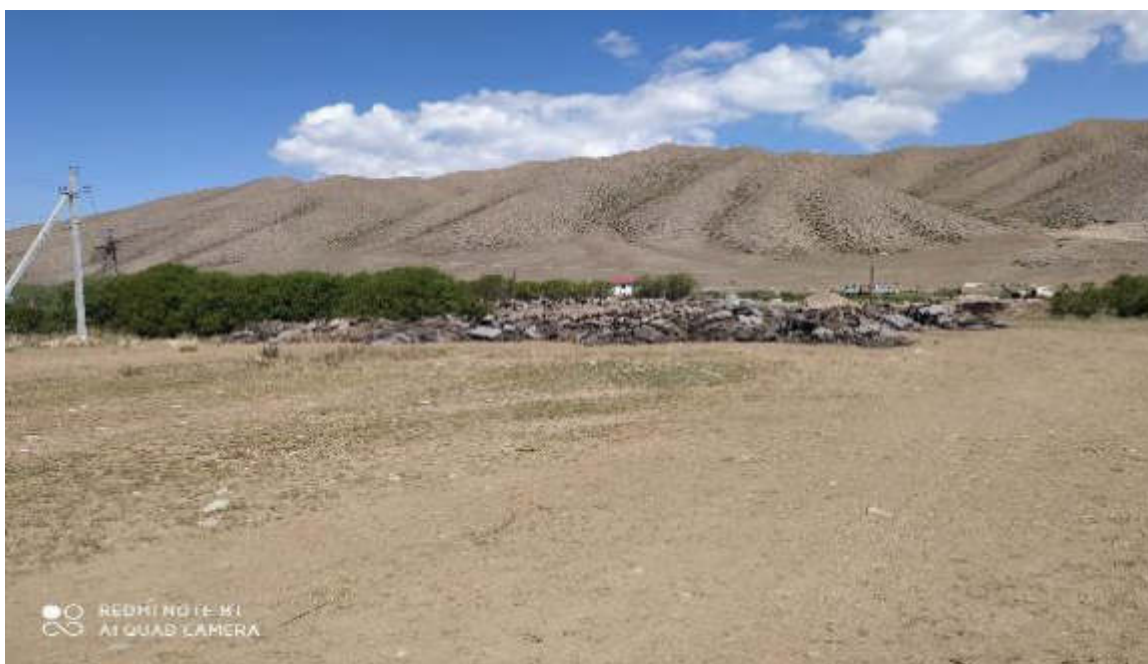
Figure 30. Old asphalt on the territory Ak-Chiy v. for backfilling roads

91. On a section km 91 + 600, the residents and representatives of the Ak-Chiy ayil okmotu addressed the Contractor with a letter to remove the old asphalt to the territory of this ayil okmotu, explaining that they need this old asphalt to backfill roads inside the village. In this regard, the stripped old asphalt in this area was removed and stored at designated sites in the territory of this village. In the future, this asphalt will be used as needed for the improvement of the internal roads of the named village.

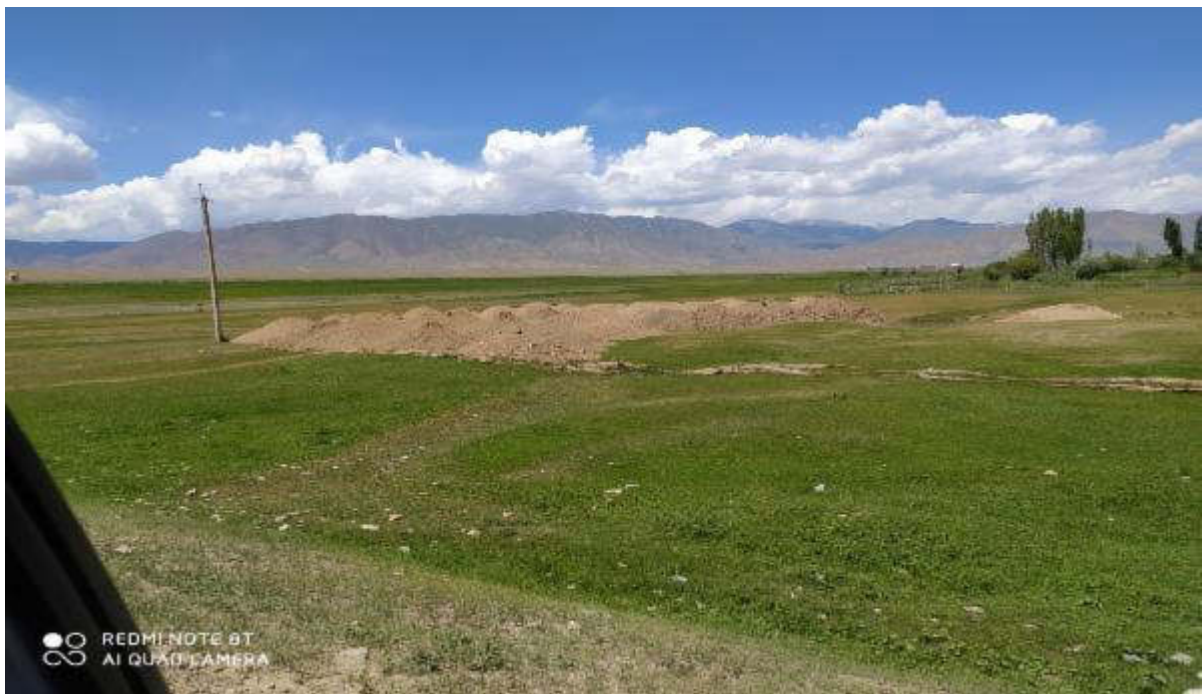
Figure 32. Dump on the private land

95. At km 149 + 000, unnecessary material is transported to private land at the request of the site owner.

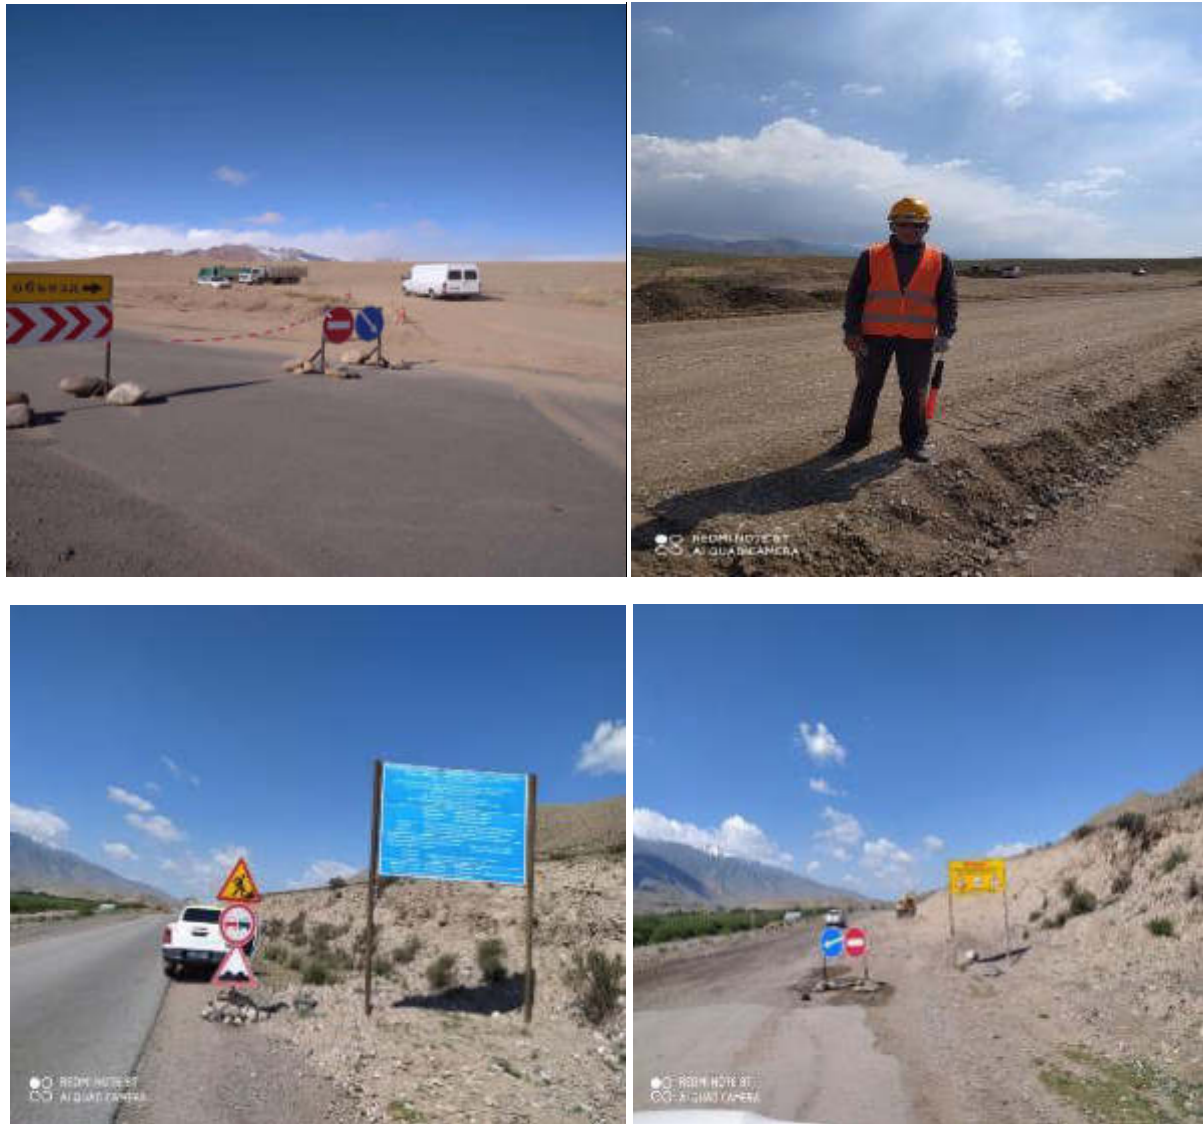
Figure 47. Implementation of Road Safety Measures

148. Road safety measures are not being properly implemented as there are not enough road signs and markings.
149. In the course of supervision of construction works, violations of safety rules made by workers were identified, such as work without personal protective equipment, lack of protective helmets, respirators, lack of special shoes and etc.
