Initial Environmental Examination

Cambodia: National Solar Park Project

**Hydrological Study
Preliminary Study**

APPENDIX VI: ENVIRONMENTAL AUDIT OF EXISTING FACILITY (GS6)

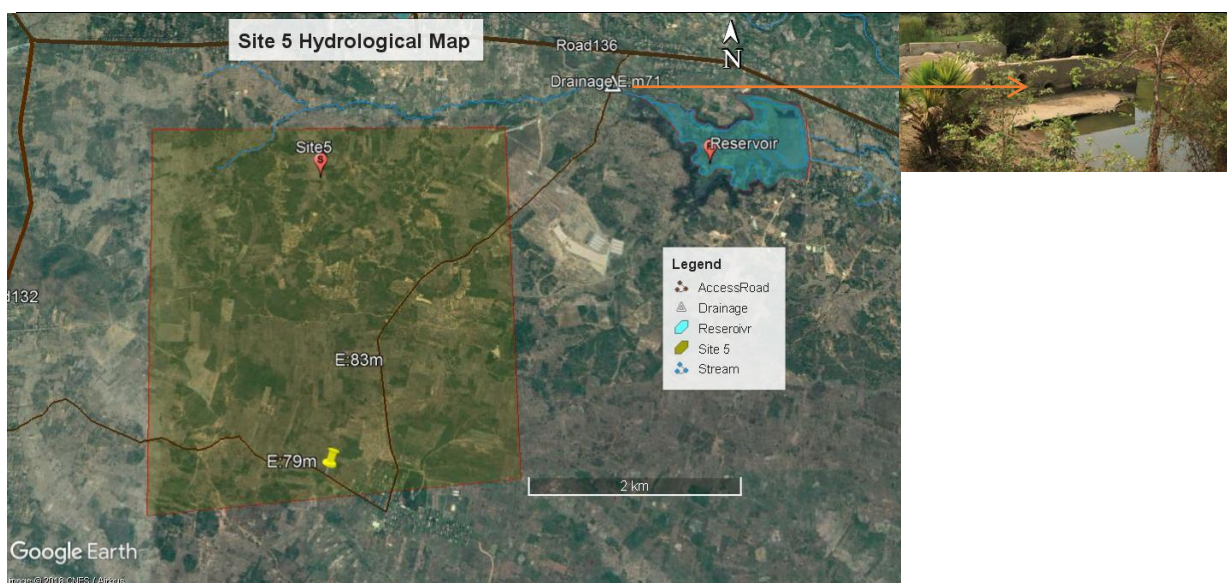
Figure 6 Hydrological and Drainage system at Site 5

Figure 5 Pictorial of Hydrological and Drainage system for Site 5
A stream drains out the water from the site basin which is located out of the setup boundary of the study area (see figure 6). It connects to a reservoir at the lower part of the site by a drainage

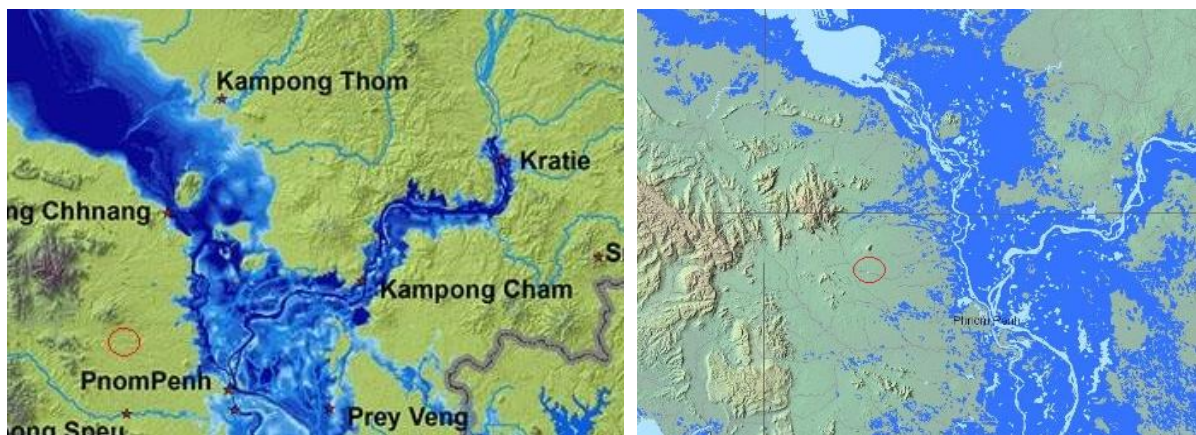
Figure 13 Cambodia Flood extent in 2000 and 2001

The figure 13 below illustrates (a) the maximum flood extent in 2000 by Mekong flood; and (b) maximum flash flood event in 2001. The image clearly indicates that the site areas (SITE-5 & SITE-6) represented in red circle were out of the flood boundary in the worst flood event in 2000 and 2011.

From the 13 figure above, it is clearly noted that the propose site areas were not affected by the severred flood event. Where the most flooded area were occurred in lower land area i.e. lower Mekong basin and surround the Tonlé Sap Lake.

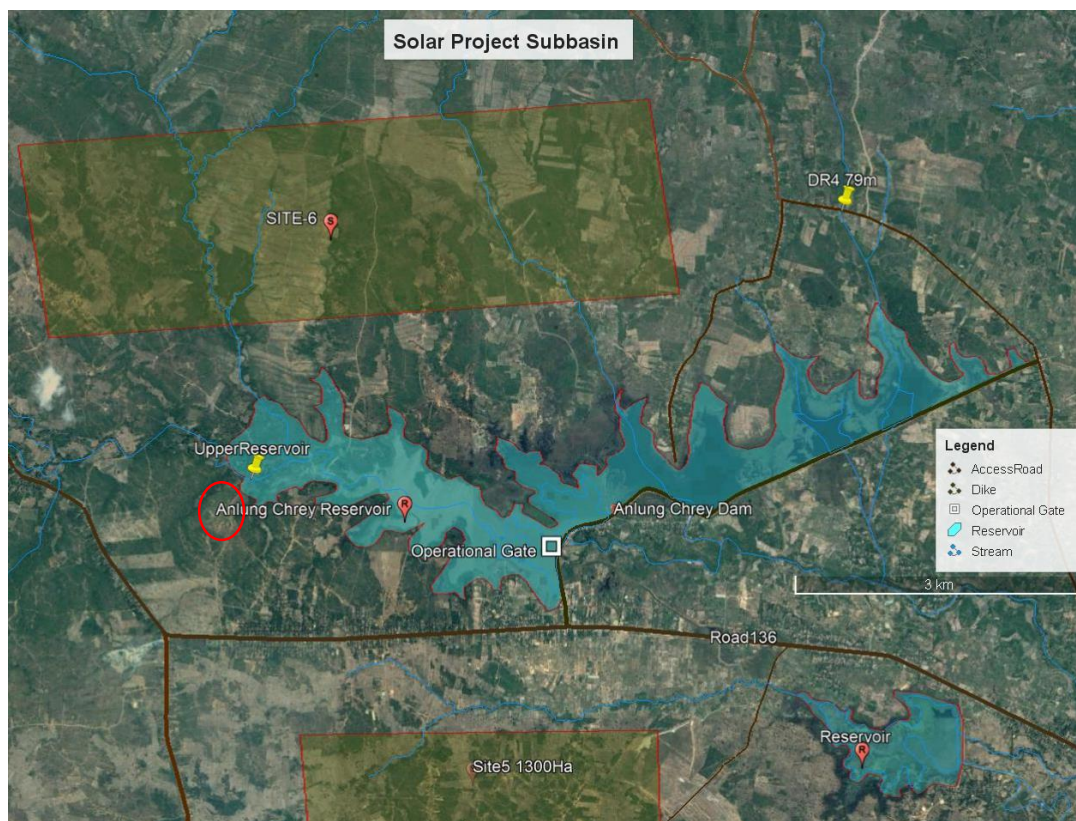
Figure 14 Solar Project Subbasin

The flood were reached to the upstream of the reservoir illustrated in red circle below (433999E, 1300808N, 48N), reported by the residential. The flood occurred by the accumulated flow stored in the reservoir by the hydro power operation. There were no serverred strom affected the site area from the neighborhood country.

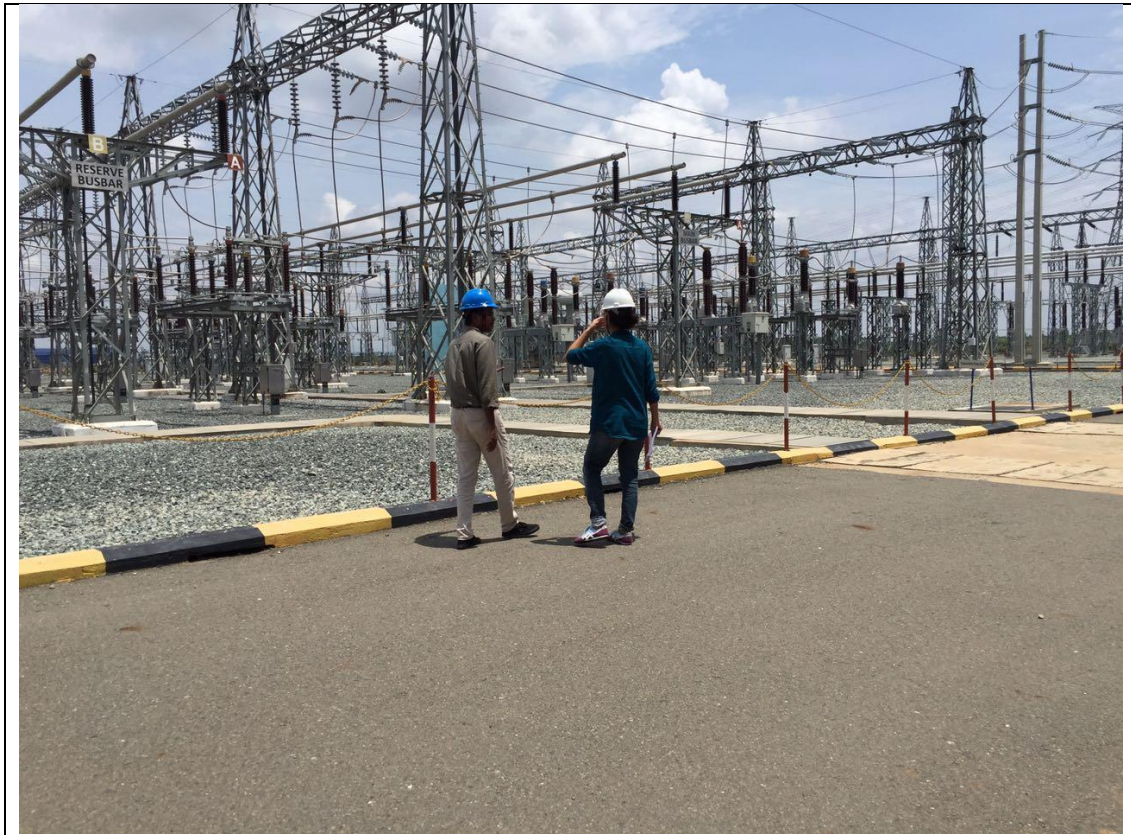
At GS6

15. **Equipment storage.** CTL has warehouses for equipment storage and repairing parts. There has been no re-sale or auction so far for any equipment at the substation site.
