PRC: HEILONGJIANG ROADS NETWORK DEVELOPMENT PROJECT Environmental Monitoring Report for Rural Link Roads (September 2009)

**Heilongjiang Province Jixi-Nehe Road Jixi-Baiquan Section
Link roads project**

**Environmental Monitoring Report
in Construction Period
In 2009**

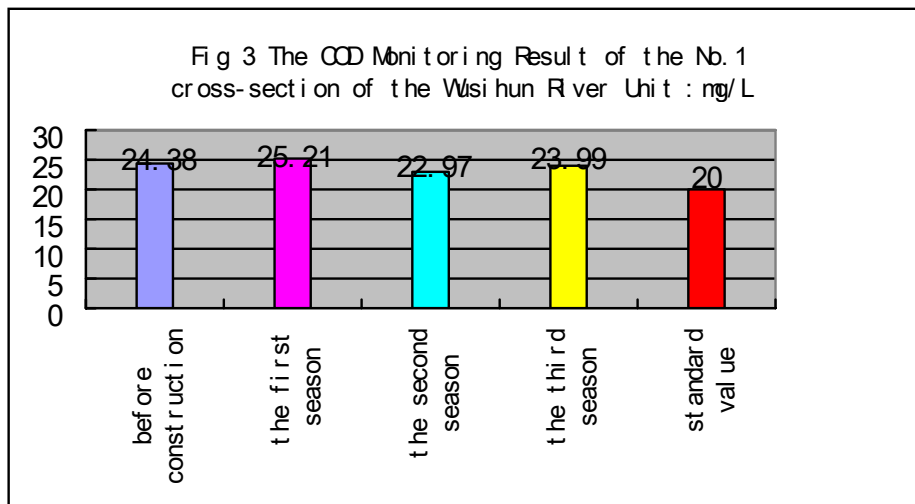
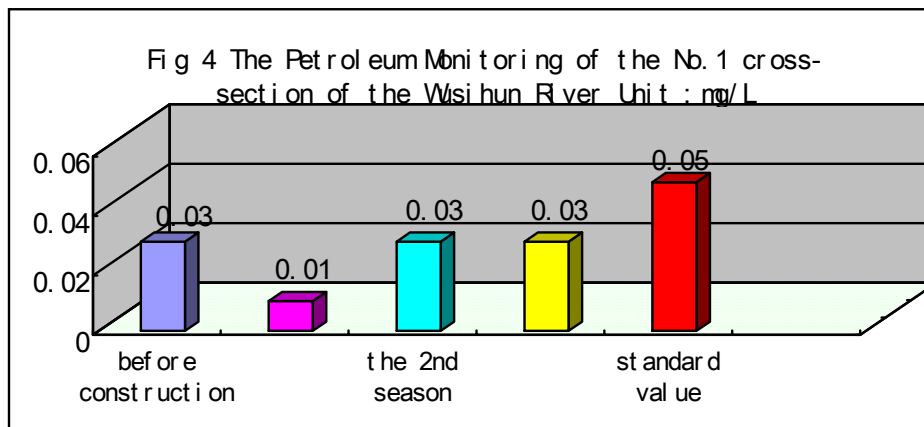
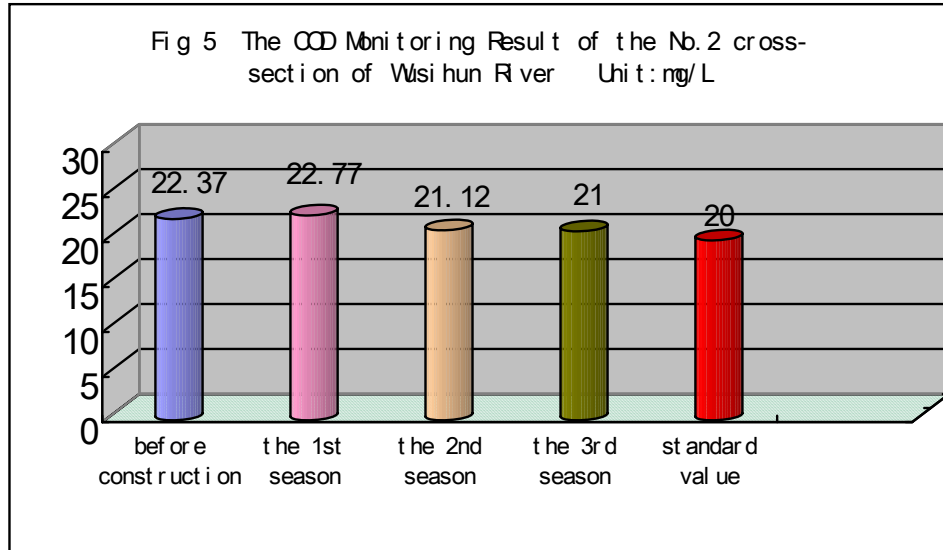
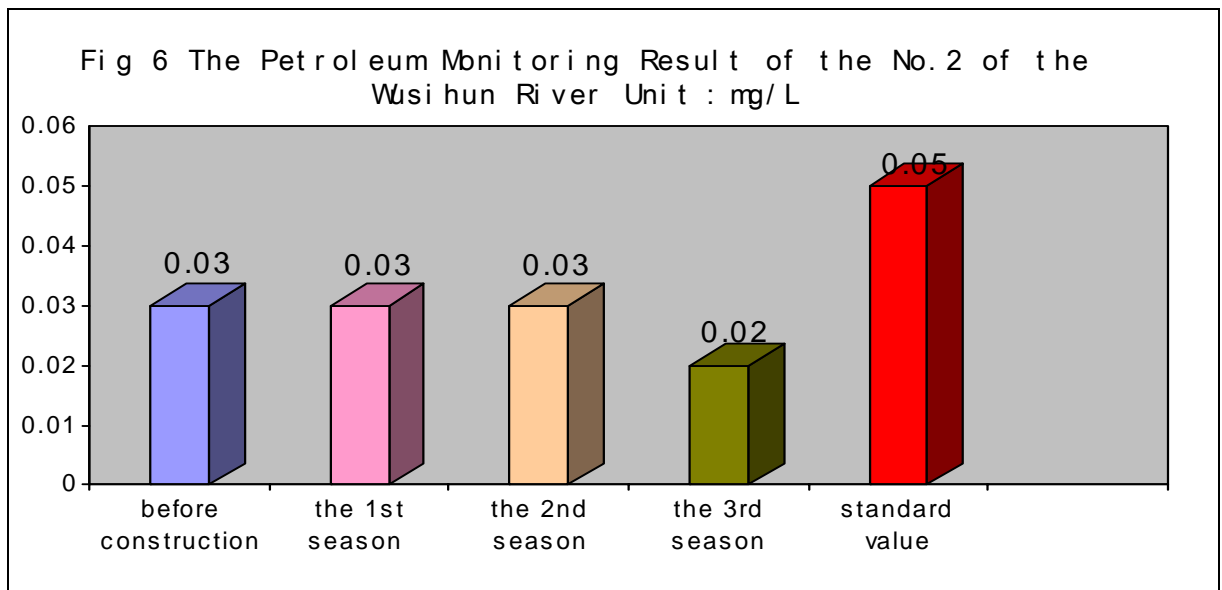
The monitoring results in construction period are in Table 3-7. It states the water quality did not change obviously, all monitored parameters data are lower than the related standards except COD, and the COD concentrations did not change more compare to the data monitored before construction. The changing trends of COD and Petroleum are in Figure 3, 4, 5 and 6.

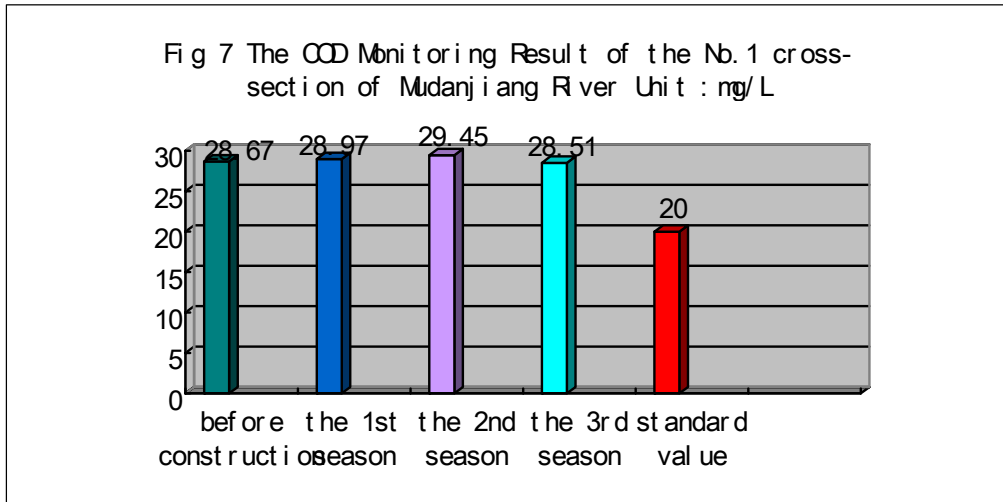
The monitoring results in 2009 are in Table 3-8. It states the water quality did not change obviously, all monitored parameters data are lower than the related standards except COD, and the COD concentrations did not change greater compare to the data monitored before construction. The changing trends of COD and Petroleum are in Figure 7, 8, 9 and 10.

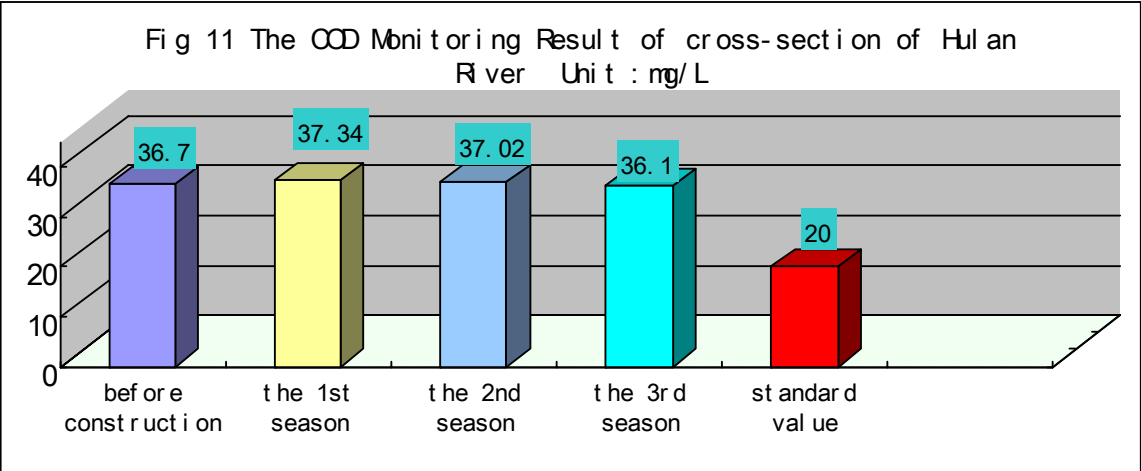
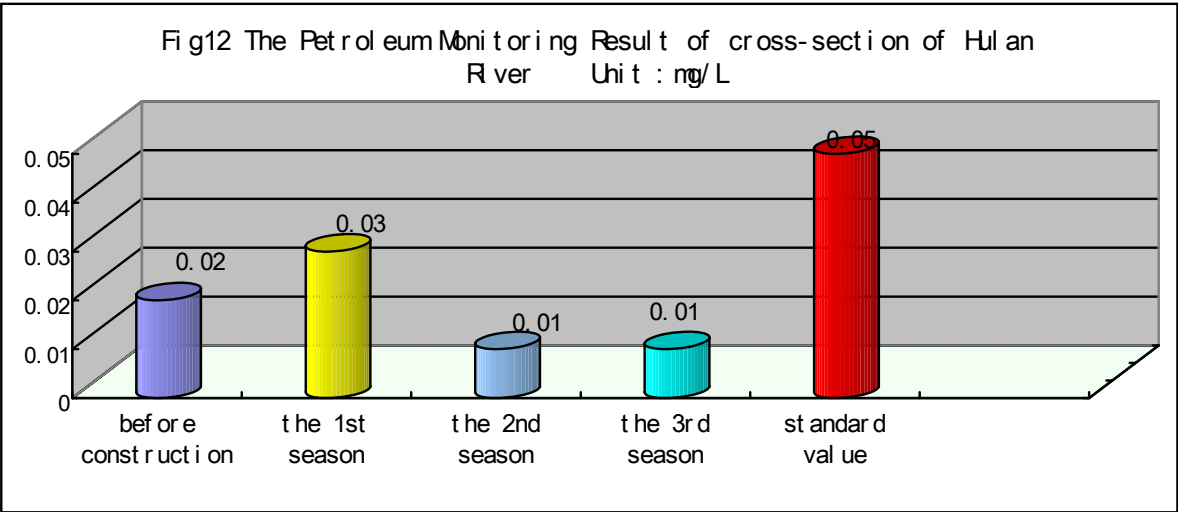
The monitoring results in 2009 are in Table 3-9. It states the water quality did not change obviously, all monitored parameters data are lower than the related standards except COD, and the COD concentrations did not change greater compare to the data monitored before construction. The changing trends of COD and Petroleum are in Figure 11 , 12.
