Project Number: 38928-014  
Annual Report (2018-2019)  
June 2019

## Pakistan: New Bong Escape Hydropower

Prepared by Laraib Energy Limited for the Asian Development Bank.

# **Environmental and Social Compliance Report**

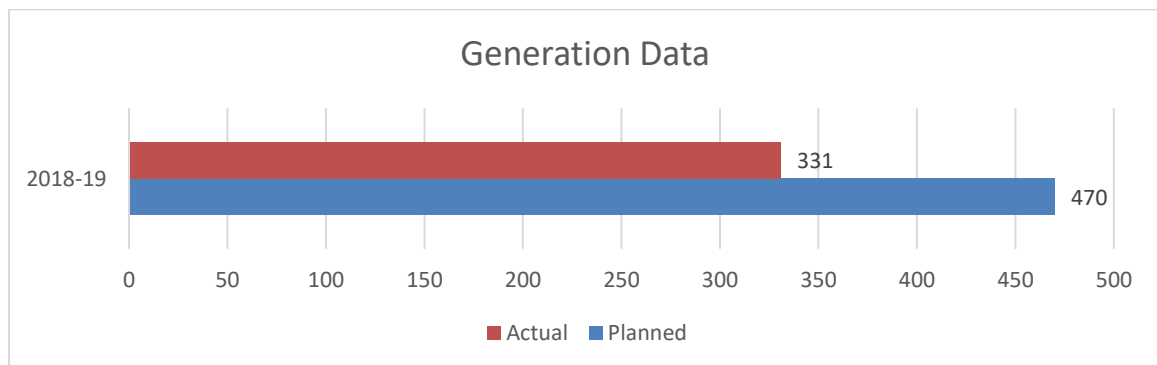
In this year net energy generated from NBE Power Complex is 331 GWh and plan was 470 GWh. NBE Power Complex generated less 141 GWh energy due to low hydrology. Monthly generation plan and actual graph is as follows;

This generation of 331 GWh from hydel energy has helped save 28,453 tons of oil equivalent which is beneficial both in terms of CO<sub>2</sub> displacement by the project and saving precious foreign reserves which would otherwise be consumed by importing furnace oil.
