Bi-Annual Environmental Monitoring Report (Sindh Provincial Road Improvement Project - SPRIP)
(December 2019)

PAK: Sindh Provincial Road Improvement Project (SPRIP)

Project Number: 46377-002-PAK

July to December 2019

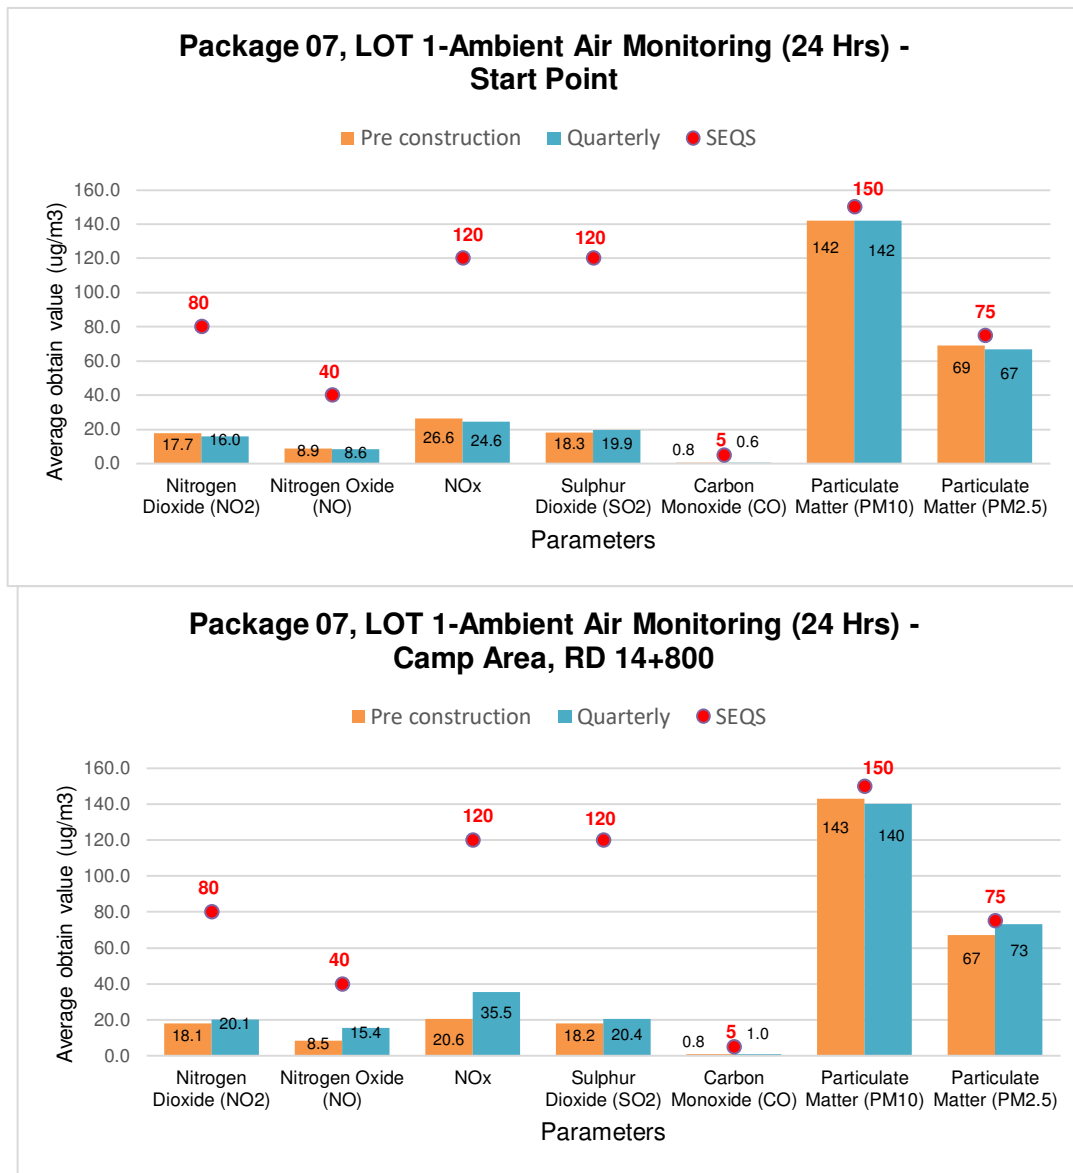
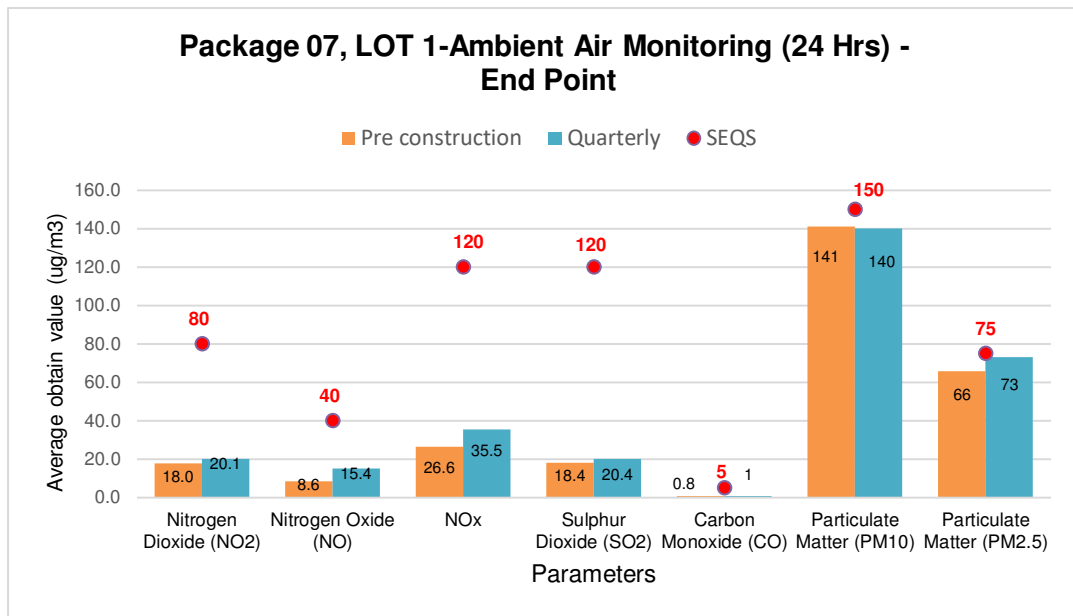
Figure 6: Comparison of Ambient Air Monitoring of Package 07, LOT 1

41. However, Baseline/pre-construction and quarterly air monitoring have been done at Package 07 (LOT 1, 2 & 3). Baseline/pre- construction monitoring was held in the mid of August 2019 before the start of construction work and quarterly monitoring was conducted at the end of December 2019 when about 20% of the work has been completed.
42. We have compared both data values and no considerable difference can be seen which indicates that there is environmental compliance in the work done so far. And all the values meet the SEQS. In the graph shown below, indicated the same thing for the LOT 1, 2 & 3 referring to the start point, camp area and endpoint of the road. The result has been annexed as **Annexure IV**.

50. During the last reporting period, the concentration of PM at package 07 found near but within the SEQs limit. This was due to the insufficient sprinkling during base aggregate course work so as to result, the respective contractor was instructed to increase the water spraying frequency at the spotted sites.
51. The result of noise quality remained more or the less same during baseline and quarterly monitoring period.
52. While the issue of microbial contamination at drinking water was resolved by fetching the filtered water for the construction crew at LOT 1 & 2 but for LOT 3, non-compliance has been issued.

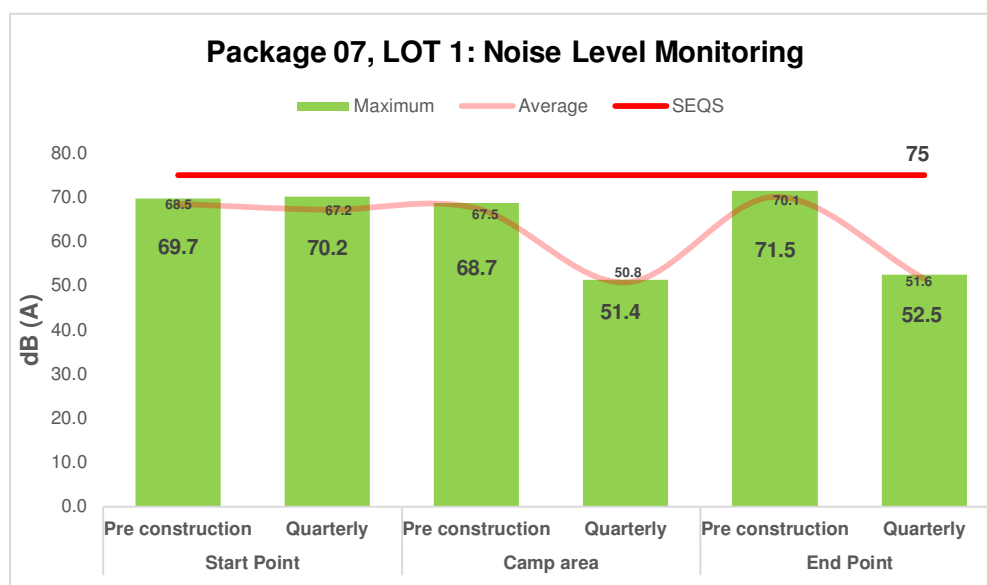
Figure 9: Noise Level Monitoring at LOT 1

machinery should be properly maintained in order to have noise levels within SEQS. Noise reduction devices or methods (e.g. hoarding) may be applied where piling equipment is operating within 500 m of sensitive sites such as schools or other receptors identified in SSEMPs of all sites. Concrete-mixing plants and similar activities are located at least 300 m away from sensitive areas such as residences, schools and hospitals. The noise quantity at the construction site was also measured at all the LOTs of package 07, which are within the permissible limits. In the quarterly monitoring, the values were quite controlled with respect to the baseline monitoring but still, the values are near the SEQS as depicted in the following figures. The result has been annexed as **Annexure IV**.
