# Environmental and Social Monitoring Report

Second Quarterly Report

## India: Jaipur Metro Rail Line 1-Phase B Project

Prepared by Jaipur Metro Rail Corporation Limited for the Asian Development Bank.

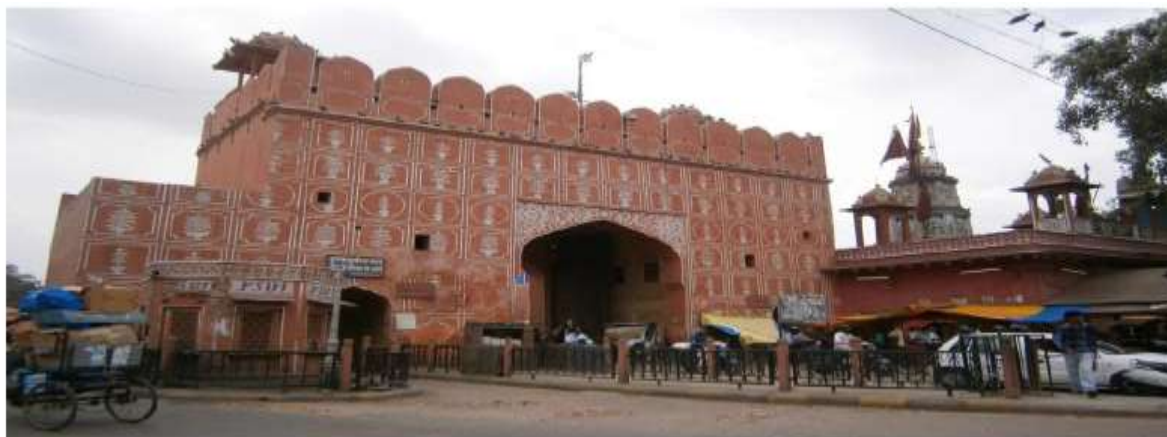
### C. Chandpole Gate Tunnel Underpass Scheme

44. Chandpole Gate is coming right in the center of alignment, attracting maximum settlement, but original drawings relating to its foundation were not available. Therefore, the foundation of Chandpole Gate has been physically examined by a team of engineers, by making several trial pits around the gate.

45. For the determination of the structure's foundation, special survey was carried out by CEC and nine trial pits were executed in certain locations near the gate.

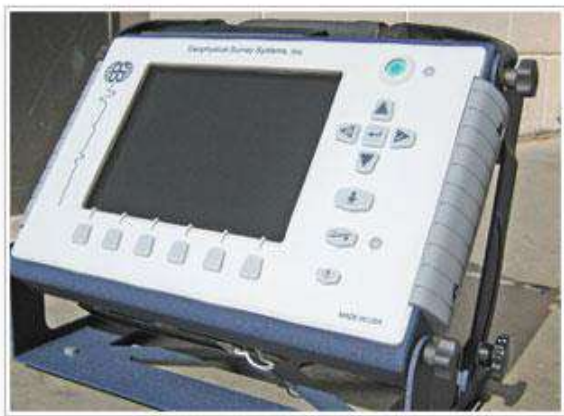
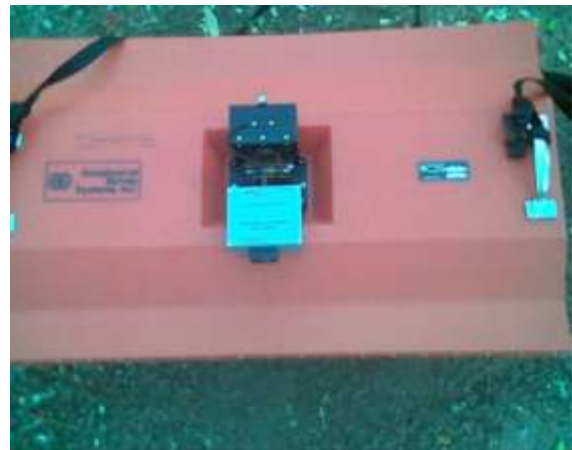
Figure 2: Equipments used for GPR survey

53. The equipment used for the scanning includes SIR-3000 (GPR) of Geophysical Survey Systems Inc. (GSSI), USA, 100 MHz paired antenna with other peripherals as shown in the Figure 2.

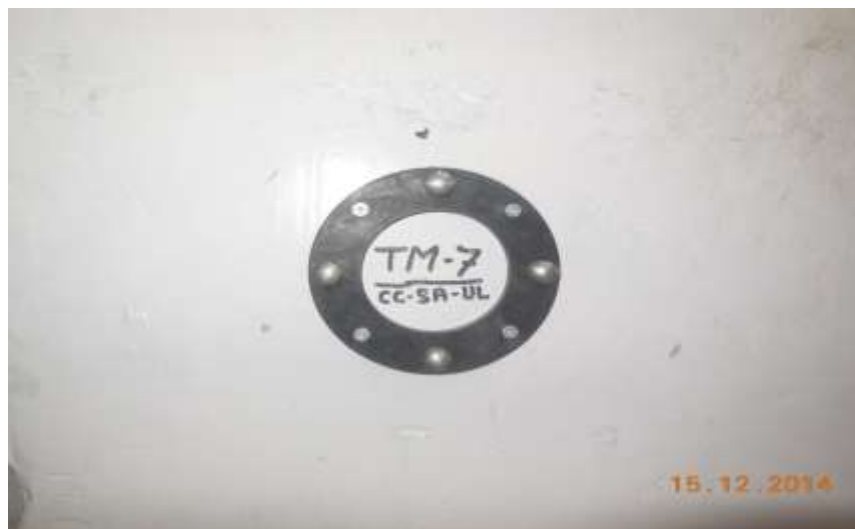
67. The EAN-70 portable tilt meter system consists of three components: tilt plate, tilt meter, and readout unit.

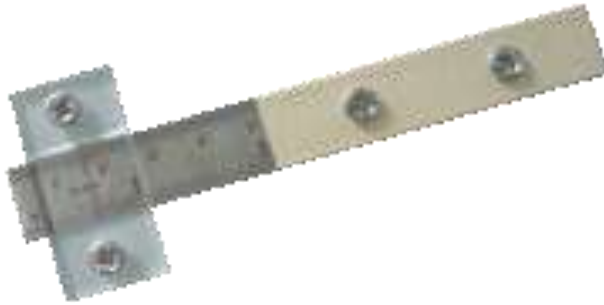
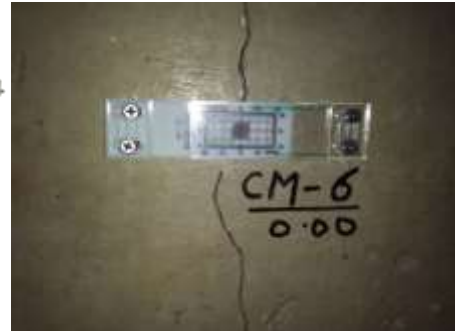
68. **Crack meter- Model AIM-100SC or equivalent:** The crack meter is suitable for measuring structured cracks ranging from 0.5 to 100 mm with a hairline cursory mark in two directions i.e. vertical and horizontal. The advantages of this instrument are: reliable and accurate, simple to install, simple to operation and low cost. This is very simple and accurate instrument to monitor the hair crack. The mechanical crack meter is made of polycarbonate transparent sheet with graduated marks. The both sheets will be assembled on crack with the help of fasteners.

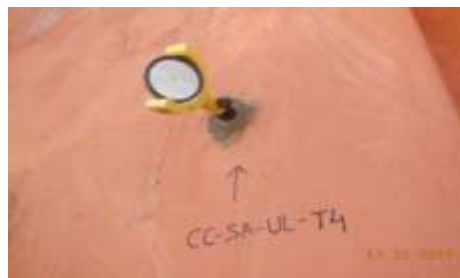
69. **Bi- Reflex Target:**

70. The bi-reflex target is one of the surveying equipment to measure deformations and settlements of the structures surrounding the construction site. It is rugged precise and low cost with an accuracy of  $\pm 0.1\text{mm}$ .

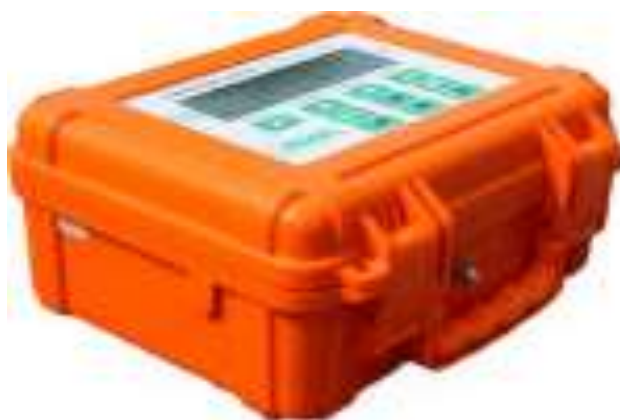
76. The equipment consists of Geophones and Kelunji Echo Seismic Recorder which is able to monitor the effect of vibration on all three planes. It is equipped with three geophones, capable of picking up signals in all the three planes described above. It is able to perform full field analysis of the event to evaluate the peak pulse velocity, peak frequency, peak acceleration and peak displacement.

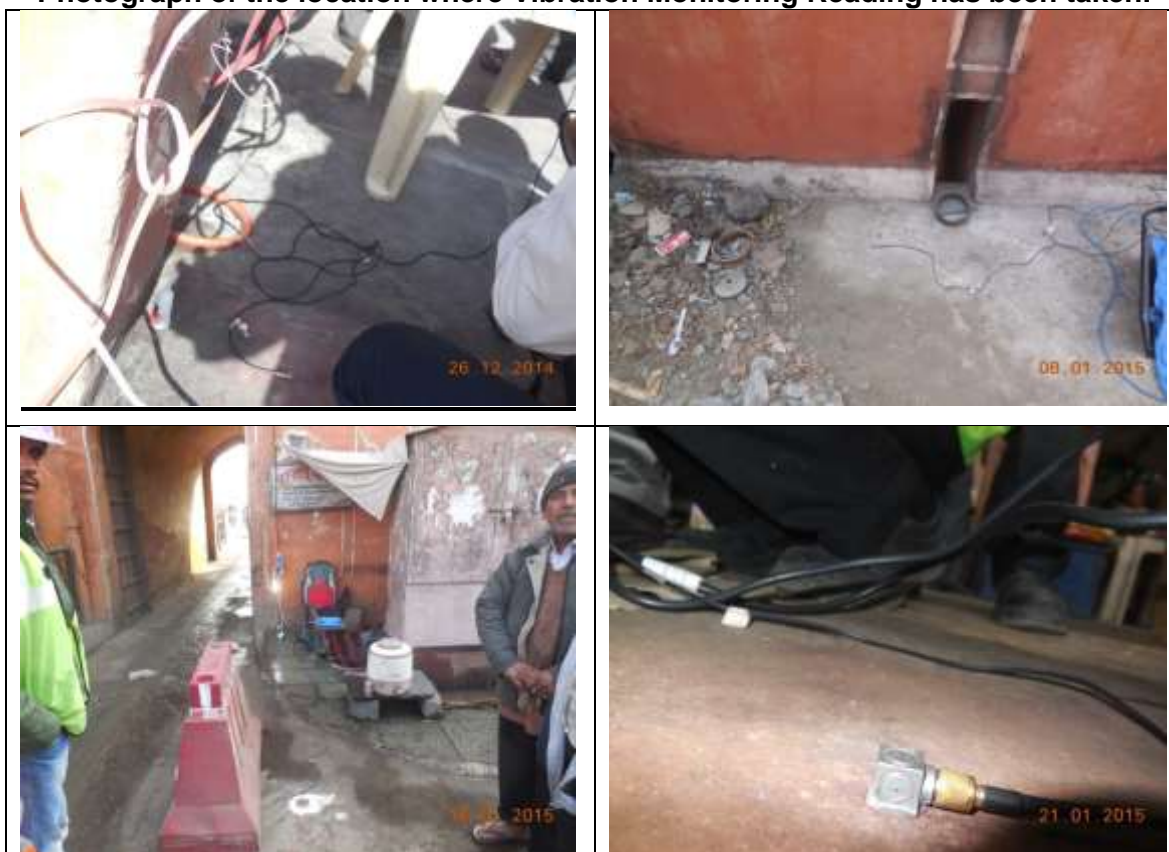
**Photograph of the location where Vibration Monitoring Reading has been taken.**

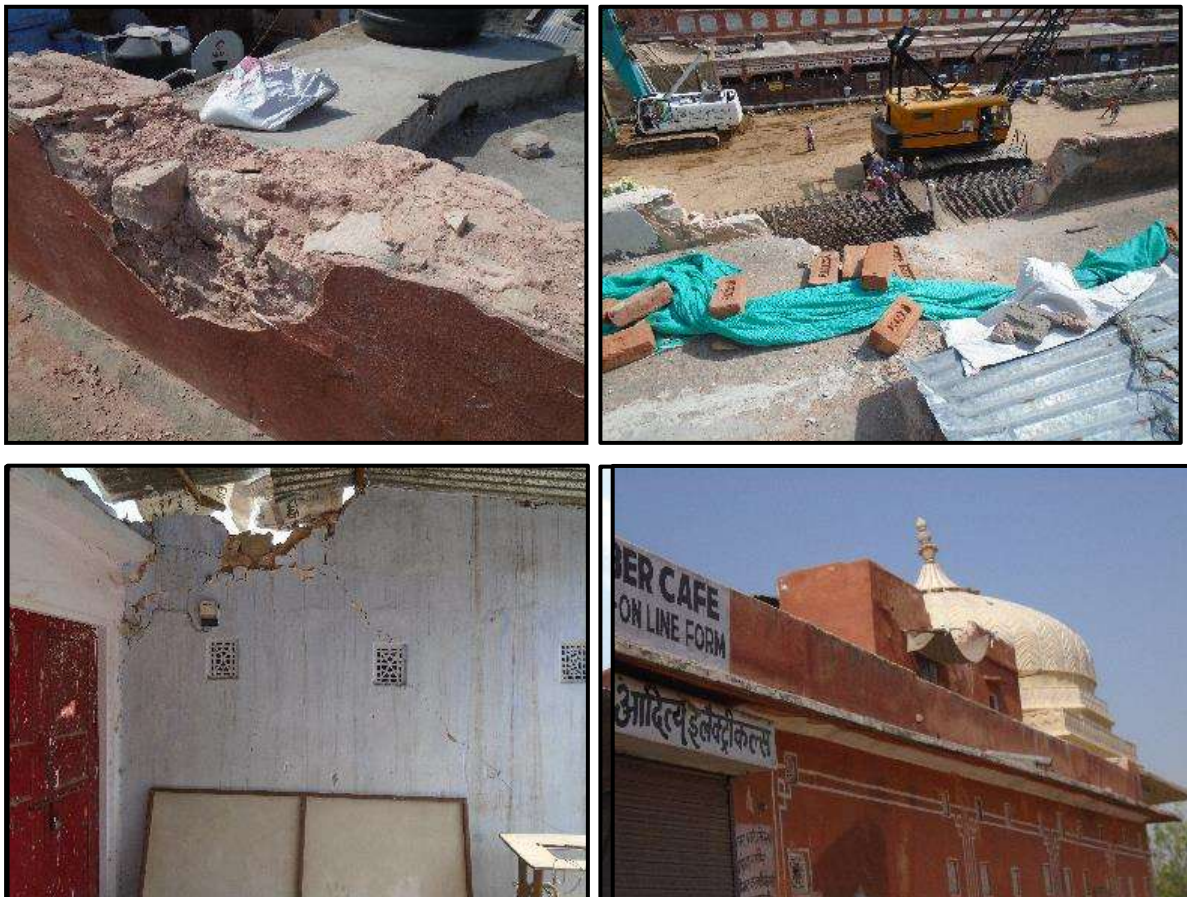
**Damaged Parapet Wall, Cracks on below wall**

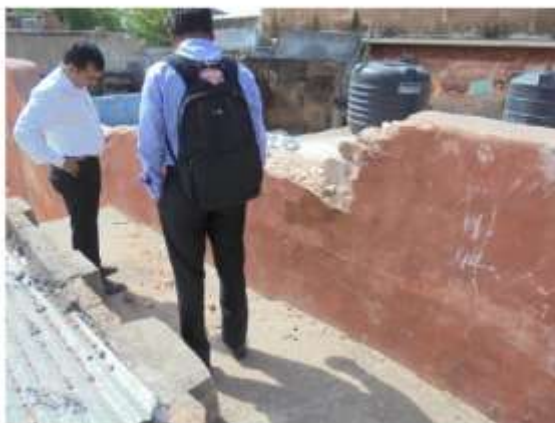
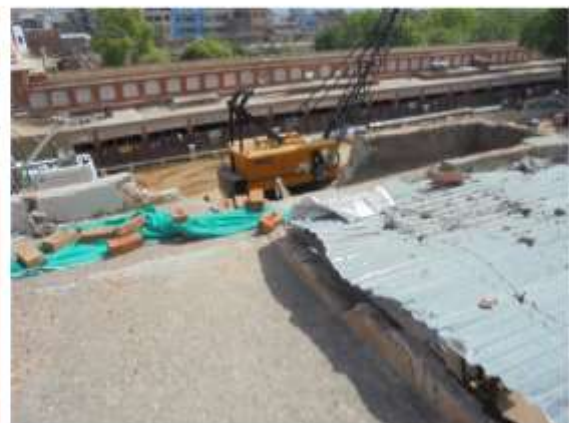
Seperation cracks were also observed which indicate tilt and seperation of the wall elements.

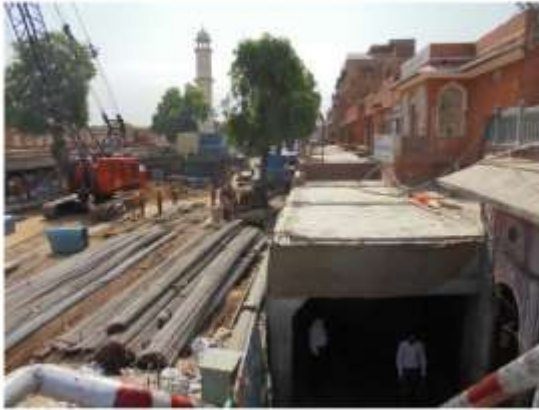
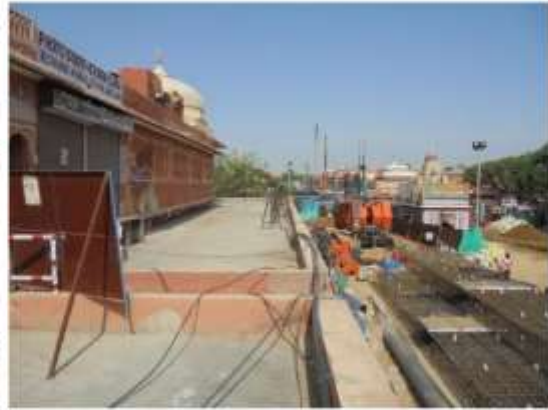
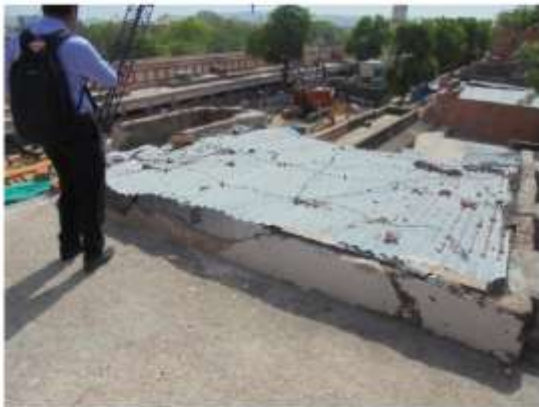
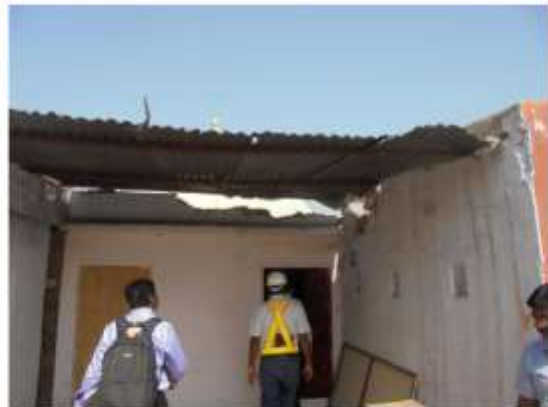
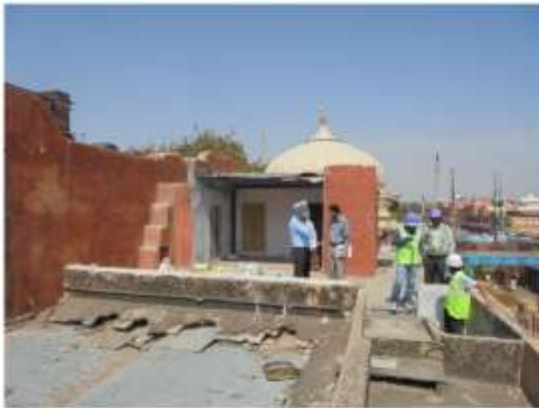
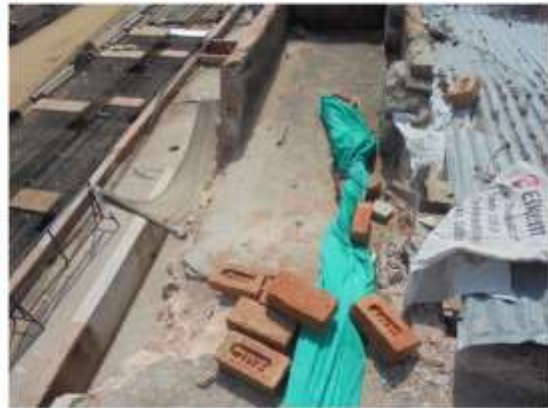
A site visit was made to inspect the shops 374 – 376 above Naval Kishor Temple due to a crane toppling incident on 7<sup>th</sup> May 2015 and hence a site visit was called upon by JMRC.

*Photographs of damaged parapet wall above shops 374 - 376 next to Naval Kishor Temple*

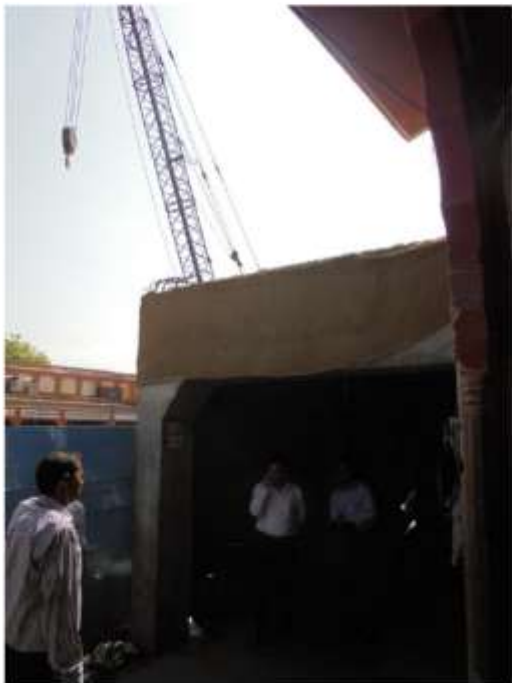
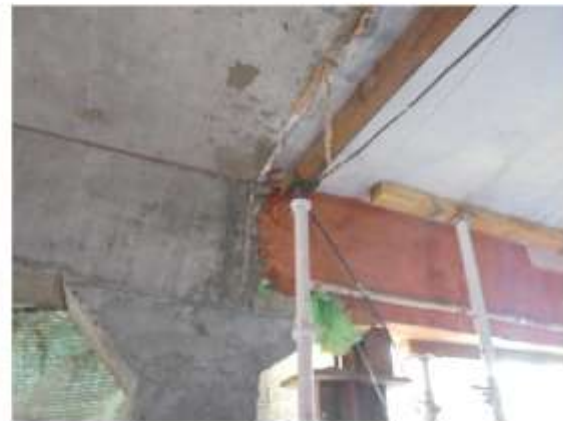
Active monitoring of these cracks has been undertaken by representatives of CEC and noted down and forwarded to JMRC and ANLA-SMA.

*Photographs of reconstruction of tripolia bazar verandah of shops from 370-374*

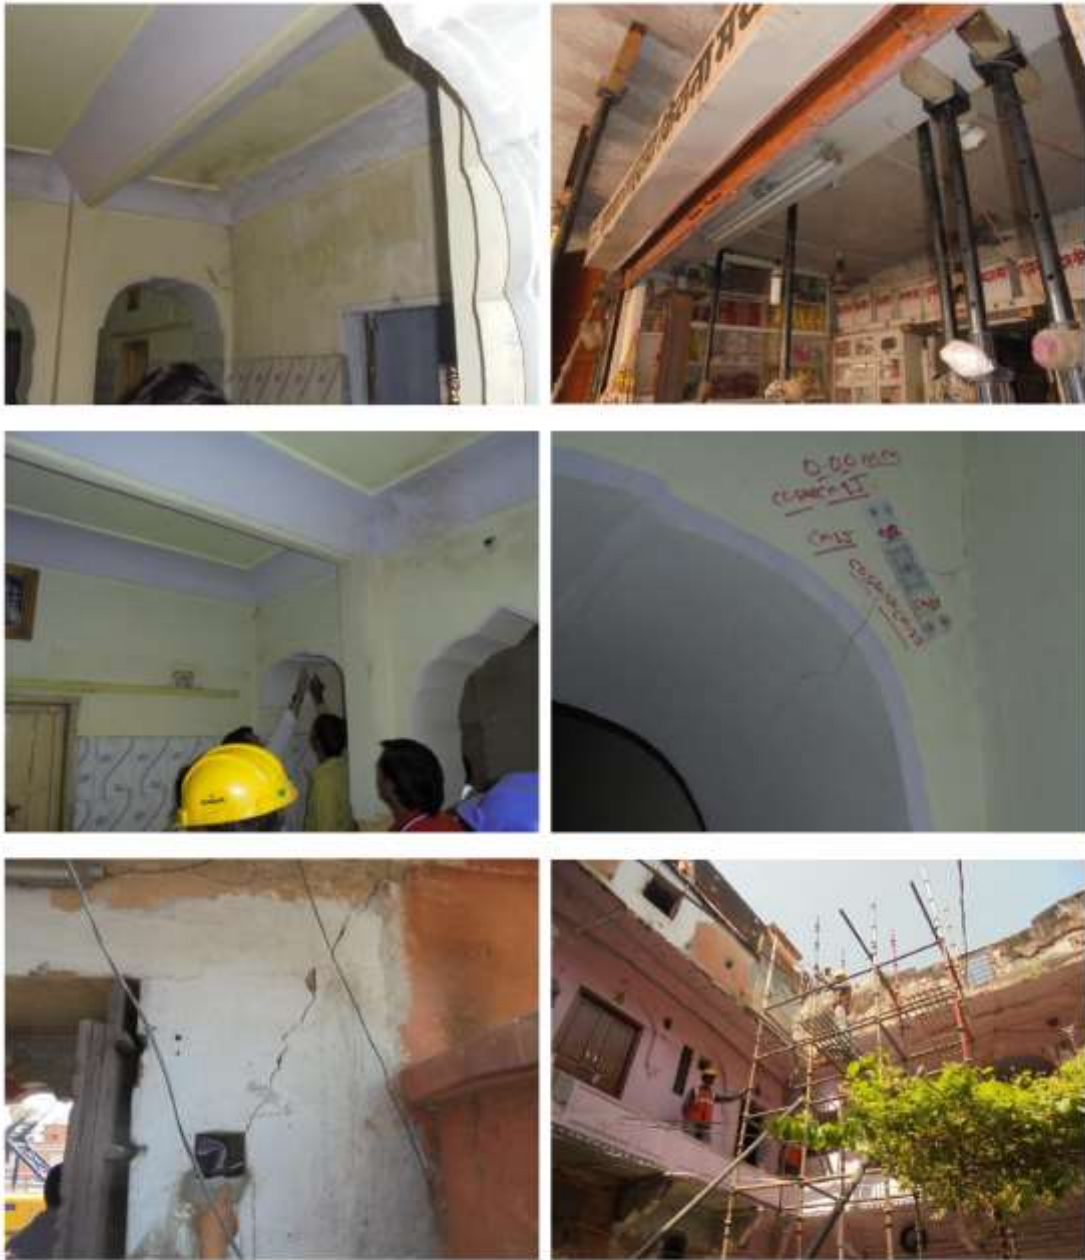
*Photographs of monitoring of cracks; development of new cracks on the inner portion of the Naval Kishor Temple due to settlement or impact of crane boom over the masonry; repairs to the upper parapet been executed; propping of*

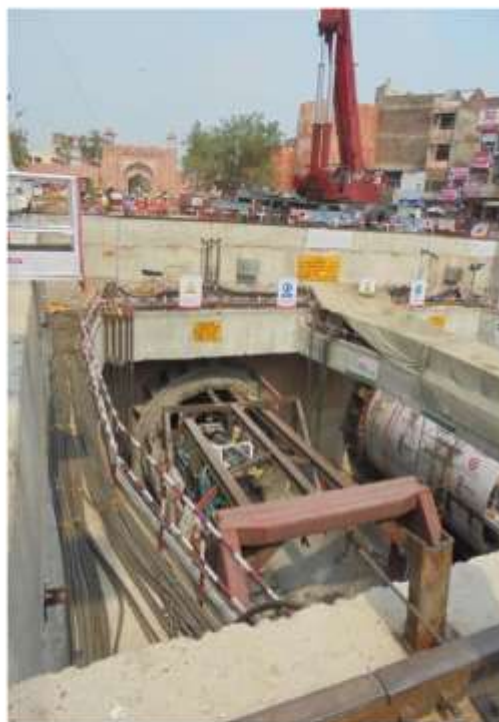
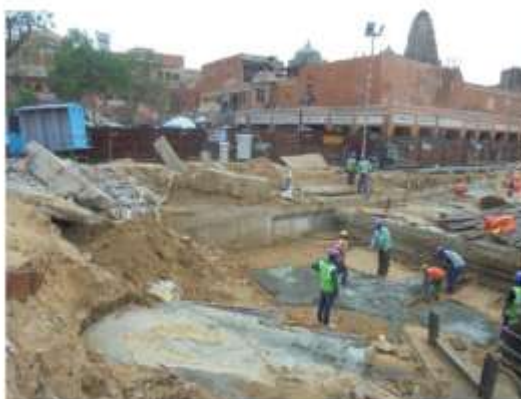
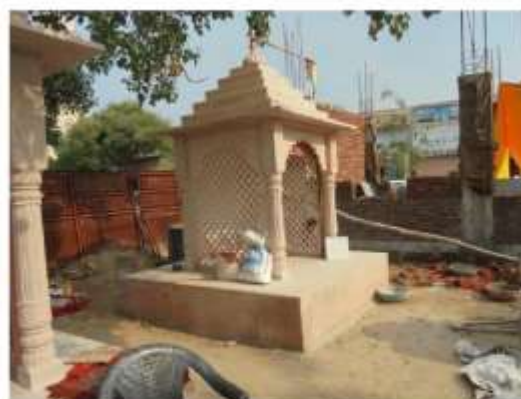
The seven temples that were dismantled along the Choti Chaupar have been shifted to Old Attish Marg and shrines have been built in consultation with the local priests by JMRC representatives.

Right: Picture showing the construction of the D- Wall at Choti Chaupar

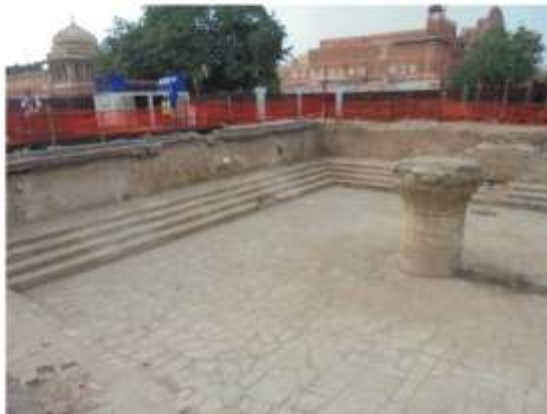
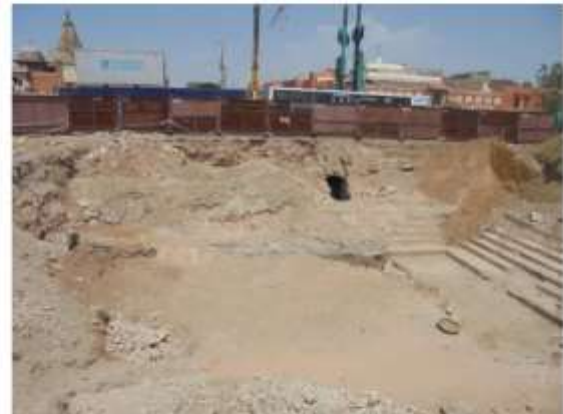
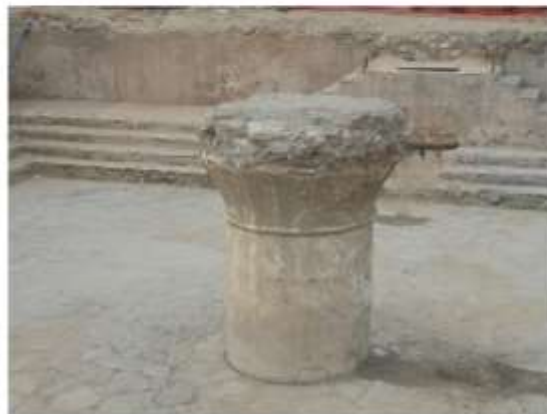
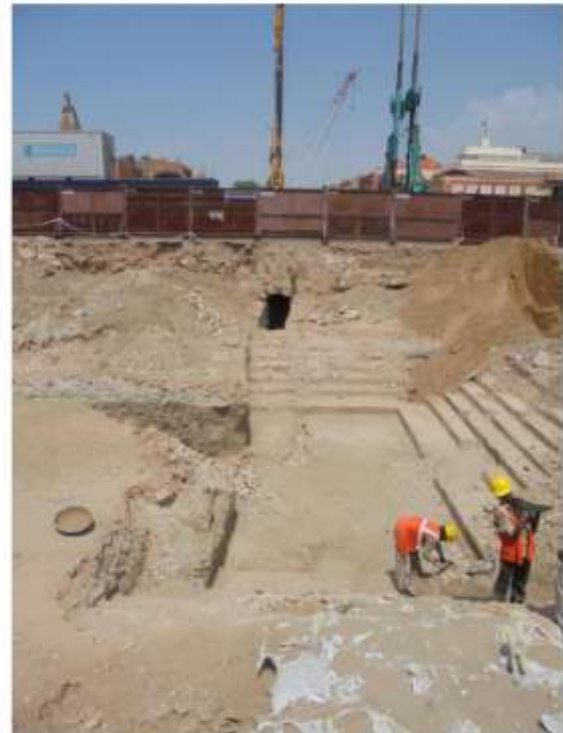
Photographs of excavation and restoration process been undertaken for Badi and Choti Chaupars

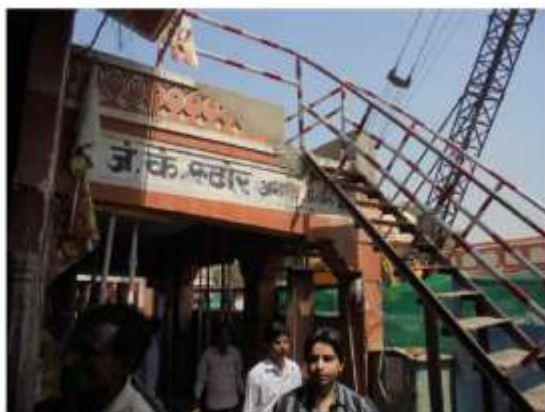
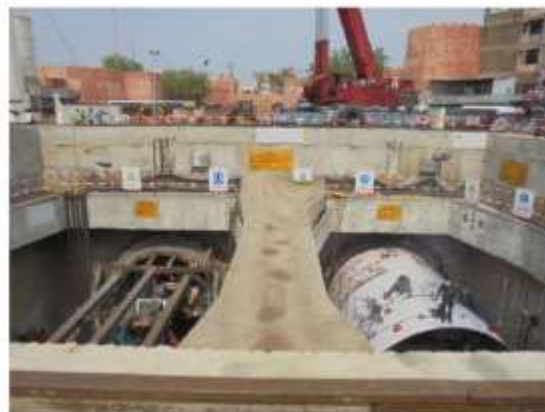
Activities on preservation and restoration of heritage structures: Presently no preservation or restoration of the heritage structures is underway. The excavations of Badi and Choti Chaupars have brought out the historic layering and identified the periods for both the tanks.

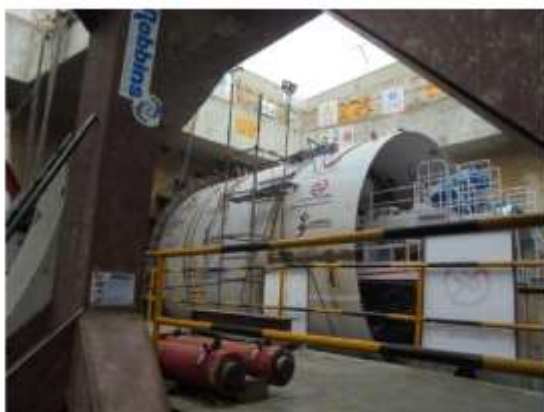
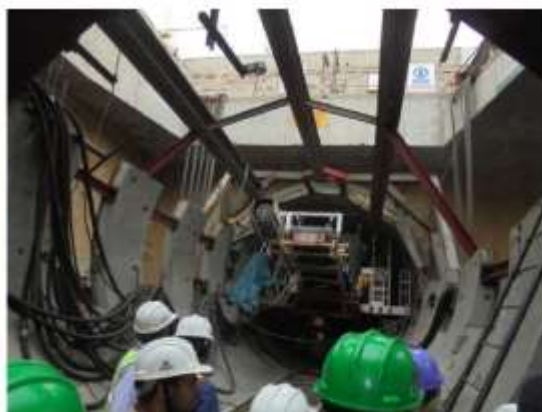
Structural propping of shops and adequate structural strengthening of shops and verandahs are currently underway.

It was also noted that for chandpol gate, additional structural support system will have to be provided while tunneling underneath the gate by structural consultants SMA. JMRC representatives have approached the State Archeology Department Jaipur circle for permission to carry out excavations under the chandpol gate. CEC representatives had approached IIT as consultants to review the structural inputs provided by the consultants. After approval from IIT and submission of their report, the State Archeological Department has given permission to carry out activities to the JMRC officials. However the structural consultants – SMA have advised and instructed that the grouting process be carried out by proper channeling and licensing firms.
