MON: Western Regional Road Corridor  
Development Project – Phase I

**ENVIRONMENTAL MONITORING  
INCEPTION REPORT**

**(Packages I & II and Package V)**

**Revised on March 2013**

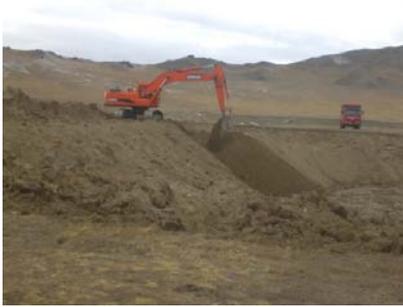
Borrow pit rehabilitation process

As there were not many activities except several bulldozers working on rehabilitation of borrow pits along the road alignment (N48 39 7.6; E89 58 16.3). The road base was built along the road alignment from Ulgii to Tolbo Lake. The work of restoration of borrow pit was at the technical rehabilitation stage: fill up the digged area with earth. There was not found topsoil piles to cover after the holes have been filled up. Once there is no topsoil conserved for biological rehabilitation, the constructor would need to recover the mined area into its natural condition through planting perennials and native grass.

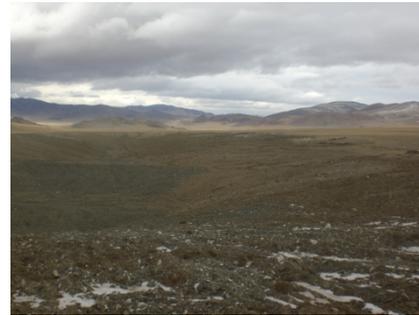
Technical rehabilitation completed

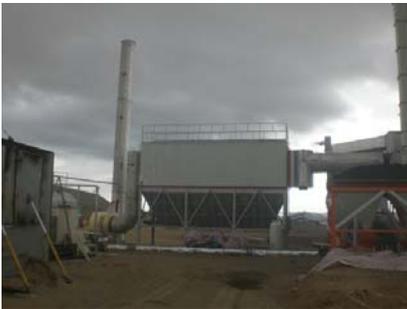
Bitumen plant with emission control

As explained its field officer, the contractor has installed a newly obtained bitumen technology with emission control to avoid harmful emission to ambient air. When next construction season starts, its performance needs to be checked and if found effective, the project should encourage contractors use this type of bitumen technology.

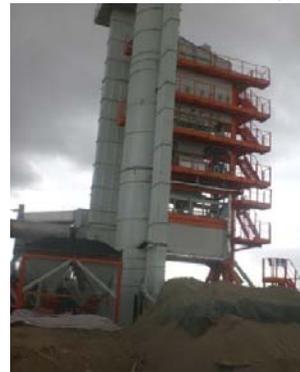
A part of bitumen plant

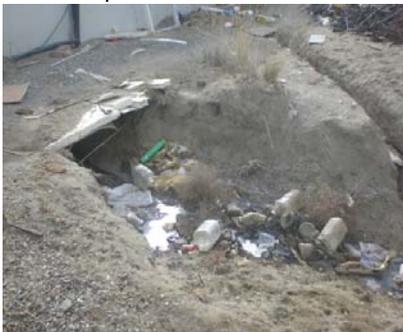
Solid waste is an issue

Soil pollution by household solid waste is common situation in all camping areas (Camp in Altai soum, Camps #28, 42, and 76), where consultant has visited. In areas far from surface water it poses less pollution. However, in limited space areas like in Bodonch canyon, all these solid waste pose serious pollution risk to River water. Oil and lubricant spills are unfortunately not being managed well in camping area. A short interview with an operator of diesel distribution vehicle regarding accidental oil spilling, did not bring a satisfaction. Temporal disposal area for solid waste and waste water should be selected considering the following factors: not to threat to underground water, away from flash flooding risk areas, and avoid open air disposal site (to barrier entrance of wild animals)

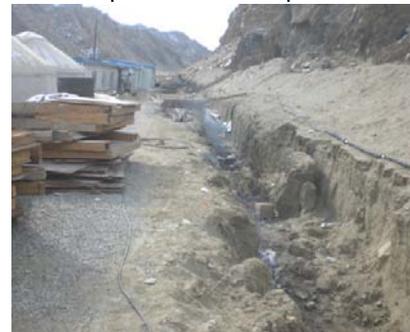
Canals for waste disposals

Solid waste and waste water: No treatment facility for waste water. Waste water and solid waste are commonly disposed through a canal with size of two meters in depth and width, which surrounds the camp area and is also used as a barrier against trespassing outsiders. During summer, when gets hot, waste water and solid waste disposed into canal can be a source of diseases and unpleasant odor.

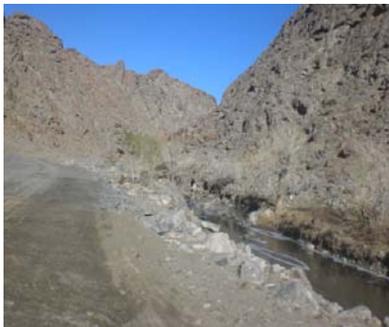
Elm trees for removal in Bodonch Canyon

There are quite many cases, when growing old trees are required to either cut or replace. As noticed, contractor is also seriously taken care of this. All trees, which need replacement, were numbered and consulting with local people, where to move and plant. In meeting with Altai soum administration, it also interested in re-planting these removed trees in soum center. This activity can serve as a good initiative of cooperation between contractor and

local population to involve them in nature conservation. So, it needs professional or experienced people/approach for removing/replanting old but valuable for local community trees. While visiting local administration building, I have witnessed some not successful attempts for replanting old trees. Practical training is needed for this community as most of them have a little practice for cropping and vegetable growing.

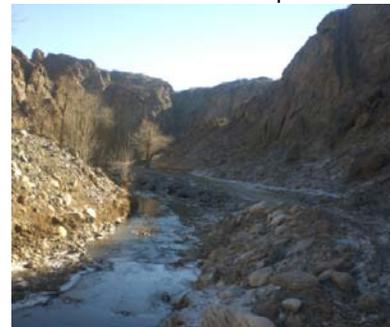
Bunch of elm and willows for removal

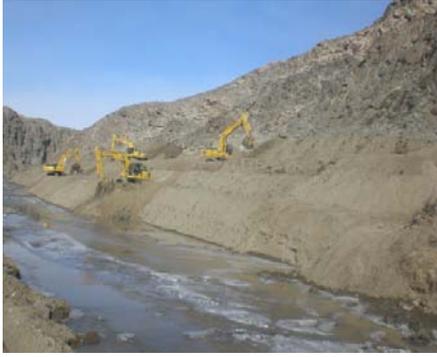
Excavators working on earth slope

As most of Bodonch Canyon have steep slopes, it needs careful approach for stabilizing the rocks and soil, after the making the space. Especially, slopes created by the constructor in dimension of 350 meter long and 20 meters wide (N46 4 42.7; E92 30 54.1 ) and 470 x 15 m (N46 5 46; E92 30 8.8) should be re-vegetated with native grasses and perennials. Thus, it can reduce landslide risks in this steep area.

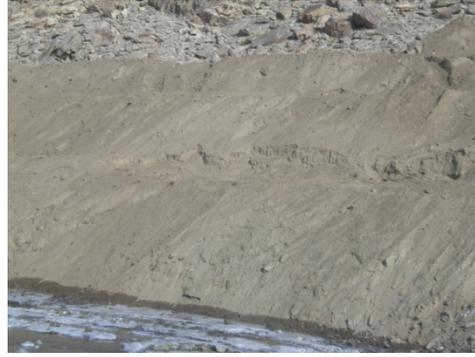
Slopes need re-vegetation

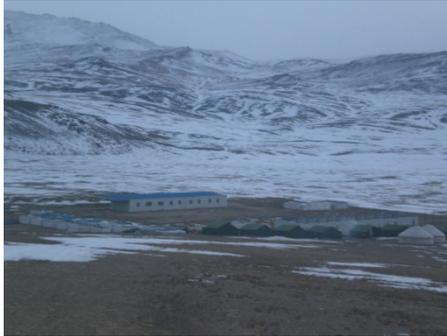
View on Tsahiurt camp (Package 2 area)

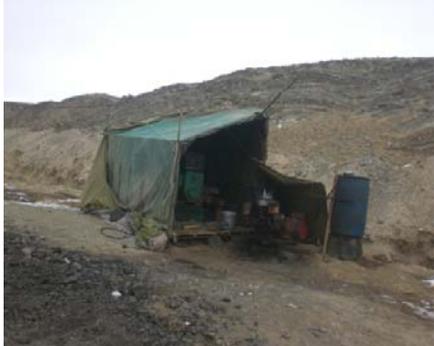
A diesel generator for electricity

Energy: the camp is established to function during warm season. However, it was heated with electricity, which goes from a generator, mounted in the camp.

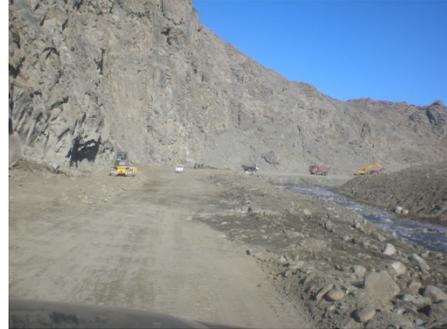
View of construction work in Bodonch Canyon

As identified during the first visit to project site, one of major environmental direct impact during construction period is the pollution of drinking water. It was obvious especially in complex terrain area of Bodonch Canyon. All local herders with population of about 300 ( 80 households ) use their drinking water directly from the Bodonch River, which lies along the road alignment in length of about 90 kilometers. Local herders are the major sensitive receptor of this impact. The water pollution is caused by the following reasons during the construction phase:

- Cut and fill operation along the water stream
- Blasting of rocks and cliffs for widening for road alignment
- Accidental spills of oil and petroleum of construction machineries
- Leakage of waste water and solid waste of construction camps
- Diversion of water stream to construct the road

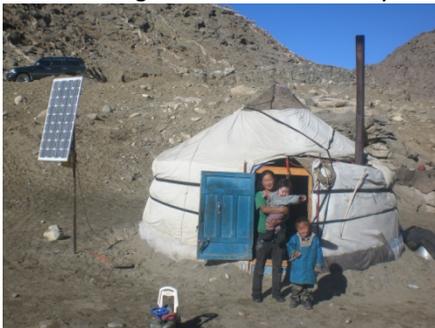
Herders households located in between River and Road alignment

Bodonch Canyon is home of rich wildlife and nationally and globally threatened species such as Argali sheep, ibex, and snow leopard. It also shelters about 30 herder households of Altai soum and 50 herder households of neighboring Must soum of Khovd aimag. They are constantly living along the Bodonch River and pastures along river basin are the main source of fodder for their herds.

All these inhabitants are using water for their all needs from Bodonch River, where road construction takes place. With this circumstance, construction activity should be well

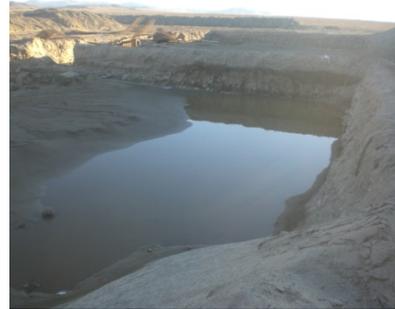
Water from river is used for sand washing in a Crushing plant

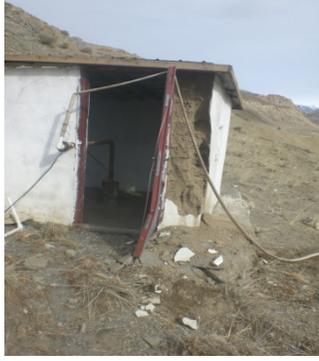
View in drinking water pump

- Existing water wells and springs would be clearly marked to prevent accidental damage from construction vehicles.
- To organize a public meeting among local herders-drinking water consumers in Bodonch Canyon area with a purpose to introduce the construction methods and schedule of operation (weekly and daily) along the water stream and agree with water consumers when drinking water would be accessible. The recommendation is no operation takes place during 4- 7 AM daily, which allows water consumers to take relatively clean water from the Bodonch River.

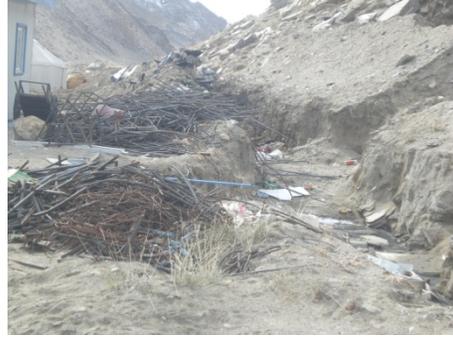
Storage of construction materials
