# Environmental Monitoring Report

Semi-Annual Environmental Monitoring Report  
( January – June 2017)

## Loan 3173-VIE: Integrated Rural Development Sector Project in the Central Provinces - Additional Financing

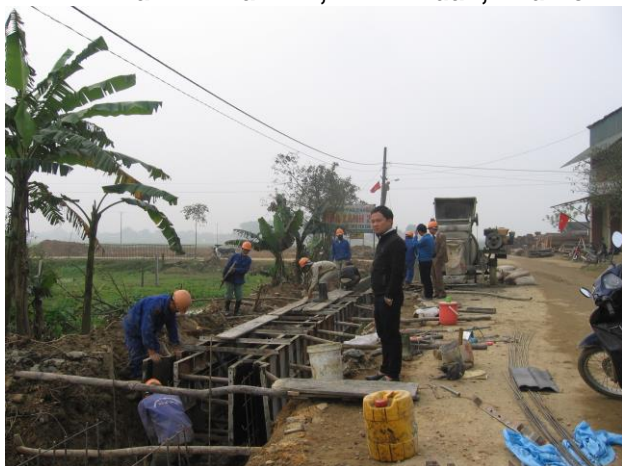
Lot 1 :Repairing and upgrading irrigation and transportation works in Duc Tho district –at Duc Tho Commune ( 2 Mar 2017)

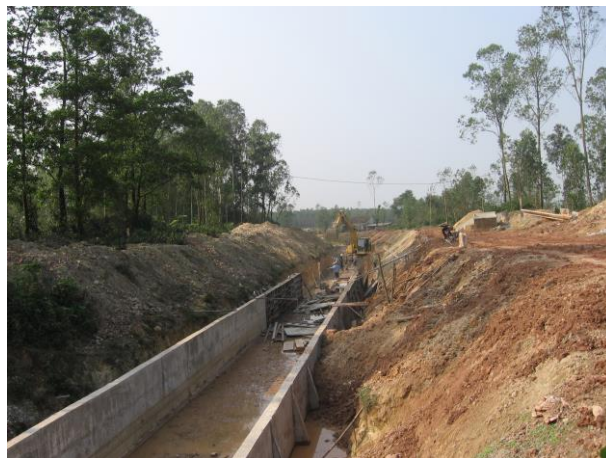
Rac river subproject –Km 4+000 ( 2 Mar 2017)

- The contractors of Rac river canal subproject in Ha Tinh, Du Du reservoir & Quao river canal subproject in Binh Thuan are requested to store oil drums and empty oil drums in a suitable storage area to avoid oil leakage on the soil and water contamination.

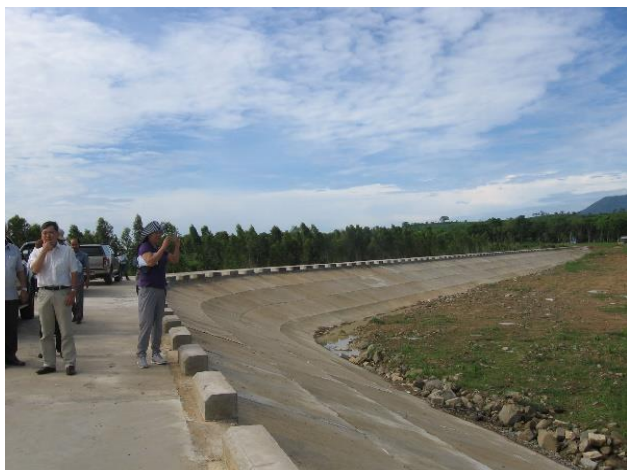
At Du Du Dam after upgraded

Inappropriate excavated soil in Upgrading Du Du Reservoir Subproject, Binh Thuan province	<ul style="list-style-type: none"> <li>- Collect and transport all excavated soil to disposal areas;</li> <li>- Levelling road surface to avoid traffic accident and obstruct;</li> <li>- Consulted with local people since construction operation and maintenance road passing Minh Tien village to ensure traveling condition for local people</li> </ul>	Contractor, CSC and PPMU Binh Thuan	<p>Immediately</p> <p>As it is in due</p>	Implemented

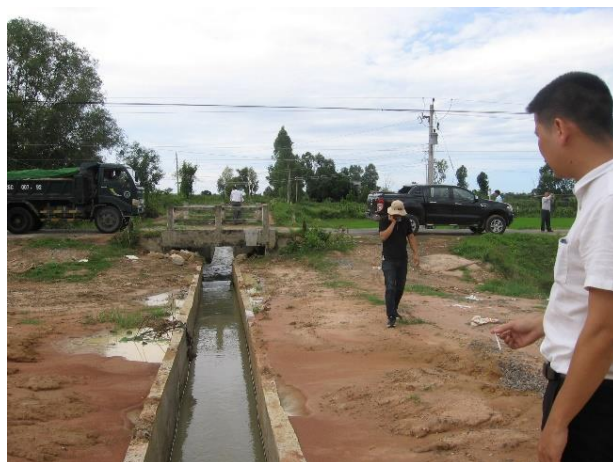
Canal N 29 - Du Du irrigation canal system

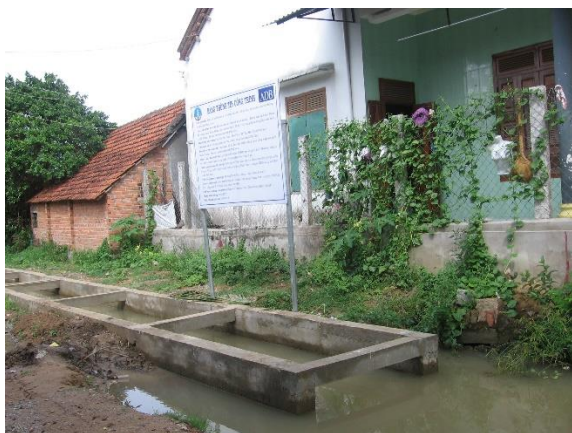
Dong Cam primary canal –at Km 0+857

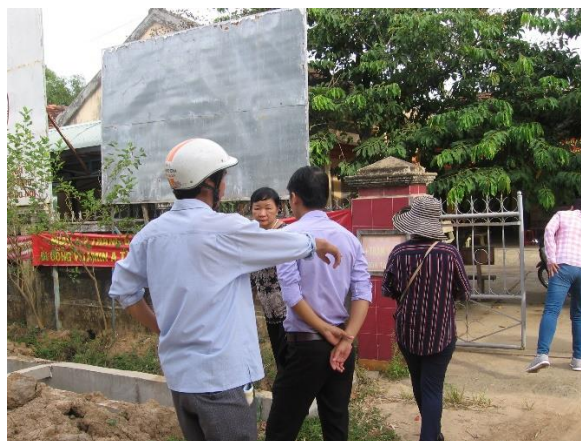
Dong Cam branch canal – passing through Hoa Tan Tay Commune's Health Care Centre

<b><i>Improper excavated soil management</i></b>			
a. The contractor Dong Cam subproject, Lot 1, to remove excavated soil in front of Health Care Center, Hoa Tan Tay Commune.	10 July 2017	Lot 1, Dong Cam canal's contractor	Phu Yen PPMU

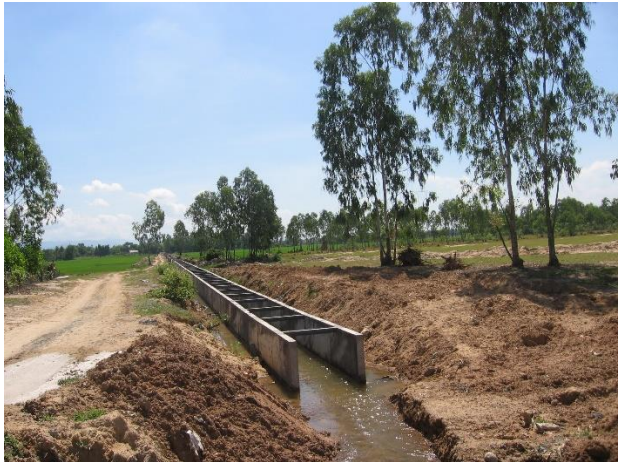
Canal N6 of Nui Mot Reservoir in Nam Tay Mot –Tan Nhon Commune-An Nhon District

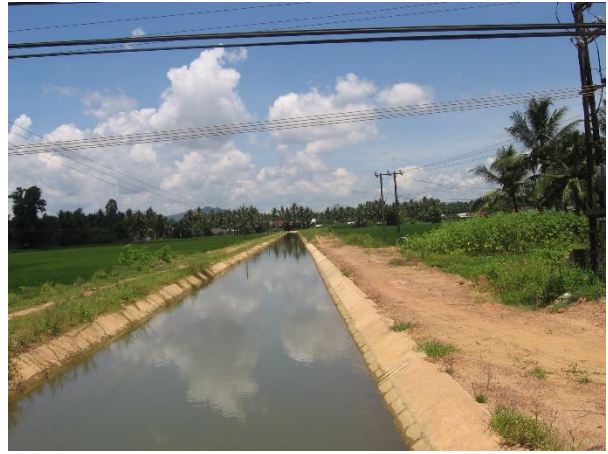
Lai Giang main canal at Km 1+000

Inadequate drainage design of Upgrading Lai Giang Dam's primary canal Subproject in Binh Dinh province	<ul style="list-style-type: none"> <li>- Conduct sufficient technical assessment of 11 drainage culverts, and 3 crossing bridges;</li> <li>- Provided necessary technical adjustments to avoid flooding for 12 ha of cultivation area and affect to 600 households in Dien Duc 3 village of Hoai Tan commune;</li> <li>- Supervision performance of PPMU, technical design and CSC performance</li> </ul>	Binh Dinh PPMU, Detail design consultant and CSC  CPMU and Technical consultants of LIC and CSBs	Immediately       As it is in due	Implemented <ul style="list-style-type: none"> <li>▪ All drainage culverts &amp; crossing bridges of Lai Giang Subproject were implemented as requested community</li> <li>▪ Drainage culverts was adjusted by design consultant &amp; Binh Dinh PPMU to avoid</li> </ul>

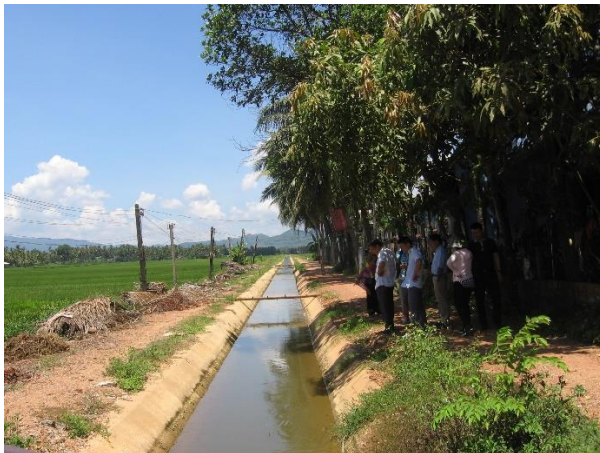
Lai Giang branch canal N2-1

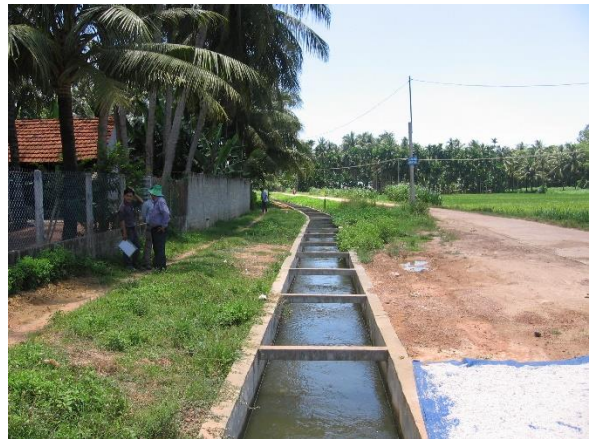
Lai Giang branch canal N2-1 Km 2+500

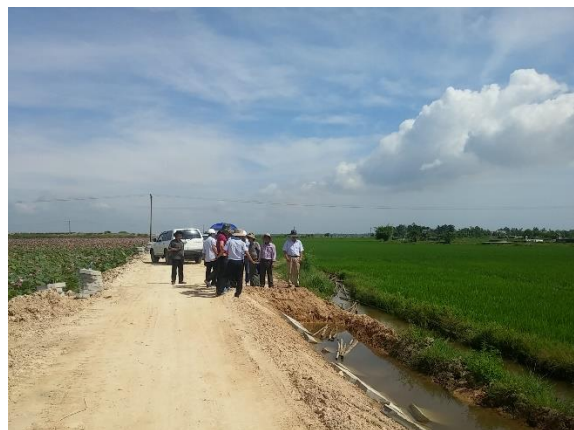
At the site of Hoi Tom Subproject

b. The contractor of East – West Hoi Tom Canal to remove excavated soil dumped at the adjacent farm	10 July 2017	Contractor	Thua Thien Hue PPMU
<b><i>5. Improper waste management</i></b>
