Initial Environmental Examination

June 2015

CAM: Provincial Roads Improvement Project

TA 7665-CAM

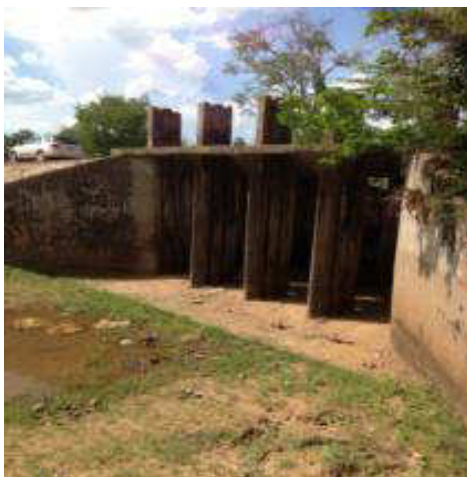
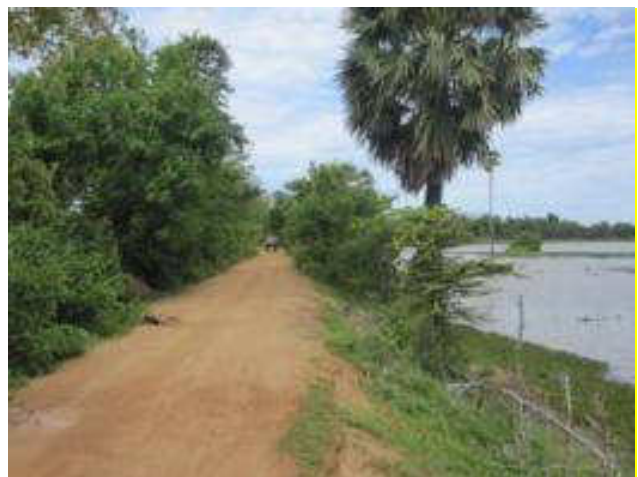
Figure 4-1: Khsaet Lake, embankment and sluice gates

86. To the south of Tuek Phos is Khsaet Lake. This was created artificially by the villagers who constructed a dam across a natural drainage basin into which a stream runs. A local road runs on top of the dam. Two sluice gates allow the captured water to overflow and be directed to the nearby rice fields.
87. The villagers wish to repair the gates and deepen the lake by excavating it further. This will increase the capacity of the reservoir and give water supplies during the dry season as well as nutrition from fish. Since the new water volume will be below the sluice gate base slab level, the new volume will need to be pumped out by the community.
88. The dredged material will be used to widen the existing embankment.

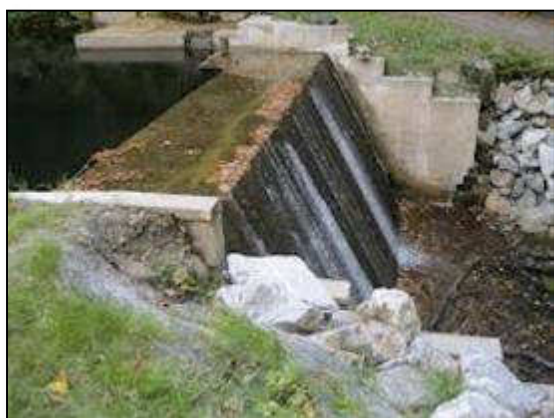
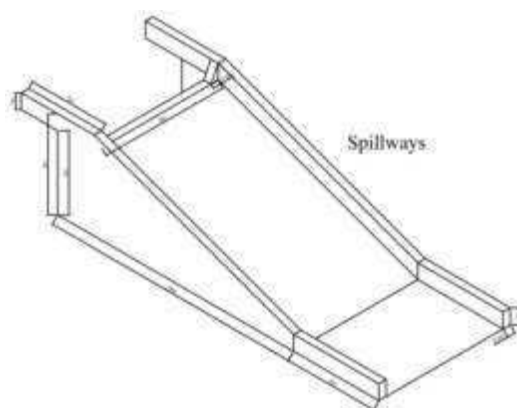
Figure 4-7: Typical Spillway

107. Existing dykes are in a bad condition and have a lot of damaged places through which water is lost for irrigation at the due time.
108. It is therefore necessary to have the dikes fixed properly and equipped with the necessary regulating structures such as spillways and gates to regulate the flow from the storage area to the down and upstream irrigation fields. The spillway will look like the sample shown below.

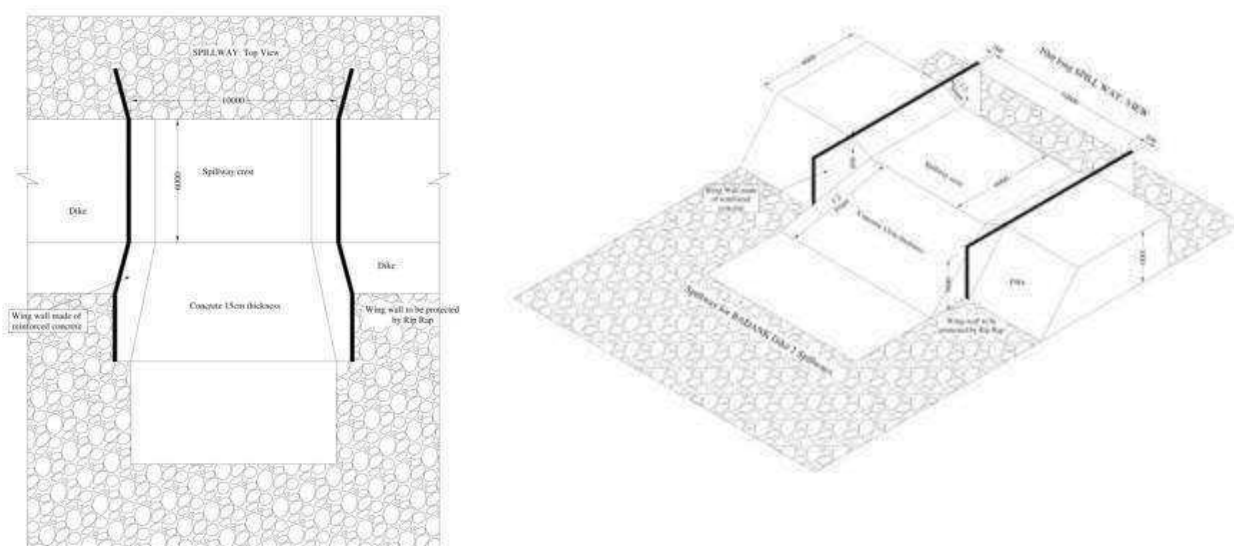
Figure 4-8: Spillway Design

113. Manually operated gates can be used but the operation of the gate needs to be monitored and recorded to allow the computation of water needs against distribution. Farmer themselves cannot do that and they need support from a NGO or Government organization. Dikes can be equipped with spillways to avoid overtopping. The spillway acts as a safety device and lets the water flow downstream before the water level overtops the dike.

116. Once the profiling and compaction have been done, the cuts can begin for the two spillways of the western dike and the spillway of the eastern dike. Once the cuts are ready, the foundation of each spillway can be concreted followed by the elevation works which include the wing walls and the crest.

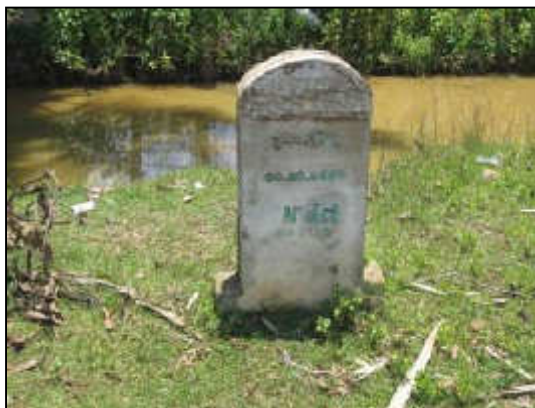
Figure 6-5: Concrete Marker Post showing Boundary of PAWS

Site surveys were carried out together with the PAWS Rangers from the Provincial Department of Environment, and the District Village Heads. A series of concrete posts were identified which mark the boundary of PAWS. Each post is numbered, states the Royal Decree and has the UTM Coordinates written on it. Some of these have been moved slightly at the request of the villagers to avoid natural features such as a drainage ditch (see Figure 6-5).

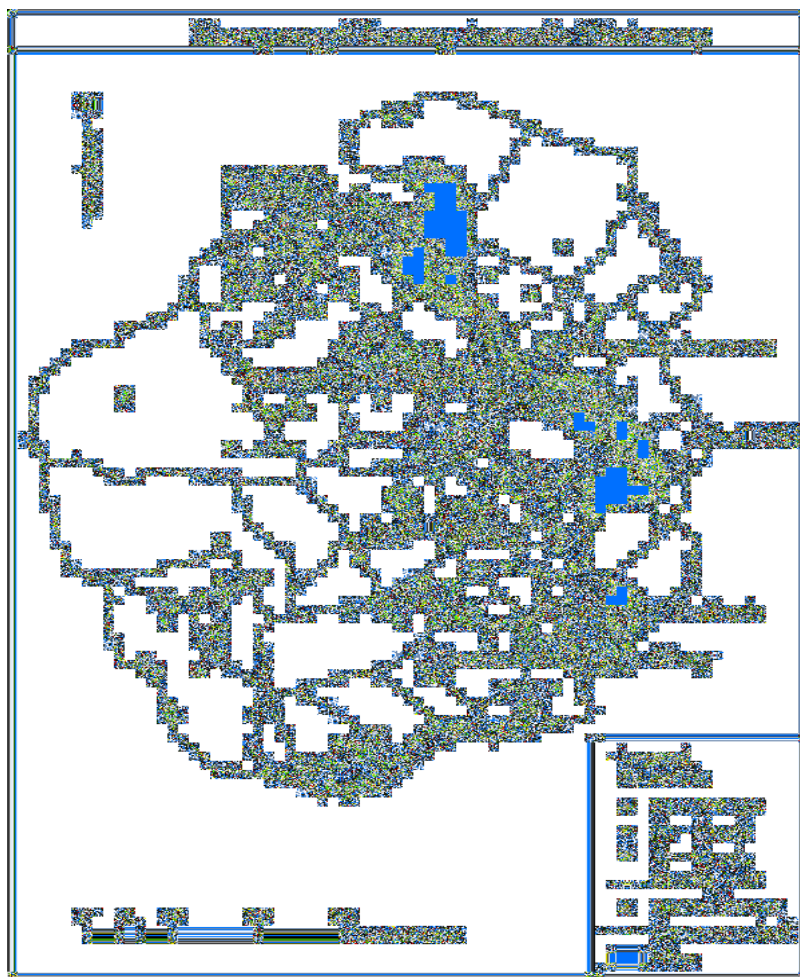
Figure 6-9: Arsenic Risk Map Kg Chhnang & Kg Leaeng

The arsenic risk map for Kampong Chhnang is given below. This was extracted from the MRD main study. It includes results for Kampong Leaeng. (See below)

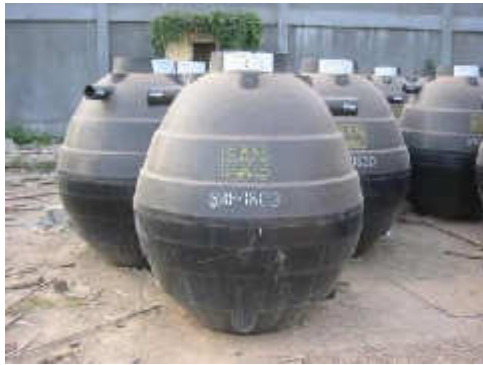
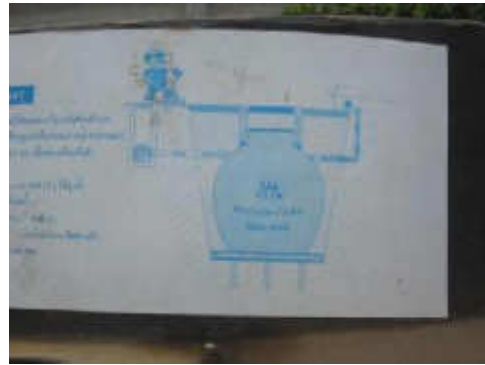
Figure 6-11: Septic Tanks Locally Available with Installation Instructions

294. Toilets must be flushed by water which connects to septic tanks. Prefabricated septic tanks must be used which have internal baffles and connect to underground soakaways. These are readily available in the local market. It is recommended that local subcontractors / builders be used to install them as they have local knowledge of soil conditions, water table depth and are low cost.

Septic tanks must be covered with concrete slabs to control odor and must have vent pipes. They must be accessible by manhole covers with grease seals to allow emptying when needed. Soakaways must be constructed below the ground surface to allow dissipation of liquid effluents and be subsurface.
