Semi-Annual Report no. 7  
For the period covered January-June 2020  
Project Number: 47381-002  
November 2020

## Sri Lanka: Mahaweli Water Security Investment Program – Tranche 1

Upper Elahera Canal Project (UECP), Part 1 of 2

## Semi Annual Environmental Monitoring Report (SAEMR) No. 07 (January to June) for Upper Elahera Canal Project (UECP)

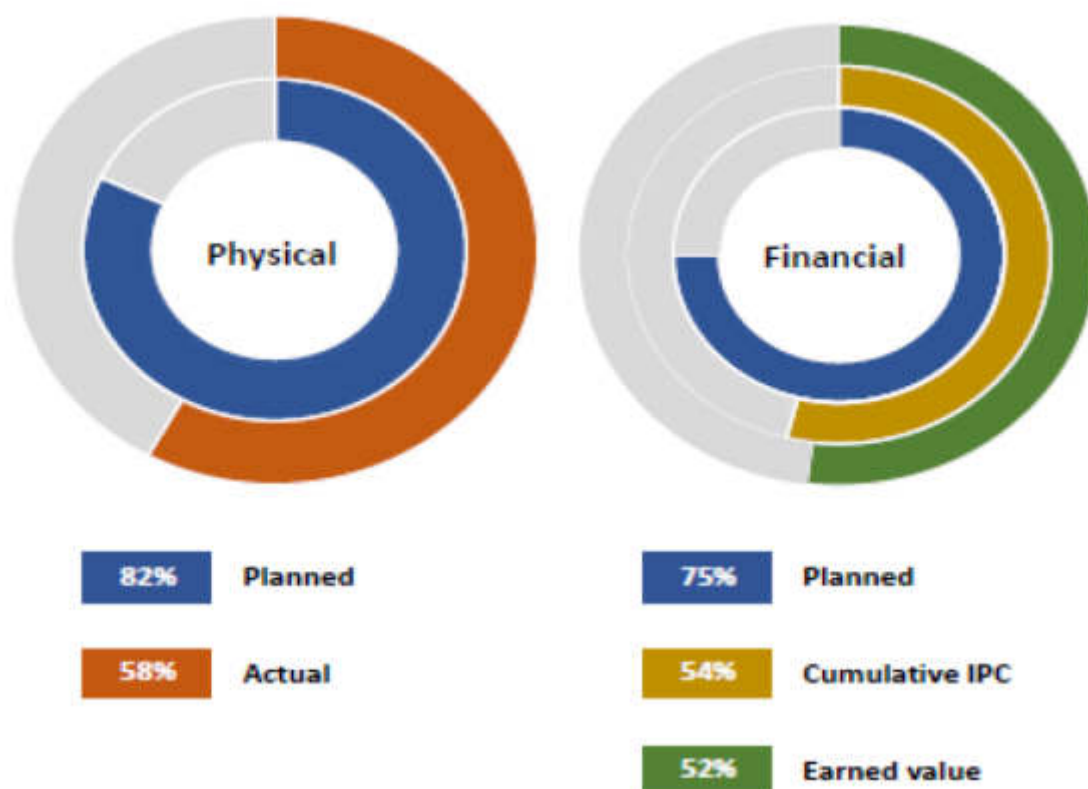
**Figure 1-1: Overall package progress of UECP-ICB-1 as of end June 2020**

9. The actual construction progress of the UECP-ICB-1 is reported as 58% and the **Figure 1-1** shows the graphical representation of the overall progress and **Table 1-3** shows the progress of the key construction work of the UECP-ICB-1 package by end June 2020.

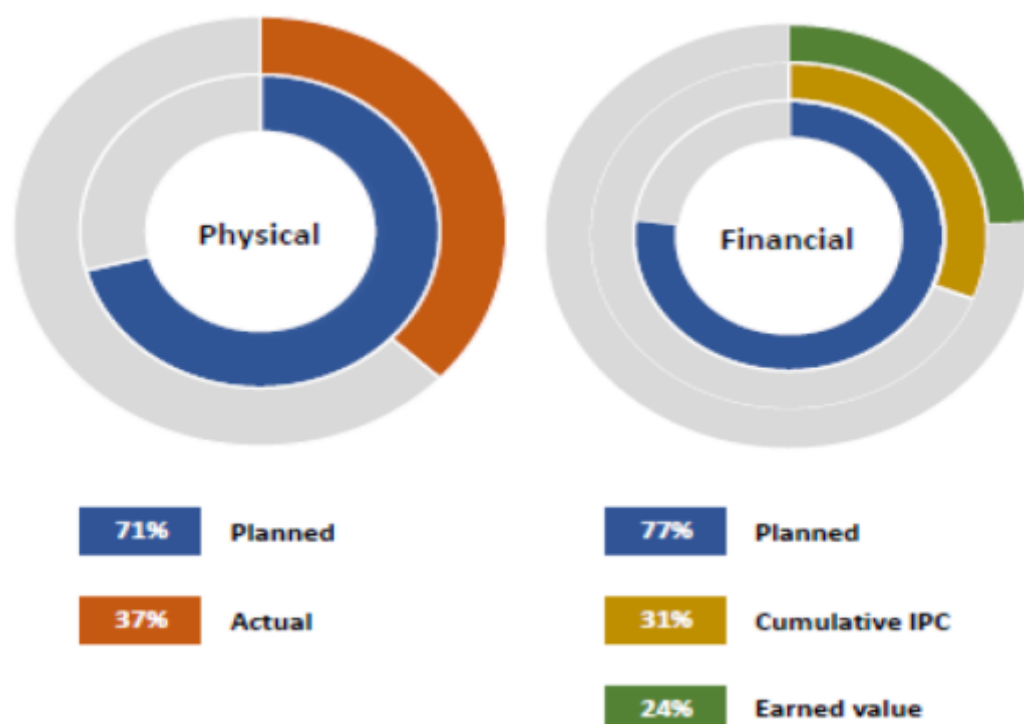
**Figure 1-2: Overall package progress of UECF-ICB-2B as of end June 2020**

Topographic surveys:	Completed 100%
Preparation of Construction drawings by Contractor:	Tunnel excavation support works 100%, Bridge 50%, Tunnel permanent support 0%, Open canal 50% , Access road 20%
Construction work:	Completed 28.50%
Concrete batching plant:	Leloya - 100% , Kambarawa - 100%
Construction activities	<ul style="list-style-type: none"> <li>Tunnel 1: 766.60 m/1910 m Excavation</li> <li>Tunnel 2: 1776.00 m / 6040 m Excavation</li> <li>Tunnel Portal of T2 Inlet, T2 Outlet and T1 Outlet excavations completed and T1 Inlet portal clearing works in progress.</li> <li>Other structures: Cut and cover excavation completed Ch: 2620-2720, construction of Bridge no 2 - 60% completed</li> </ul>

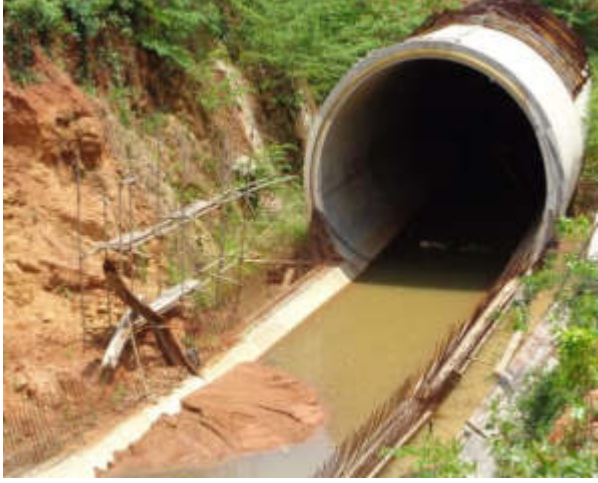
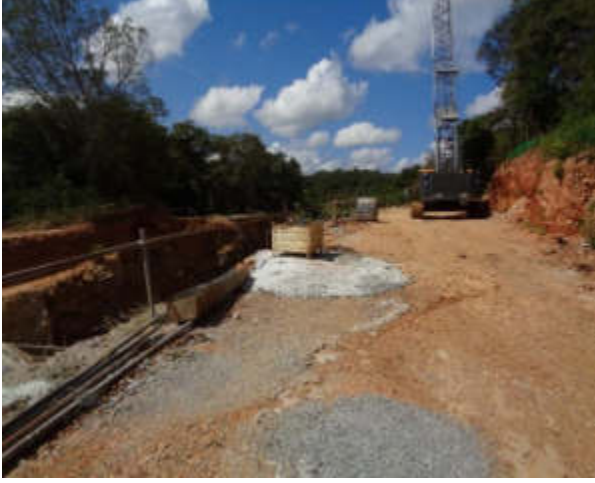
<p><b>Collapsed canal banks in section 3 (May 2020)</b></p>	<p><b>Concrete wastes are left in the site (Since March 2020)</b></p>

Abandoned safety net erected for protection of small animals	<ul style="list-style-type: none"> <li>CML to repair the safety net</li> </ul>	
	Pit at 3+980 km resulted due to construction work create risk for animals	<ul style="list-style-type: none"> <li>CML to provide with required animal protection to prevent animal falling into the pit</li> </ul>

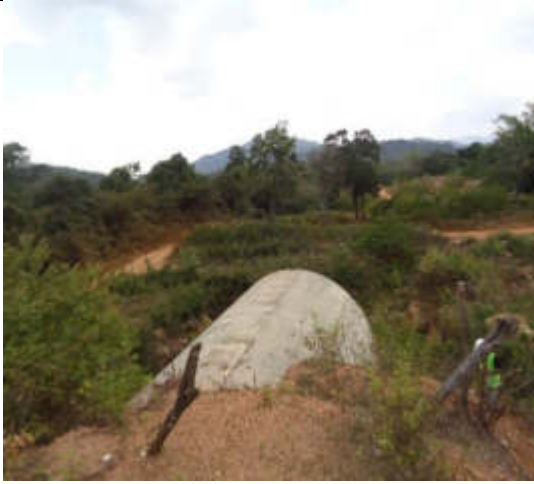
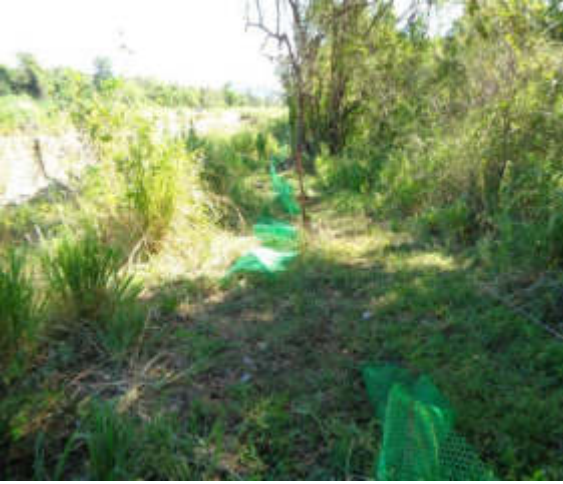
<p><b>Unsafe location for large animals at section 3 (Since January 2020)</b></p>	<p><b>Collapsed safety net at section 2 (Since March 2020)</b></p>

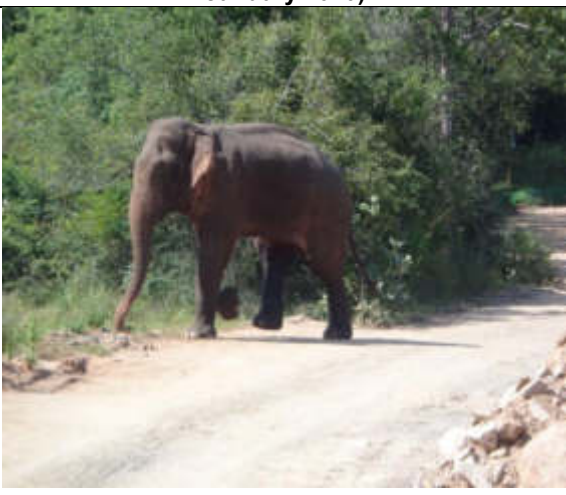
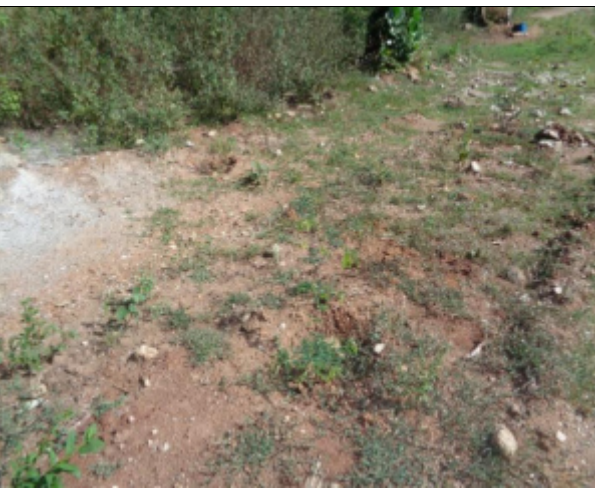
<p><b>Increased Elephant movements during the site isolated period (Since March 2020)</b></p>	<p><b>Abandoned new replanting area in section 1 (Since March 2020)</b></p>

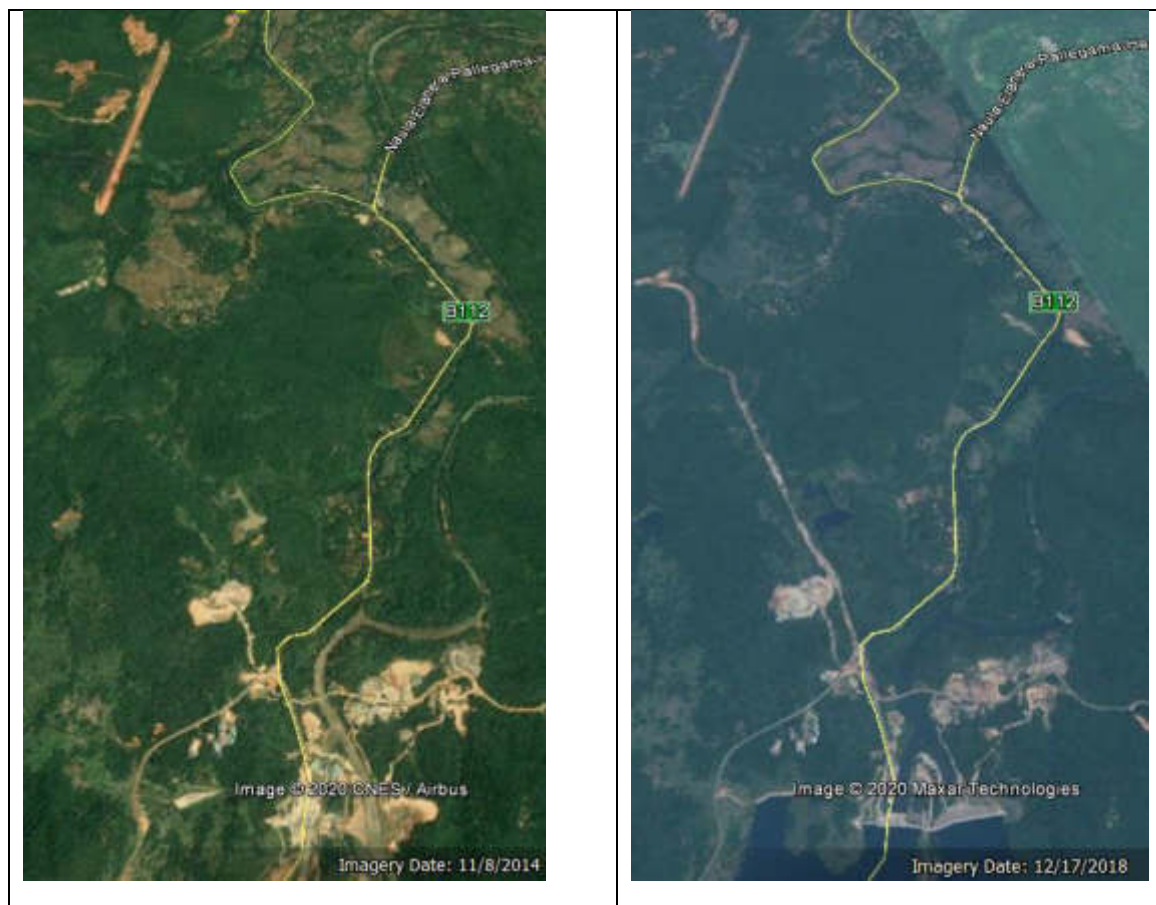
**Figure 2-2: Map showing land use of the UEC-ICB-1 project area (before and after)**

evergreen forest (undisturbed and degraded), riverine forest, marshes, scrubland, rock outcrop vegetation, grasslands etc. In addition, natural stream network is active almost throughout the year except in dry spell, associated with 3 tanks (Kirimetiya, Welankatuwa anicut and Kongketiya).
