Environmental Monitoring Report

Project Number: 45389-004
July 2019

AZE: Second Road Network Development Investment Program, Tranche 2

Upgrading of Yevlakh-Zagatala-Georgian Border road (M5), Section
Lot 1.Khaldan-Suchma (Km 0+300 to Km 33+100)

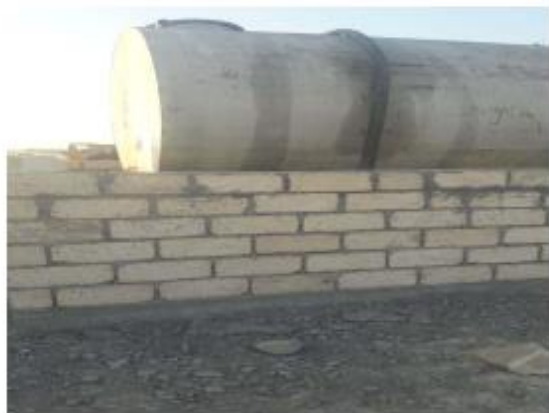
Special bounded area provided for oil production

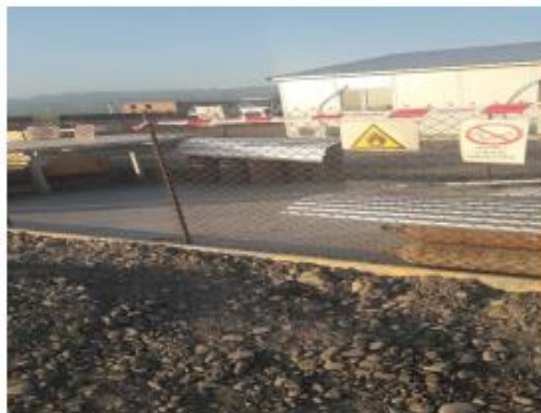
Special bounded area provided for oil and chemical production

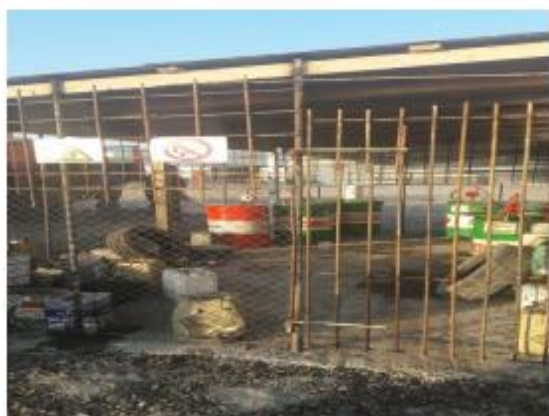
Special bounded area provided for oil and chemical production

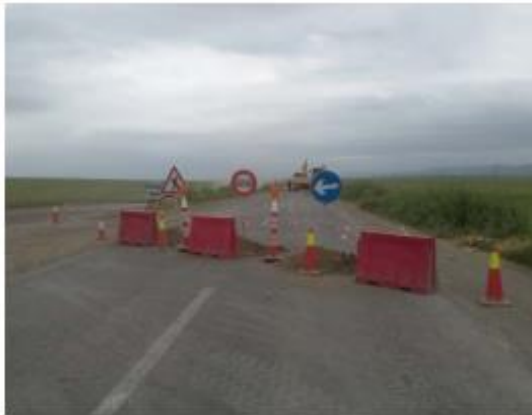
Traffic Safety Measures Provided at all Site

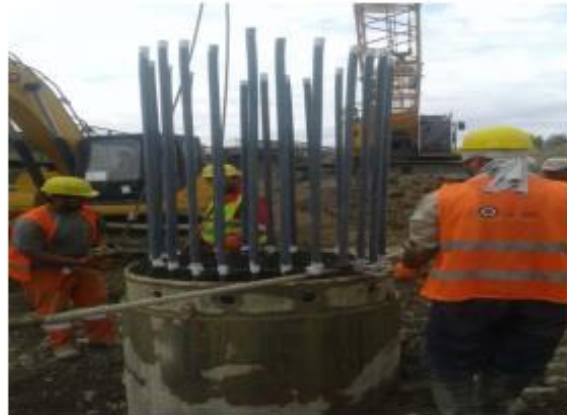
All workers use PPE

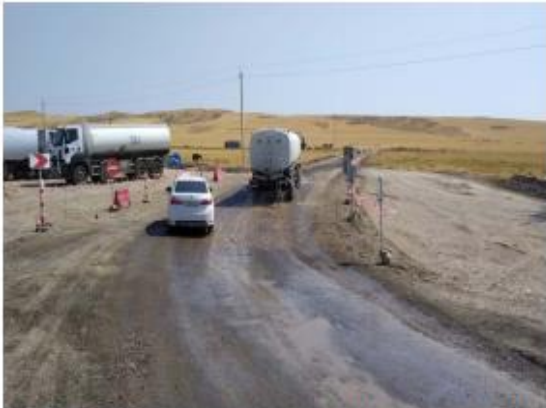
Contractor provided water tankers against dust emissions

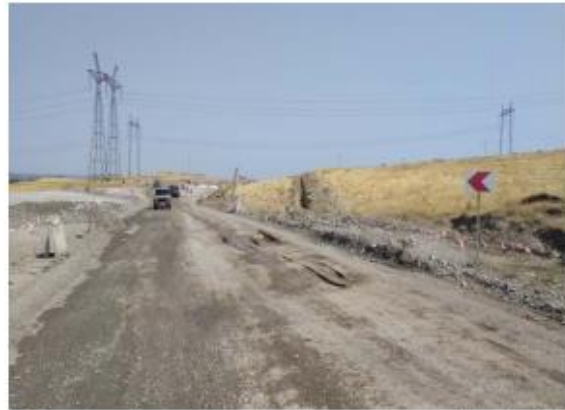
Construction site and detour roads provided with water spreading and traffic safety signs

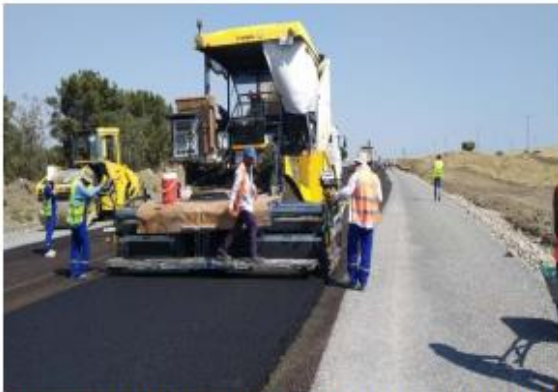
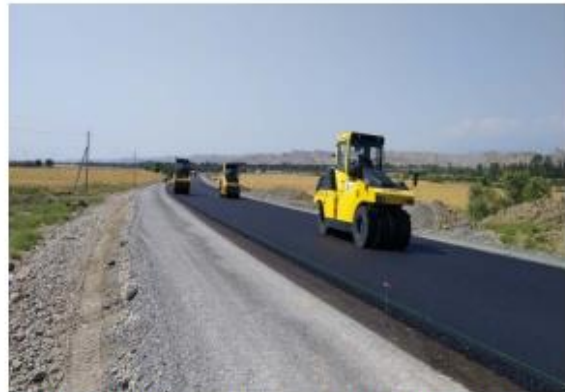
Pavement works started between km 9 and km 6, Environmental and safety measures provided

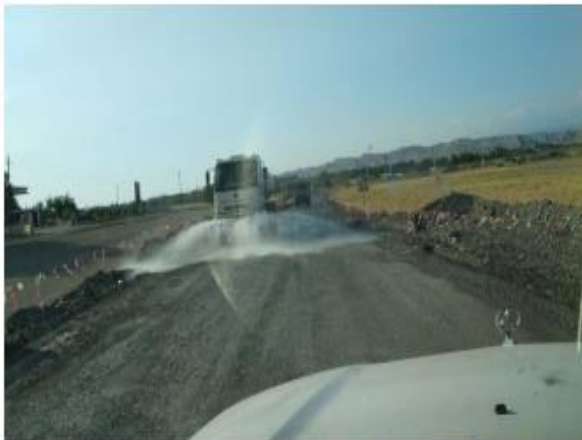
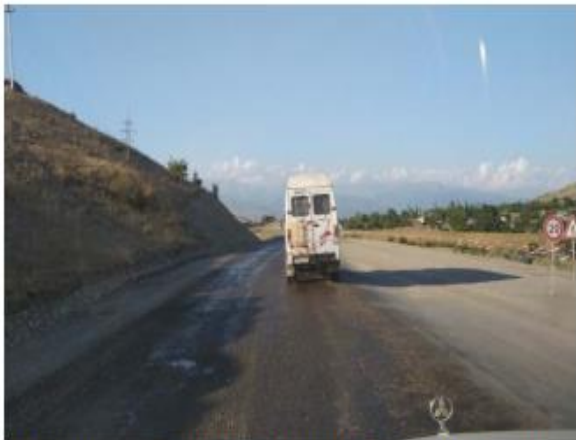
Maintenance and watering of Service / diversion roads provided

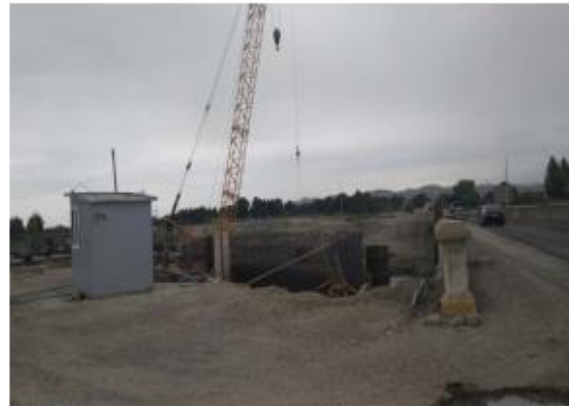
Safety measures provided at bridge construction site

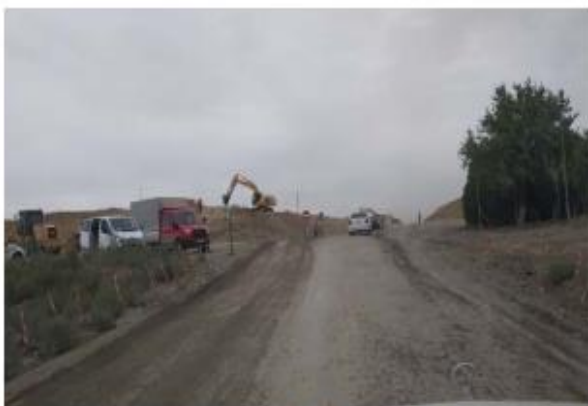
Maintenance of access roads and anti-dust sprinkler and road safety measures are provided
